Project: 002703.C | Green Hills WTF
Equipment/Material/Spec: GeoHazard Assessment

**Reconnaissance- Level Geologic Hazards Assessment
Green Hills Sewer and Water - Maple Hills WTP
922 N. Maple Street Huntsville, Utah 84317**

GeoStrata Job No. 1929-001

September 13, 2024

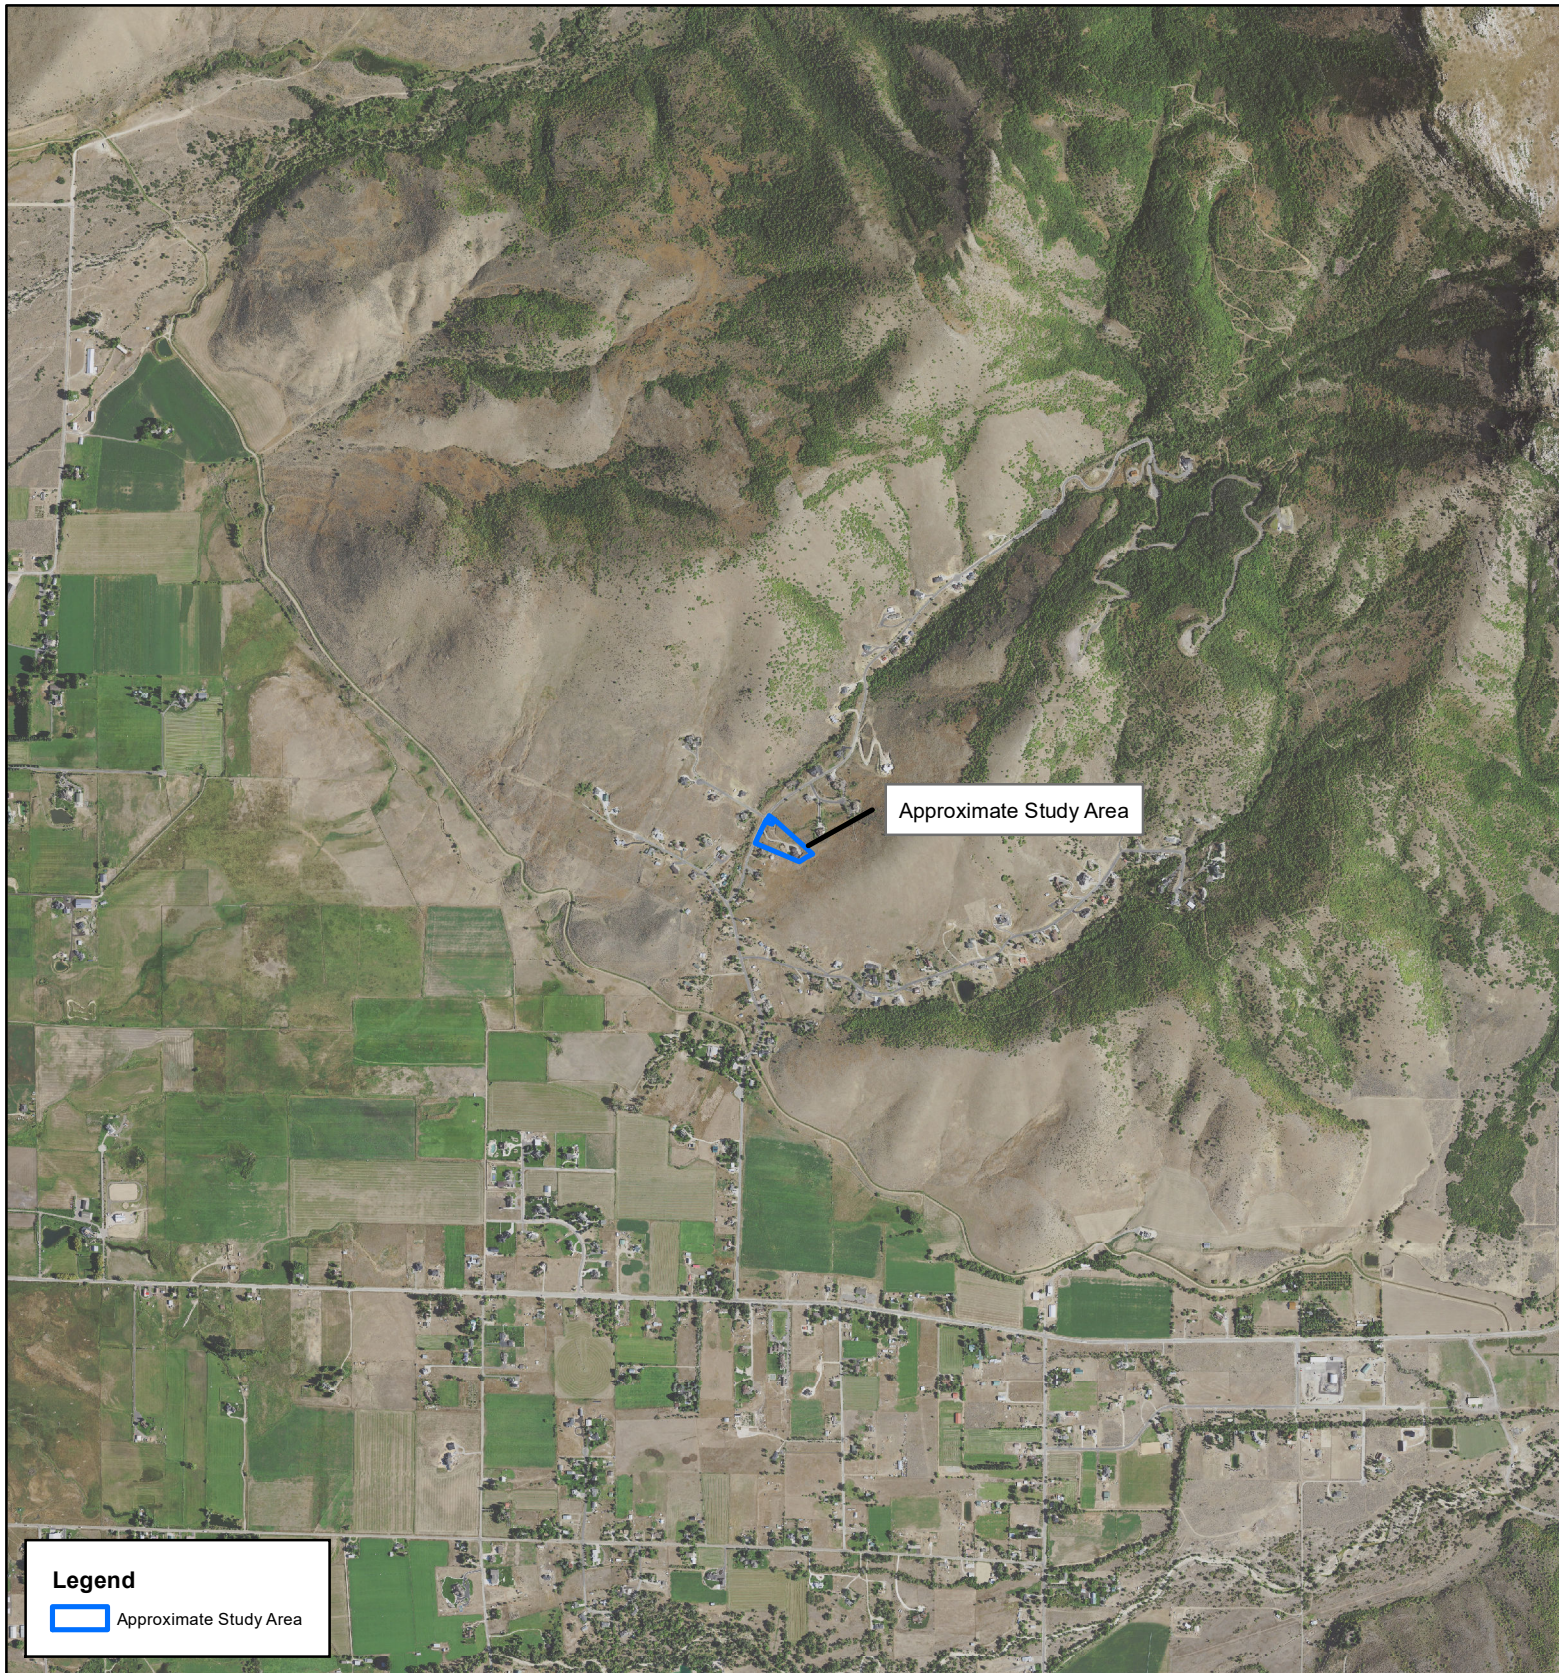
**Plate
1**

Based on our review of .6-meter 2021 aerial imagery (Plate 1 *Site Vicinity Aerial Imagery Map*), and our review of hillshade and slope imagery derived from 2016 .5-meter lidar elevation data, no bedrock outcroppings that could be a rockfall and topple source were identified in the vicinity of the subject property and no rockfall talus was observed within or adjacent to the subject property. It is the opinion of GeoStrata that rockfall and topple hazard within the subject site is considered low and should not preclude development of the proposed water treatment facility.

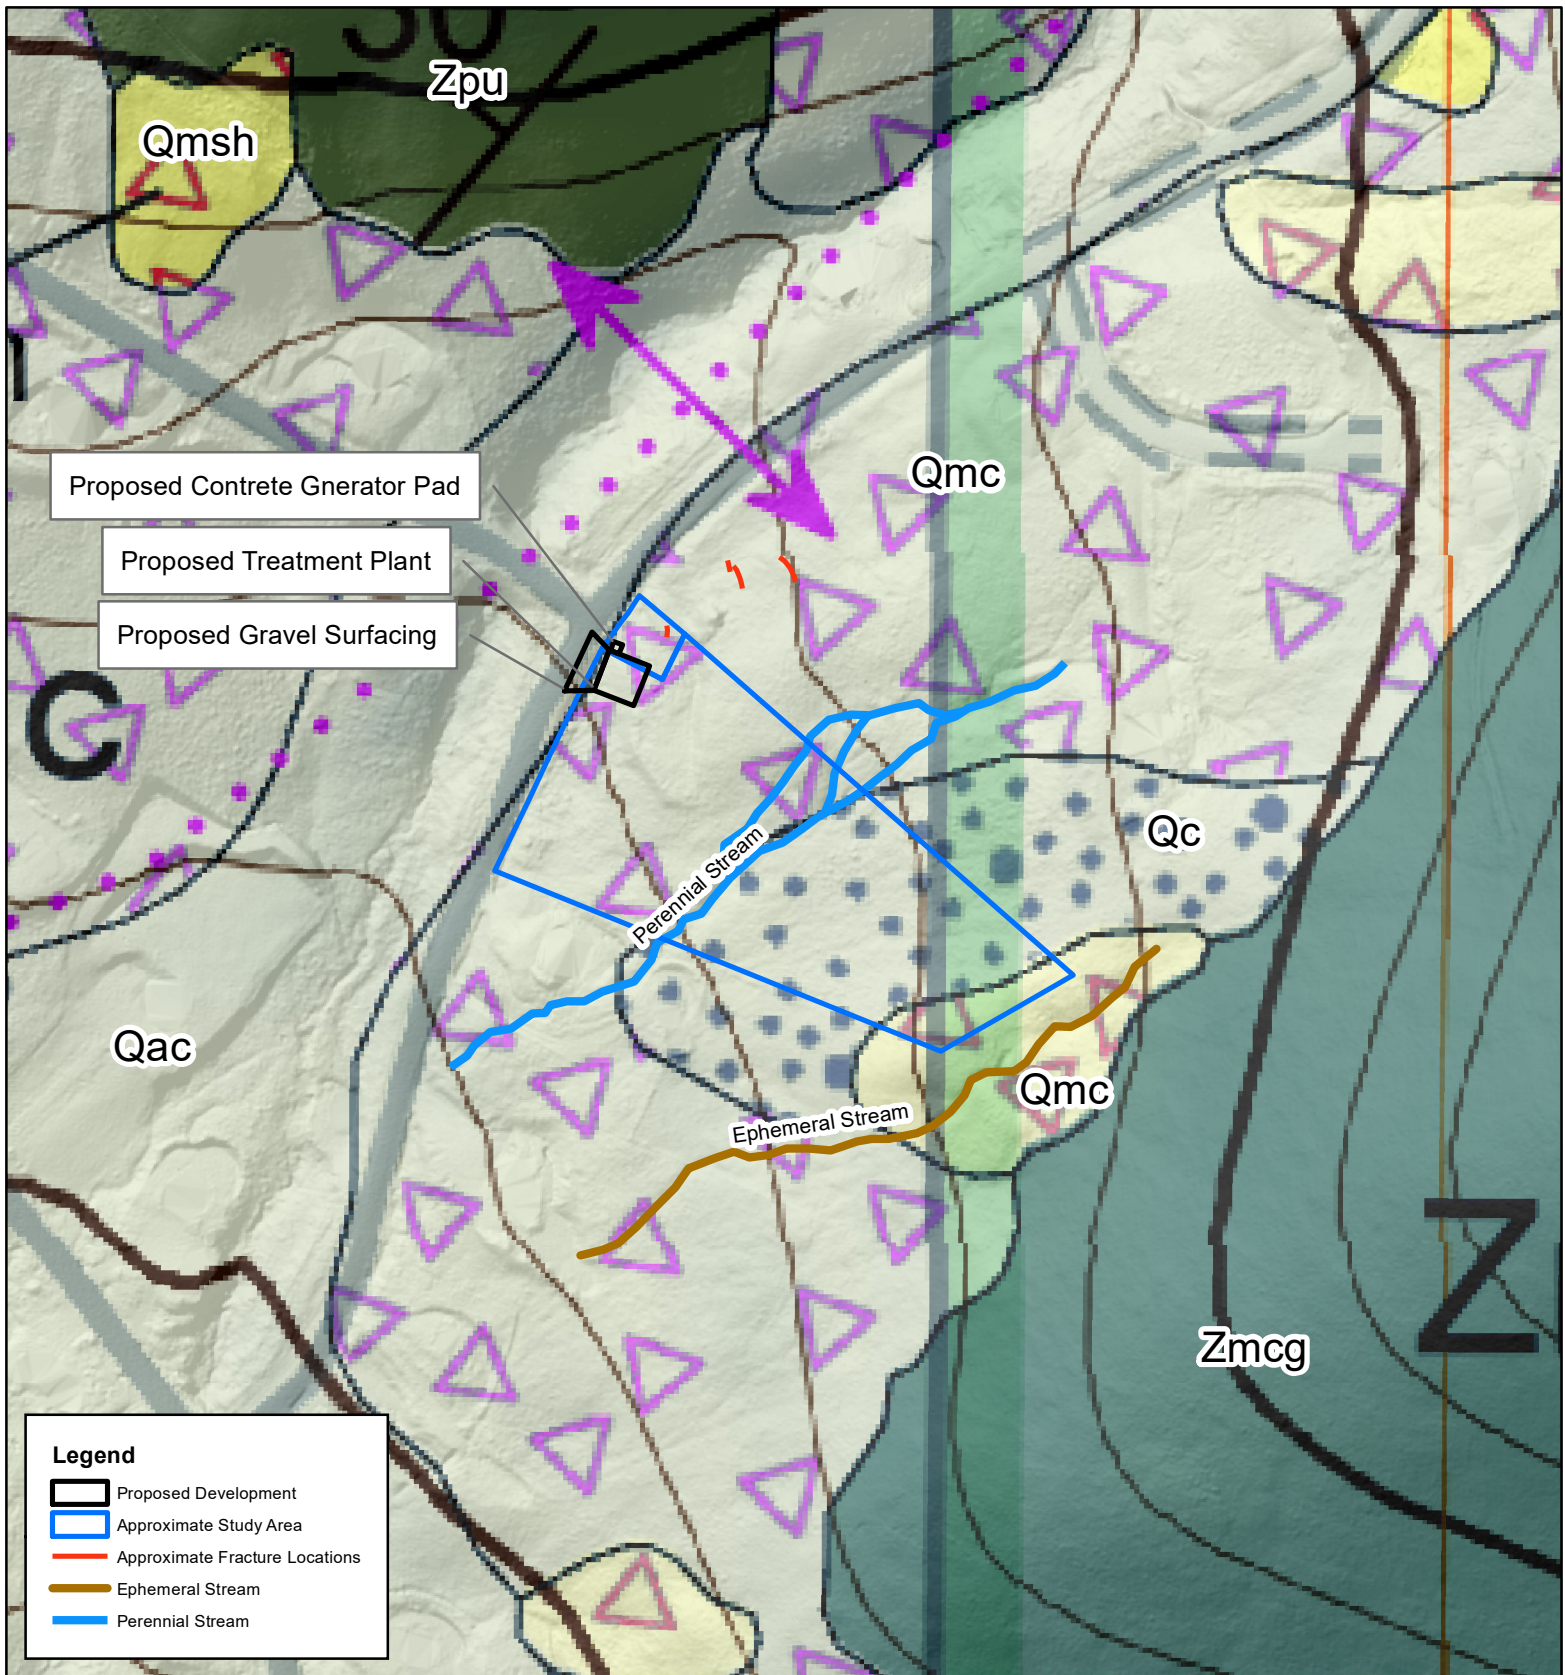
**Plate
4**

The subject site is located near the mouth of Maple Canyon on the west dipping and moderately sloping east side of the Maple Canyon drainage within the western foothills of the mountains along the central-eastern margin of Ogden Valley. The subject site generally slopes to the southwest. The area to the north and northeast of the subject site has been heavily modified by previous grading activities associated with the construction of Maple Street, local utilities, and the development of the homes built in the area. A minor perennial stream was observed running northeast to southwest through parcel # 21-083-0006 east of the area of the proposed development and just east of the existing graded fenced off area. Further to the southeast, just past the eastern boundary of parcel # 21-083-0006, an ephemeral stream was observed (Plate A-4 *Site Specific Geologic Map*).

Based on our review of the site topography, a minor perennial stream was observed east and southeast of the subject site. (Plate A-4 *Site Vicinity Geologic Map*). This stream and associated flood plain were observed to be incised in the surrounding topography. It is our opinion that due to the observed confinement of the incised stream channel; the stream has a low likelihood of overflowing the channel and affecting the proposed water treatment building. Review of current FEMA flood hazard maps (<https://msc.fema.gov/portal/home>) show that there is no FEMA flood hazard zone mapped in the area of the proposed development. It is the opinion of GeoStrata that stream flooding hazard is considered low and should not preclude development of the proposed water treatment plant.
