July 13, 2015

**Re: Engineering Geology Assessment
Lot 15, Ski Lake Estates No. 3
6640 East 1100 South
Huntsville, Utah
Job No. 145150**

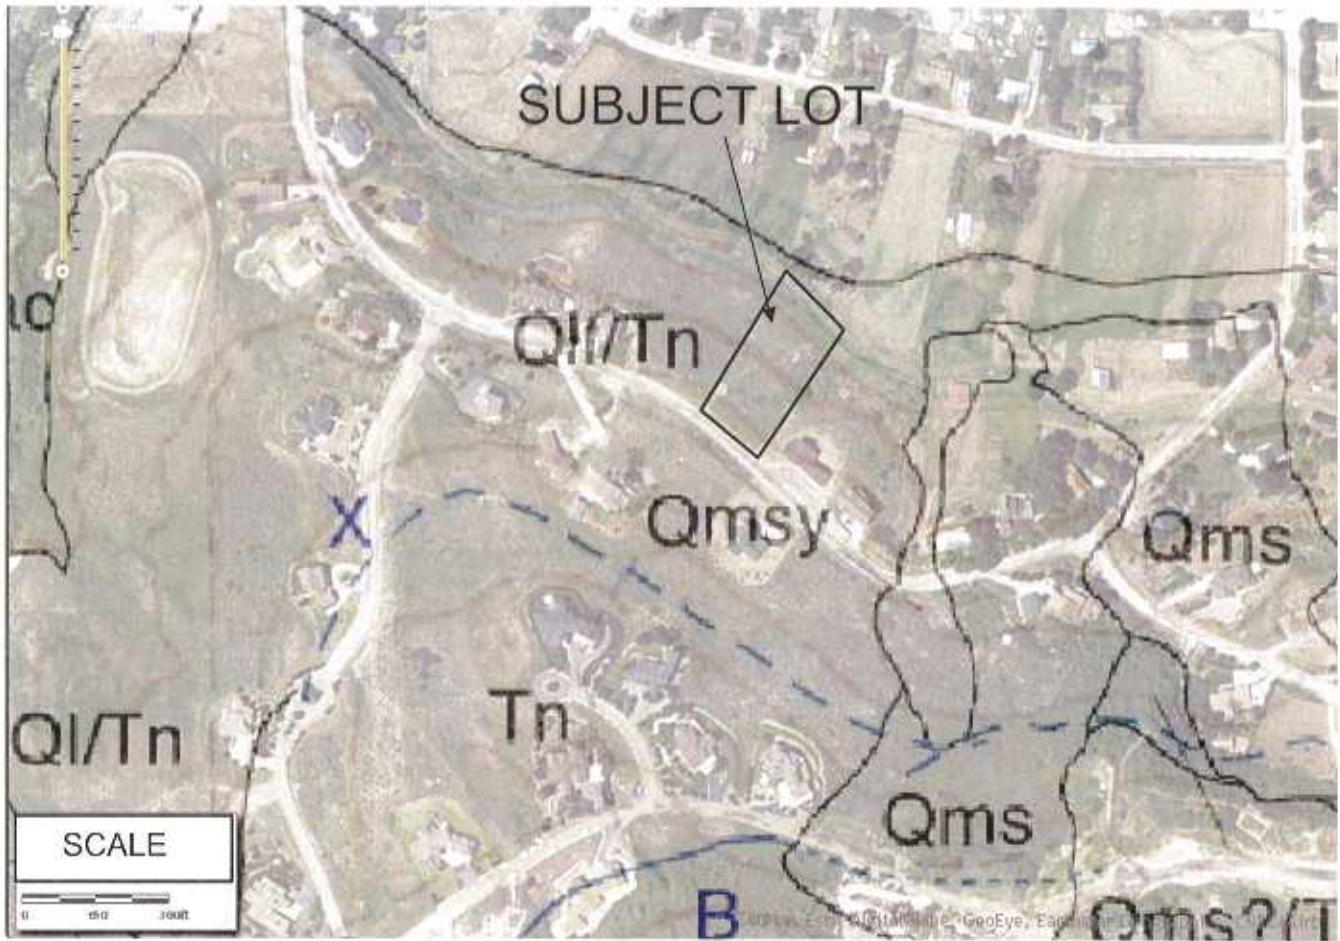
SITE GEOLOGIC MAP
LOT 15, SKI LAKE ESTATES NO. 3
6640 EAST 1100 SOUTH
HUNTSVILLE, UTAH

Yonkee, and Coogan⁵. The geology at the location of the subject lot as shown on the referenced map is Lake Bonneville fine-grained deposits (Map Unit Qlf, upper Pleistocene) overlying older deposits of the Norwood Formation (Map Unit Tn, lower Oligocene and upper Eocene). The Norwood Formation is extensive along the margins of the Ogden Valley, the Morgan Valley to the south, and in the hilly terrain between the valleys. The formation is known to be very prone to experiencing landslide activity. Several landslides (Map Units Qmsy and Qms) are mapped approximately 200 to 360 feet to the east of the subject lot on the referenced geologic map. These mapped landslides appear to have occurred within the Norwood Formation. No landslide deposits or features are mapped on or immediately adjacent to the subject lot on the referenced map. However, the literature accompanying the referenced map states that some landslides and other slope failure features may not have been mapped due to scale. A portion of the referenced geologic map that includes the location of the subject property and surrounding area is included as Figure No. 2, *Site Geologic Map*, at the end of this report. It should be noted that the geologic units included on Figure No. 2 are only those mapped at the location of the subject lot and immediate surrounding areas.

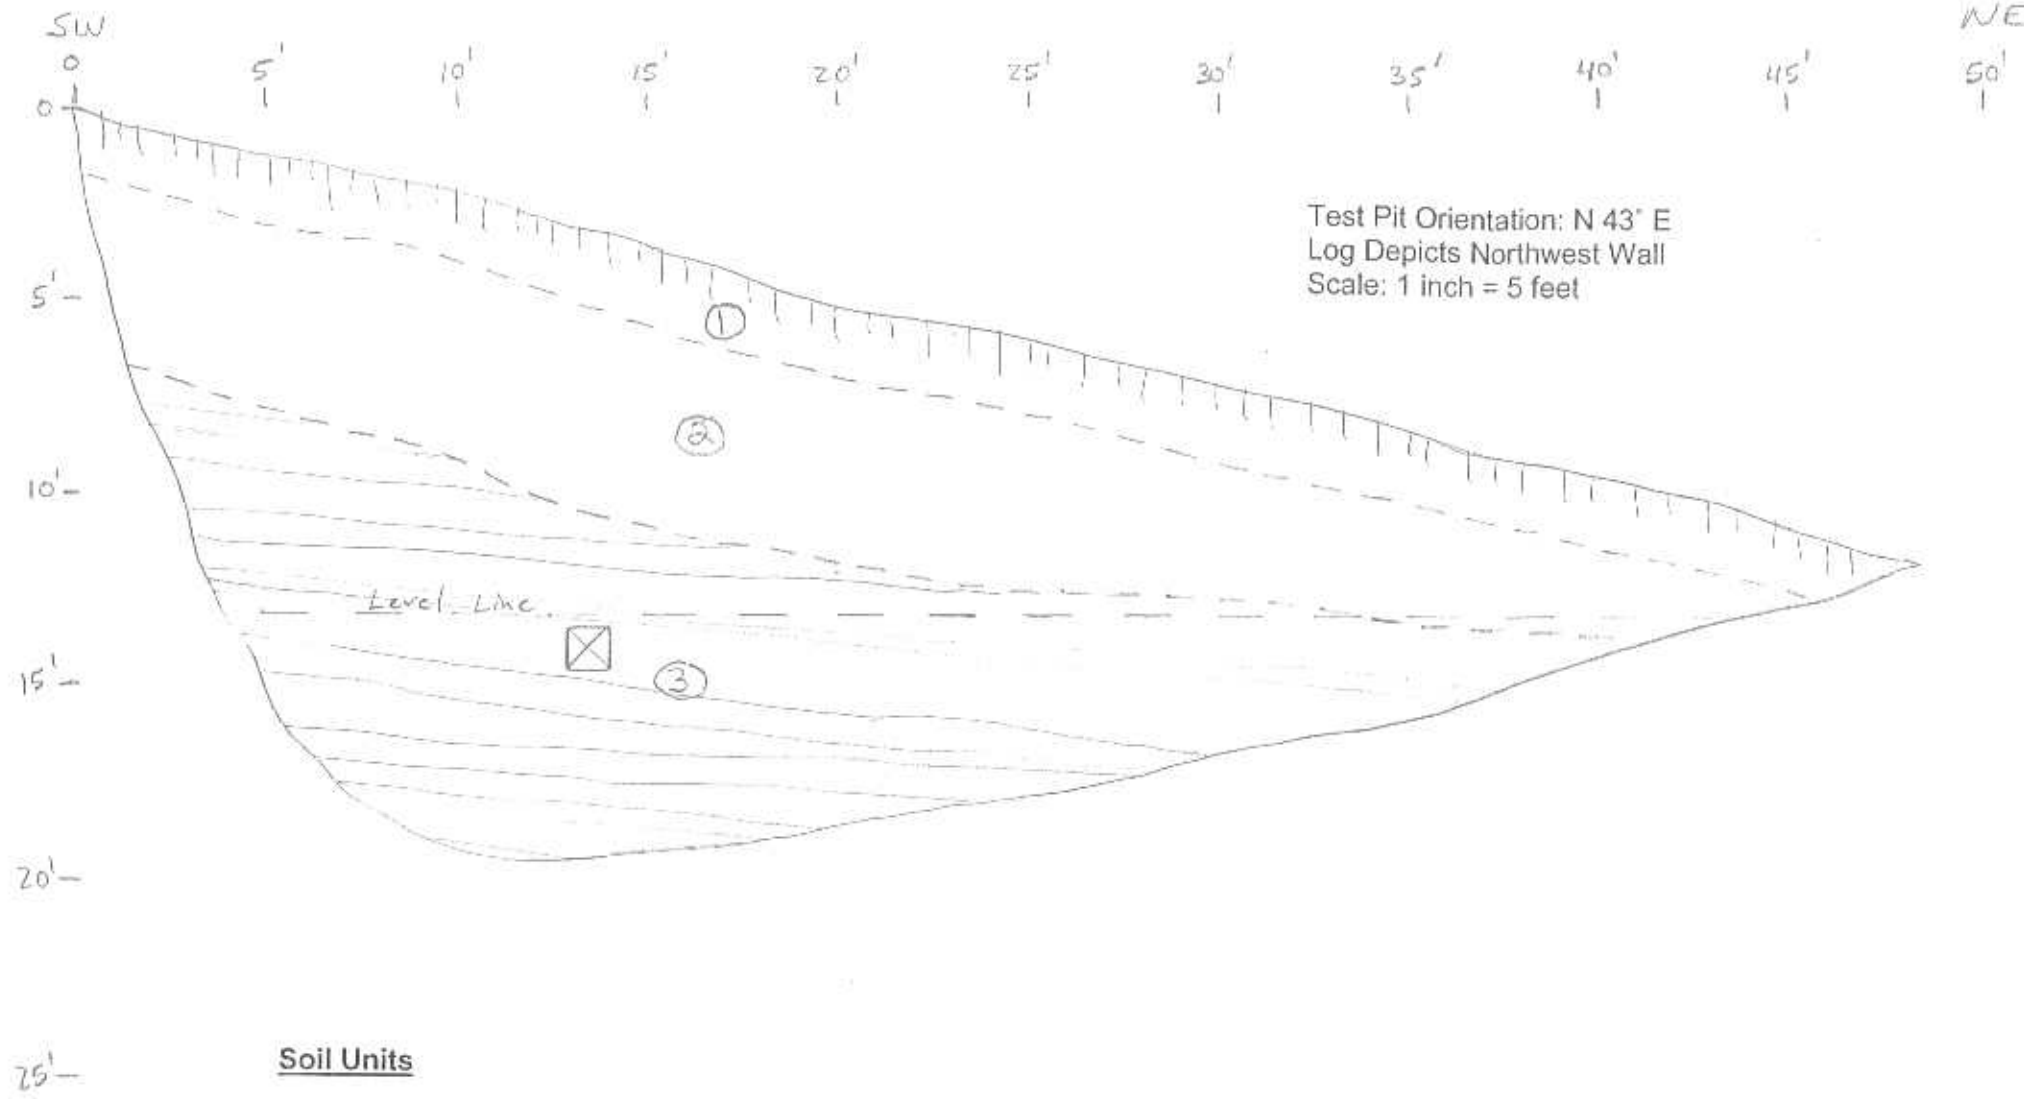
As shown on Figure No. 4, TP-3 exposed approximately 1½ to 2 feet of relatively well-formed, modern topsoil (Soil "A" Horizon) at the surface (Unit 1, Figure No. 4). The topsoil was formed

on what is interpreted to be slope wash deposits consisting of sandy Lean Clay (CL) (Unit 2, Figure No. 4) observed to be approximately 2½ to 5 feet thick at the location of the test pit. No significant internal stratification was observed within the slope wash deposits and the in-situ soils were estimated to be soft to medium stiff. Underlying the slope wash deposits, and extending to the base of the test pit which was approximately 16½ feet below the surface at its deepest point, we observed thin to moderately bedded deposits of Silty Sand (SM) with thin layers of interbedded Silt (ML) and occasional Lean Clay (CL) layers. These deposits (Unit 3, Figure No. 4) are interpreted to be lacustrine deposits of the Bonneville lake cycle and correlate with mapped Unit Qlf mapped by King and others (2008). Bedding within Unit 3 was measured to dip (apparent) down to the northeast at between approximately 3 and 8 degrees. The Bedding was observed to be continuous and relatively undisturbed through the length of the test pit. Bedding in the upper portion of Unit 3 at the contact with Unit 2 was observed to be truncated by the overlying material of Unit 2 suggesting that the contact is likely an erosional unconformity. No planes of shearing or zones of gouge suggesting past slope movements were observed within TP-3. It should be noted that TP-3 was excavated just down-slope of the location of the previous TP-2. In TP-2 a layer of gravel (logged as "sandstone" in the referenced geotechnical report) was encountered between the near-surface slope wash deposits and the underlying lacustrine deposits. However, this gravel bed was not encountered in TP-3. It is our interpretation that the gravel bed observed in TP-2 may be a lense of granular slope wash material or older debris flow deposits placed on the underlying lacustrine deposits.

The extension of TP-3 down-slope to the elevation of TP-4 on the lot showed that the lacustrine sands (Unit 3, Figure No. 4) thinned down slope and eventually pinched out at the elevation of TP-4 where the gravel bed (Unit 3, Figure No. 5) was encountered below the overlying slope wash deposits. TP-5 excavated adjacent to the southwest side of the footprint of the proposed house exposed approximately 1 to 2 feet of topsoil followed by approximately 4 feet of the

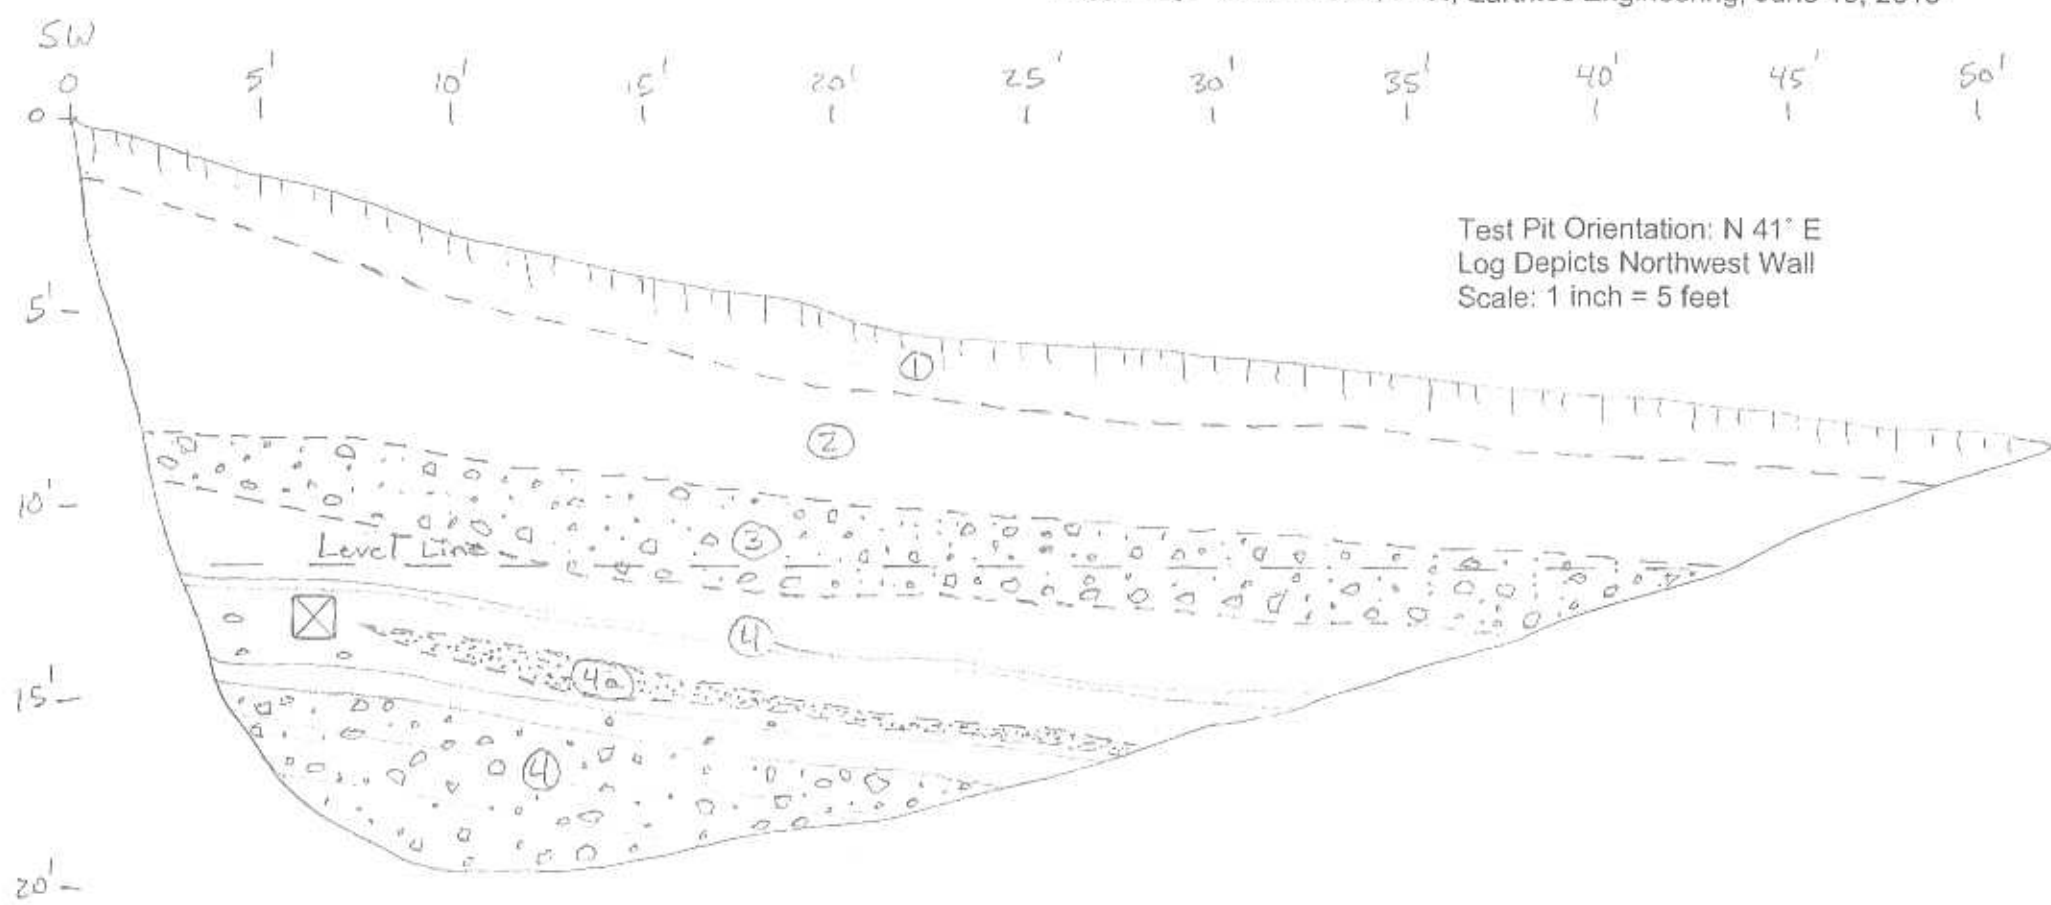
Test Pit Orientation: N 41° E
 Log Depicts Northwest Wall
 Scale: 1 inch = 5 feet

As shown on Figure No. 5, TP-4 exposed similar near surface topsoil and slope wash deposits (Units 1 and 2, Figure No. 5) as those observed in TP-3. Underlying the slope wash deposits in TP-4 we observed an approximately 1 to 2½ foot thick gravel bed (Unit 3, Figure No. 5). According to the engineer who logged the gravel bed (logged as "sandstone") in TP-2, this gravel bed in TP-4 appeared very similar to the gravel bed in TP-2. The gravel bed was comprised predominantly of angular to subangular, pebble to small cobble sized sandstone clasts that were generally clast supported. The matrix of the gravel bed included some pinhole voids. Unit 3 was observed to thin up-slope in the test pit suggesting it may pinch out upslope from the test pit. As with the gravel bed observed in TP-2, Unit 3 in TP-4 is interpreted to be a bed or lense of granular slope wash material or older debris flow deposits. This gravel bed was not encountered in TP-1 down-slope of TP-4. Underlying Unit 3 in TP-4 we encountered beds of the Norwood Formation (Unit 4, Figure No. 5) extending to the base of the test pit at approximately 16½ feet below the surface at its deepest point. The beds of the Norwood formation observed in TP-4 consisted of sandy Lean Clay (CL) and sandy Elastic Silt (MH) grading downward to Poorly Graded Gravel with Silty Sand (GP-GM). The gravels in the lower portion of the test pit may be a weathered sandstone bed and displayed some weak bedding structure. A lense of Silty Sand (SM) (Unit 4a, Figure No. 5) was observed in the exposed Norwood Formation Deposits. Bedding in the observed Norwood Formation deposits was measured to dip (apparent) down to the northeast at between 10 and 13 degrees. The bedding in the exposed Norwood Formation deposits in TP-4 was observed to be continuous and relatively undisturbed through the length of the test pit. No evidence of slip or shearing, or zones of gouge, was observed in the exposed soils and bedrock (Norwood Formation). None of the beds or bedding contacts within the exposed Norwood Formation appeared to be a slip plane.

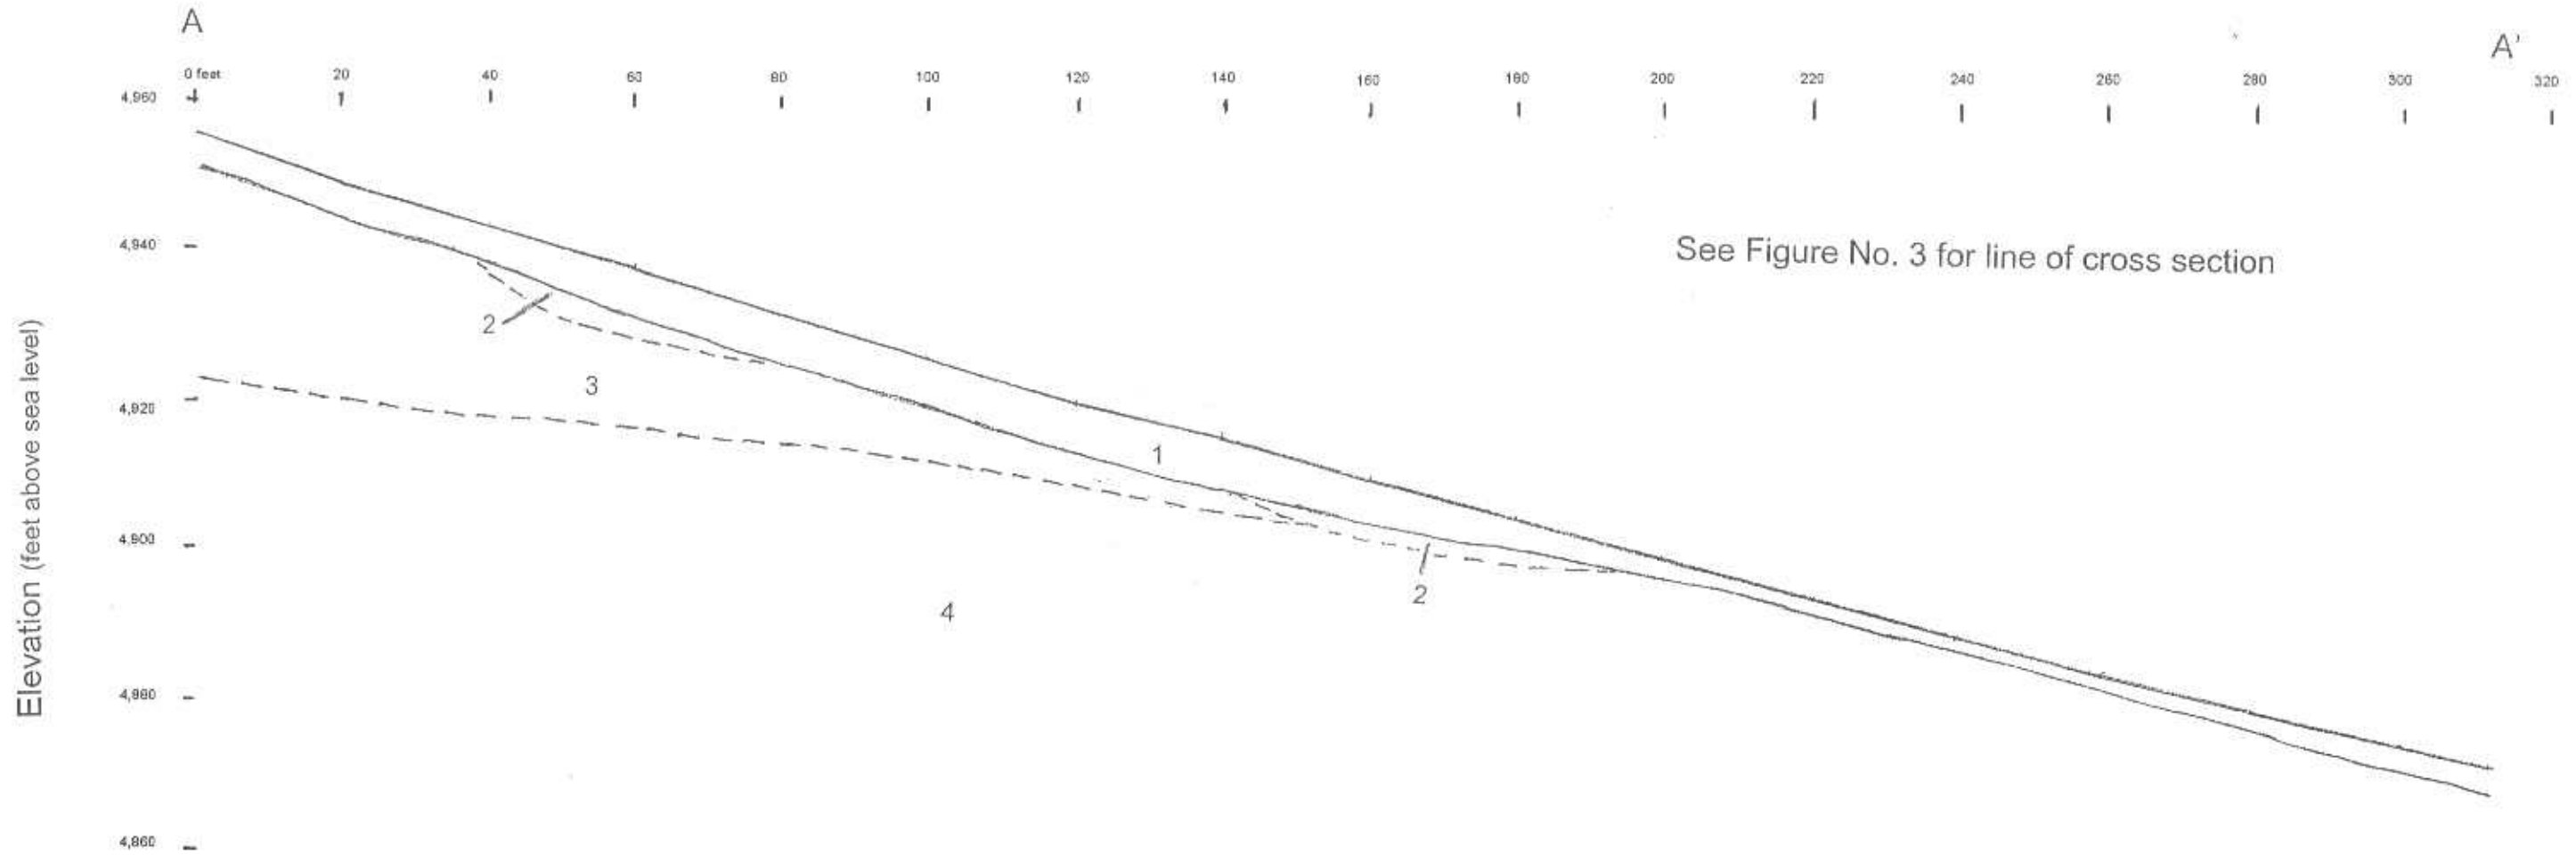
Geologic Cross Section
 Lot 15, Ski Lake Estates No. 3
 6640 East 1100 South, Huntsville, Utah

Based on the subsurface information obtained from the test pits and our geologic interpretations, a geologic cross section through the subject lot was produced. The cross section is included at the end of this report as Figure No. 6, Geologic Cross Section. The line of cross section through the lot is shown on Figure No. 3 as A – A'. Several assumptions were made in the completion of the cross section. First, due to the fact that the gravel beds/lenses observed immediately below the near-surface slope wash deposits in TP-2 and TP-4 were not observed in any of the other test pits we decided to show the gravels as two separate lenses at the elevations of TP-2 and TP-4. It is our opinion, that, due to relatively small thickness of the gravels and their apparent lack of lateral continuity across the lot, the gravels will not likely have significant influence on slope stability on the lot. Second, the depth of the lacustrine sands encountered in TP-2, TP-3, and TP-5 was not determined as none of these test pits penetrated the sands. We did observe that the sands thinned and pinched out down-slope of TP-3. As such, the base of the lacustrine sands shown on the cross section is inferred primarily based on the depth of TP-3 and the grade of the slope, however, the sands may be thicker than shown below the southwestern portion of the lot. And lastly, the thickness of the Norwood Formation below the lot could not be determined. So, for the purposes of the cross section, it was assumed that the Norwood formation extends through the remainder of the profile shown on Figure No. 6.
