October 9, 2015

**Re: Engineering Geology Assessment-Revised  
Lot 15, Ski Lake Estates No. 3  
6640 East 1100 South  
Huntsville, Utah  
Job No. 145150**

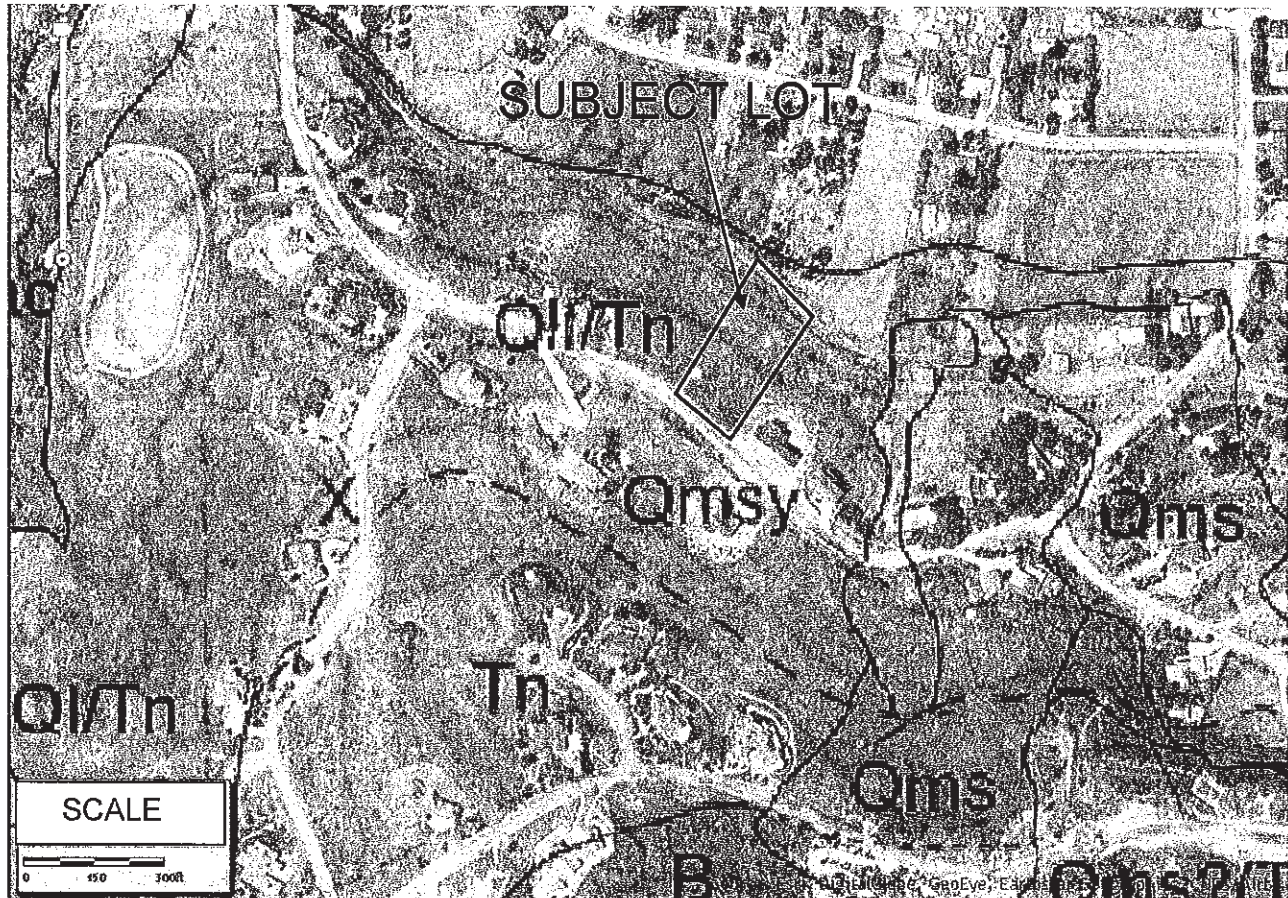
**SITE GEOLOGIC MAP**  
**LOT 15, SKI LAKE ESTATES NO. 3**  
**6640 EAST 1100 SOUTH**  
**HUNTSVILLE, UTAH**

Yonkee, and Coogan<sup>5</sup>. The geology at the location of the subject lot as shown on the referenced map is Lake Bonneville fine-grained deposits (Map Unit Qlf, upper Pleistocene) overlying older deposits of the Norwood Formation (Map Unit Tn, lower Oligocene and upper Eocene). The Norwood Formation is extensive along the margins of the Ogden Valley, the Morgan Valley to the south, and in the hilly terrain between the valleys. The formation is known to be very prone to experiencing landslide activity. Several landslides (Map Units Qmsy and Qms) are mapped approximately 200 to 360 feet to the east of the subject lot on the referenced geologic map. These mapped landslides appear to have occurred within the Norwood Formation. No landslide deposits or features are mapped on or immediately adjacent to the subject lot on the referenced map. However, the literature accompanying the referenced map states that some landslides and other slope failure features may not have been mapped due to scale. A portion of the referenced geologic map that includes the location of the subject property and surrounding area is included as Figure No. 2, *Site Geologic Map*, at the end of this report. It should be noted that the geologic units included on Figure No. 2 are only those mapped at the location of the subject lot and immediate surrounding areas.

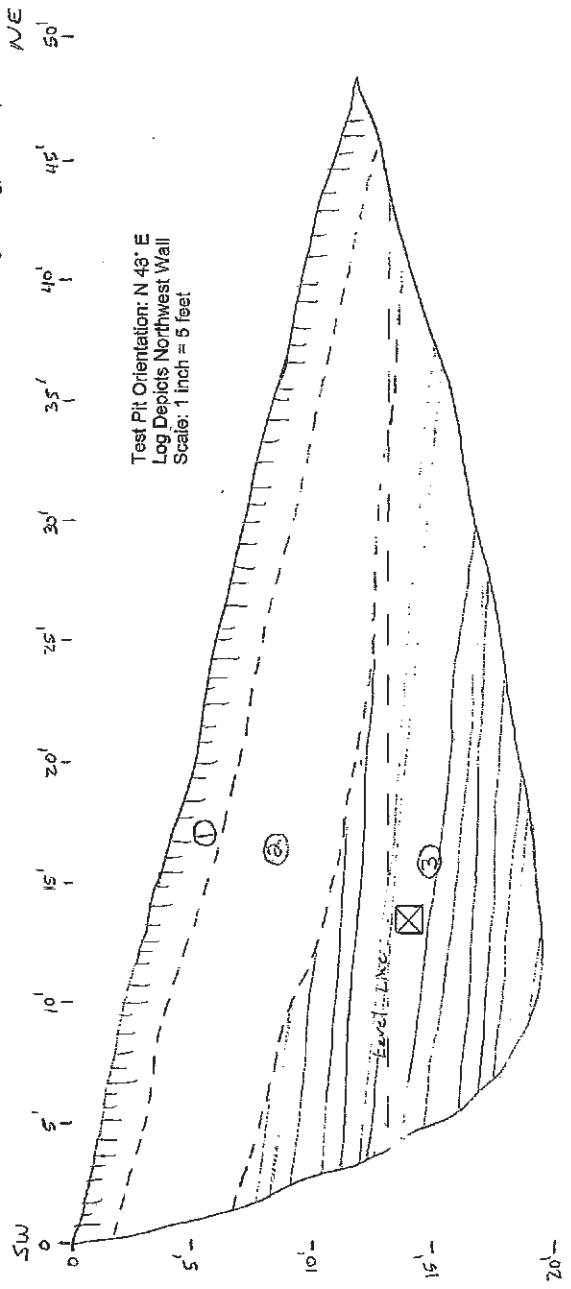
**Test Pit Log, TP-3, Lot 15, Ski Lake Estates No. 3**  
 6640 East 1100 South, Huntsville, Utah  
 Logged by: Mark Larsen, P.O., Earthtec Engineering, June 19, 2015

As shown on Figure No. 4, TP-3 exposed approximately 1½ to 2 feet of relatively well-formed,

modern topsoil (Soil "A" Horizon) at the surface (Unit 1, Figure No. 4). The topsoil was formed on what is interpreted to be slope wash deposits consisting of sandy Lean Clay (CL) (Unit 2, Figure No. 4) observed to be approximately 2½ to 5 feet thick at the location of the test pit. No significant internal stratification was observed within the slope wash deposits and the in-situ soils were estimated to be soft to medium stiff. Underlying the slope wash deposits, and extending to the base of the test pit which was approximately 16½ feet below the surface at its deepest point, we observed thin to moderately bedded deposits of Silty Sand (SM) with thin layers of interbedded Silt (ML) and occasional Lean Clay (CL) layers. These deposits (Unit 3, Figure No. 4) are interpreted to be lacustrine deposits of the Bonneville lake cycle and correlate with mapped Unit Qlf mapped by King and others (2008). Bedding within Unit 3 was measured to dip (apparent) down to the northeast at between approximately 3 and 8 degrees. The Bedding was observed to be continuous and relatively undisturbed through the length of the test pit. Bedding in the upper portion of Unit 3 at the contact with Unit 2 was observed to be truncated by the overlying material of Unit 2 suggesting that the contact is likely an erosional unconformity. No planes of shearing or zones of gouge suggesting past slope movements were observed within TP-3. It should be noted that TP-3 was excavated just down-slope of the location of the previous TP-2. In TP-2 a layer of gravel (logged as "sandstone" in the referenced geotechnical report) was encountered between the near-surface slope wash deposits and the underlying lacustrine deposits. However, this gravel bed was not encountered in TP-3. It is our interpretation that the gravel bed observed in TP-2 may be a lense of granular slope wash material or older debris flow deposits placed on the underlying lacustrine deposits.

The extension of TP-3 down-slope to the elevation of TP-4 on the lot showed that the lacustrine sands (Unit 3, Figure No. 4) thinned down slope and eventually pinched out at the elevation of TP-4 where the gravel bed (Unit 3, Figure No. 5) was encountered below the overlying slope wash deposits. TP-5 excavated adjacent to the southwest side of the footprint of the proposed

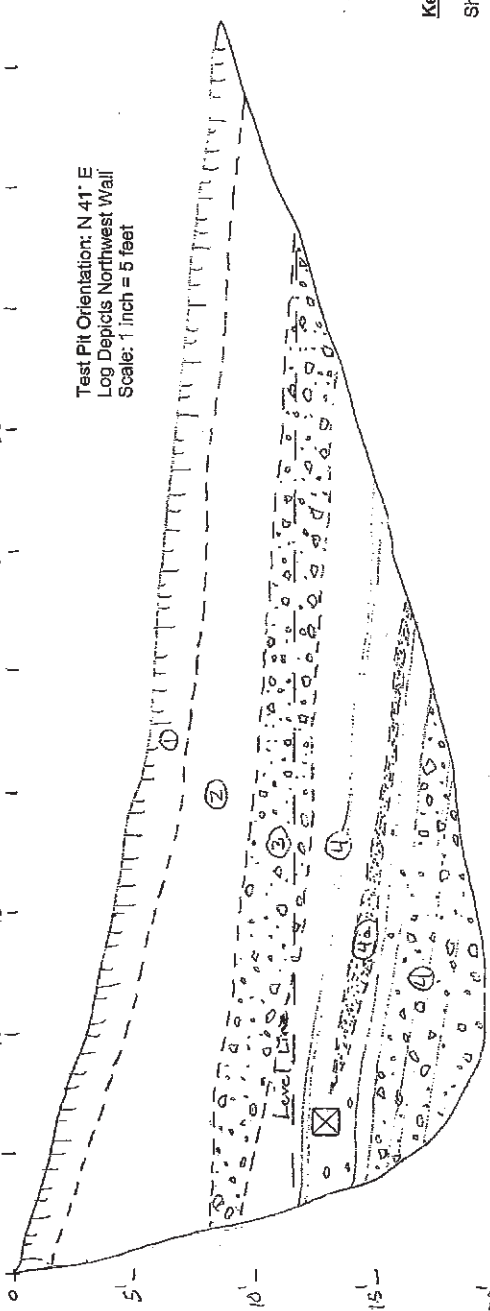
Test Pit Log, TP-4, Lot 15, Ski Lake Estates No. 3  
 6640 East 1100 South, Huntsville, Utah  
 Logged by: Mark Larsen, P.G., Earthtec Engineering, June 19, 2015

As shown on Figure No. 5, TP-4 exposed similar near surface topsoil and slope wash deposits (Units 1 and 2, Figure No. 5) as those observed in TP-3. Underlying the slope wash deposits in TP-4 we observed an approximately 1 to 2½ foot thick gravel bed (Unit 3, Figure No. 5). According to the engineer who logged the gravel bed (logged as "sandstone") in TP-2, this gravel bed in TP-4 appeared very similar to the gravel bed in TP-2. The gravel bed was comprised predominantly of angular to subangular, pebble to small cobble sized sandstone clasts that were generally clast supported. The matrix of the gravel bed included some pinhole voids. Unit 3 was observed to thin up-slope in the test pit suggesting it may pinch out upslope from the test pit. As with the gravel bed observed in TP-2, Unit 3 in TP-4 is interpreted to be a bed or lense of granular slope wash material or older debris flow deposits. This gravel bed was not encountered in TP-1 down-slope of TP-4. Underlying Unit 3 in TP-4 we encountered beds of the Norwood Formation (Unit 4, Figure No. 5) extending to the base of the test pit at approximately 16½ feet below the surface at its deepest point. The beds of the Norwood formation observed in TP-4 consisted of sandy Lean Clay (CL) and sandy Elastic Silt (MH) grading downward to Poorly Graded Gravel with Silty Sand (GP-GM). The gravels in the lower portion of the test pit may be a weathered sandstone bed and displayed some weak bedding structure. A lense of Silty Sand (SM) (Unit 4a, Figure No. 5) was observed in the exposed Norwood Formation Deposits. Bedding in the observed Norwood Formation deposits was measured to dip (apparent) down to the northeast at between 10 and 13 degrees. The bedding in the exposed Norwood Formation deposits in TP-4 was observed to be continuous and relatively undisturbed through the length of the test pit. No evidence of slip or shearing, or zones of gouge, was observed in the exposed soils and bedrock (Norwood Formation). None of the beds or bedding contacts within the exposed Norwood Formation appeared to be a slip plane.

4. Nonwood Formation - Sandy Lean Clay (CL) and sandy Elastic Silt (MH) grading downward to a Poorly Graded Gravel with Silty Sand (GP-GM) that may be a weathered sandstone bed, slightly moist, olive brown to grayish brown. Clays and silts are generally stiff to very stiff (estimated), thin to moderately bedded, bedding has an apparent dip down to the northeast at between 10 and 13 degrees, bedding is generally continuous and relatively undisturbed. The gravels are predominantly angular to subangular sandstone clasts in a silty sand matrix and mostly clast supported. The gravels display some weakly-formed bedding. Lower Oligocene and upper Eocene based on mapping by King, Yankee, and Coogan (2008), correlates with mapped unit Th.

4a. Sand lense within Unit 4 - Silty Sand (SM), slightly moist, light brown, dense (estimated). Lense dips (apparent) Northeast at about 10 degrees.

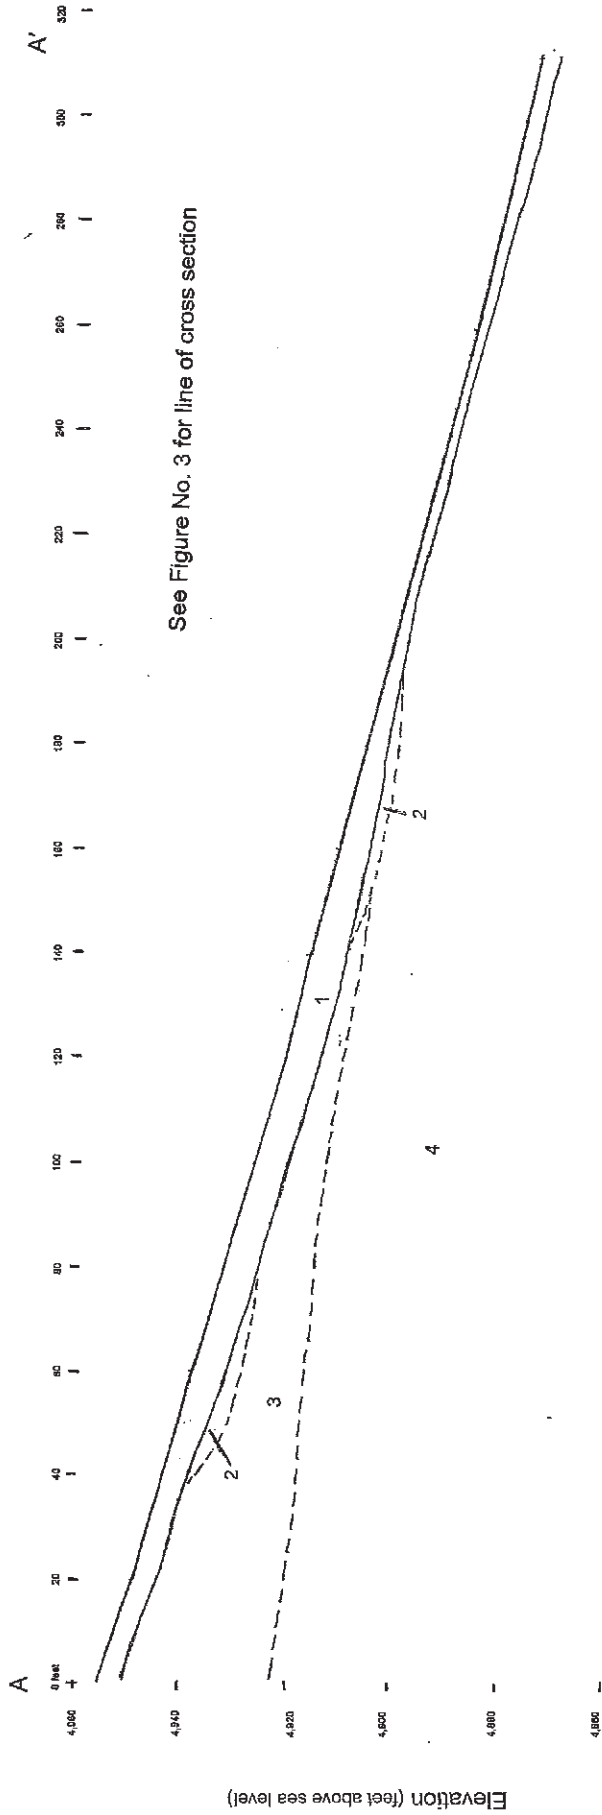
Geologic Cross Section  
 Lot 15, Ski Lake Estates No. 3  
 6640 East 1100 South, Huntsville, Utah

Based on the subsurface information obtained from the test pits and our geologic interpretations, a geologic cross section through the subject lot was produced. The cross section is included at the end of this report as Figure No. 6, Geologic Cross Section. The line of cross section through the lot is shown on Figure No. 3 as A – A'. Several assumptions were made in the completion of the cross section. First, due to the fact that the gravel beds/lenses observed immediately below the near-surface slope wash deposits in TP-2 and TP-4 were not observed in any of the other test pits we decided to show the gravels as two separate lenses at the elevations of TP-2 and TP-4. It is our opinion, that, due to relatively small thickness of the gravels and their apparent lack of lateral continuity across the lot, the gravels will not likely have significant influence on slope stability on the lot. Second, the depth of the lacustrine sands encountered in TP-2, TP-3, and TP-5 was not determined as none of these test pits penetrated the sands. We did observe that the sands thinned and pinched out down-slope of TP-3. As such, the base of the lacustrine sands shown on the cross section is inferred primarily based on the depth of TP-3 and the grade of the slope, however, the sands may be thicker than shown below the southwestern portion of the lot. And lastly, the thickness of the Norwood Formation below the lot could not be determined. So, for the purposes of the cross section, it was assumed that the Norwood formation extends through the remainder of the profile shown on Figure No. 6.
