Subject: Geologic Hazard Assessment  
Prado Subdivision Phase 1  
Powder Mountain, Utah  
Project No. 1250702

Test Pit Locations and Geologic Map

Figure 2

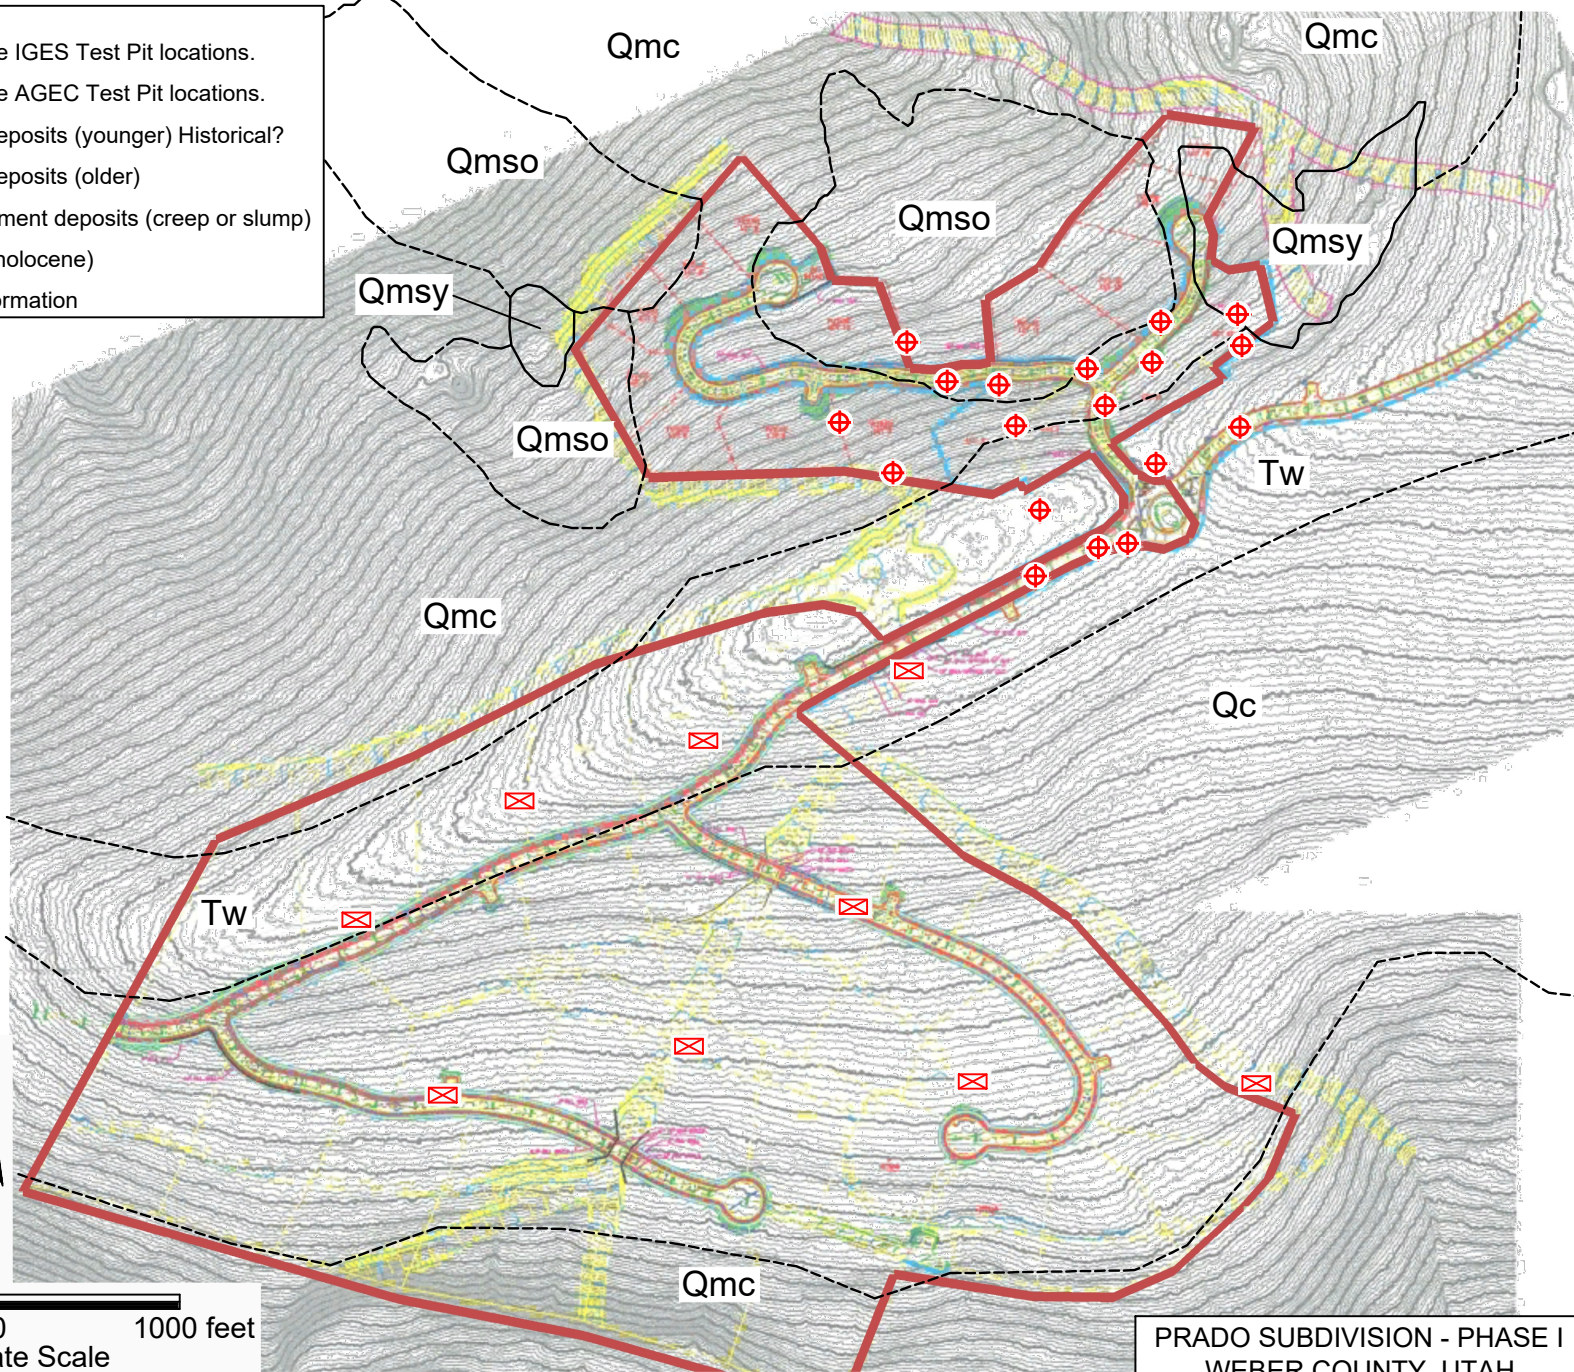
Test pits excavated on the south side of the ridge (see Figure 2) show predominantly clayey gravel of the Tertiary Wasatch Formation down to approximately 15 feet. Test Pits 8 and 12 have a layer in sandy fat clay between 8 and 12 feet below the ground surface.

During our site reconnaissance on October 3, 2025, we found evidence of scarp-like structures in the northwest portion of the property, near the water seep. Many of the trees on the north slope have downhill curvature of tree trunks, an indication of slope movement. We observed less distinct scarp-like structures in the central portion of the project area that we interpret as older landslides. The southern portion showed no evidence of soil creep or scarp-like structures other than the south end of the site (see Figure 2). We recommend additional geologic evaluations be conducted on these structures to look for evidence of landslides.

The latest geology map for the area (Anderson and others, 2023 and McDonald and others, 2025) shows mass movement and colluvial deposits undifferentiated for most of the lot. These are described as mixed landslide, slump, slope wash, and soil creep deposits with a slightly hummocky appearance and lacks clear landslide scarps and lateral margins. Review of aerial photographs, site reconnaissance, and lidar data finds potential landslide deposits. Figure 2 is a geology map based on our review of the site.

Based on our geologic review of the site, it is our professional opinion that potential landslide, expansive soils, shallow groundwater, and strong earthquake ground motions are geologic hazards that may negatively affect the proposed development of the site. Earthquake ground motions are mitigated through structural design of the building. A geotechnical study is recommended to address the other hazards identified. Additional geologic evaluation is recommended as part of the geotechnical study to assist in the stability analysis for the project.

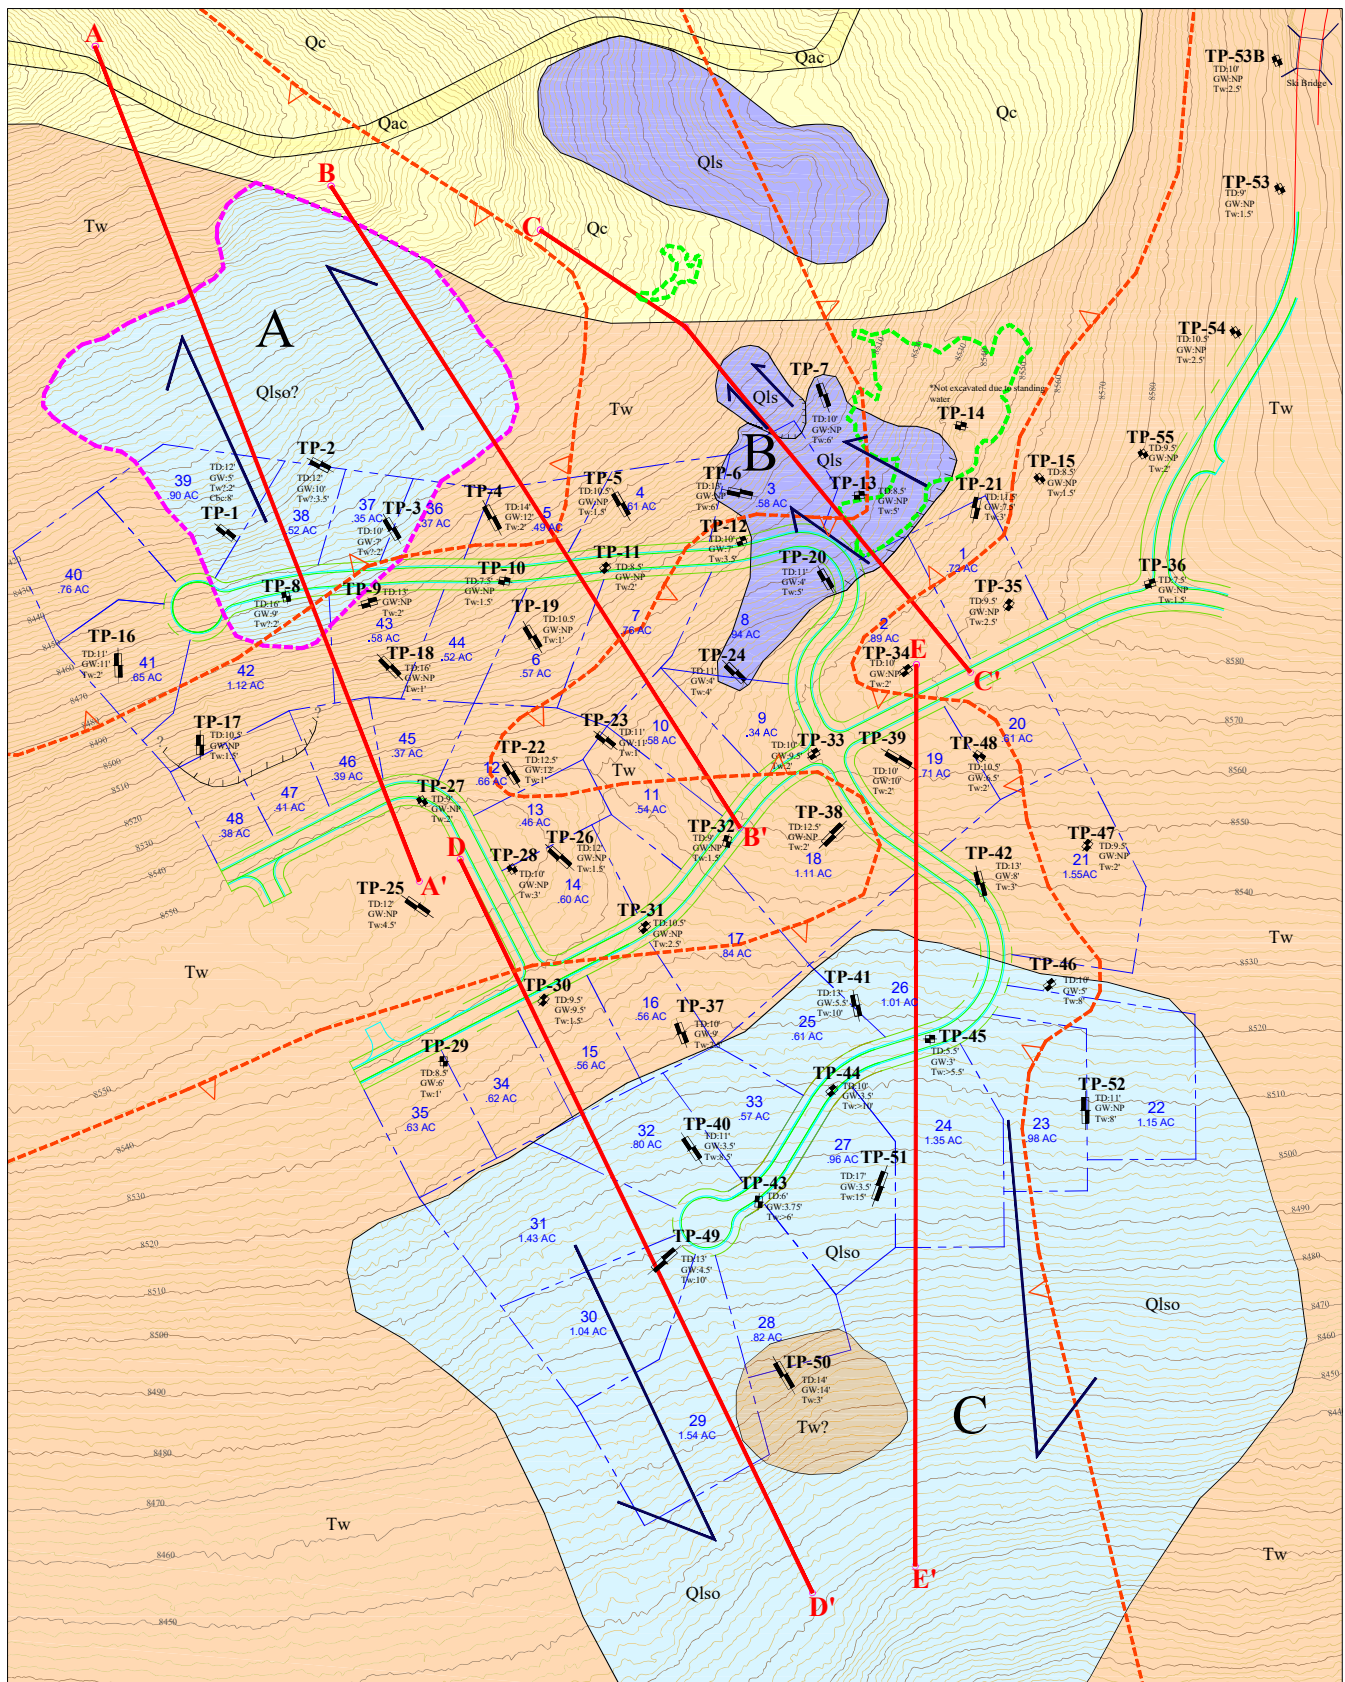
**A-2**

A geologic hazard assessment report of the northeast end of Prado Phase 1 (formerly Bobcat Ridge) prepared by IGES with report date September 20, 2018 and Project No. 01628-028 was reviewed. The IGES map (see Appendix) shows that shallow landslide deposits were encountered in the southern test pits, that area was labeled Slide C. Older and deeper landslide failure planes were encountered in the northern section, labeled as Slide A & B. A landslide head scarp was mapped by IGES in the northwest portion of the project area. Based on test pit logs presented in the IGES report, the subsurface materials at the site consist of a mixture of clay, sand and gravel. IGES' TP-1 shows a fat clay overlying the Calls Fort Shale Member.

The project site is undeveloped. There is an unpaved road that generally follows the ridge which is oriented south-southwest to north-northeast through the central portion of the proposed development. There are wet areas in the northwestern portion of the property as noted by IGES on their Figure A-2 and observed during our site visit. The ground surface north of the ridge slopes down to the northwest at approximately 3 ½ horizontal to 1 vertical and flatter. The ground surface to the south of the ridge slopes to the south at approximately 8 horizontal to 1 vertical and flatter.
