**REPORT  
ENGINEERING GEOLOGY STUDY  
THE BRIDGES AT WOLF CREEK EAST PHASE 1  
PARTS OF SECTIONS 15, 16, AND 22 TOWNSHIP 7  
NORTH, RANGE 1 EAST SLBM  
EDEN, UTAH**

Job No. 1661-08N-16

**Re:** Engineering Geology Study  
The Bridges at Wolf Creek East Phase 1  
Parts of Sections 15, 16 and 22 Township 7 North, Range 1 East SLBM  
Eden area, Ogden Valley Township, Unincorporated Weber County, Utah  
(41.3389 N, 111.8323 W)

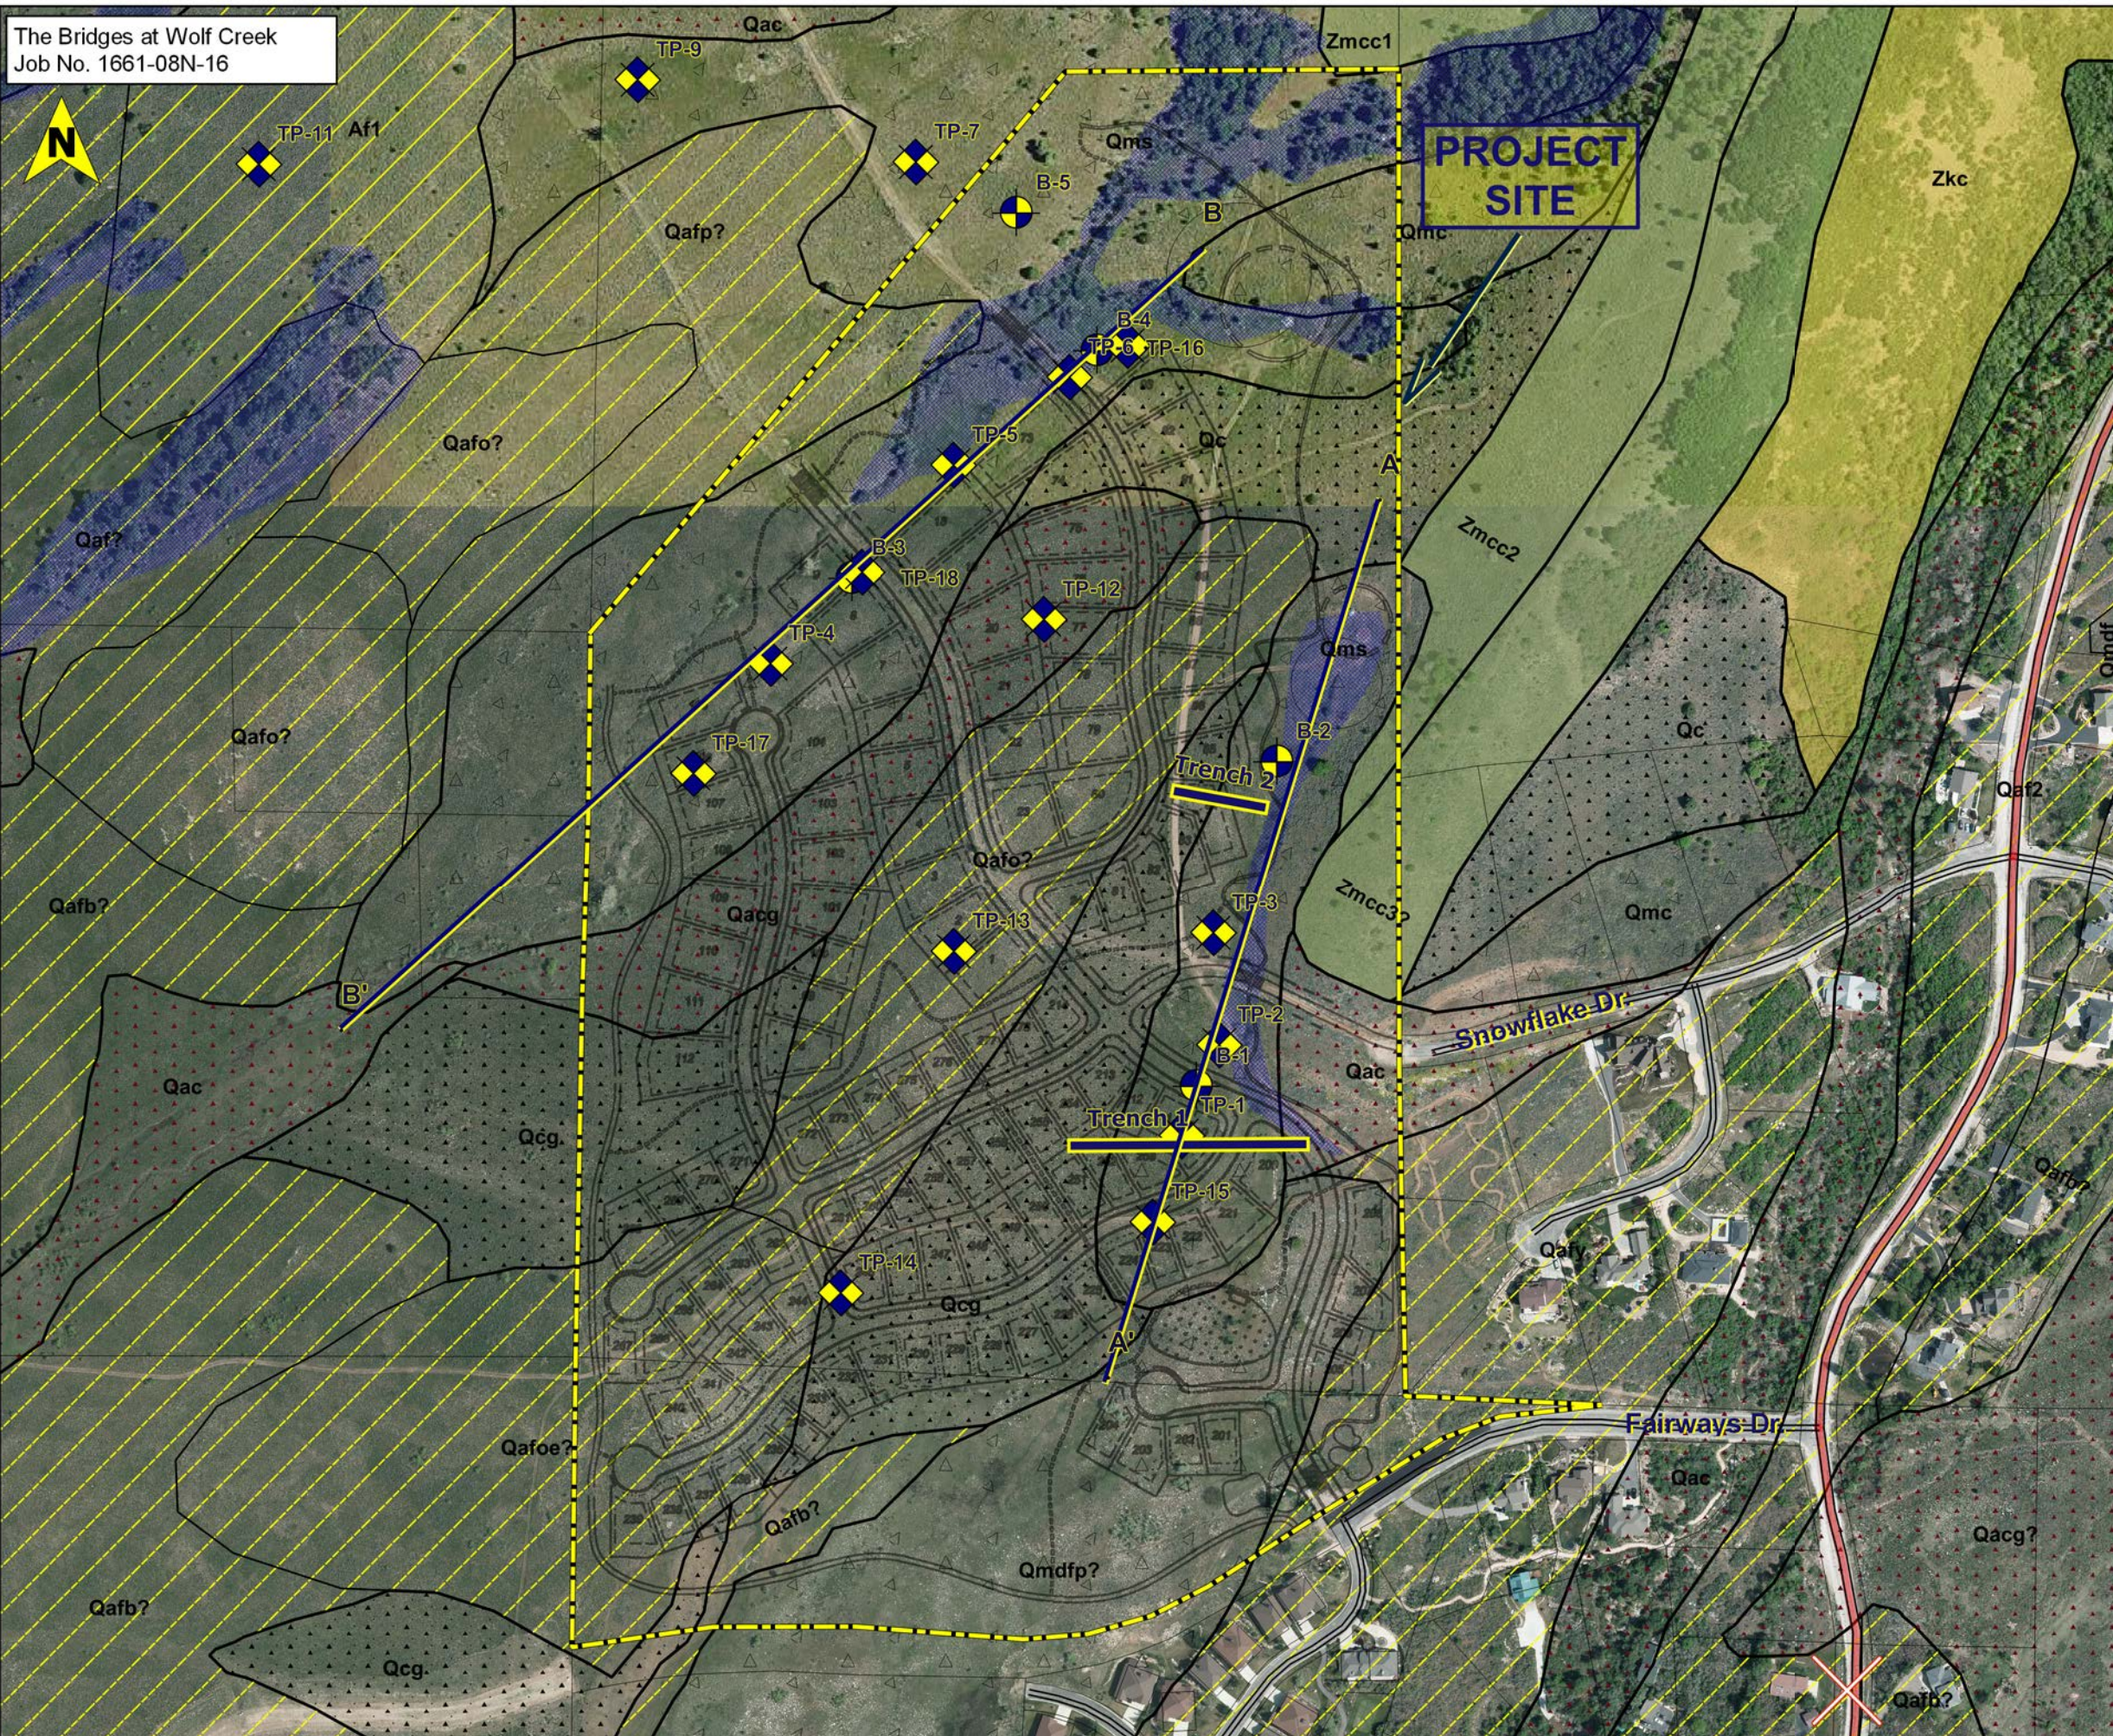
**FIGURE 3**  
**SITE EVALUATION AND**  
**ENGINEERING GEOLOGY**  
 **GSH**

**4.1.1 Shallow-Seasonal Groundwater, Hazards** or conditions include the mapped Cienega Areas as shown on Figure 3, where groundwater emerges to the surface. These areas were identified through the aerial photography analysis and site reconnaissance. The affect of shallow groundwater presents limitations for site development, and will also affect the soil strength and mass of site slopes, and can negatively affect slope stability.

Alluvial Fan-Debris Flow Hazard areas shown on Figure 19 include engineering geology units mapped as **Af1, Qaf?, and Qafy** on Figure 3. Older alluvial fan deposits mapped as **Qaf2, Qafp?, Qafb?, Qafo?, and Qafoe?** on Figure 3, are believed to have been formed by alluvial fan debris-flow processes, but are believed to not presently be subject to those process activities.

The Landslide-Mass Movement Hazard areas shown on Figure 19 include engineering geology units mapped as **Qms** on Figure 3. The locations of the landslide deposits on the East Phase area appear to correlate to areas downslope of Maple Canyon Formation argillite beds mapped as **Zmcc2** on Figure 3.

**4.1.5 Slope Stability Hazards** Although evidence of active landslide movement is not apparent, areas on the site covered with soils that are inherently weak and/or expansive, or consisting of older landslide deposits, may become unstable upon implementation of site grading and/or improvements. The areas classified on Figure 19 as Slope Stability Hazards, and include areas mapped on Figure 3 as **Qmc** and **Qmso**.

**4.1.6 Flood Hazards** shown on Figure 19 include areas on or near the East Phase where alluvial stream deposition along Wolf Creek has occurred in response to overbank stream flows. These include areas mapped as **Qac** on Figure 3.

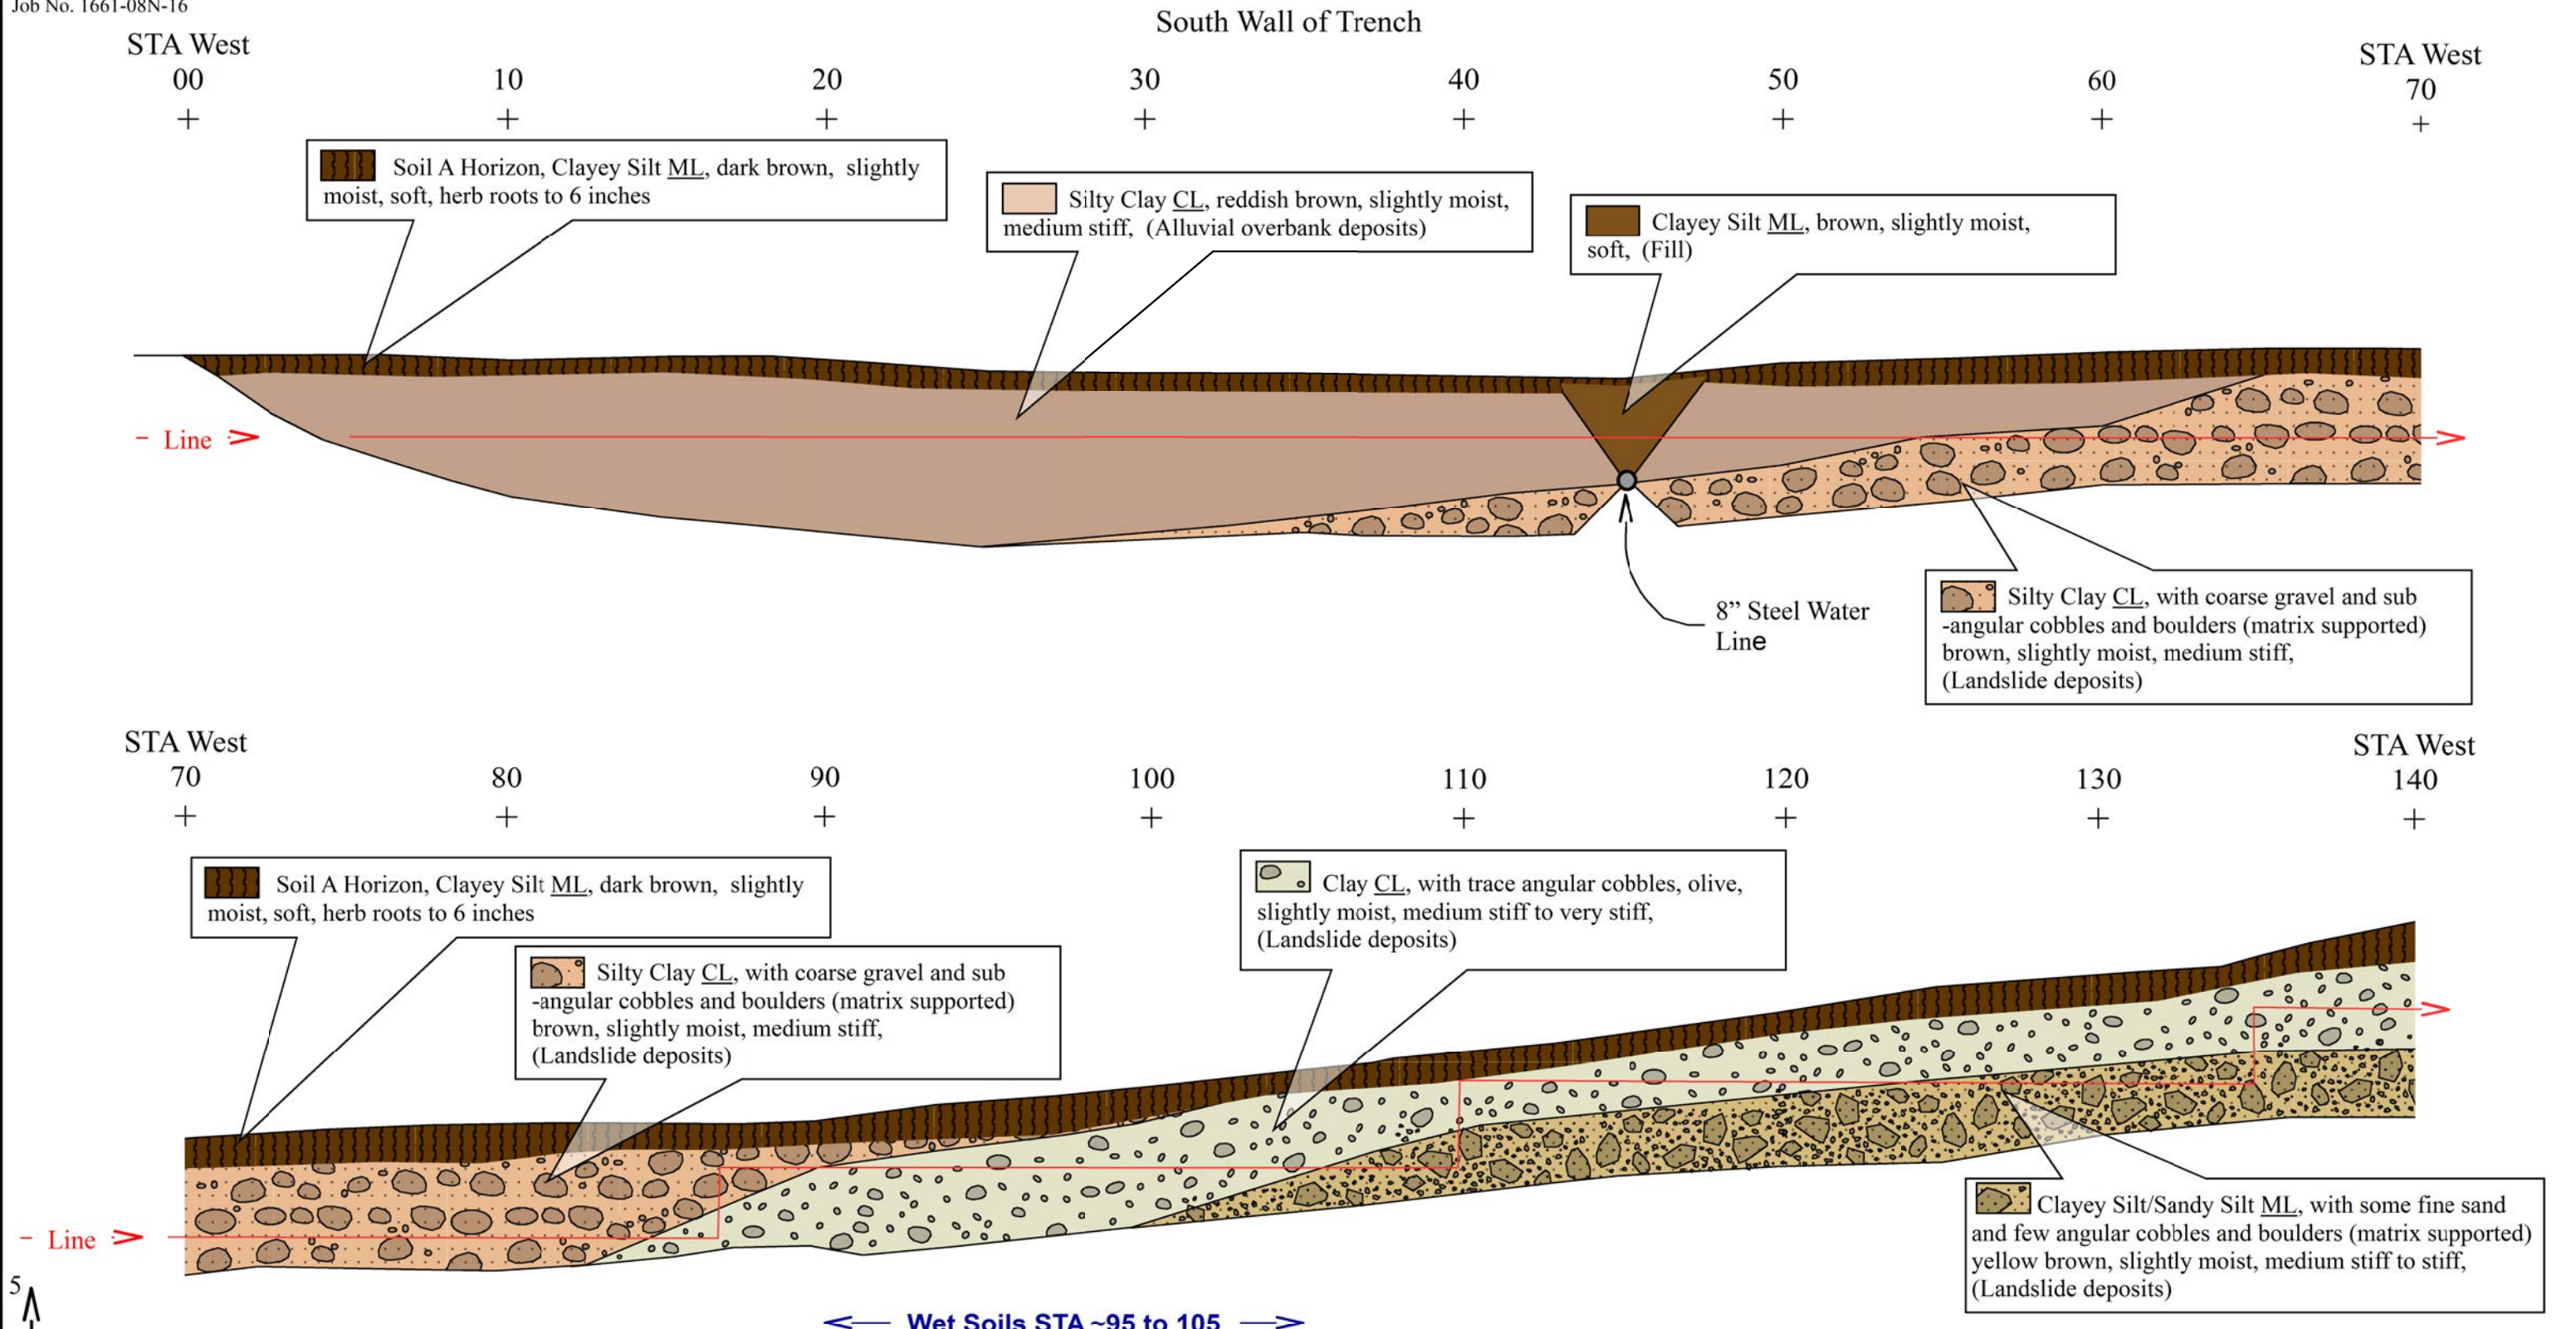
**FIGURE 4**  
**LOG OF TRENCH 1**  
**STA 00 TO 140 WEST**

The soils interpreted to have undergone landslide movement showed soft to medium-stiff consistencies, with rotated over sized clasts, and coloration from oxidation (Fe-iron staining) and reduction (gleization) oxides, and/or mottled coloration from both processes. Higher moisture conditions were generally found in the landslide soil deposits. Landslide and slope creep deposit soils were observed in Trench 1 and 2, Test Pits 1, 2, 3, 4, 5, 6, 7, 9, 15, 16, 17 and 18, and Borings 1 through 5.

The residual and colluvial soil deposits encountered on the site were observed in similar context with the landslide deposits except that these deposits were stiff to very stiff in consistency, and not as strongly colored in response to oxidation and reduction processes. The residual and colluvial deposit soils were observed in Trench 1 and 2, and Test Pits 2, 3, 12, 13, 14 and 15.

The debris flow deposits consisted of sandy clays (CL), and clayey gravels (GC) with clast supported matrices, and significantly higher percentages of sand. Diagnostic pin-hole structures were observed in the sandy clay soils (CL) classified as debris flow deposits. Debris flow deposit soils were observed in Trench 1, Test Pits 10 and 11.

The silty clay (CL) alluvial overbank deposits consisted of massive medium-stiff clay deposits. The Alluvial overbank deposit soils were observed in the west part of Trench 1

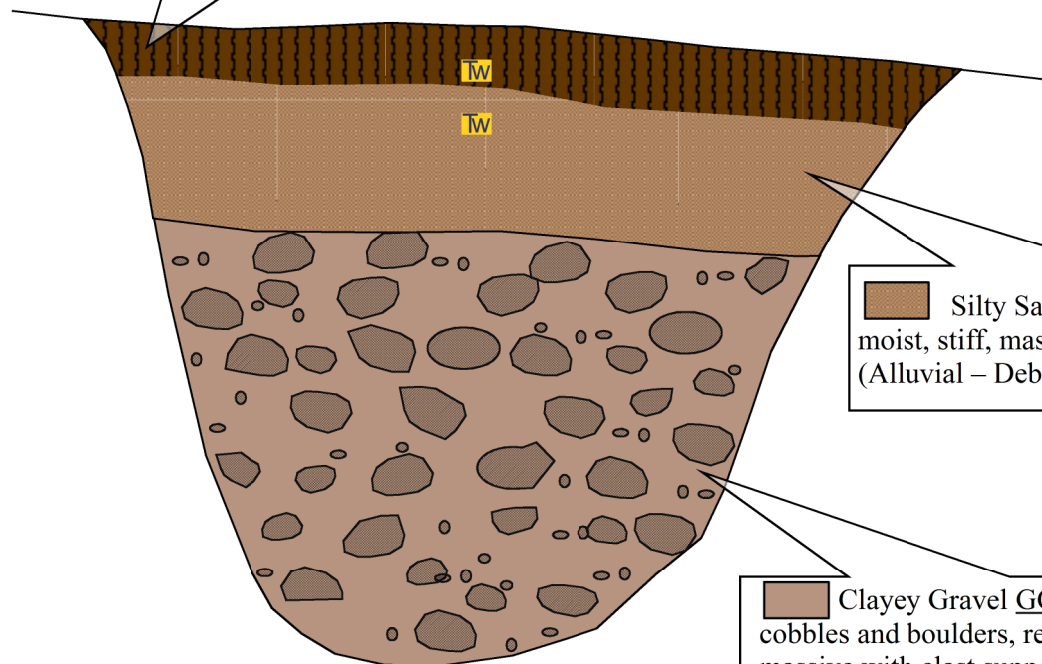
Silty Sandy Clay CL, fine sand, red brown, moist, stiff, massive with pin-holes, (Alluvial – Debris Flow)

Clayey Gravel GC, with silt and sand cobbles and boulders, reddish brown, moist, dense, massive with clast supported matrix, (Alluvial Debris Flow)

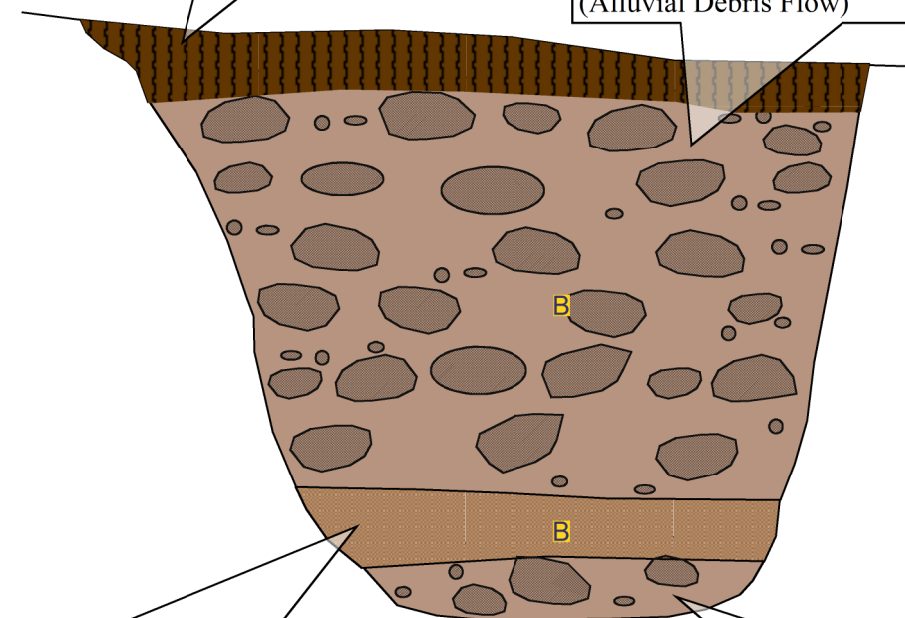
Test Pit #11  
East Wall of Pit

Clayey gravel GC with silt sand cobbles and Boulders, reddish brown, moist, dense, massive with slight imbricate clast supported matrix, (Alluvial Debris Flow)

Silty Sandy Clay CL, fine sand, red brown, moist, stiff, massive with pin-holes, (Alluvial – Debris Flow)

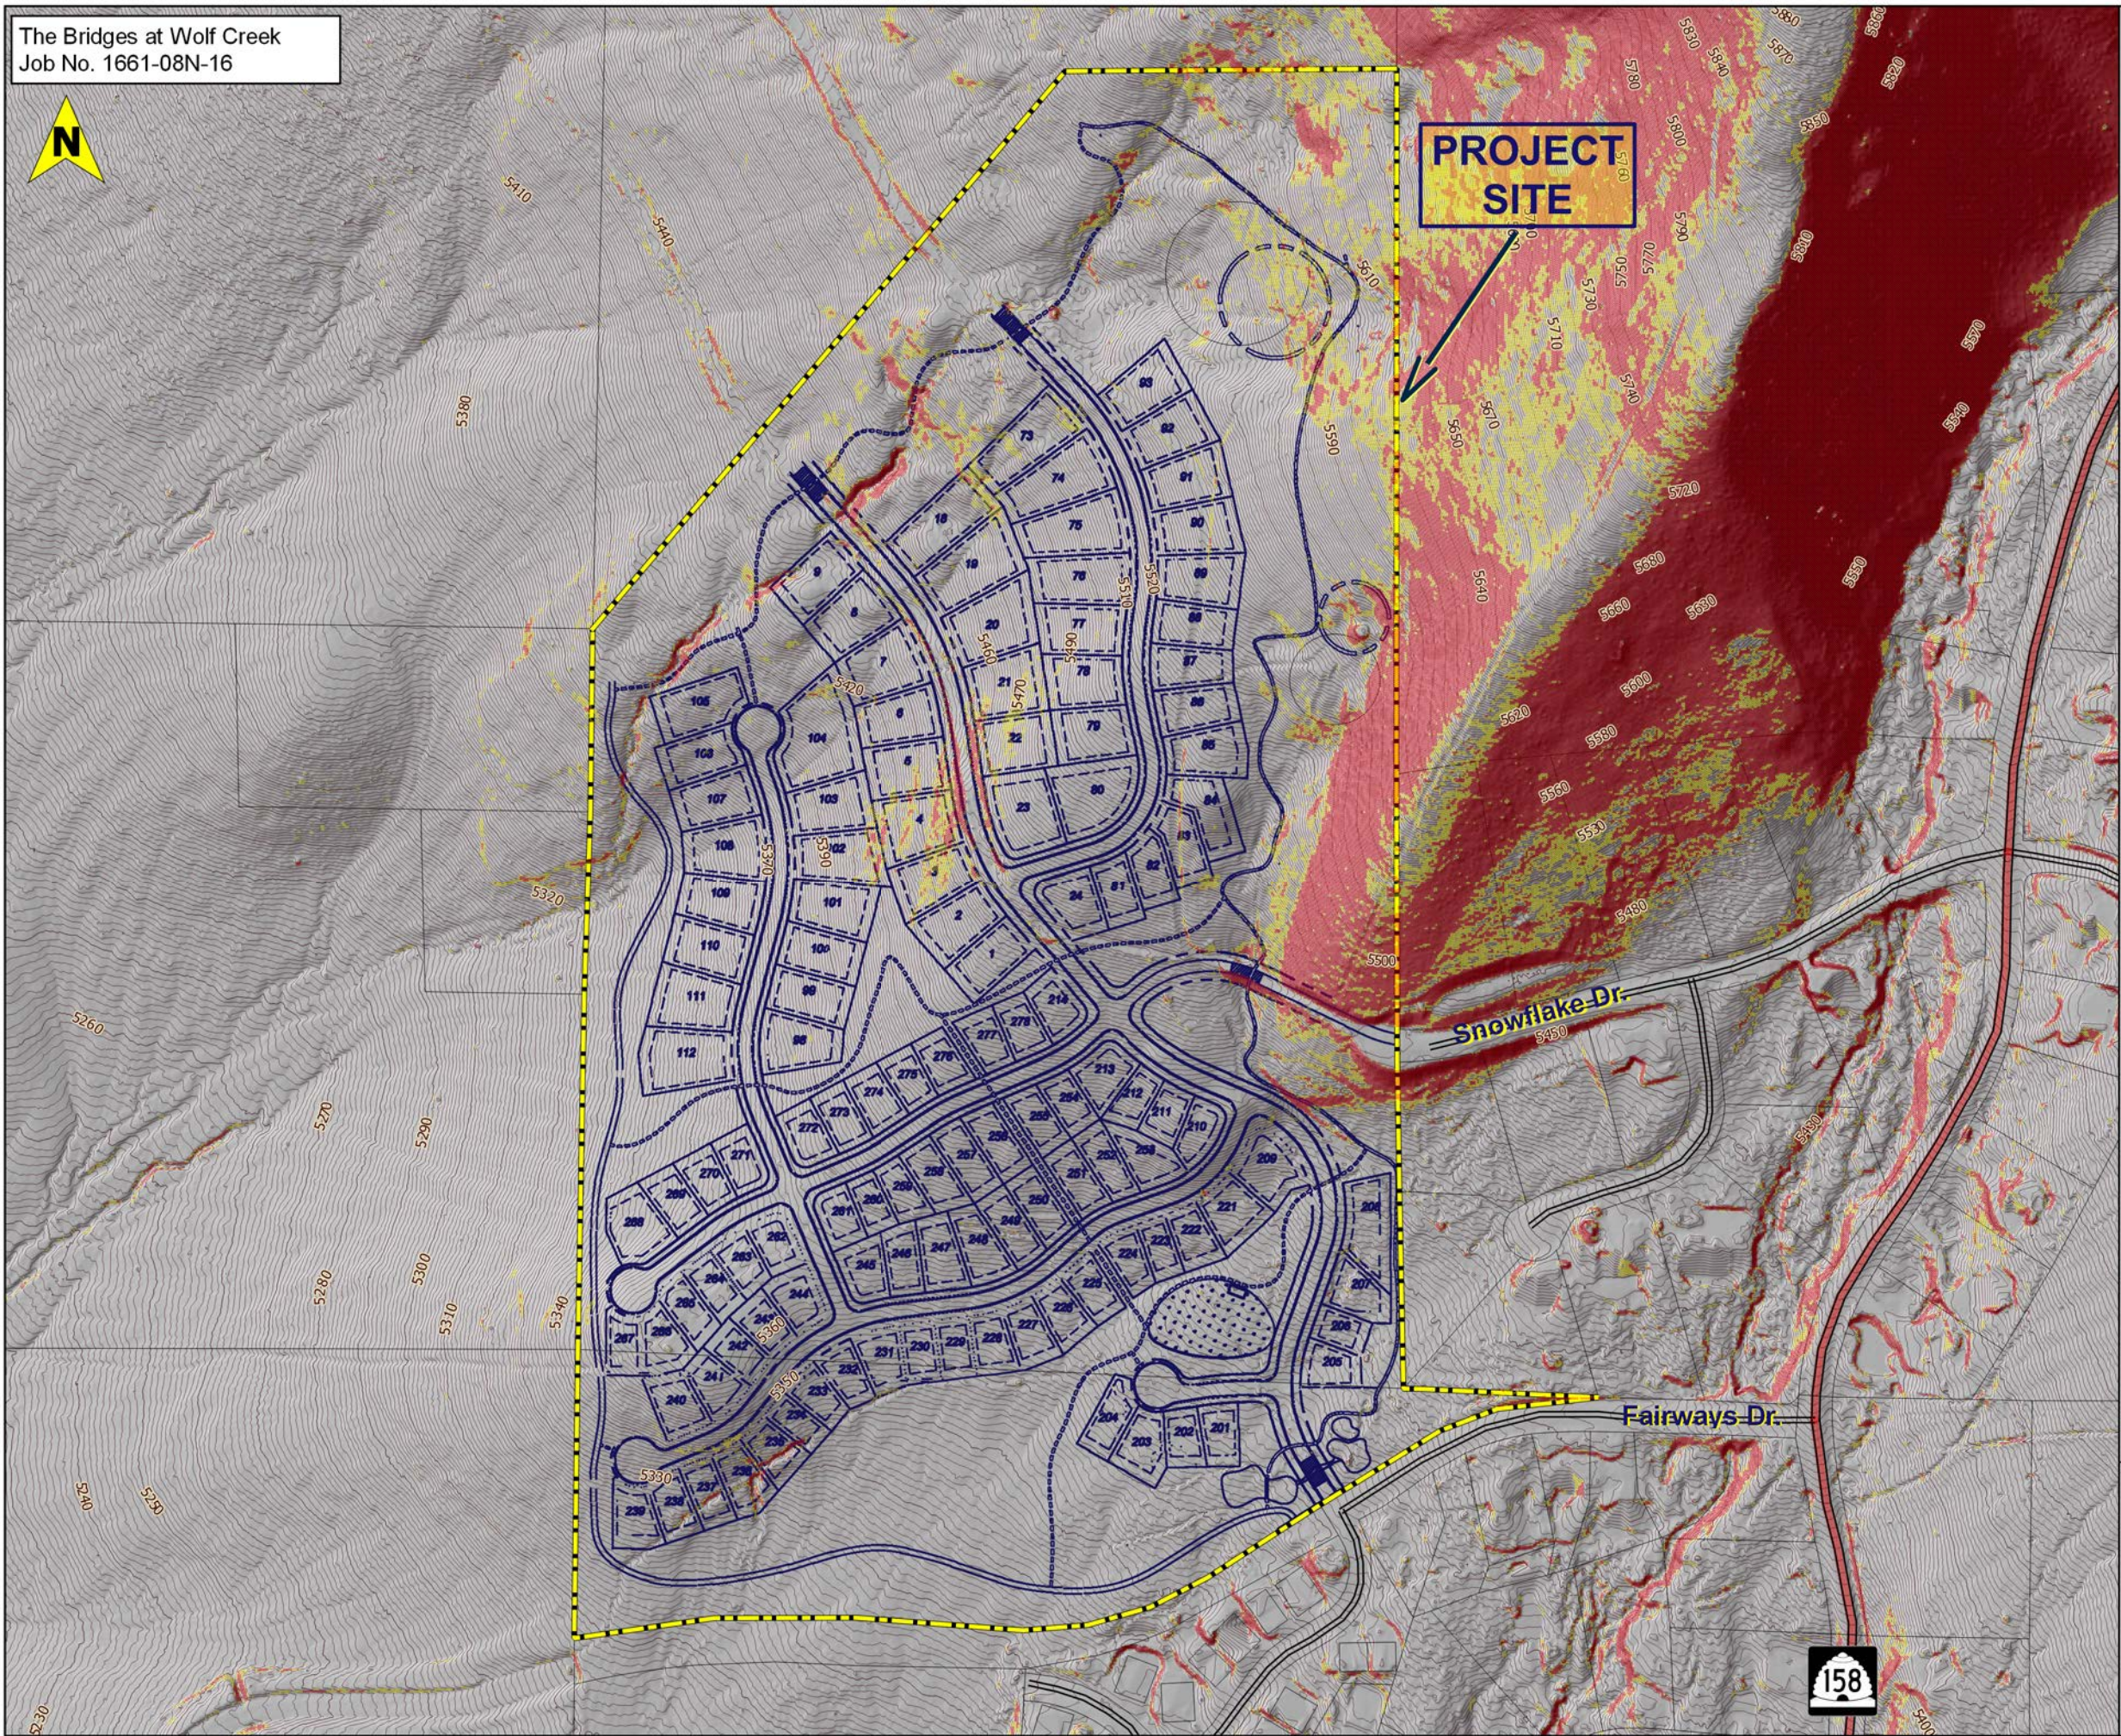
Site slopes and terrain conditions are presented on Figure 18, LiDAR-Slope Analysis. The elevation contours and site slope gradients on Figure 18 were developed from our LiDAR analysis. Surface gradients were found to range from level to over 65-percent as shown on Figure 18. For the site area, the slope gradient averaged 15.6-percent, with areas both above and below the average as shown on Figure 18. As previously mentioned in Section 2.3 of this report, the critical slope gradient for site development considerations according to the Weber County Code is 25-percent or greater. The terrain features illustrated by the relief shading on Figure 18, assisted in the interpretation and/or confirmation of the engineering geology units presented in Figure 3.

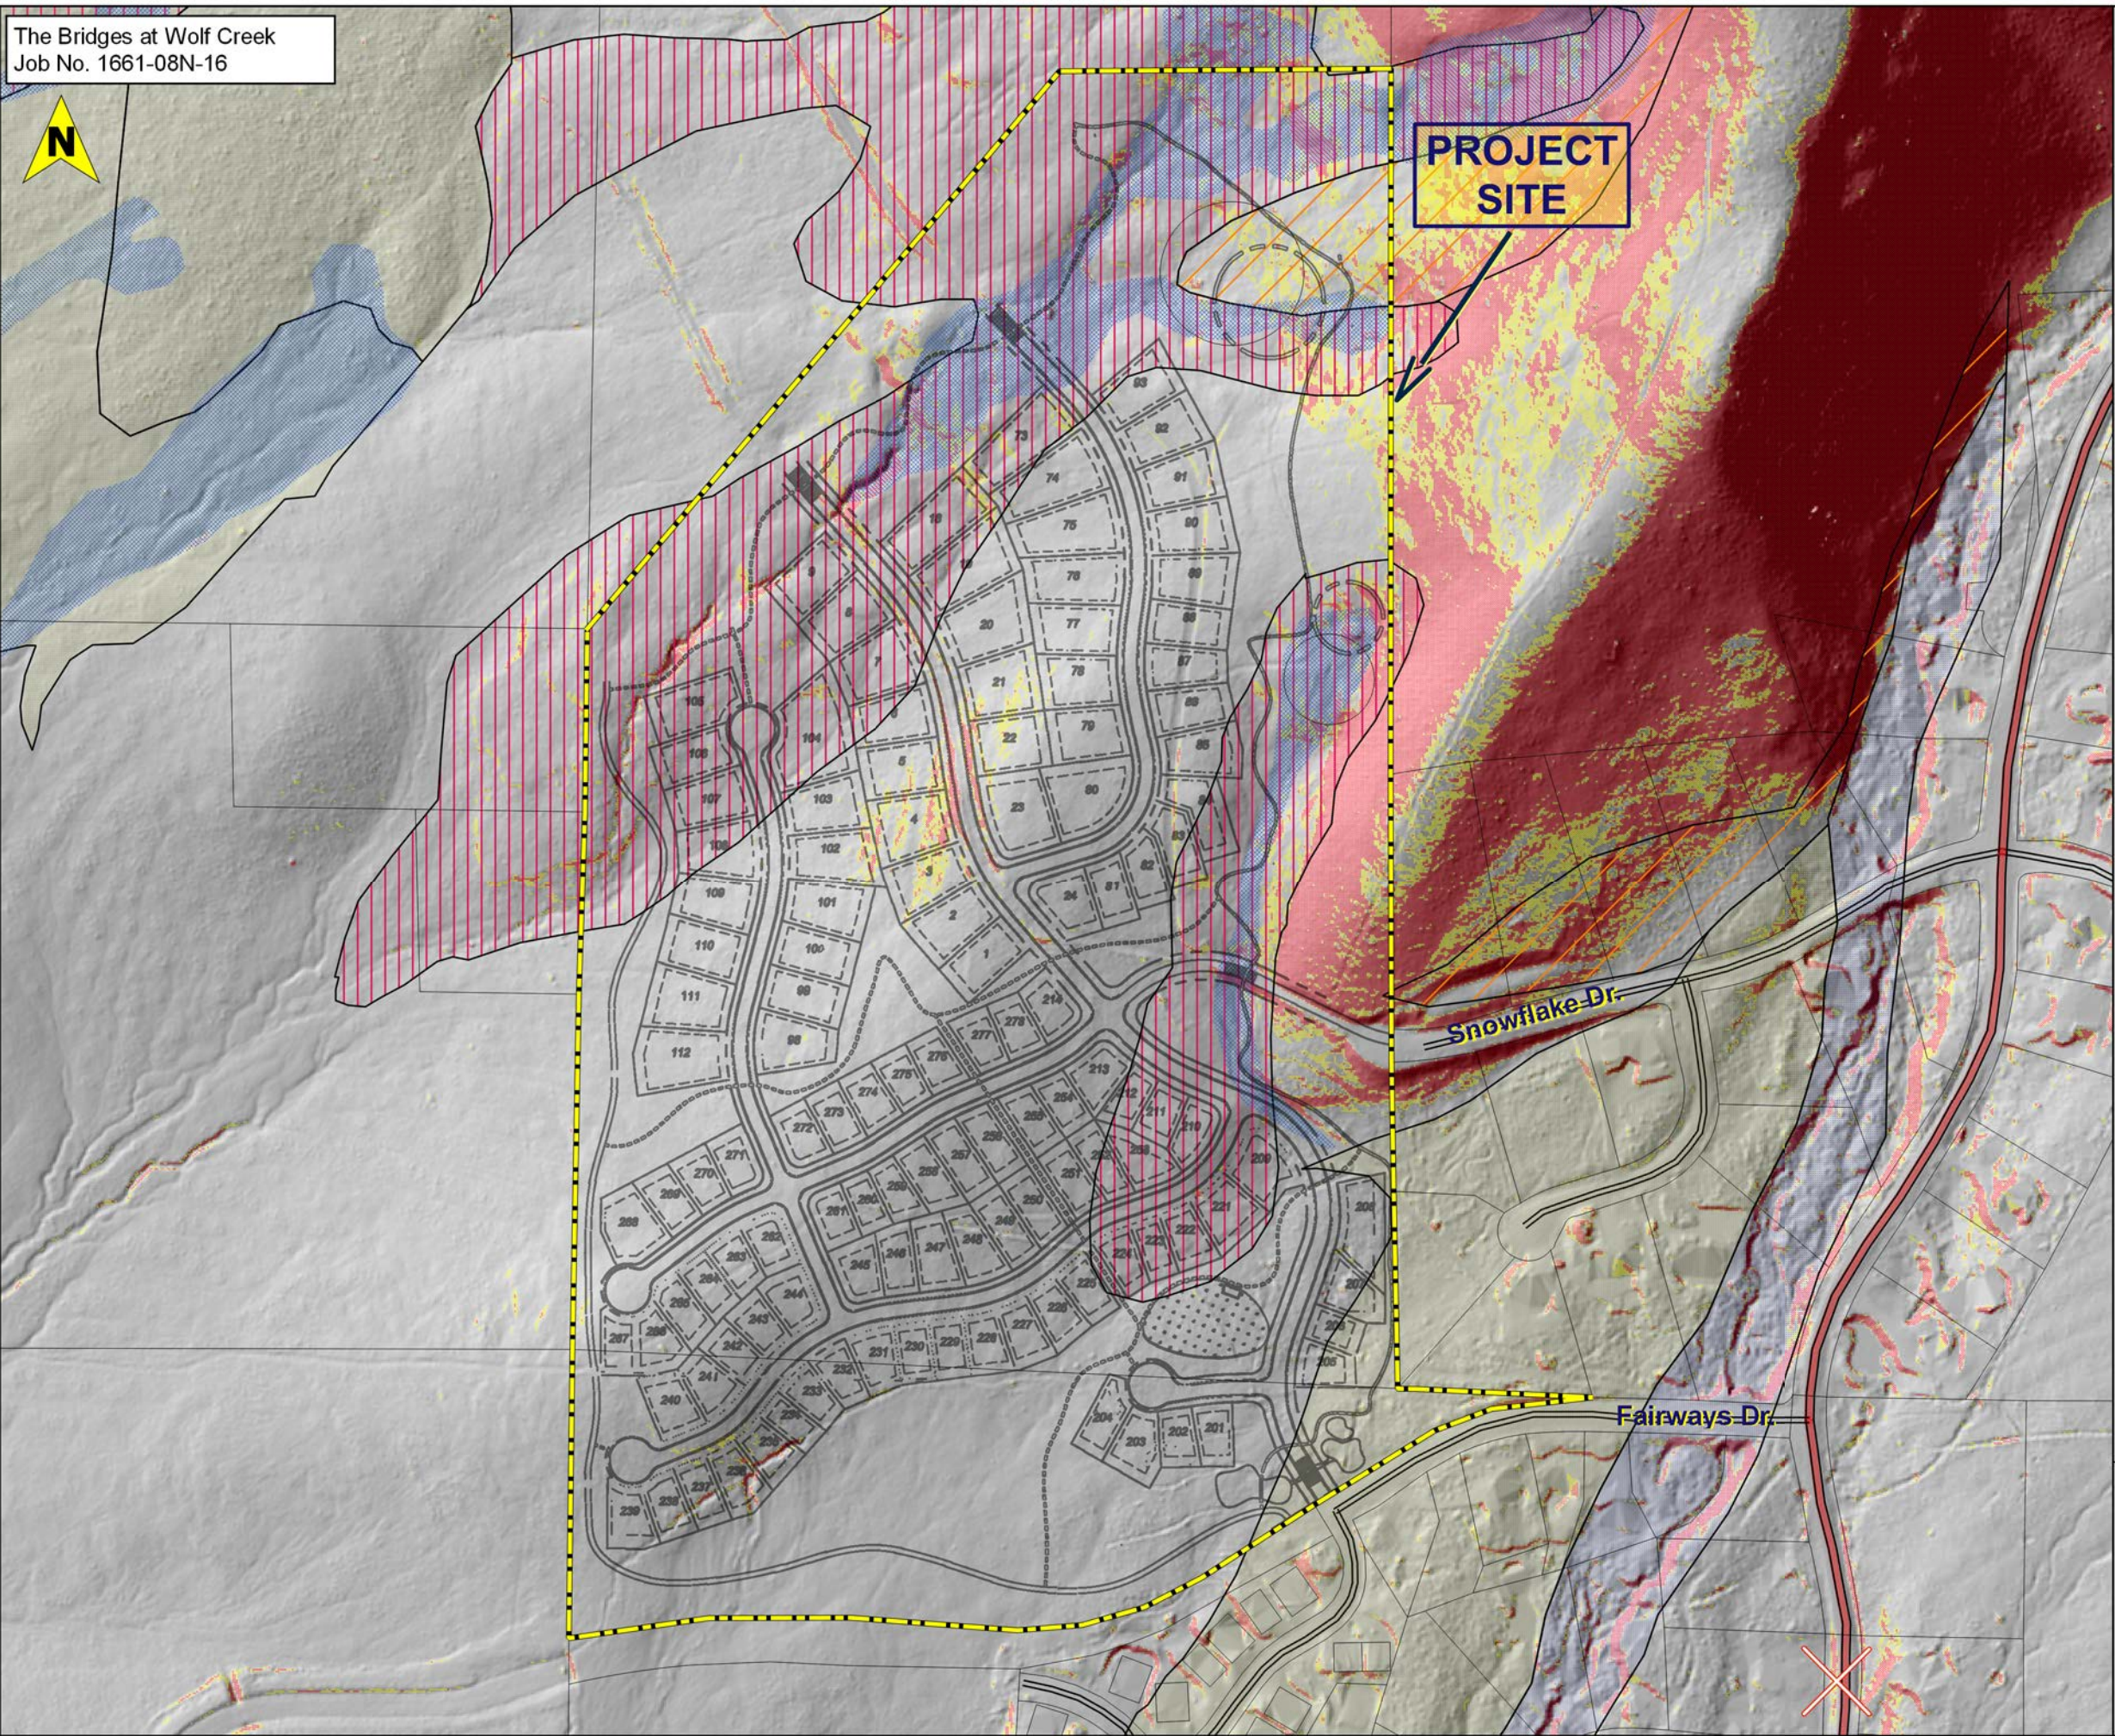
**FIGURE 19**  
**GEOLOGIC/NATURAL**  
**HAZARD EXPOSURE**  
 **GSH**

Hazards exposure for the East Phase of the Bridges at Wolf Creek is shown on Figure 19, and includes Shallow-Seasonal Groundwater areas (**Cienega**), Landslide-Mass Movement Hazard areas (**Qms**), and Alluvial Fan - Debris Flow Hazard areas (**Qafy**).

The two landslide areas described herein are complex combined earth-flow/soil creep features that have occurred on relatively low gradient slopes, and appear to be relatively shallow in thickness. Apparent from the mapping on Figure 19, is the areal relationship between Shallow-Seasonal Groundwater areas Landslide-Mass Movement Hazard areas. The location of the Shallow-Seasonal Groundwater areas over Landslide-Mass Movement Hazard areas indicates a systemic relationship between these two phenomena. As previously mentioned, the Landslide-Mass Movement Hazard areas appear to correlate to areas downslope of Maple Canyon Formation argillite beds mapped as **Zmcc2** on Figure 3. The emergence of the ground water on the surface on the same areas suggest the argillite beds may also controlling factor for the location of the groundwater emergence. The occurrence of the Shallow-Seasonal Groundwater on the Landslide-Mass Movement Hazard areas is believed to have a negative effect on the soil strength and stability of these soils, thus the removal of the water in these areas is believed to be a possible strategic measure for attaining stability in these areas.

**Debris Flow Hazard areas (Qafy)** are shown on Figure 19 to occur on the very southeast side of the East Phase site. These Younger Alluvial Fan Deposits (Holocene and Pleistocene) (**Qafy**), occur adjacent to the active floodplain deposits along the Wolf Creek channel. The Debris Flow Hazard area defined by the **Qafy** deposits is potentially exposed to both debris flows and clear-water flooding should Wolf Creek avulse during a future flood event. It is our understanding that no flood control or significant diversion structures on Wolf Creek exist upstream from the East Phase site, thus these hazards exist under the present conditions.

The area exposed to the debris flow hazards includes four residential development lots on the very southeast side of the East Phase, however the source of the hazard (Wolf Creek) is located off site, and is thus not feasible for hazard modification remediation. Therefore modifying what is at risk may be the only feasible approach to protect the improvements proposed for this area. Risk modification may include disclosure that exposed properties are subject to the potential debris-flow/flood hazards, and prescribed site specific grading and structural measures taken to reduce the potential impact of the hazards to the proposed improvements, which may include building setbacks, deflection berms, minimum finished floor elevations, limits to basement locations, and/or limits to door/window openings in basements.

These guidelines should be considered a basis for landslide hazards reductions where proposed improvements are exposed to landslide hazards as shown on Figure 19.

Remedial hazard risk reduction measures will need to be implemented where improvements will be exposed or potentially exposed to the hazard processes. These areas are shown on Figure 19, however more detailed and specific studies in-grading circumstances may find conditions different than presented on Figure 19. Hazard reduction measures may include site engineering measures to contain, deflect, drain or stabilize these processes, and/or include site development planning to avoid exposure to the hazards.
