November 23, 2016

IGES Project No. 02348-001

Subject: Geologic Hazards Assessment (Revision 1)
The Ridge Subdivision Phases 3, 4, and 5
Eden, Utah

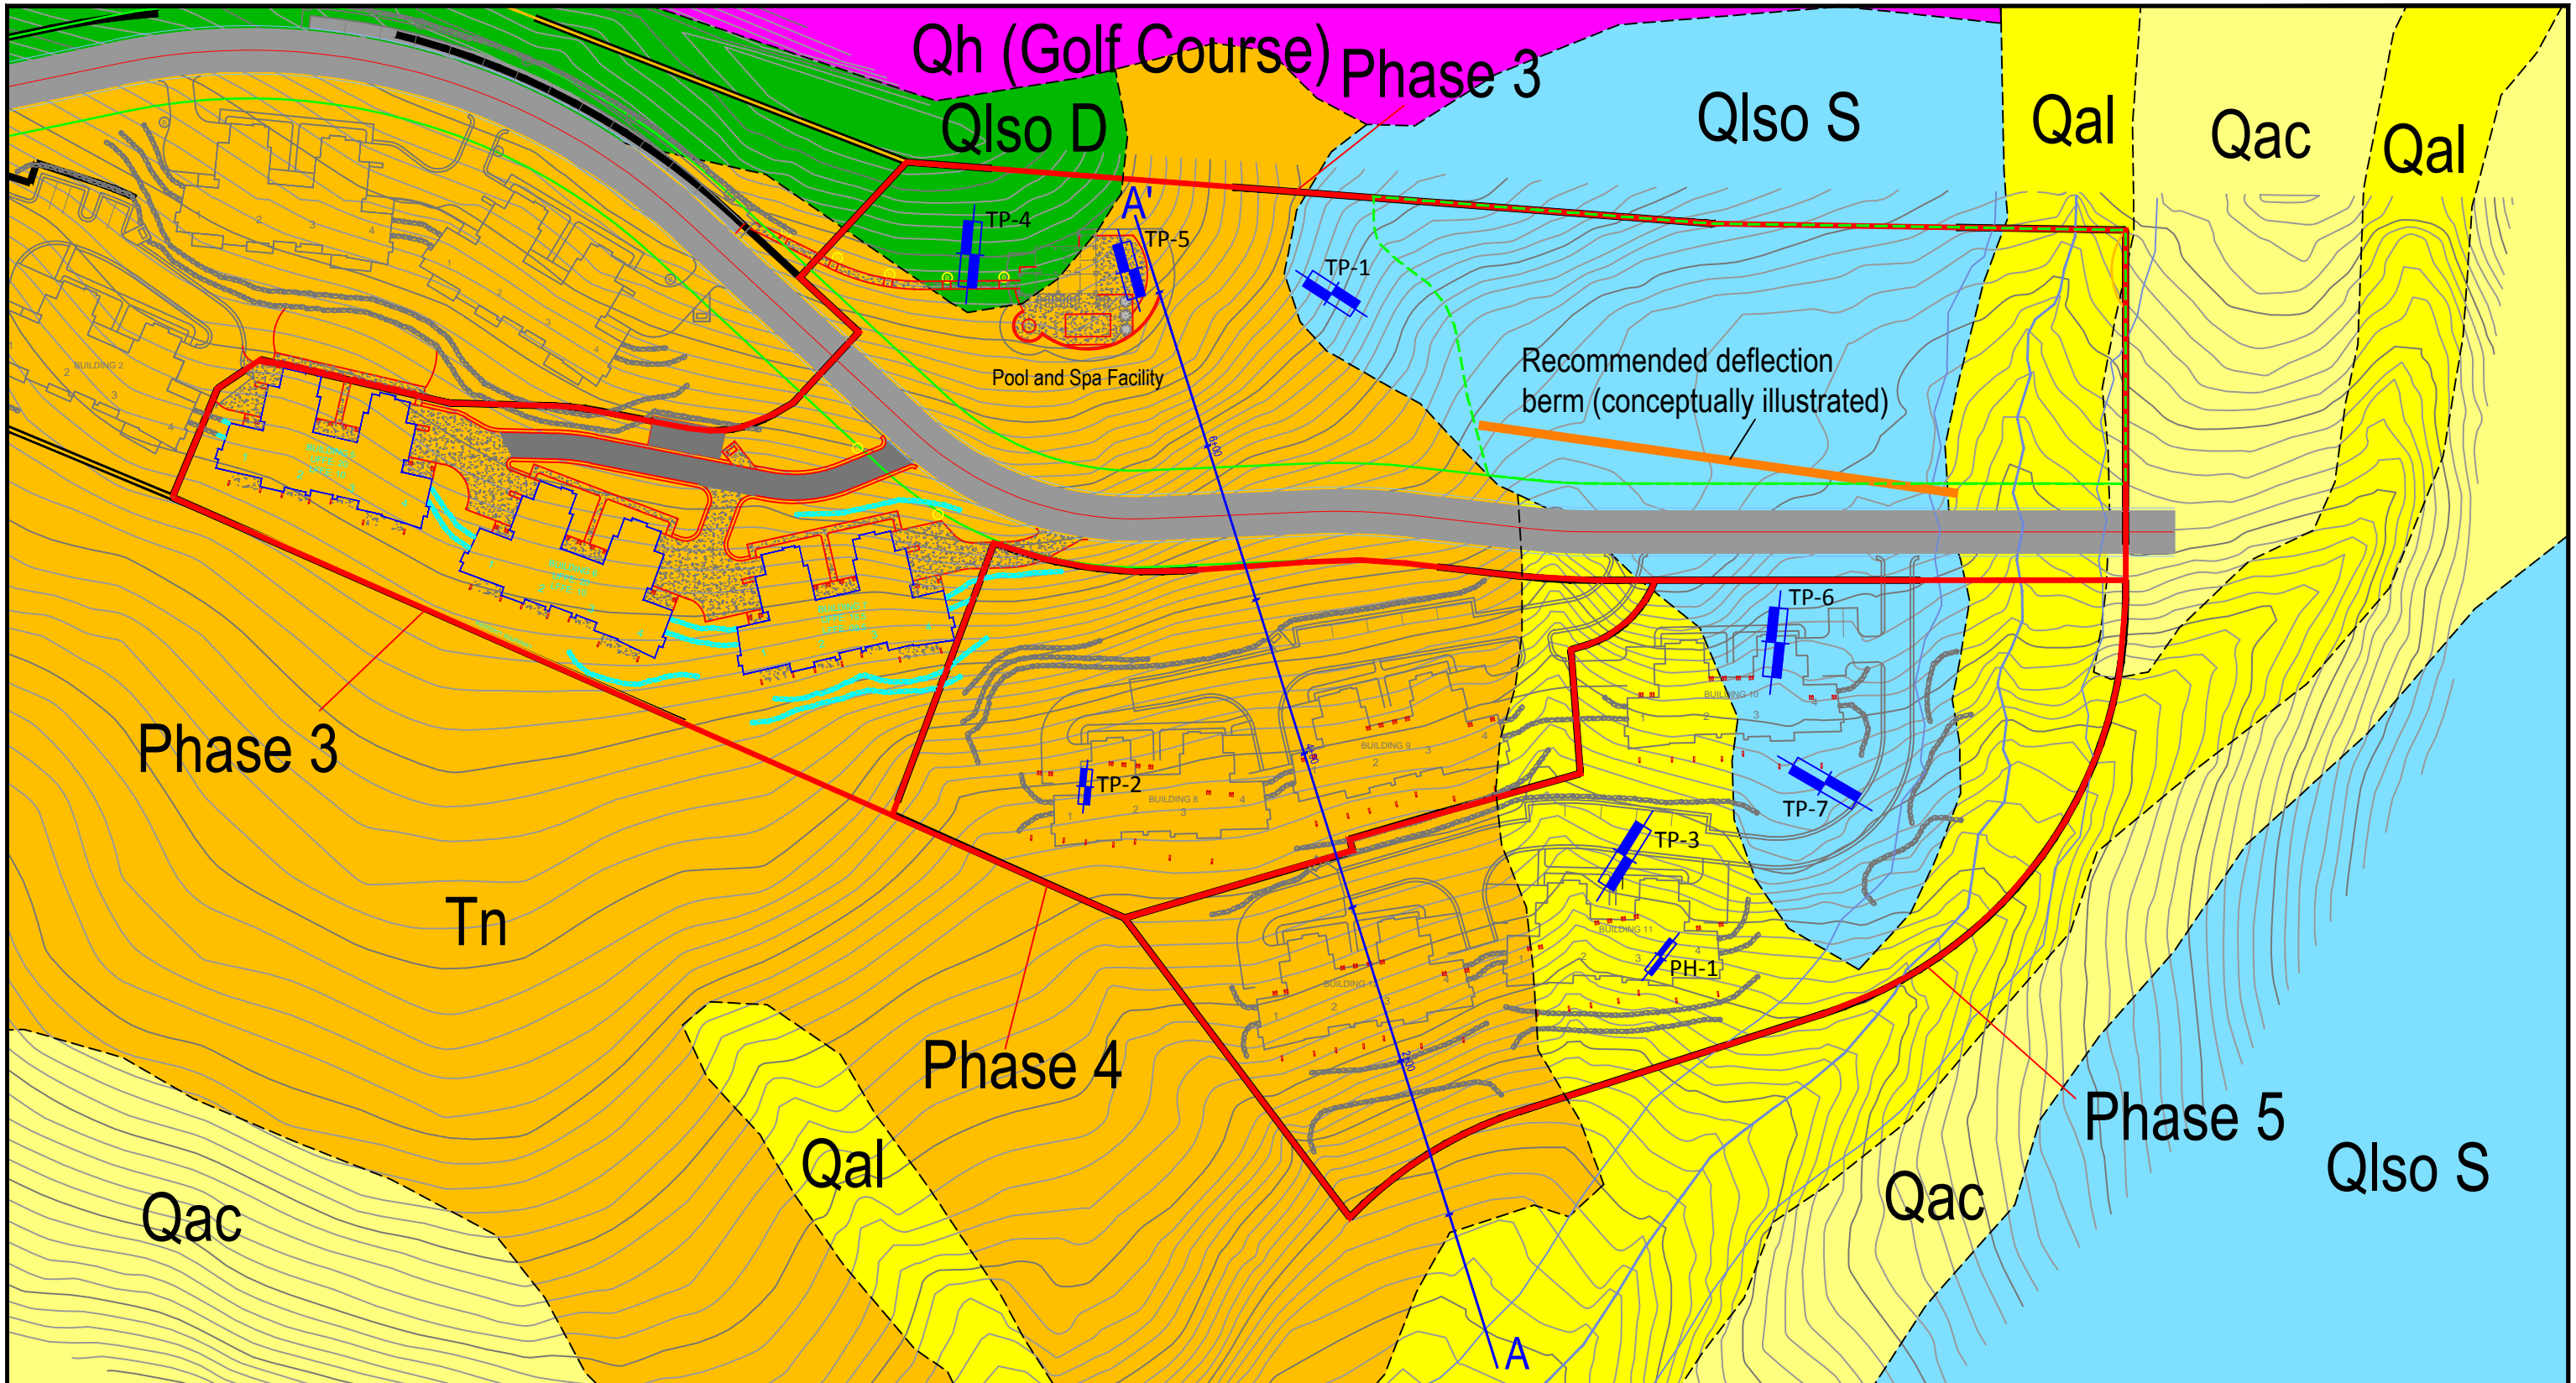
The initial subsurface investigation showed the landslide deposits to be limited to the northern part of the Phase 3 area and the northeastern part of the Phase 5 area, which was subsequently differentiated into two distinct landslide masses following the second phase of subsurface excavations (see Figure A-4). Of the eight subsurface excavations, explicit mass-movement evidence was only observed in TP-1, TP-4, TP-6, and TP-7 in the form of irregular, chaotic bedding and/or shear zones exhibiting multiple slide planes with slickensides.

The second landslide mass was a deeper-seated landslide deposit (Qlso D) that was only observed in the subsurface in TP-4. A very well-developed brownish gray shear zone approximately 4 feet thick (Unit 4 in Figure A-9) was observed to be dipping to the north (into the slope) at between 18 and 24 degrees. The shear zone exhibited a glassy/polished appearance due to abundant shearing and slickensides, and given the rotated nature of the lithologic units encountered in TP-4, was interpreted to be associated with a large-scale slump⁴ block. The top of the shear zone was found to be approximately 10 feet below existing grade at the northernmost part of the trench, and was exposed at the surface in the southernmost part of the trench. The rotational nature of the beds as seen in TP-4 was consistent with some of the rotated bedding observed in the road cut, and as such was interpreted to be part of the same slump block (see Figure A-4).

Our slope stability analysis indicates that areas outside of the mapped landslide areas (designated as Qlso on Figure A-4) meet the minimum acceptable factors-of-safety of 1.5 (static) and 1.0 (seismic or pseudo-static). It should be noted that our model only took into consideration the existing grade and not proposed topography (e.g., the finish grade after the townhomes are built). The results of the stability analyses are presented in Appendix C.
