**GEOTECHNICAL AND GEOLOGIC HAZARD INVESTIGATION  
Building 4 Lodge, Development Parcel D7R  
8569 E. Spring Park  
Summit Powder Mountain Resort  
Weber County, Utah**

IGES Project No. 01628-024

August 7, 2017

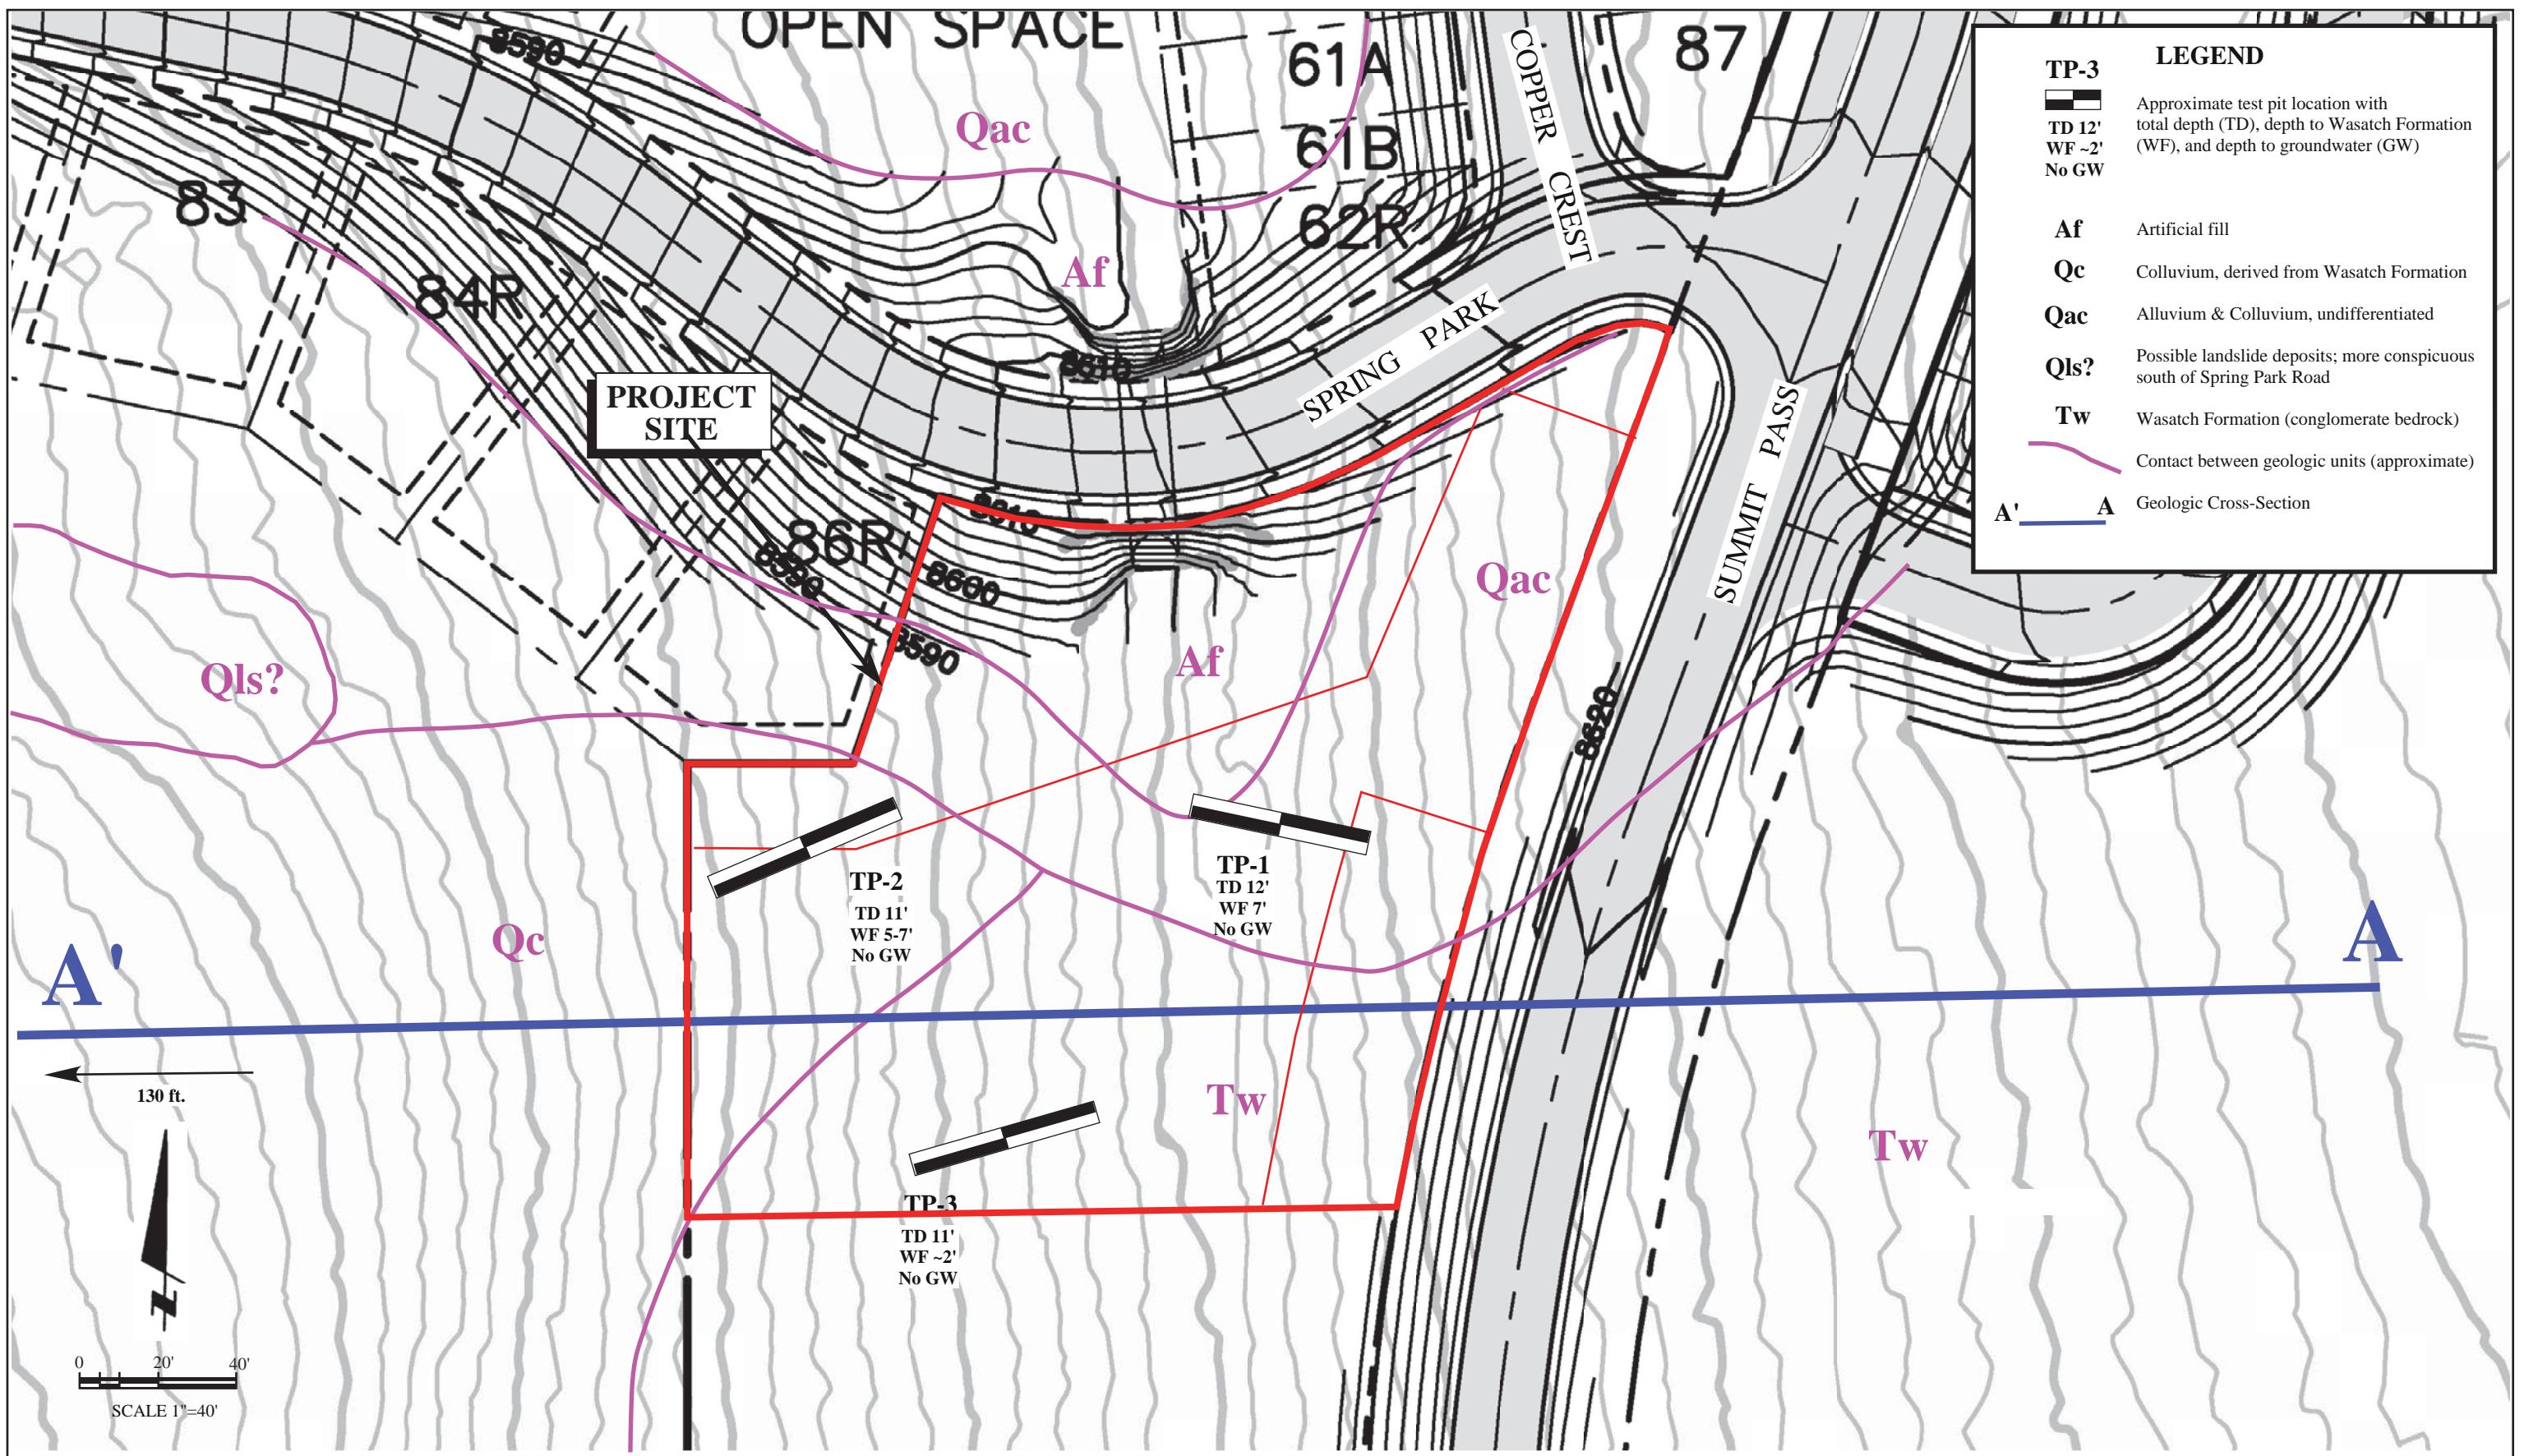
Approximately 100 feet west of the western margin of the property, a small, localized lobe of material interpreted to be possible landslide deposits was observed at the surface, though no associated headscarp was observed (see Figure A-2).

No springs, seeps, or running water were observed on the property at the time of the site visit. Additionally, no evidence of landsliding or other geologic hazards was observed on the property, though potential localized landslide features were observed to the west of the property, and a small break in slope was observed immediately west of the property (see Figure A-2).

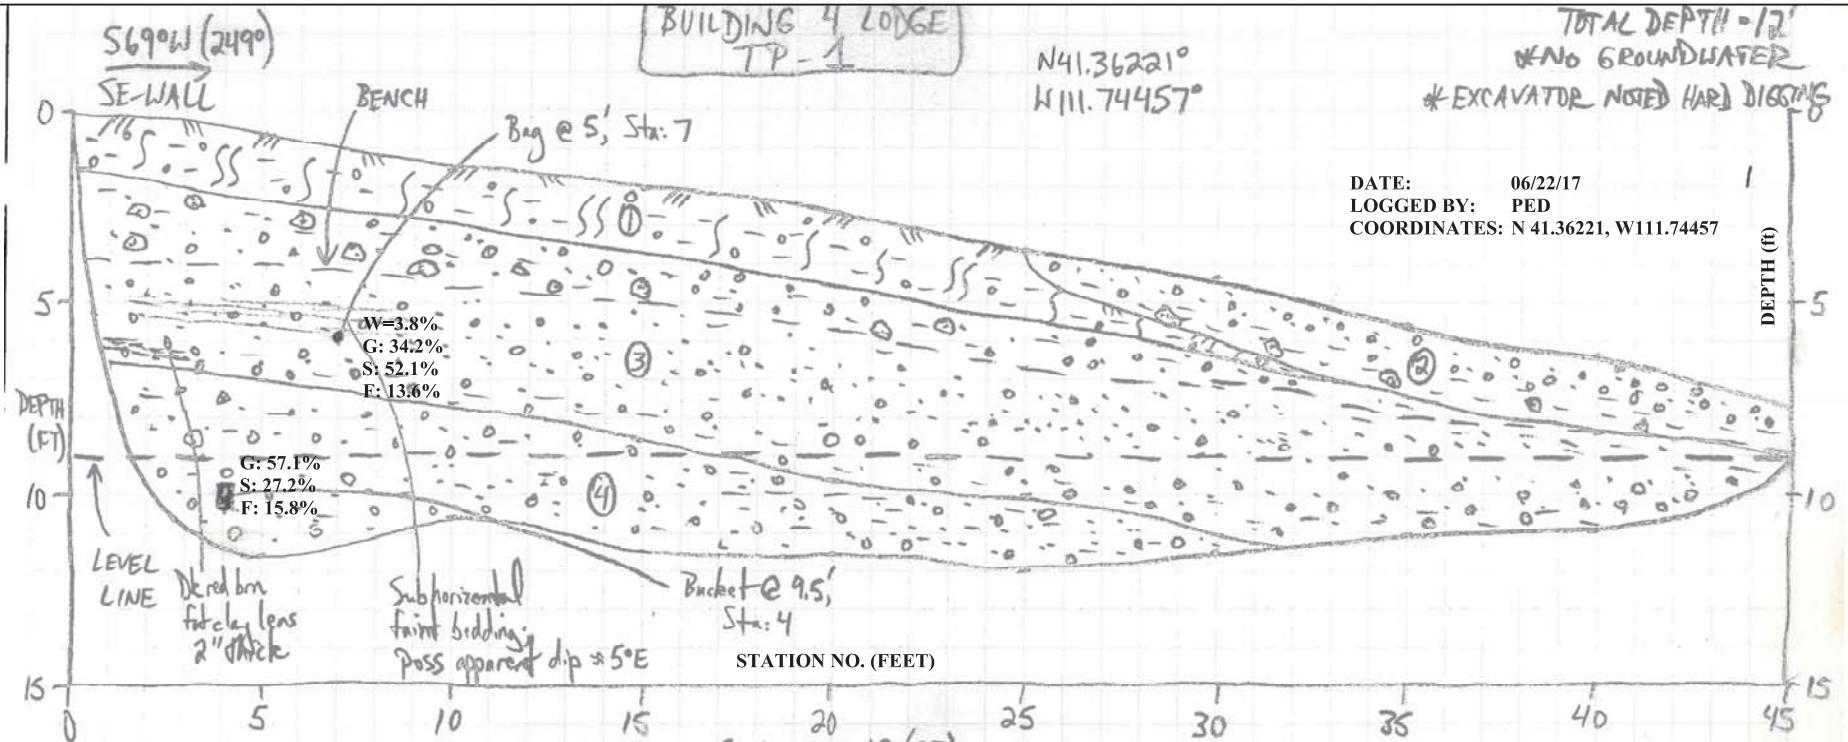
A-3

1) **A/B Soil Horizon:** ~1.5-2' thick; grayish brown (5Y 3/2) sandy lean CLAY with gravel (CL), medium stiff, moist, low plasticity, massive; gravel and larger sized clasts comprise ~15% of unit; clasts entirely surrounded medium light gray (N6) to pale yellowish orange (10YR 8/6) quartzite up to 1' in diameter, though mode size ~1"; abundant plant and tree roots; thickens slightly downslope; gradational, planar basal contact.

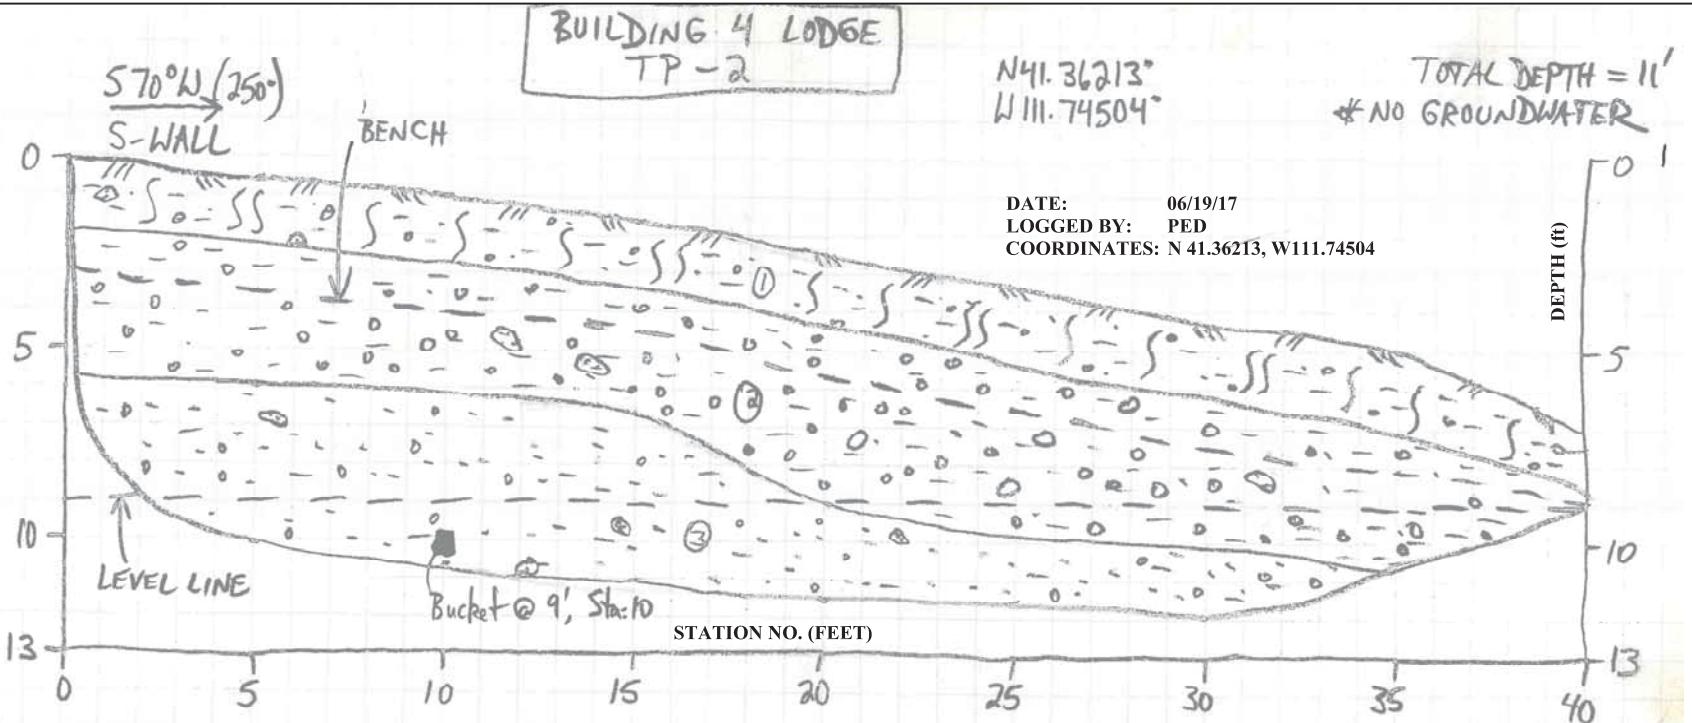
**Figure**  
**A-4**

1) **A/B Soil Horizon:** ~1.5-2' thick; grayish brown (5YR 3/2) to brownish black (5YR 2/1) sandy lean CLAY with gravel (CL), medium stiff, moist, low plasticity, massive; gravel and larger sized clasts comprise ~5-10% of unit; clasts entirely surrounded medium gray (N5) to dark yellowish orange (10YR 6/6) quartzite up to 8" in diameter, though mode size <1"; abundant plant and tree roots; gradational, largely planar basal contact.

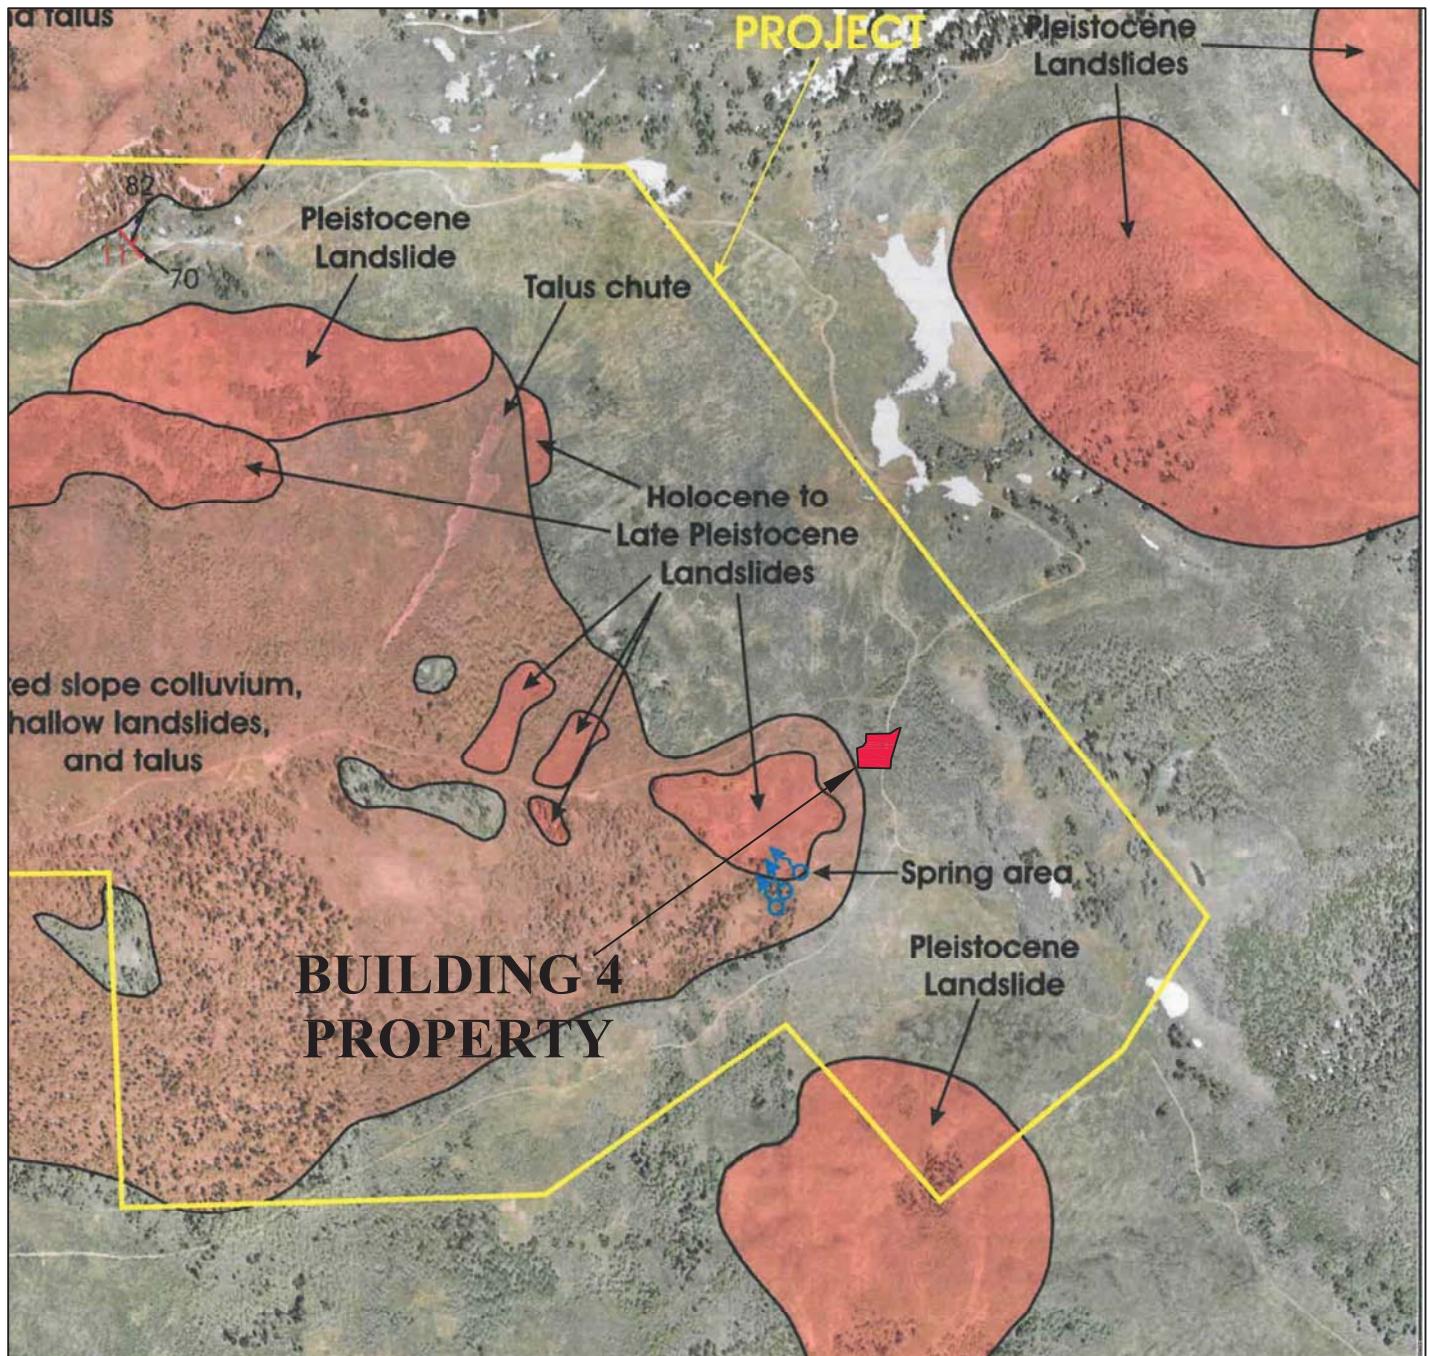
**Figure**  
**A-9**

Two regional-scale landslide hazard maps have been produced that cover the project area. Colton (1991) does not show the property to be underlain by or adjacent to landslide deposits. Elliott and Harty (2010) shows deposits mapped as “Landslide undifferentiated from talus and/or colluvial deposits” near the southwestern margin of the property. Most recently and more site-specific, Western Geologic (2012) used the Elliott and Harty (2010) map as a base map, which shows “mixed slope colluvium, shallow landslides, and talus” deposits southwest of the property (see Figure A-9).

However, springs are known to be present southwest of the property (see Figures A-1 and A-9) and groundwater seepage has been noted in the excavations conducted on nearby properties (IGES, 2016a and 2017). Given the existing data, it is expected that groundwater levels will fluctuate both seasonally and annually, and the risk associated with shallow groundwater hazards is considered to be low to moderate. Spring thaw and runoff are likely to significantly contribute to elevated groundwater conditions. Shallow groundwater issues can be mitigated through appropriate grading measures and/or the avoidance of the construction of residences with basements, or constructing basements with foundation drains.

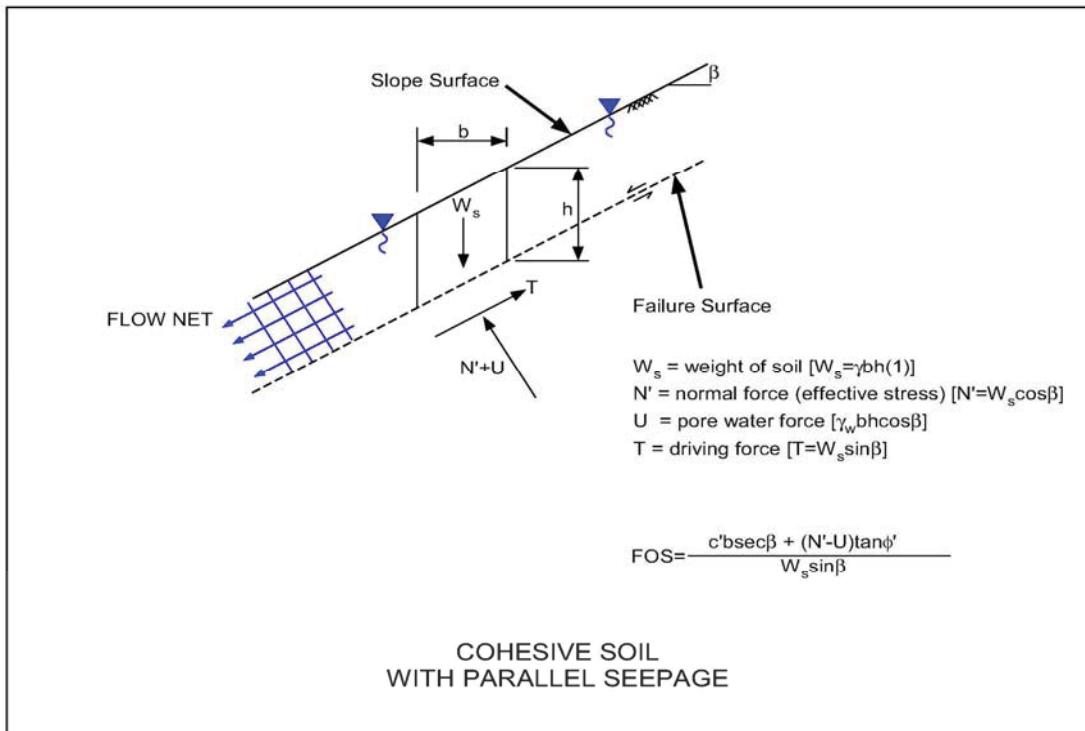
Figure D-2

IGES assessed the potential for the upper three feet to become mobilized under saturated parallel seepage conditions. Our assessment assumes three feet of clayey colluvium or topsoil, fully saturated, and a 4H:1V slope (this would be a transient condition that could occur during primary spring run-off and snowmelt). Our model assumes an estimated effective friction angle of 28 degrees and a cohesion of 150 psf, and a saturated unit weight of 135 pcf. Based on this model, a factor-of-safety of 2.33 results. Sample calculations are presented in Appendix D.

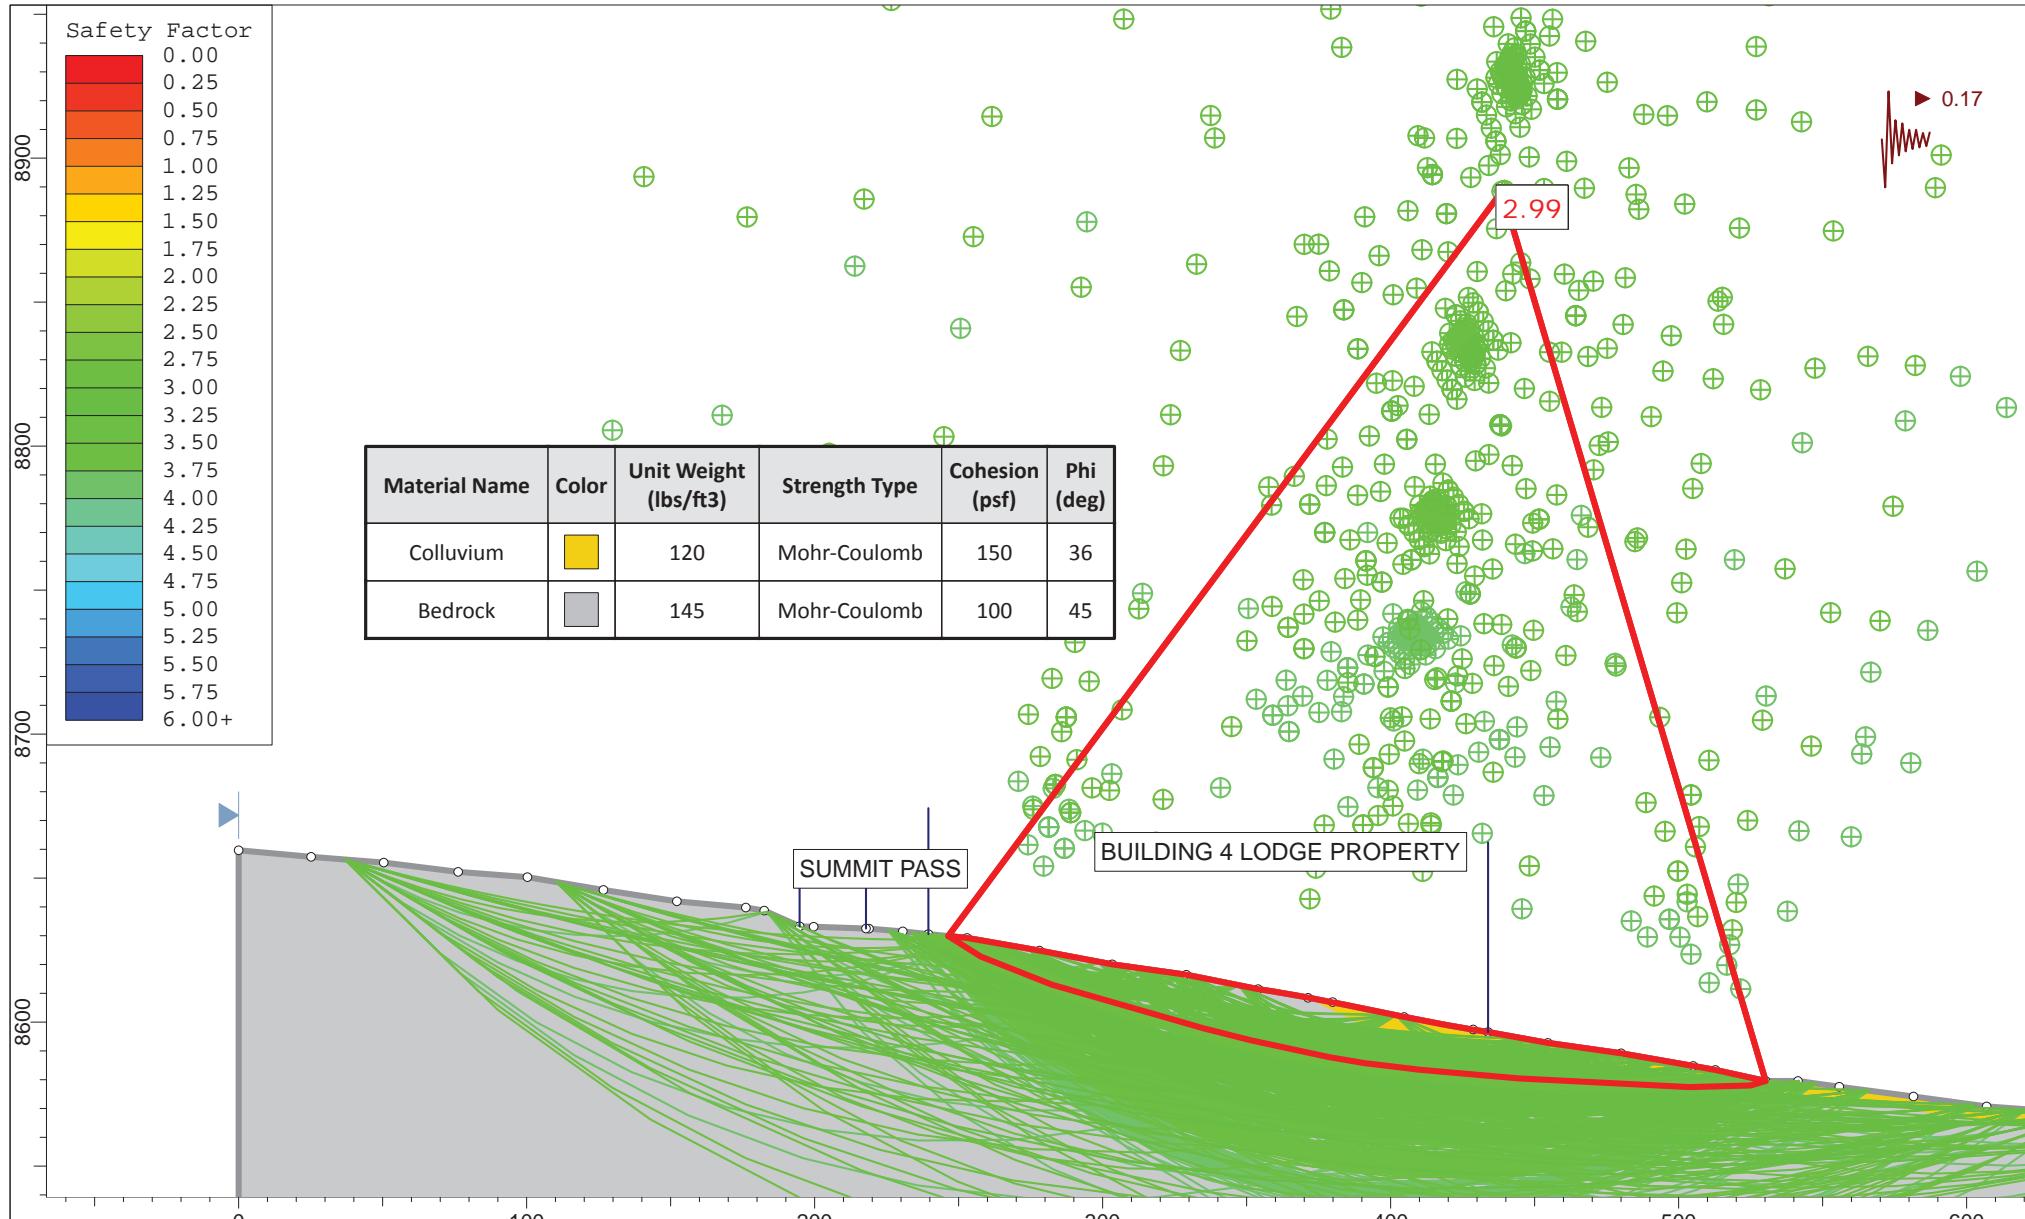
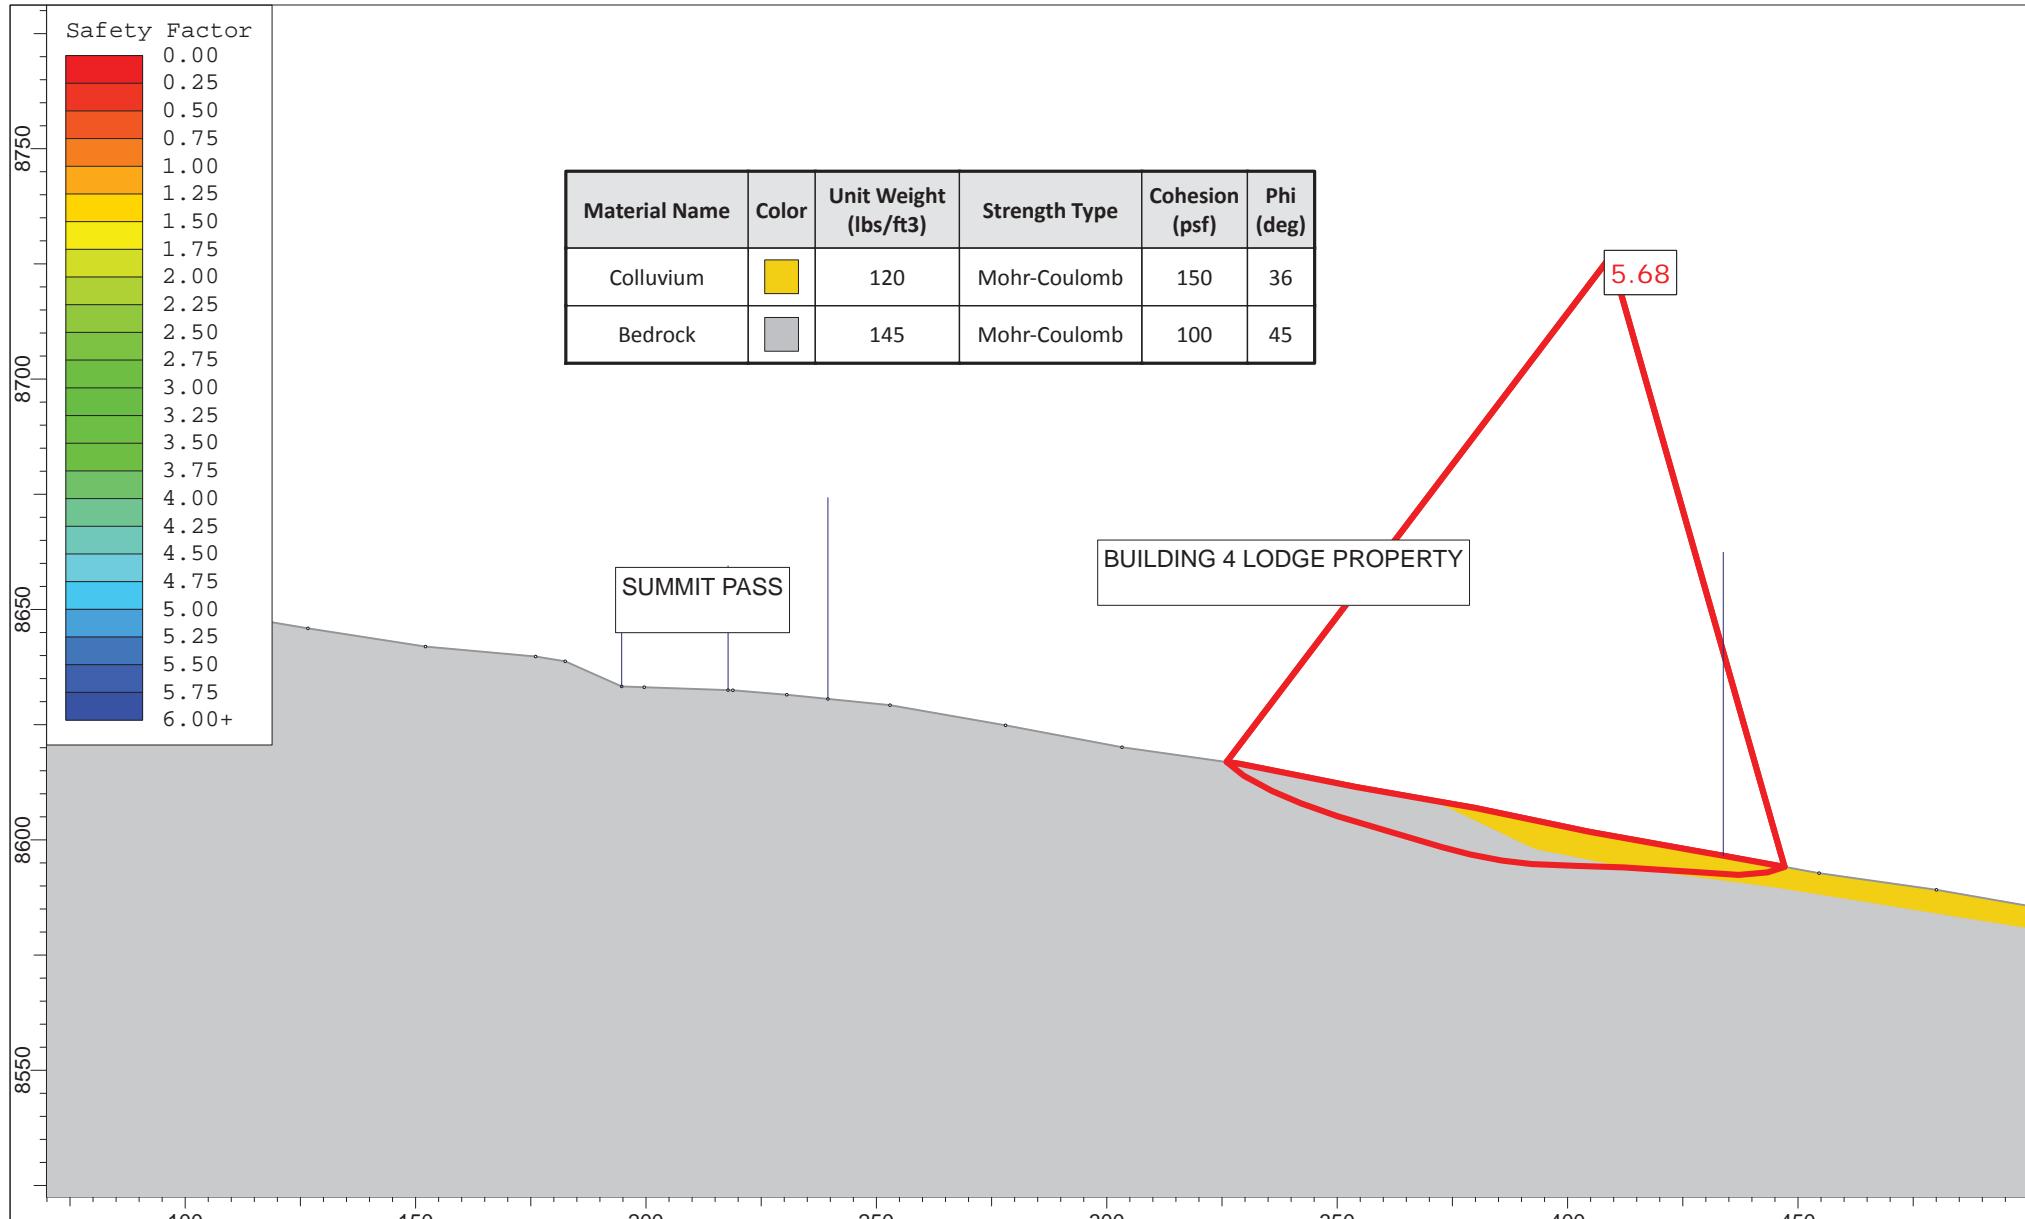
*Analysis Description* Section A-A' - Static

Section	Static Factor of Safety	Pseudo-Static Factor of Safety
Existing Condition	5.68	2.99

The results of the analysis indicated the existing conditions meet the minimum required factors-of-safety of 1.5 and 1.0 for both the static and seismic (pseudo-static) case, respectively. The planned improvements will include a deep basement level, which would tend to unload the slope and further improve the stability of the slope; significant fill placement on the slope, which would tend to load the slope and decrease stability, is not anticipated. A summary of the slope stability analysis is presented in Appendix D.
