**Geologic Hazards Assessment]
Parcel # 22-041-0007
Big Sky Estates No. 1 Lot 26
2230 North Panorama Circle
Liberty, Utah**

GeoStrata Job No. 1276-001

November 23, 2016

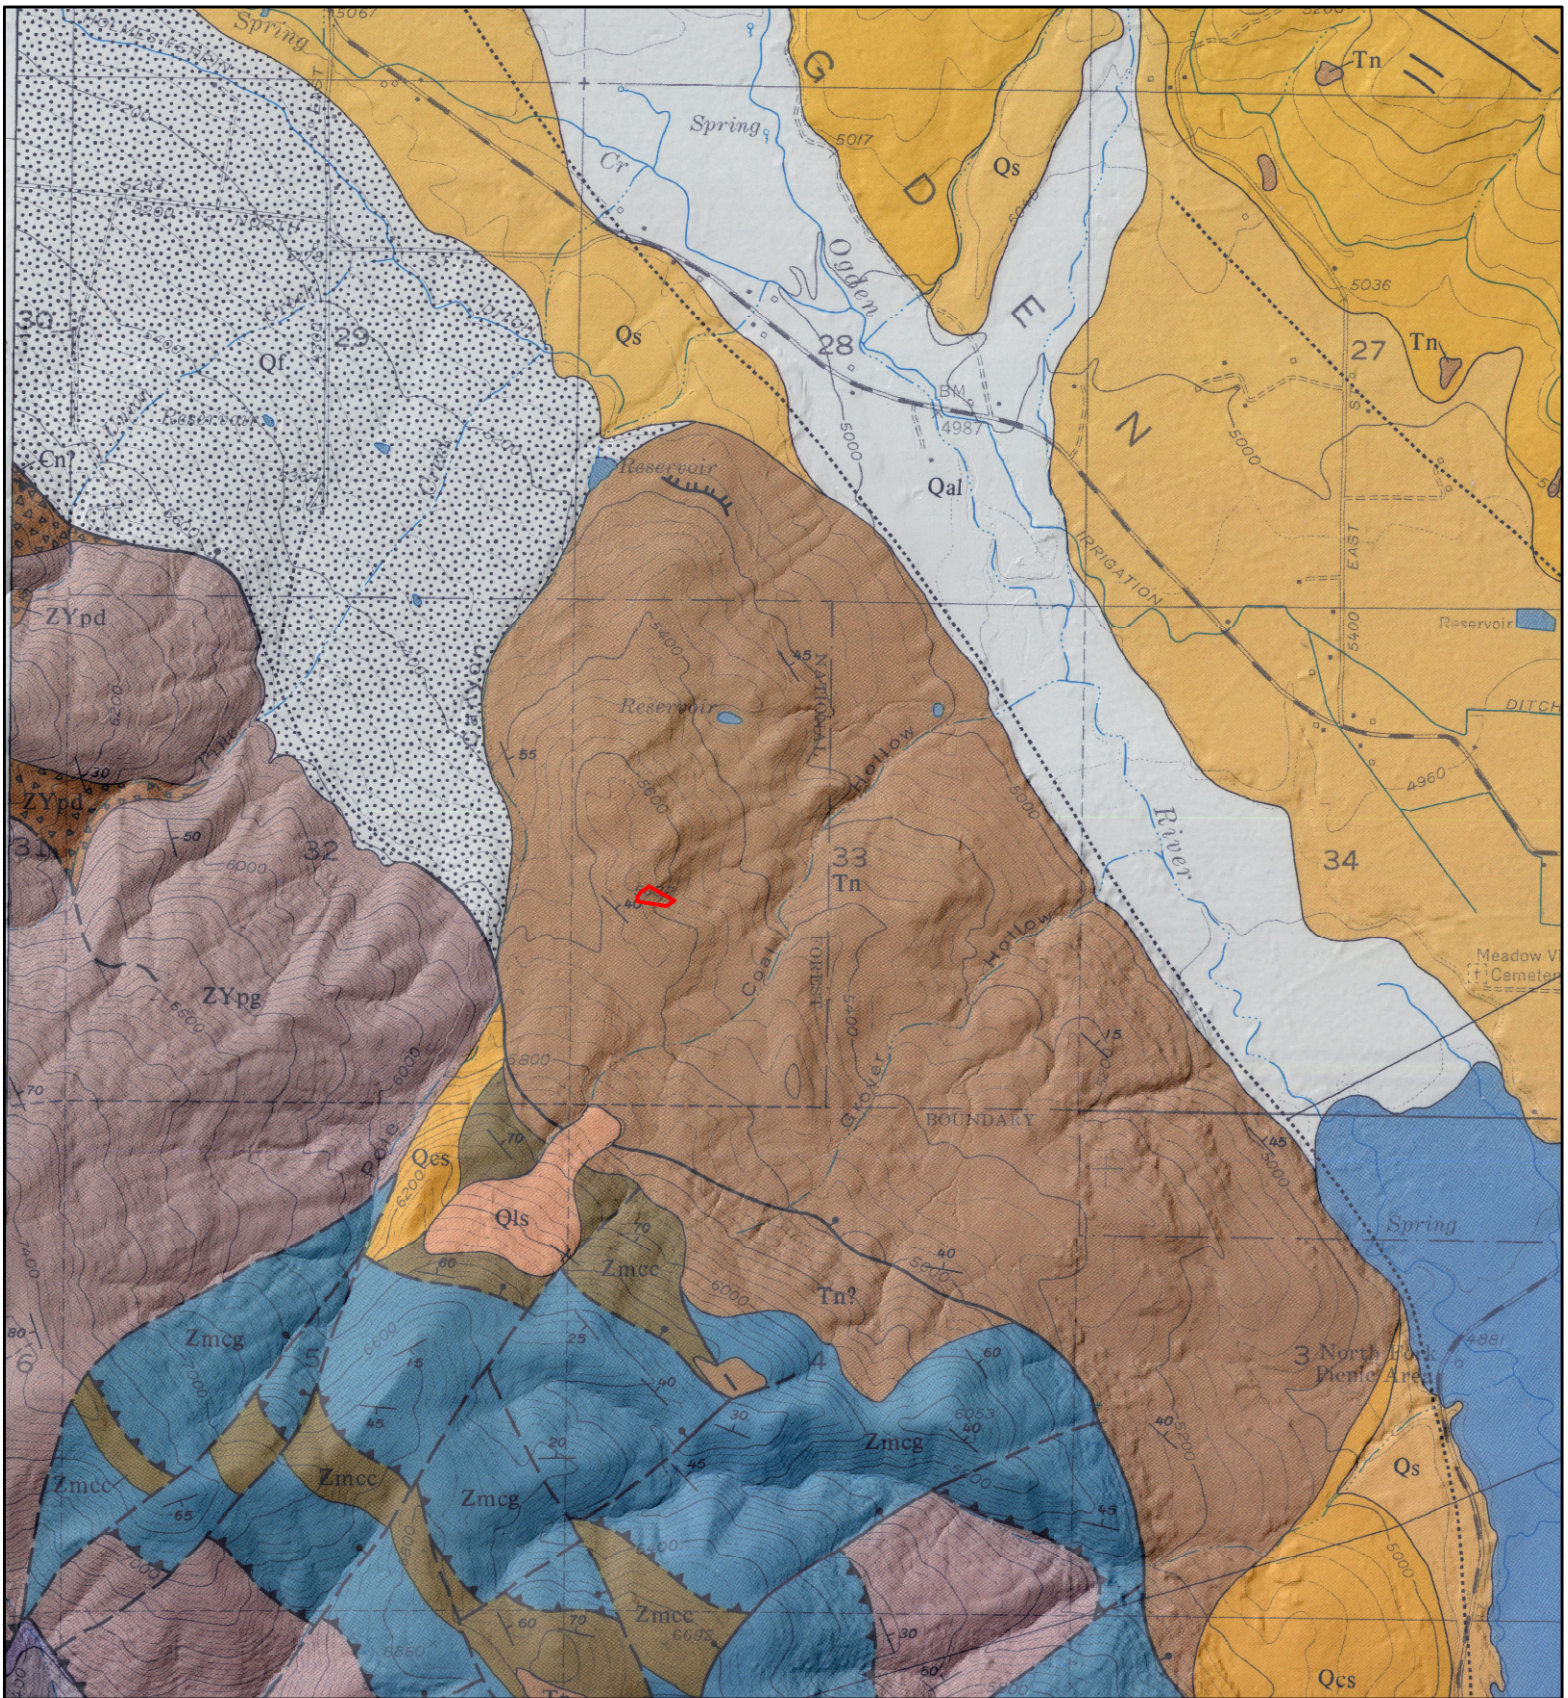
**Plate
3a**

Surface sediments within the subject site, as shown on Plate 3a Site Vicinity Geologic Map, is mapped as north east dipping lower Oligocene and upper Eocene Norwood Formation (Tn). The Tertiary Norwood Formation is described as light-gray to light-brown, locally colored light shades of red or green in the west side of Ogden Valley, altered tuff (claystone), altered tuffaceous siltstone and sandstone, and conglomerate (Coogan and King, 2016). The surficial geology mapped on the Ogden 30' X 60' Quadrangle, as shown on Plate 4 Site Vicinity 30' X 60' Geologic Map, delineates a Holocene and upper Pleistocene landslide deposit (Qms) overlying the Norwood Formation within the easternmost portion of the subject site.

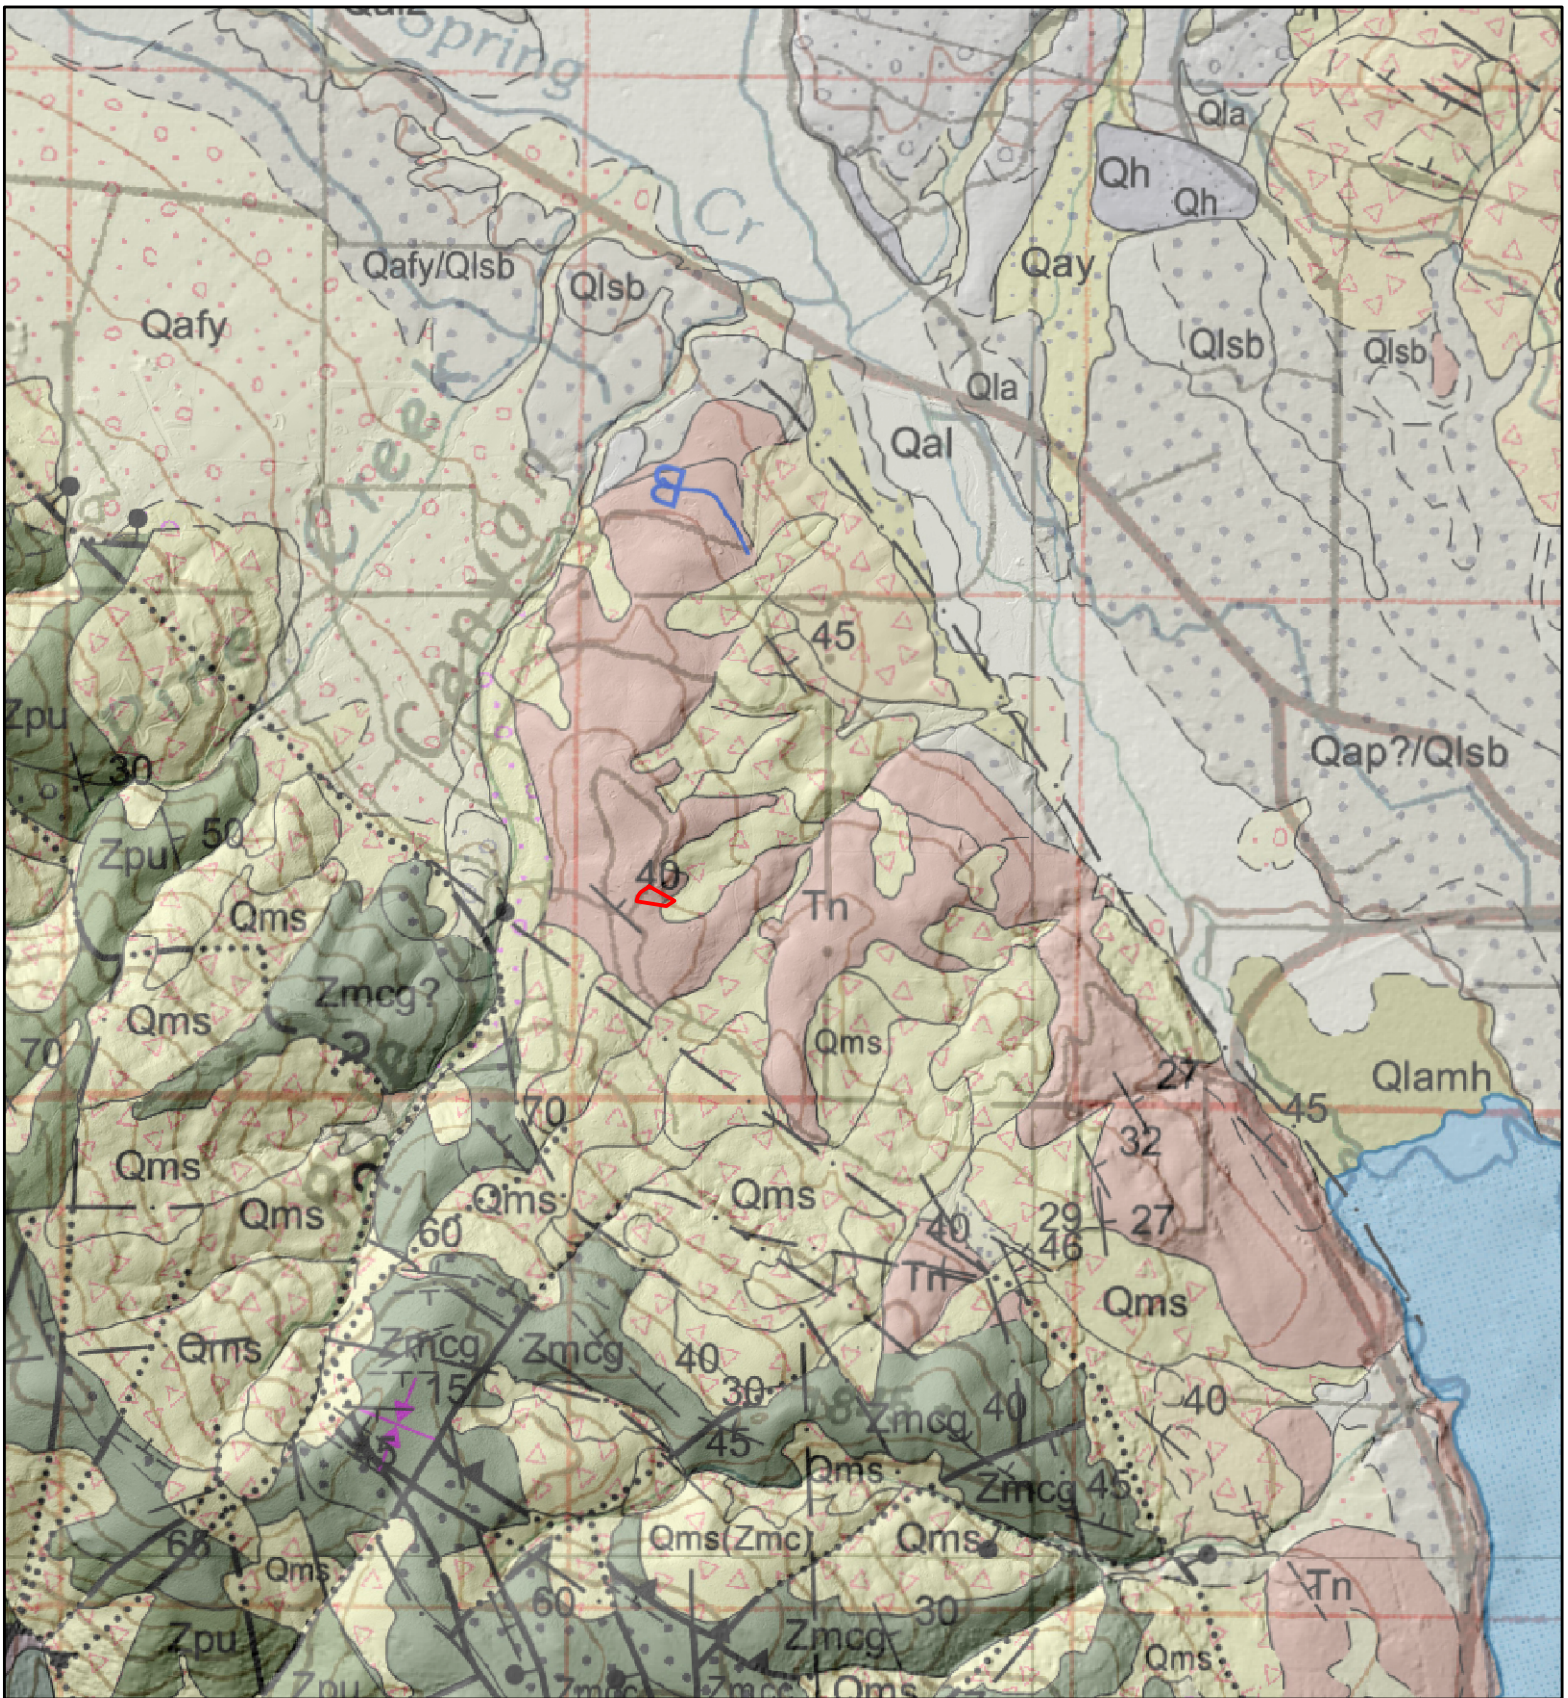
Based on review of published geologic maps, the subject westernmost portion of the subject site is mapped as a landslide deposit (Coogan and King, 2016; Plate 4 Site Vicinity 30' X 60' Geologic Map). A landslide deposit within or adjacent to the subject site is not indicated on the Huntsville Quadrangle compiled by Sorensen and Crittenden (1979). Elliot and Harty (2010) map the subject lot as being underlain by a unit defined as landslide and/or landslide undifferentiated from talus, colluvial, rock-fall, glacial, and soil-creep as presented on Plate 5 Landslide Hazard Map. No scarp features, hummocky topography, or other landslide related geomorphology features related to landslide deformation were observed within or adjacent to the subject site during our field observations, our stereographic aerial photograph interpretation and our review of the hillshades derived from the 1 meter Bare Earth LiDAR elevation data (2011). Several curved tree trucks were observed within the subject site which would suggest soil-creep or snow loading on the slope. Based on our field observations and published geologic maps, it is the opinion of GeoStrata that the area within the subject site and the area delineated by Elliot and Hart (2010) is likely colluviums and soil-creep deposits. Soil-creep is a slow moving process too small to produce shear failure and typical occurs in the uppermost extent of the soil profile. Based on field observations and office investigations, it is the opinion of GeoStrata that the landslide deposits delineated on the geologic maps were not identified during our site observations. Since no subsurface investigation was performed within the subject site, as an added precaution, GeoStrata recommends that a setback of 75 feet from the landslide delineated by Coogan and King (2016) is established (Plate 7 Landslide Setback Map). The landslide hazards within the subject lot is considered low to moderate and it is considered unlikely that existing landslides will impact the proposed location of the residential structure. It is the opinion

of GeoStrata that landslide hazards should not preclude development at the subject lot as long as the setback area is established.

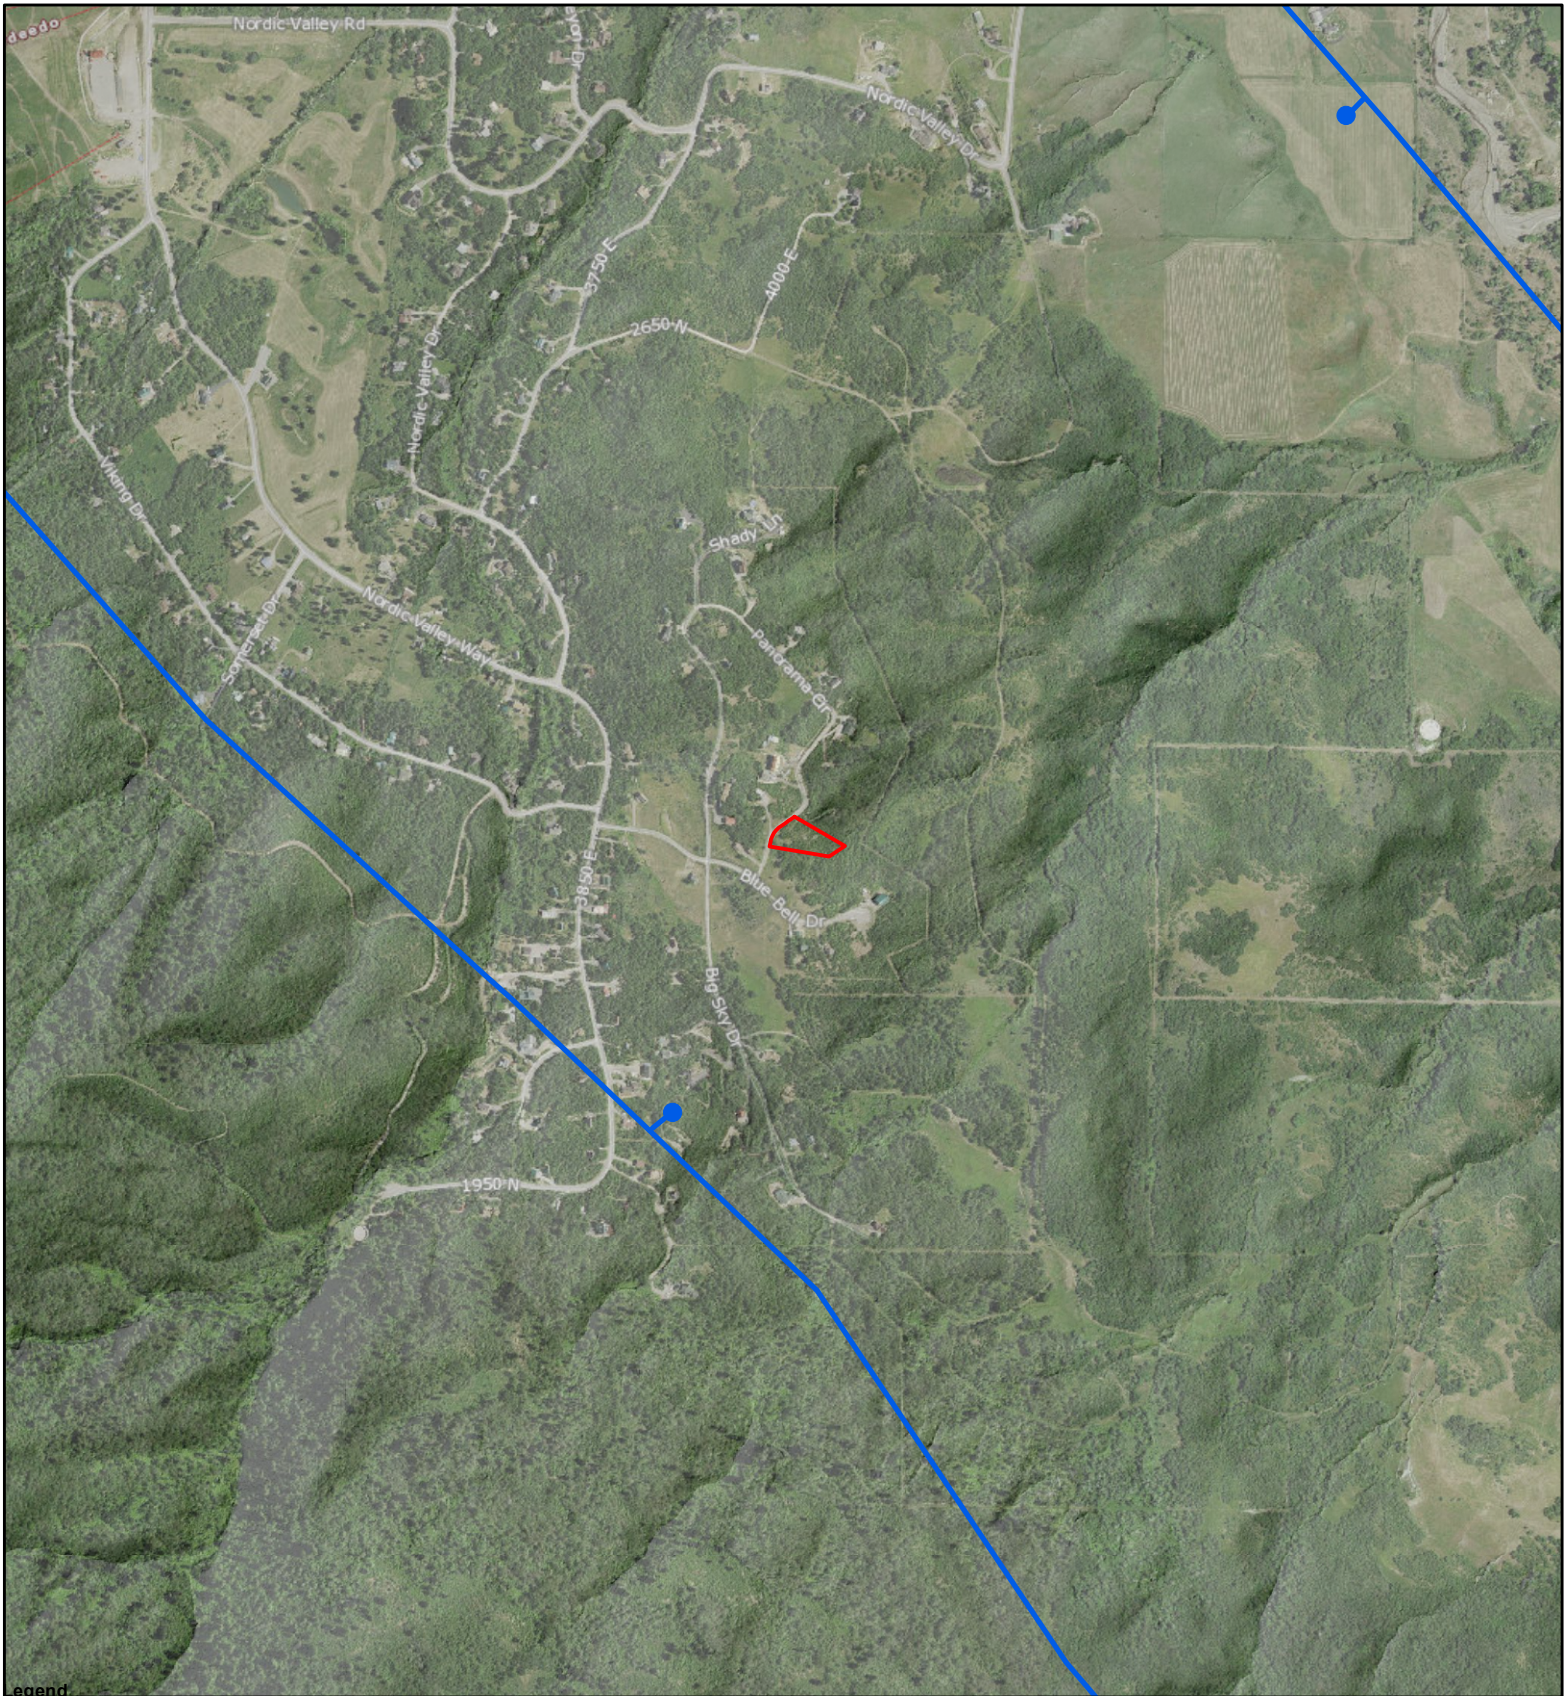
Plate
7

Based on review of published geologic maps, our stereographic aerial photograph interpretation, our review of the hillshades derived from the 1 meter Bare Earth LiDAR elevation data (2011) and our field observations, no active surface ruptures are located near the subject site (Plate 7 UGS Quaternary Faults Map). The nearest faults are the northwest-southeast trending Ogden Valley North Fork Fault and the Ogden Valley Southwestern Margin Fault which are middle and late Quaternary in age (<750,000 years old) with an undetermined reoccurrence interval and a slip rate of less than 0.2 mm/yr (Black and others, 1999). These faults are located approximately 1,600 feet to the southwest of the subject site, respectively. Given our field and office investigations, the surface fault rupture hazard within the subject site is considered low and it is considered unlikely that surface fault rupture will impact the proposed development. It is the opinion of GeoStrata that surface fault rupture hazard should not preclude development at the subject lot.

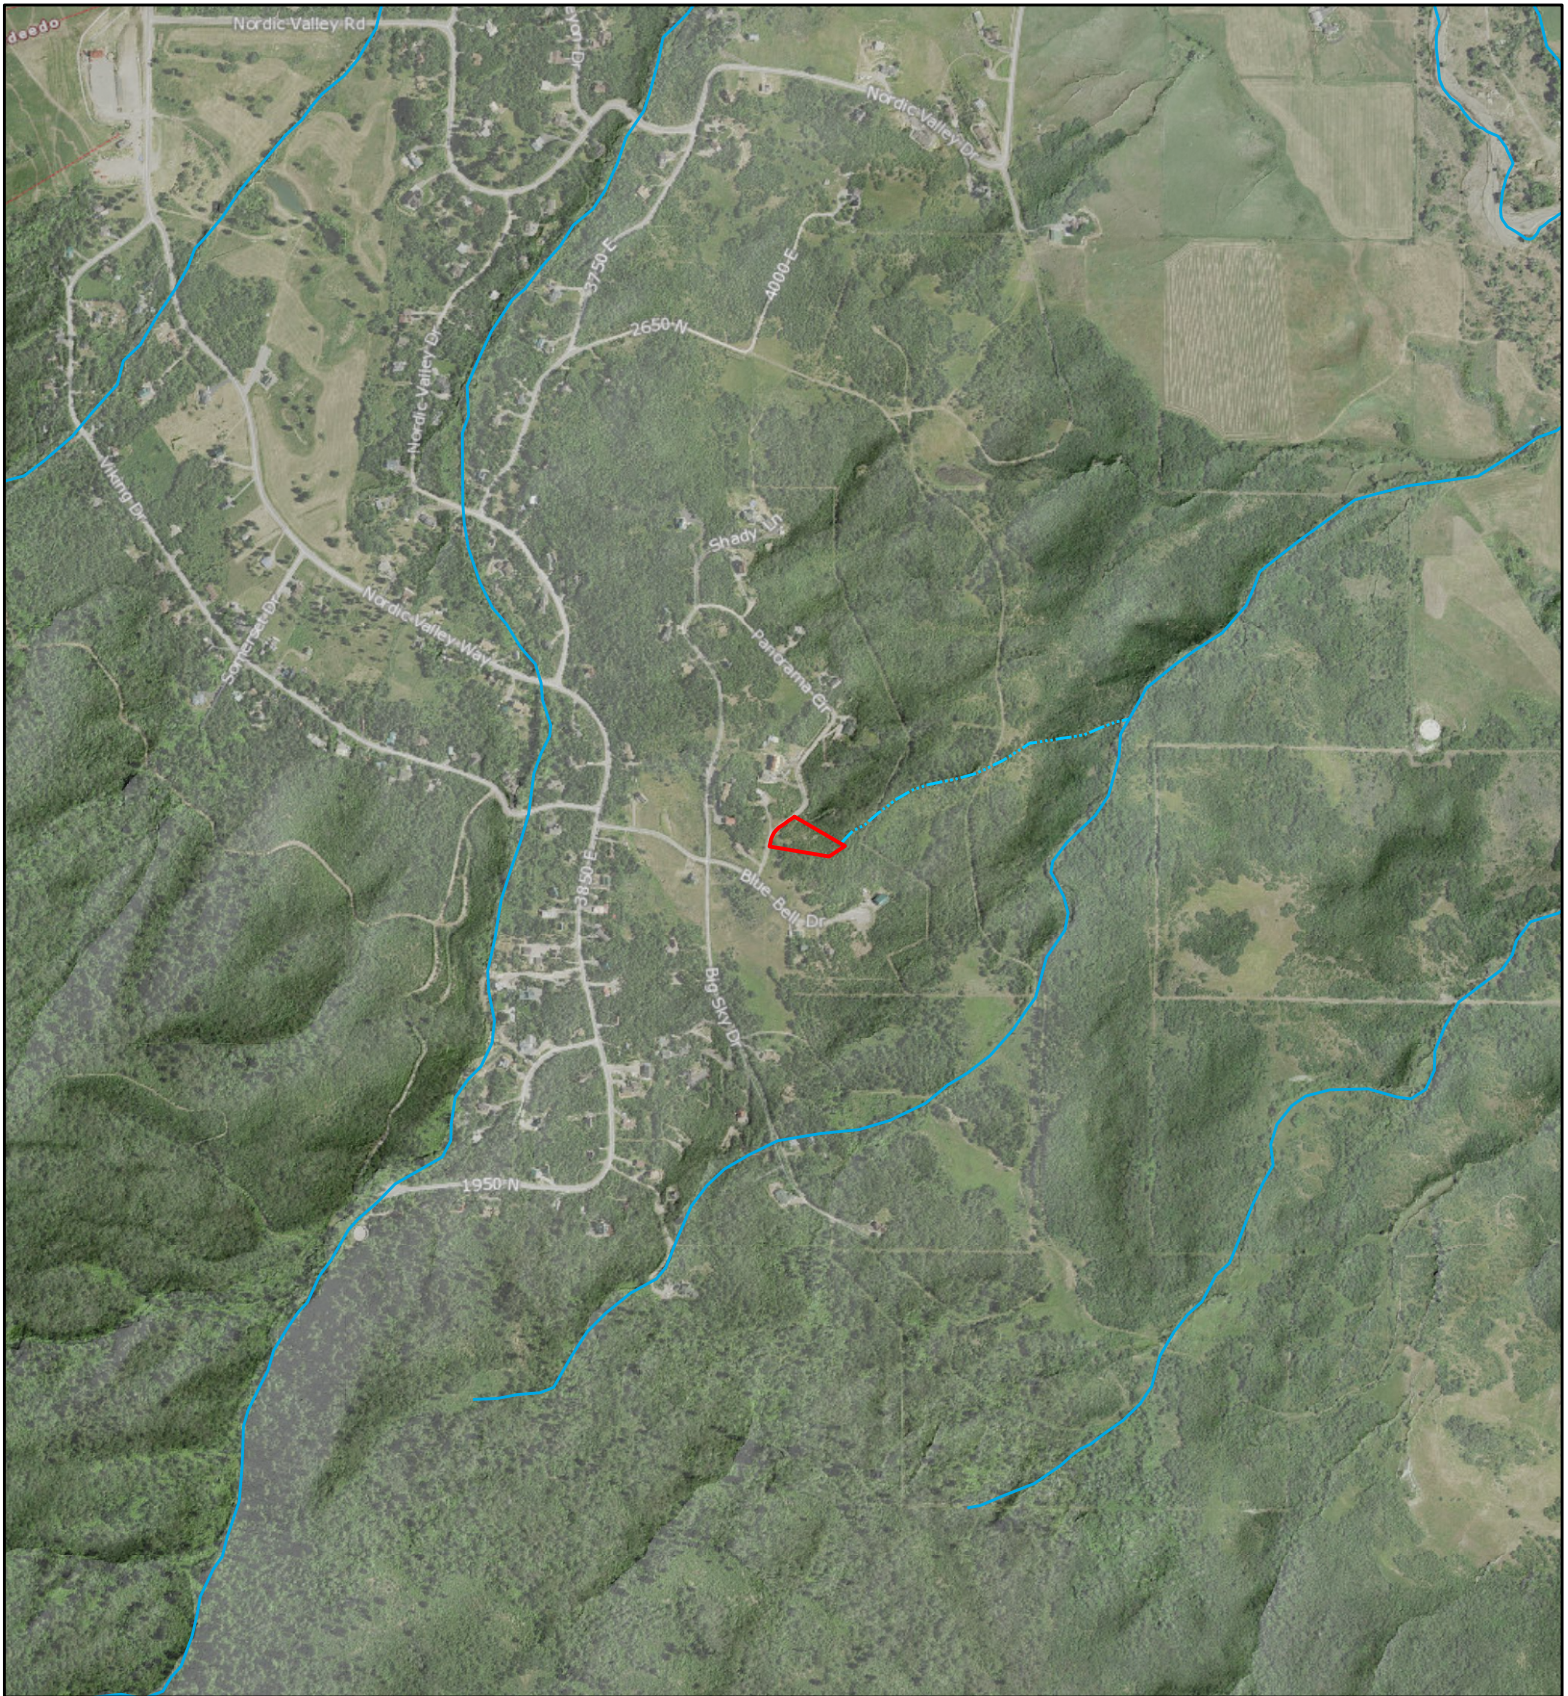
**Plate
 8**

Based on review of published geologic maps, our stereographic aerial photograph interpretation, our review of the hillshades derived from the 1 meter Bare Earth LiDAR elevation data (2011) and our field observations, there is an intermittent stream trending through the easternmost property boundary of the subject site (Plate 8 Drainage Map). Given our field and office investigations, the stream flooding hazard within the subject lot is considered low and it is considered unlikely that stream flooding will impact the proposed development. It is the opinion of GeoStrata that stream flooding hazard should not preclude development at the subject lot. Proper site grading and drainage plans should be developed for the subject site as a part of the civil engineering design for the lot.
