**GEOTECHNICAL AND GEOLOGIC HAZARD INVESTIGATION  
Lot 29 of Summit Eden Phase 1B  
Summit Powder Mountain Resort  
Weber County, Utah**

IGES Project No. 01496-004

September 13, 2017

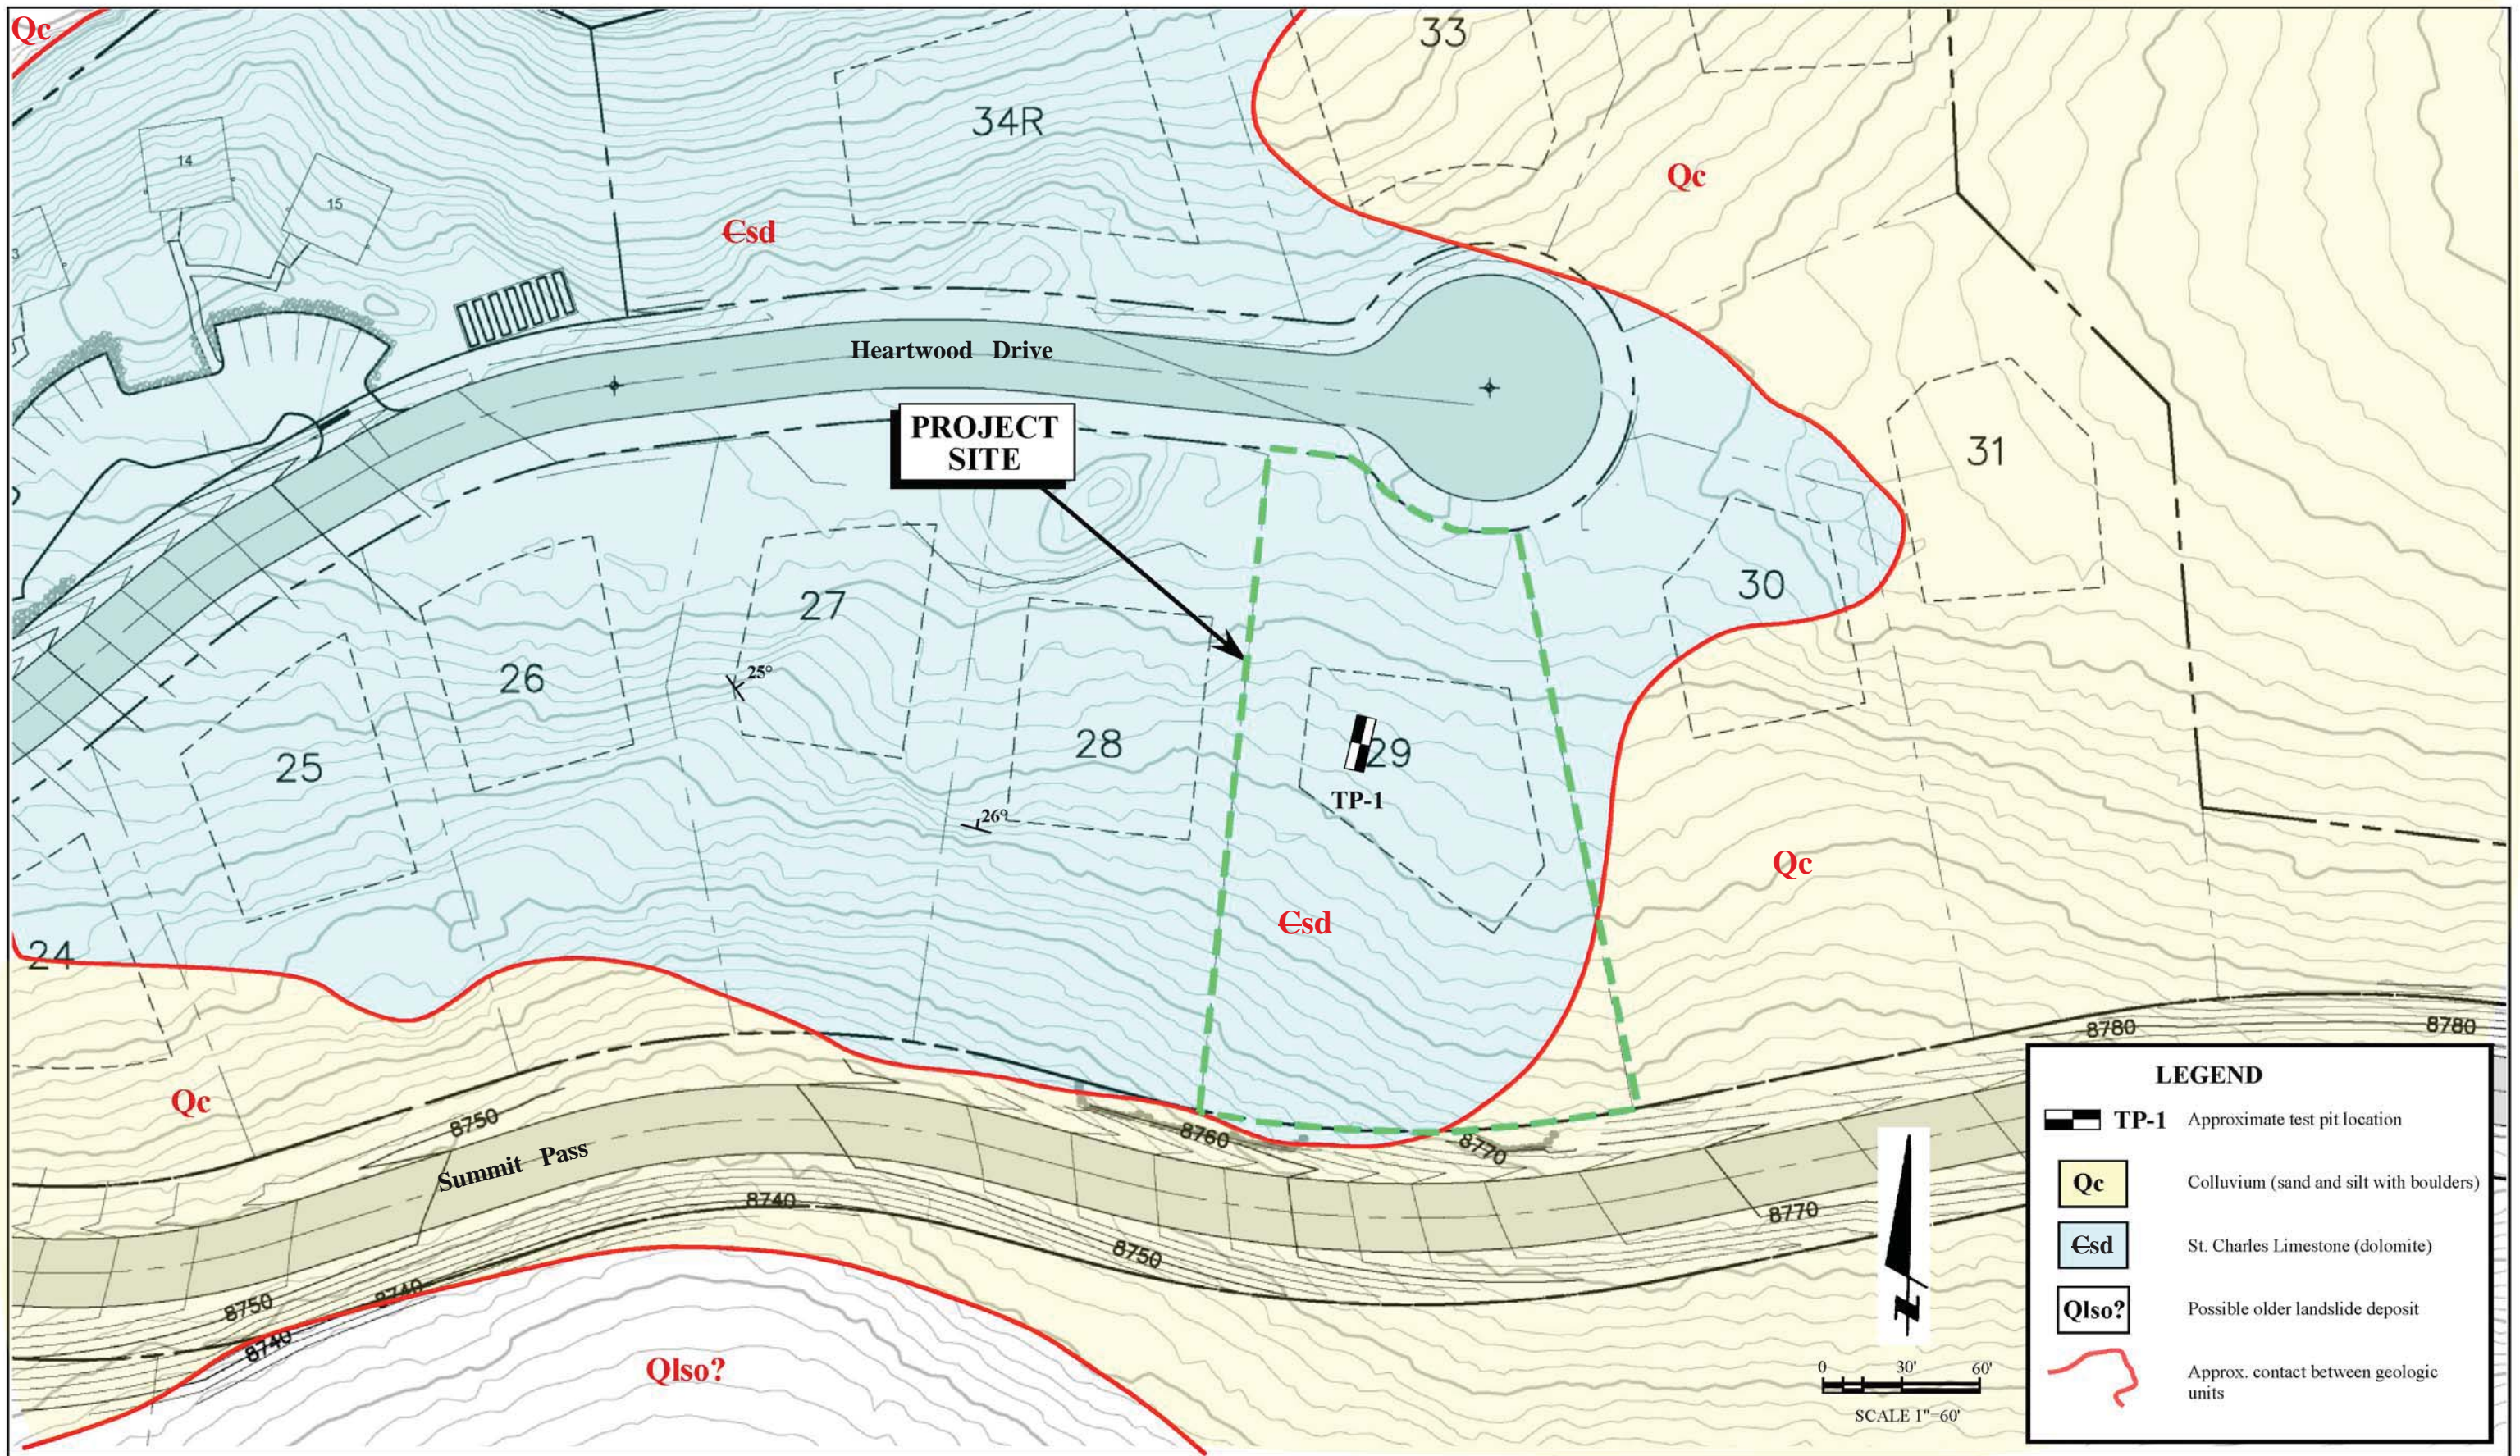
**A-2**

Mr. Peter E. Doumit, P.G., C.P.G., of IGES conducted reconnaissance of the site and the immediate adjacent properties on July 10, 2017. The site reconnaissance was conducted with the intent to assess the general geologic conditions present across the property, with specific interest in those areas identified in the geologic literature and aerial imagery reviews as potential geologic hazard areas. Additionally, the site reconnaissance provided the opportunity to geologically map the surficial geology of the area. Figure A-2 is a site-specific geologic map of the Lot 29 property and adjacent areas.

On July 10, 2017, a single exploration test pit was excavated at a central location within the building envelope (see Figure A-2). The test pit was excavated with the aid of a Caterpillar 320F tracked excavator to a depth of 8 feet below existing grade, at which point refusal upon competent bedrock was encountered. Upon completion of logging of the test pit, the test pit was backfilled without compactive effort. A detailed log of the test pit is displayed in Figure A-3. Three distinct geologic units were encountered in the subsurface. The soil and moisture conditions encountered during our investigation are discussed in the following paragraphs.
