SURFACE GEOLOGIC HAZARD STUDY

**PROPERTY LOCATION
LOT 65R
15163 EAST MILL ROAD
HUNTSVILLE, UTAH**

Re: Report
Surface Geologic Hazard Study
Property Location at
15163 East Mill Road, Lot 65
Huntsville, Utah 84317

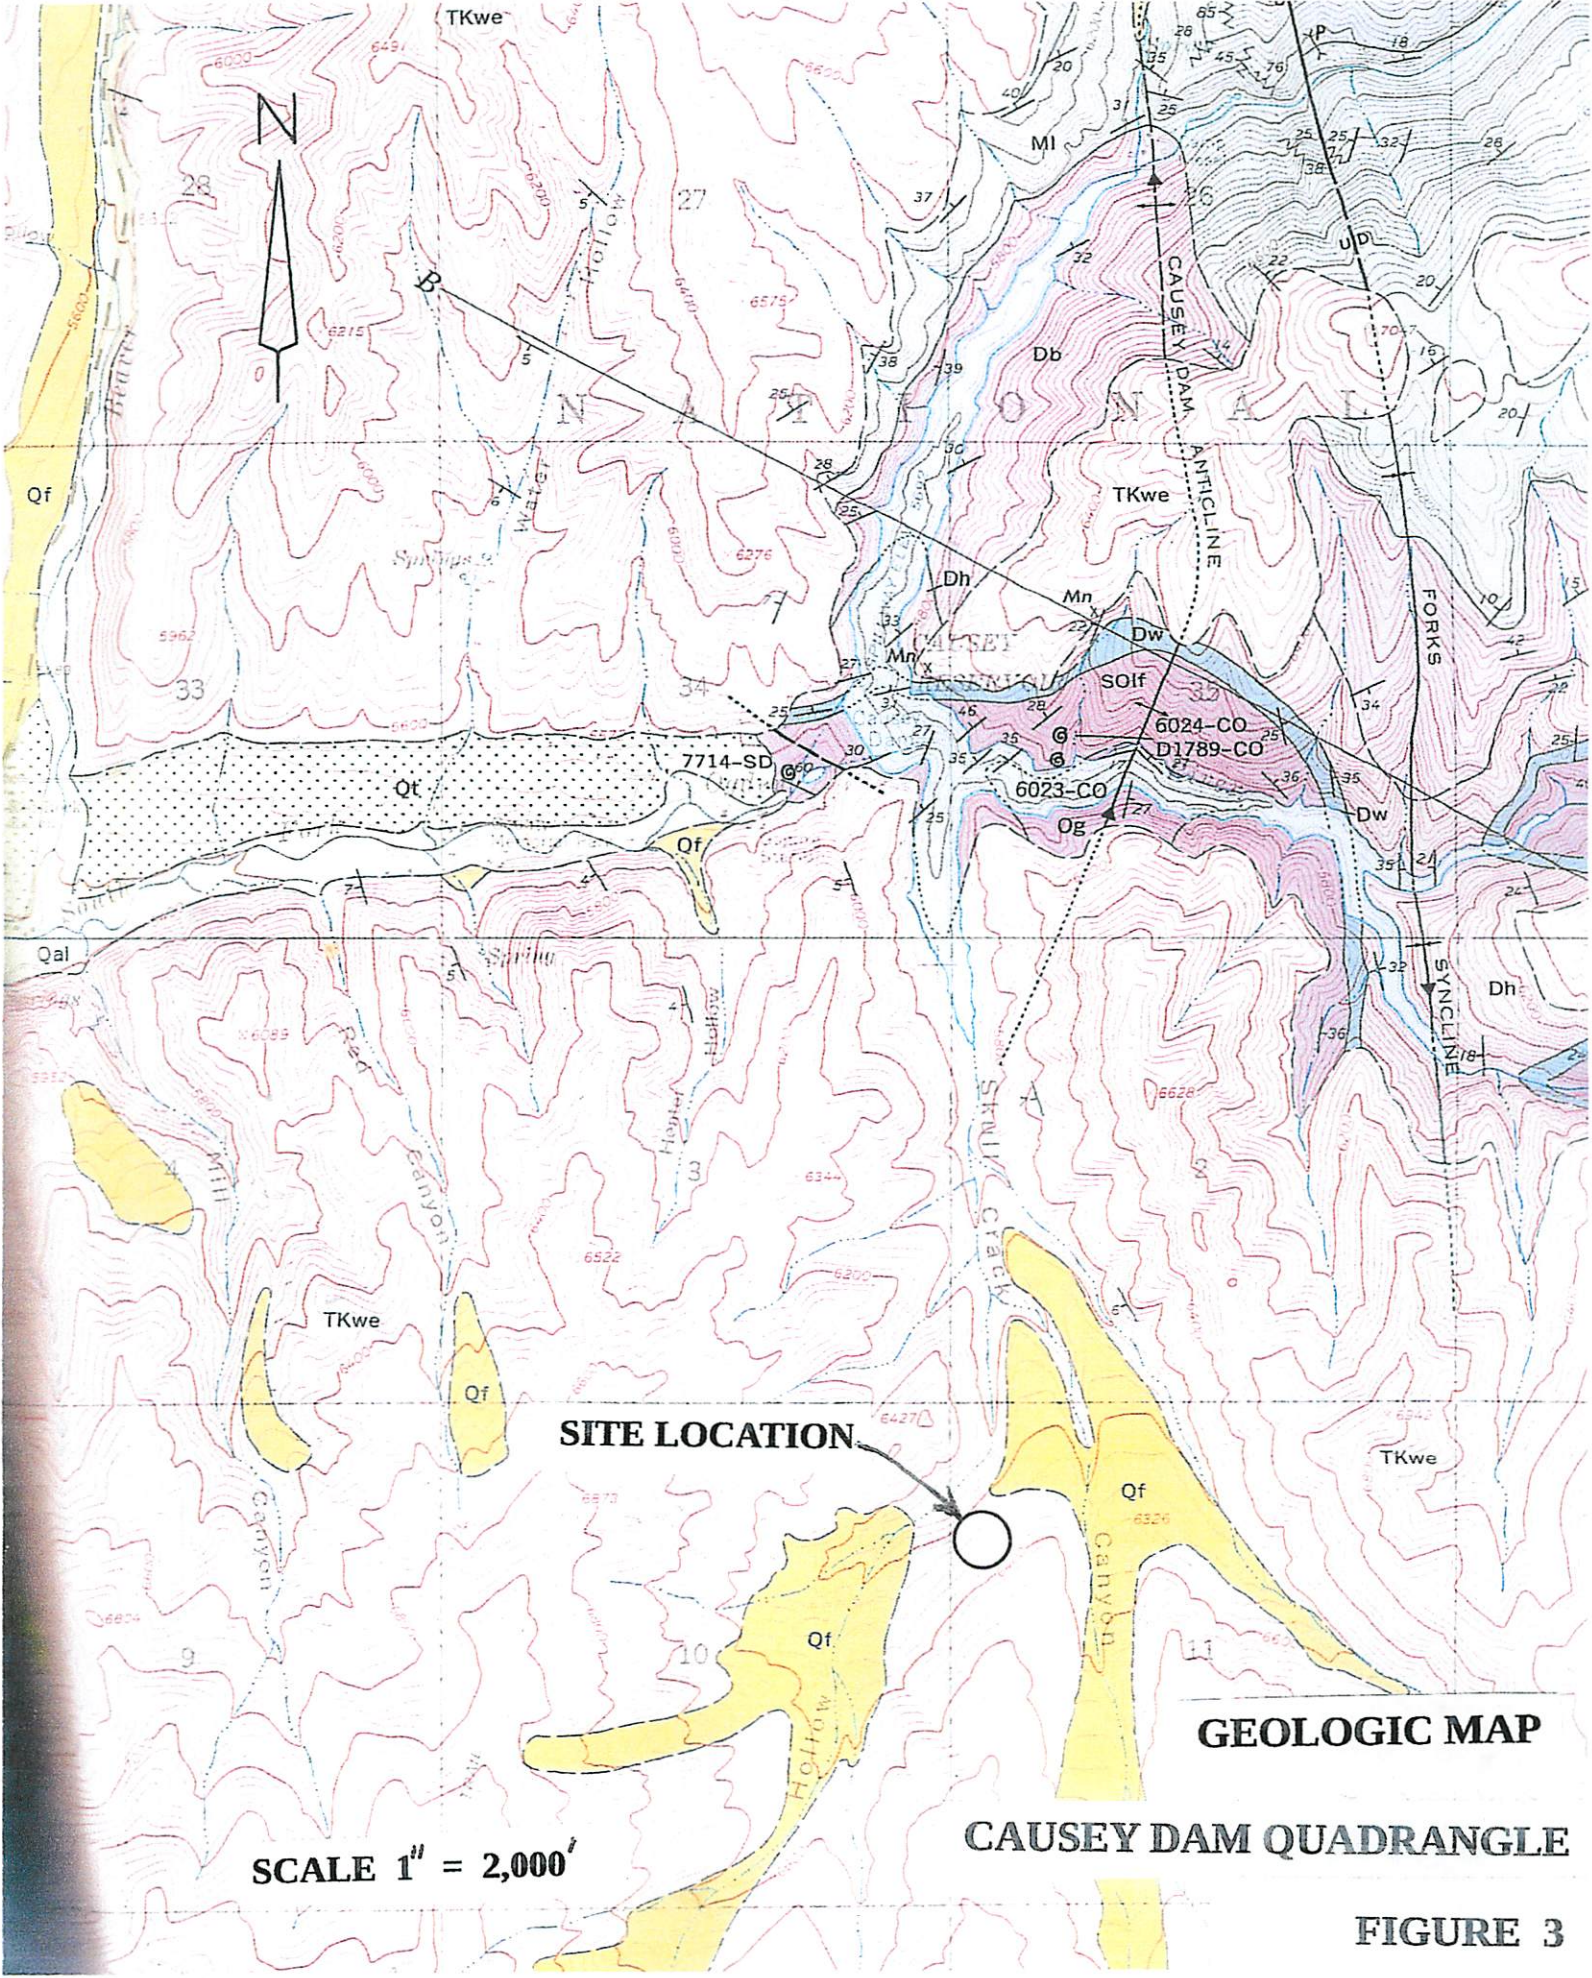
FIGURE 3

Based upon the United States Geologic Survey map of the Causey Quadrangle Lot 65 on a northwest facing slope within an area which has been mapped as part of the main body of the Wasatch and Evanston Formations (Tkwe) as shown on Figure 3. These formations may be up to 3,000 feet thick and are mainly reddish-brown poorly sorted sandstone and conglomerate containing scattered beds of reddish-brown sandy siltstone. Where the sandstone and conglomerate beds are exposed at the surface with have a gentle dip to the west. The dip slope of the sedimentary beds ranges from 4 to 7 degrees. Most of the conglomerate is composed of rounded tan, purple, and a few green quartzite pebbles, cobbles, and boulders (Mullens, 1969).
