May 25, 2018

IGES Project No. 02787-001

Subject: Reconnaissance-Level Geologic Hazards Assessment  
Under the Sun Ranch  
Weber County Parcel #22-007-0011  
East of State Road 162  
Liberty, Utah

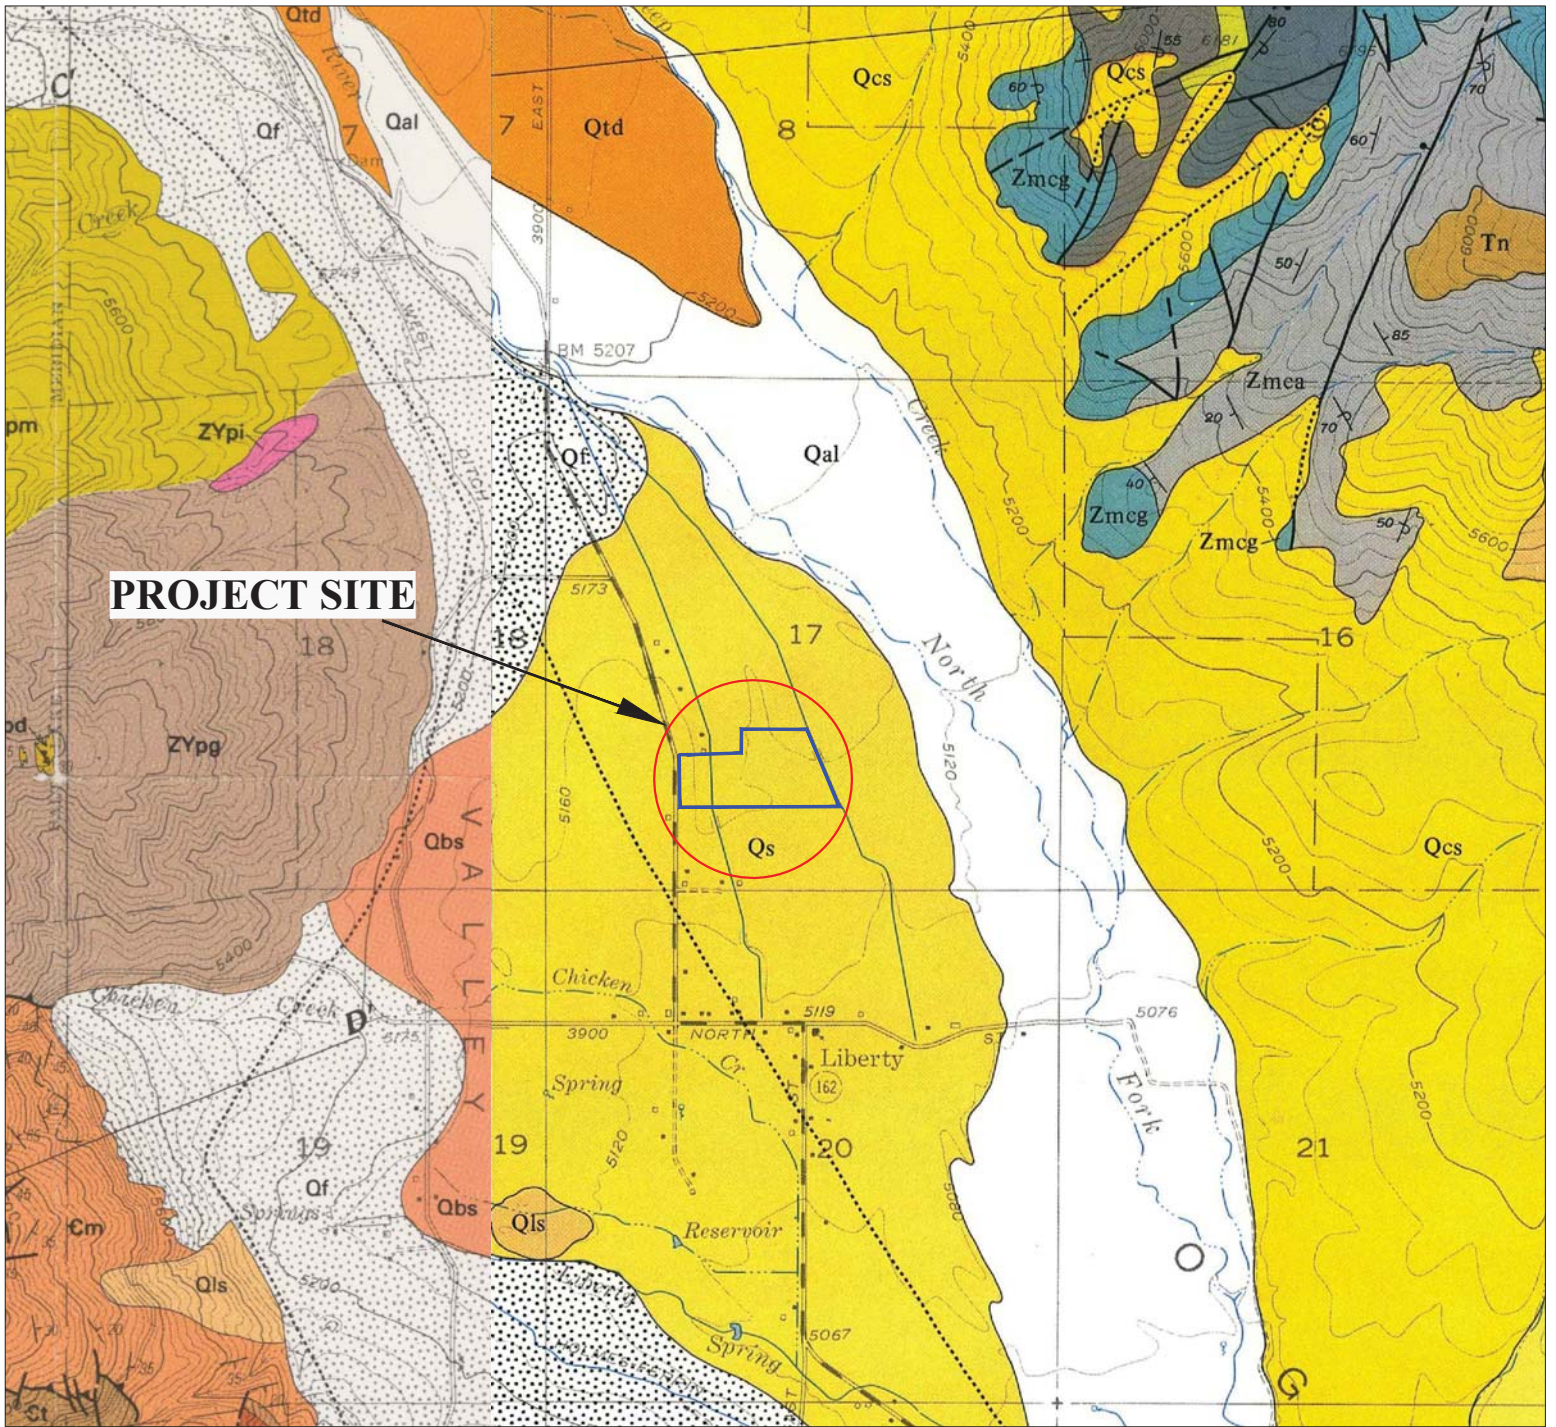
**A-2a**

According to Sorensen and Crittenden, Jr. (1979), the property is located entirely on Pleistocene-aged silt deposits (unit Qs on Figure A-2, *Regional Geology Map 1*). In this map, a concealed northwest-trending fault is shown to pass approximately 530 feet southwest of the southwestern corner of the property. Most recently, Coogan and King (2016; Figure A-3, *Regional Geology Map 2*) map the property with three distinct geologic units. Most of the property is mapped as being underlain by upper Pleistocene-aged “Transgressive and Bonneville-shoreline deltaic and lacustrine deposits” (unit Qdlb), which are described as “Mostly sand, silty sand, and gravelly sand deposited near shore in Lake Bonneville.” Unit Qalp? is mapped along the western margin of the property, denoted as “Lake Bonneville regression-age stream alluvium.” This queried unit is described as “Pebble and cobble gravel, gravelly sand and silty sand, with minor clay in channel incised into Lake Bonneville deltaic and lacustrine deposits (Qldb) in Ogden Valley.” In the eastern portion of the property, a northeast-southwest trending sliver of unit Qla? is mapped. This unit is identified as undivided Lake Bonneville lacustrine deposits and post- and pre-Lake Bonneville alluvial deposits, and is described as “Mostly poorly sorted and poorly bedded sand, silt, and clay, with some gravel; mapped where Lake Bonneville deposits are reworked by later stream action or covered by thin stream and fan deposits...unit queried where may be dominantly alluvium.” An inactive, concealed thrust fault (Willard Thrust) is shown as trending roughly to the northwest approximately 0.79 miles to the south-southwest of the property. No faults, landslide scarps, or other adverse geologic features are shown on or projecting toward the property.

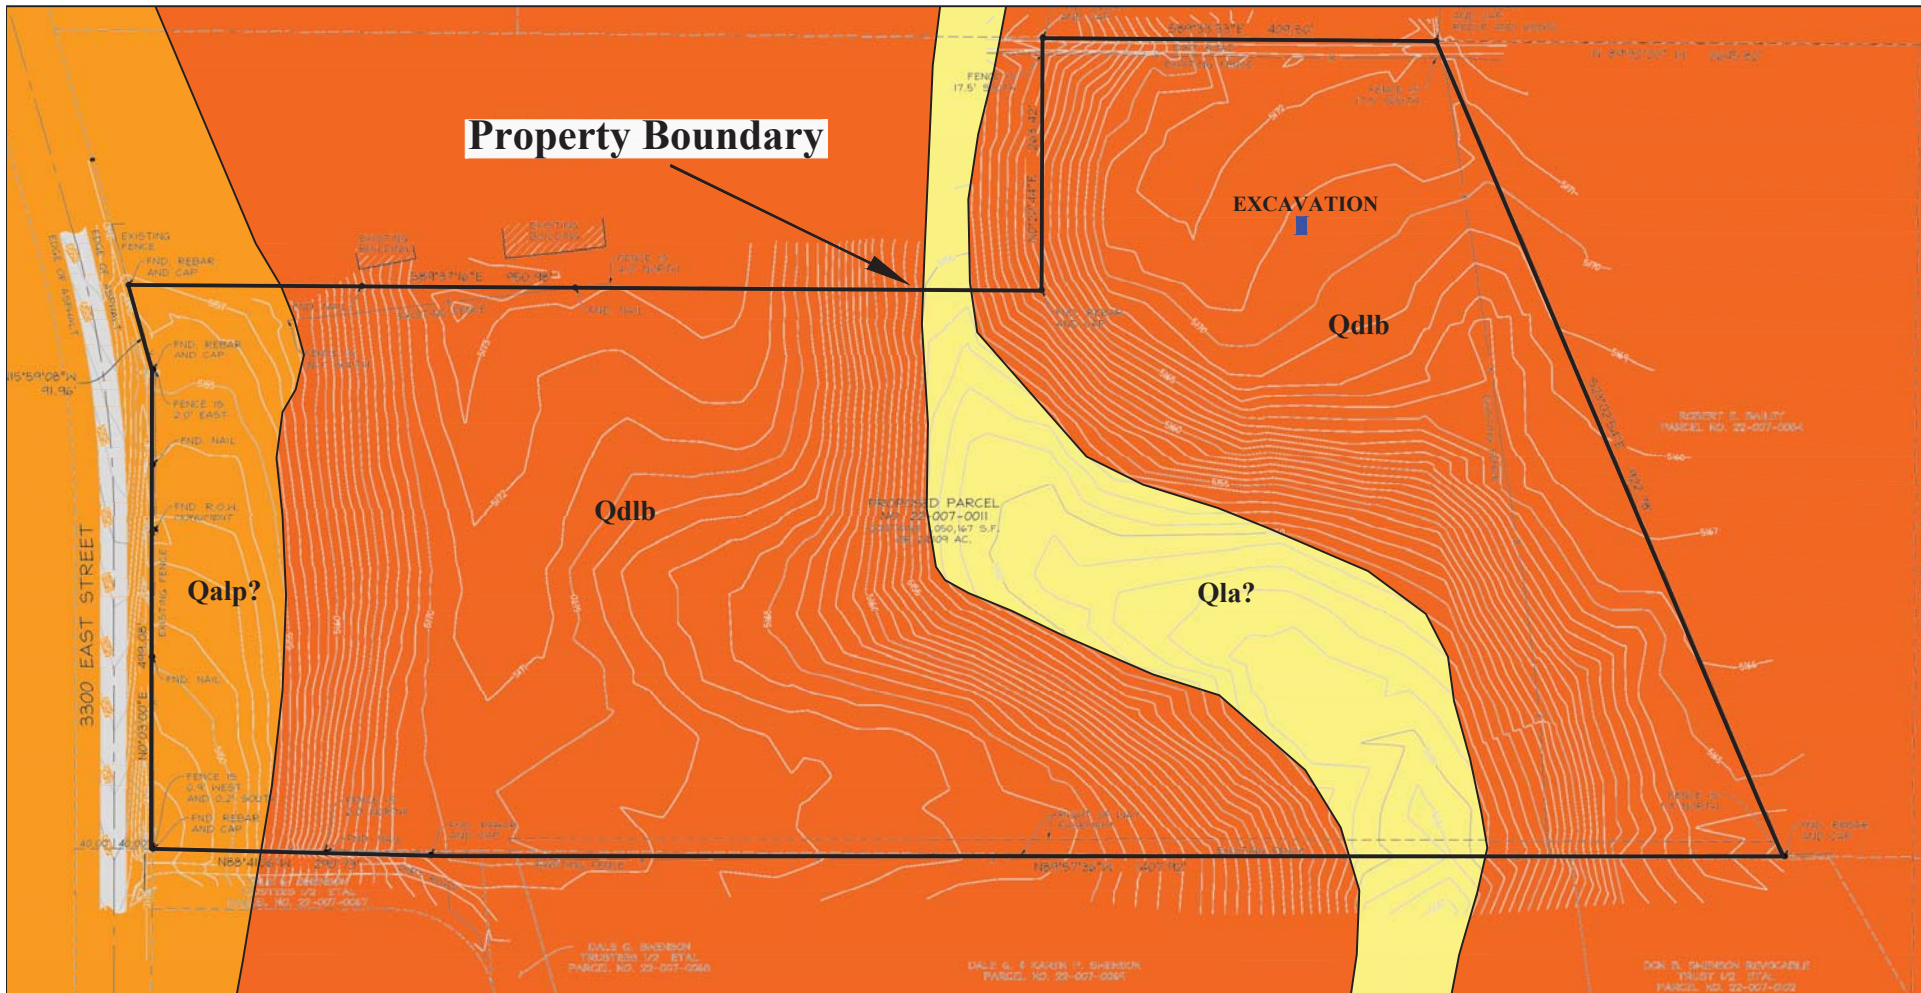
(2016); a site-specific geologic map based on observations made during the site reconnaissance is shown in Figure A-4.

Northeast of the swale was another hill that is the proposed location for the primary ranch house. Within this area, a small test pit/excavation was observed to have been left open (see Figure A-4). The excavation was approximately 12 feet long and 5 feet deep, and exposed Lake Bonneville deltaic deposits (Qdlb) to total depth. The uppermost approximately 3 feet of the soils were observed to be dark yellowish brown to grayish brown A/B Soil Horizon, consisting of a sandy lean clay with gravel that was medium dense, moist, low plasticity, and massive. Gravel and larger-sized clasts comprised approximately 20-25% of the A/B Soil Horizon; these were subrounded to subangular and up to 1½ inches in diameter, though the mode size was less than ½ inch. The A/B Horizon was also observed to be highly porous, with common voids consisting of root, worm, and bug holes up to 1 centimeter in diameter; 1- to 2-millimeter (mm) diameter pinhole voids were also common. The basal approximately 2 feet exposed in the excavation consisted of largely unaltered delta deposits comprised of moderate reddish brown clayey sand with gravel that was medium dense to dense, moist, contained low plasticity fines, and was massive. Gravel and larger-sized clasts comprised approximately 5 to 10% of these deposits, with subrounded to subangular clasts up to 1 inch in diameter. Pinhole voids up to 1 mm in diameter were also commonly observed. It should be noted that pinhole voids are a common characteristic of collapsible soils (addressed in later sections of this report). The subsurface materials exposed in the excavation are likely to be consistent across the property, however this cannot be definitively concluded as extrapolation from a single data point becomes increasingly unreliable with distance.
