**REPORT
ENGINEERING GEOLOGY STUDY
THE BRIDGES AT WOLF CREEK EAST PHASE 1
PARTS OF SECTIONS 15, 16, AND 22 TOWNSHIP 7
NORTH, RANGE 1 EAST SLBM
EDEN, UTAH**

Job No. 1661-08N-16

Re: Engineering Geology Study
The Bridges at Wolf Creek East Phase 1
Parts of Sections 15, 16 and 22 Township 7 North, Range 1 East SLBM
Eden area, Ogden Valley Township, Unincorporated Weber County, Utah
(41.3389 N, 111.8323 W)

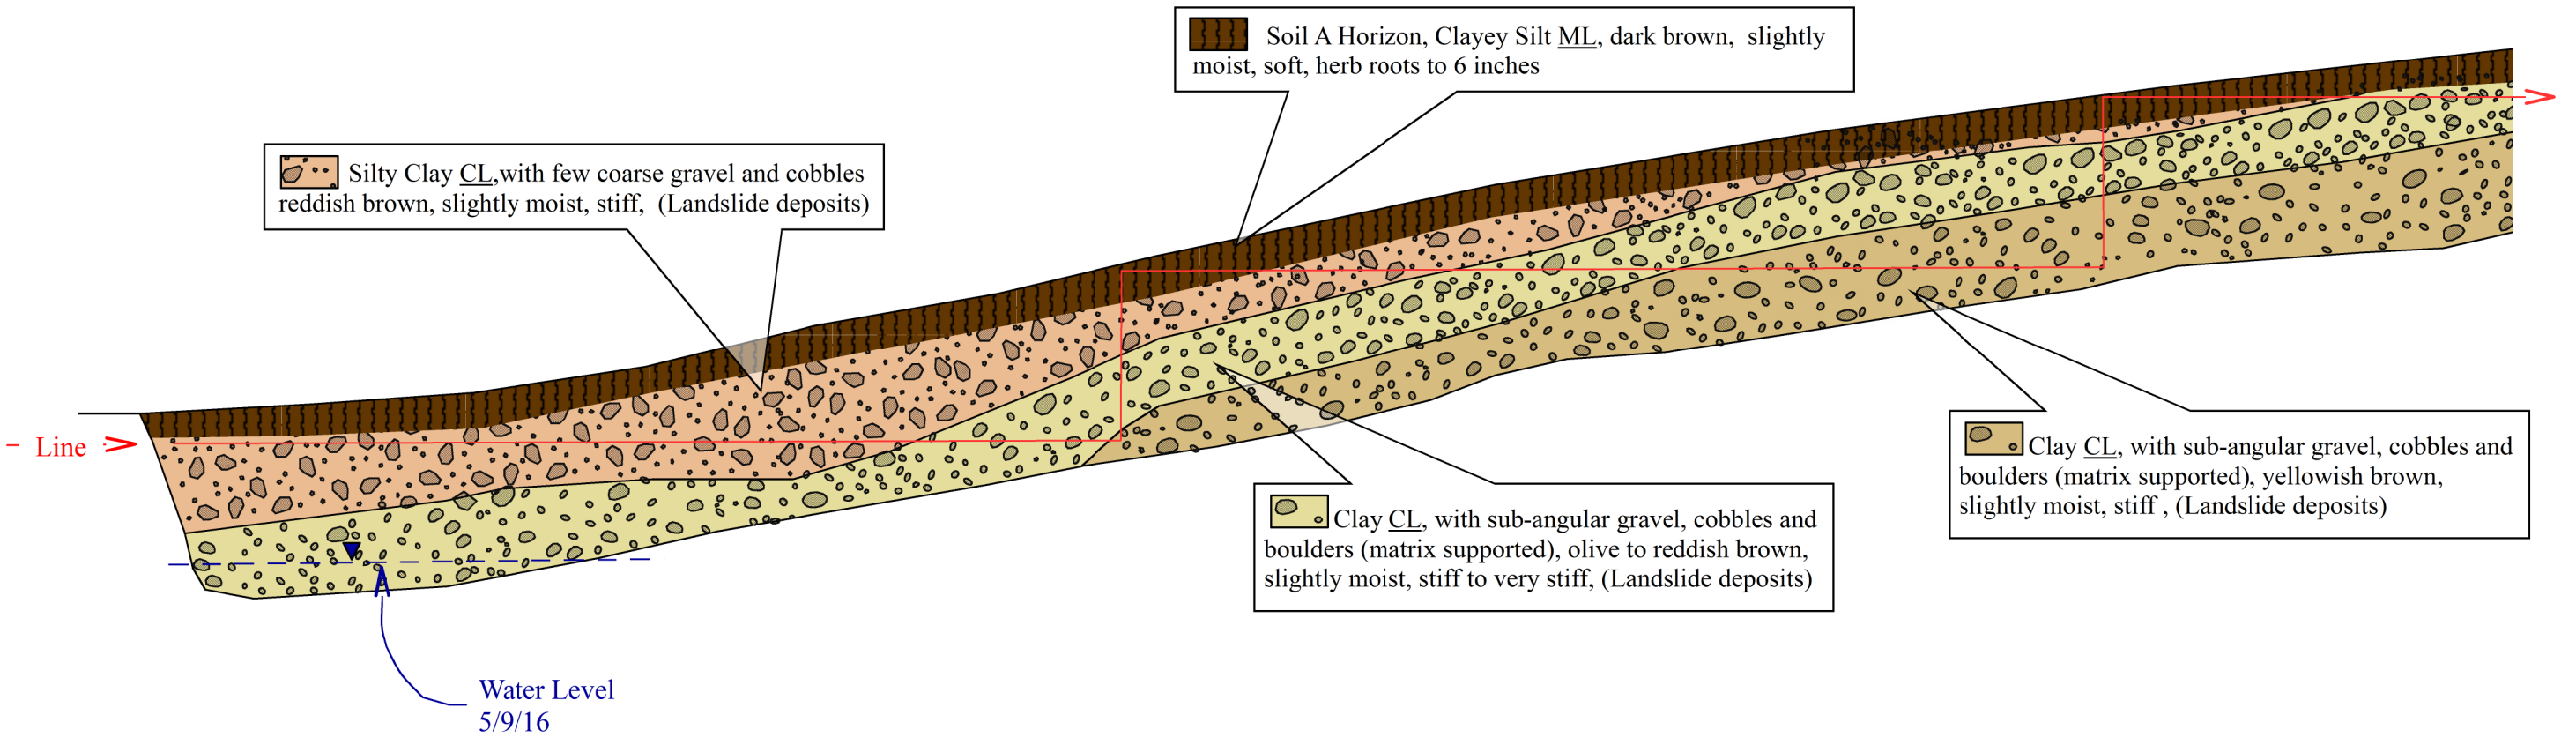
Silty Clay CL, with few coarse gravel and cobbles reddish brown, slightly moist, stiff, (Landslide deposits)

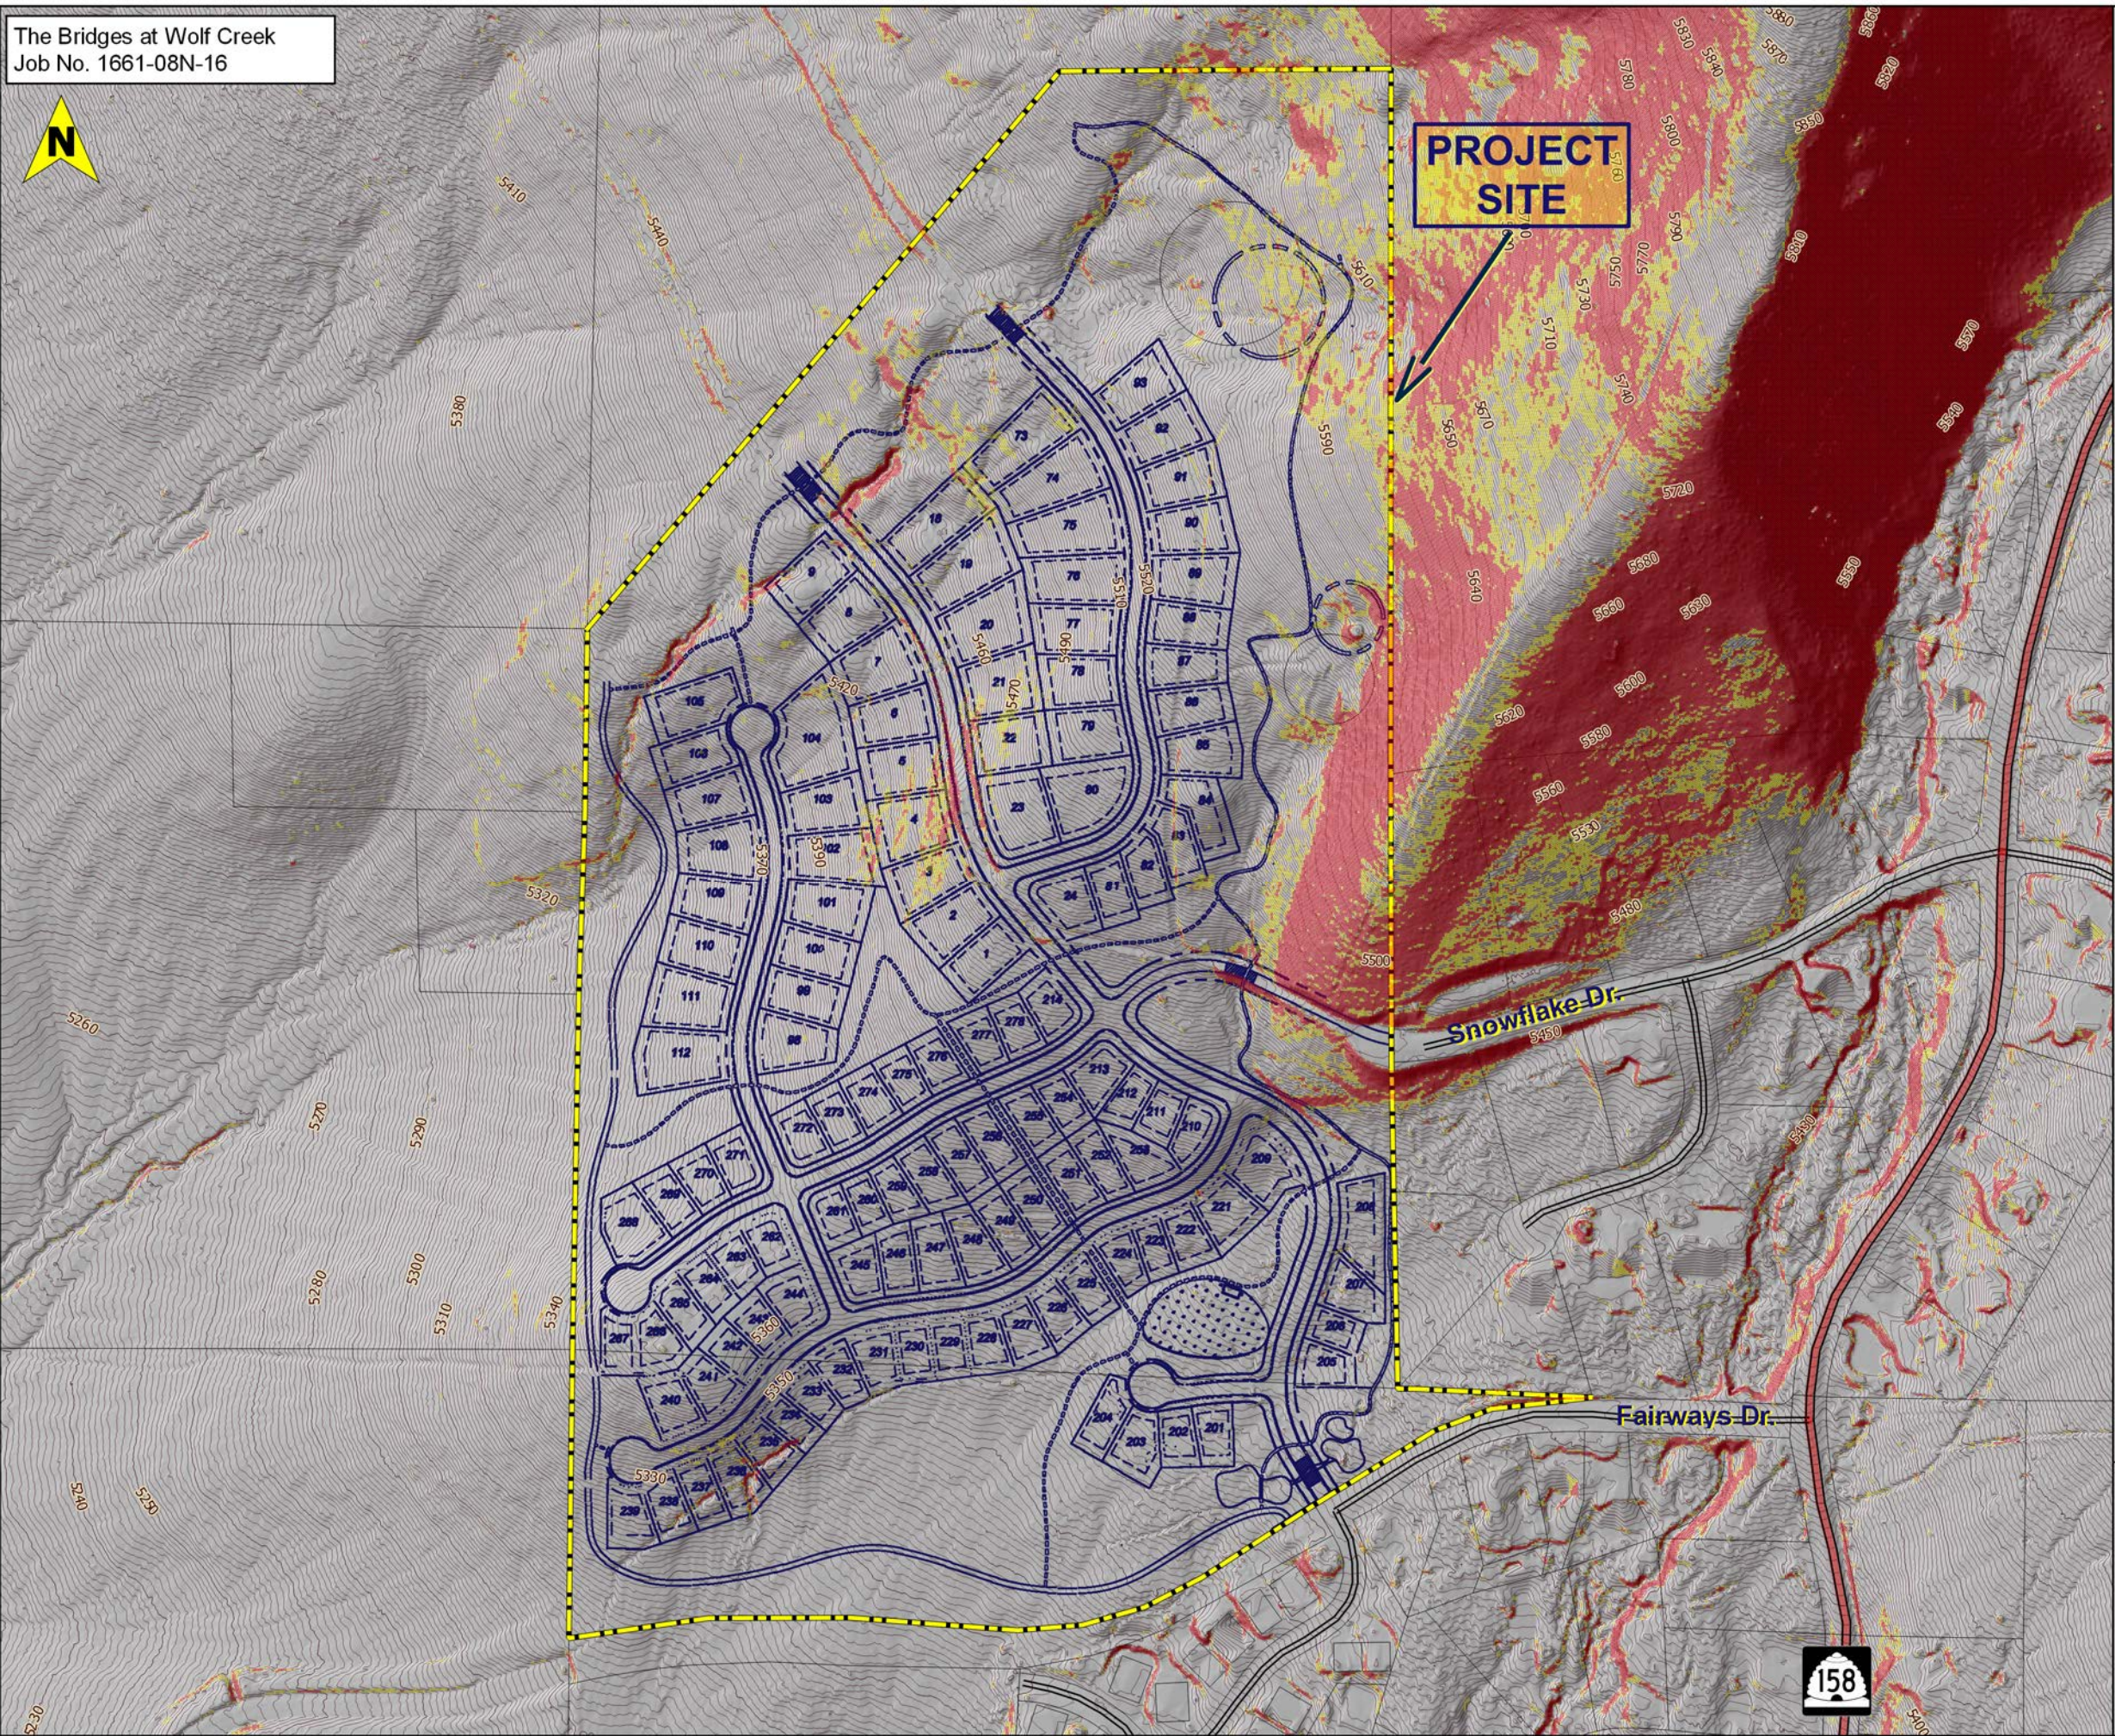
Site slopes and terrain conditions are presented on Figure 18, LiDAR-Slope Analysis. The elevation contours and site slope gradients on Figure 18 were developed from our LiDAR analysis. Surface gradients were found to range from level to over 65-percent as shown on Figure 18. For the site area, the slope gradient averaged 15.6-percent, with areas both above and below the average as shown on Figure 18. As previously mentioned in Section 2.3 of this report, the critical slope gradient for site development considerations according to the Weber County Code is 25-percent or greater. The terrain features illustrated by the relief shading on Figure 18, assisted in the interpretation and/or confirmation of the engineering geology units presented in Figure 3.

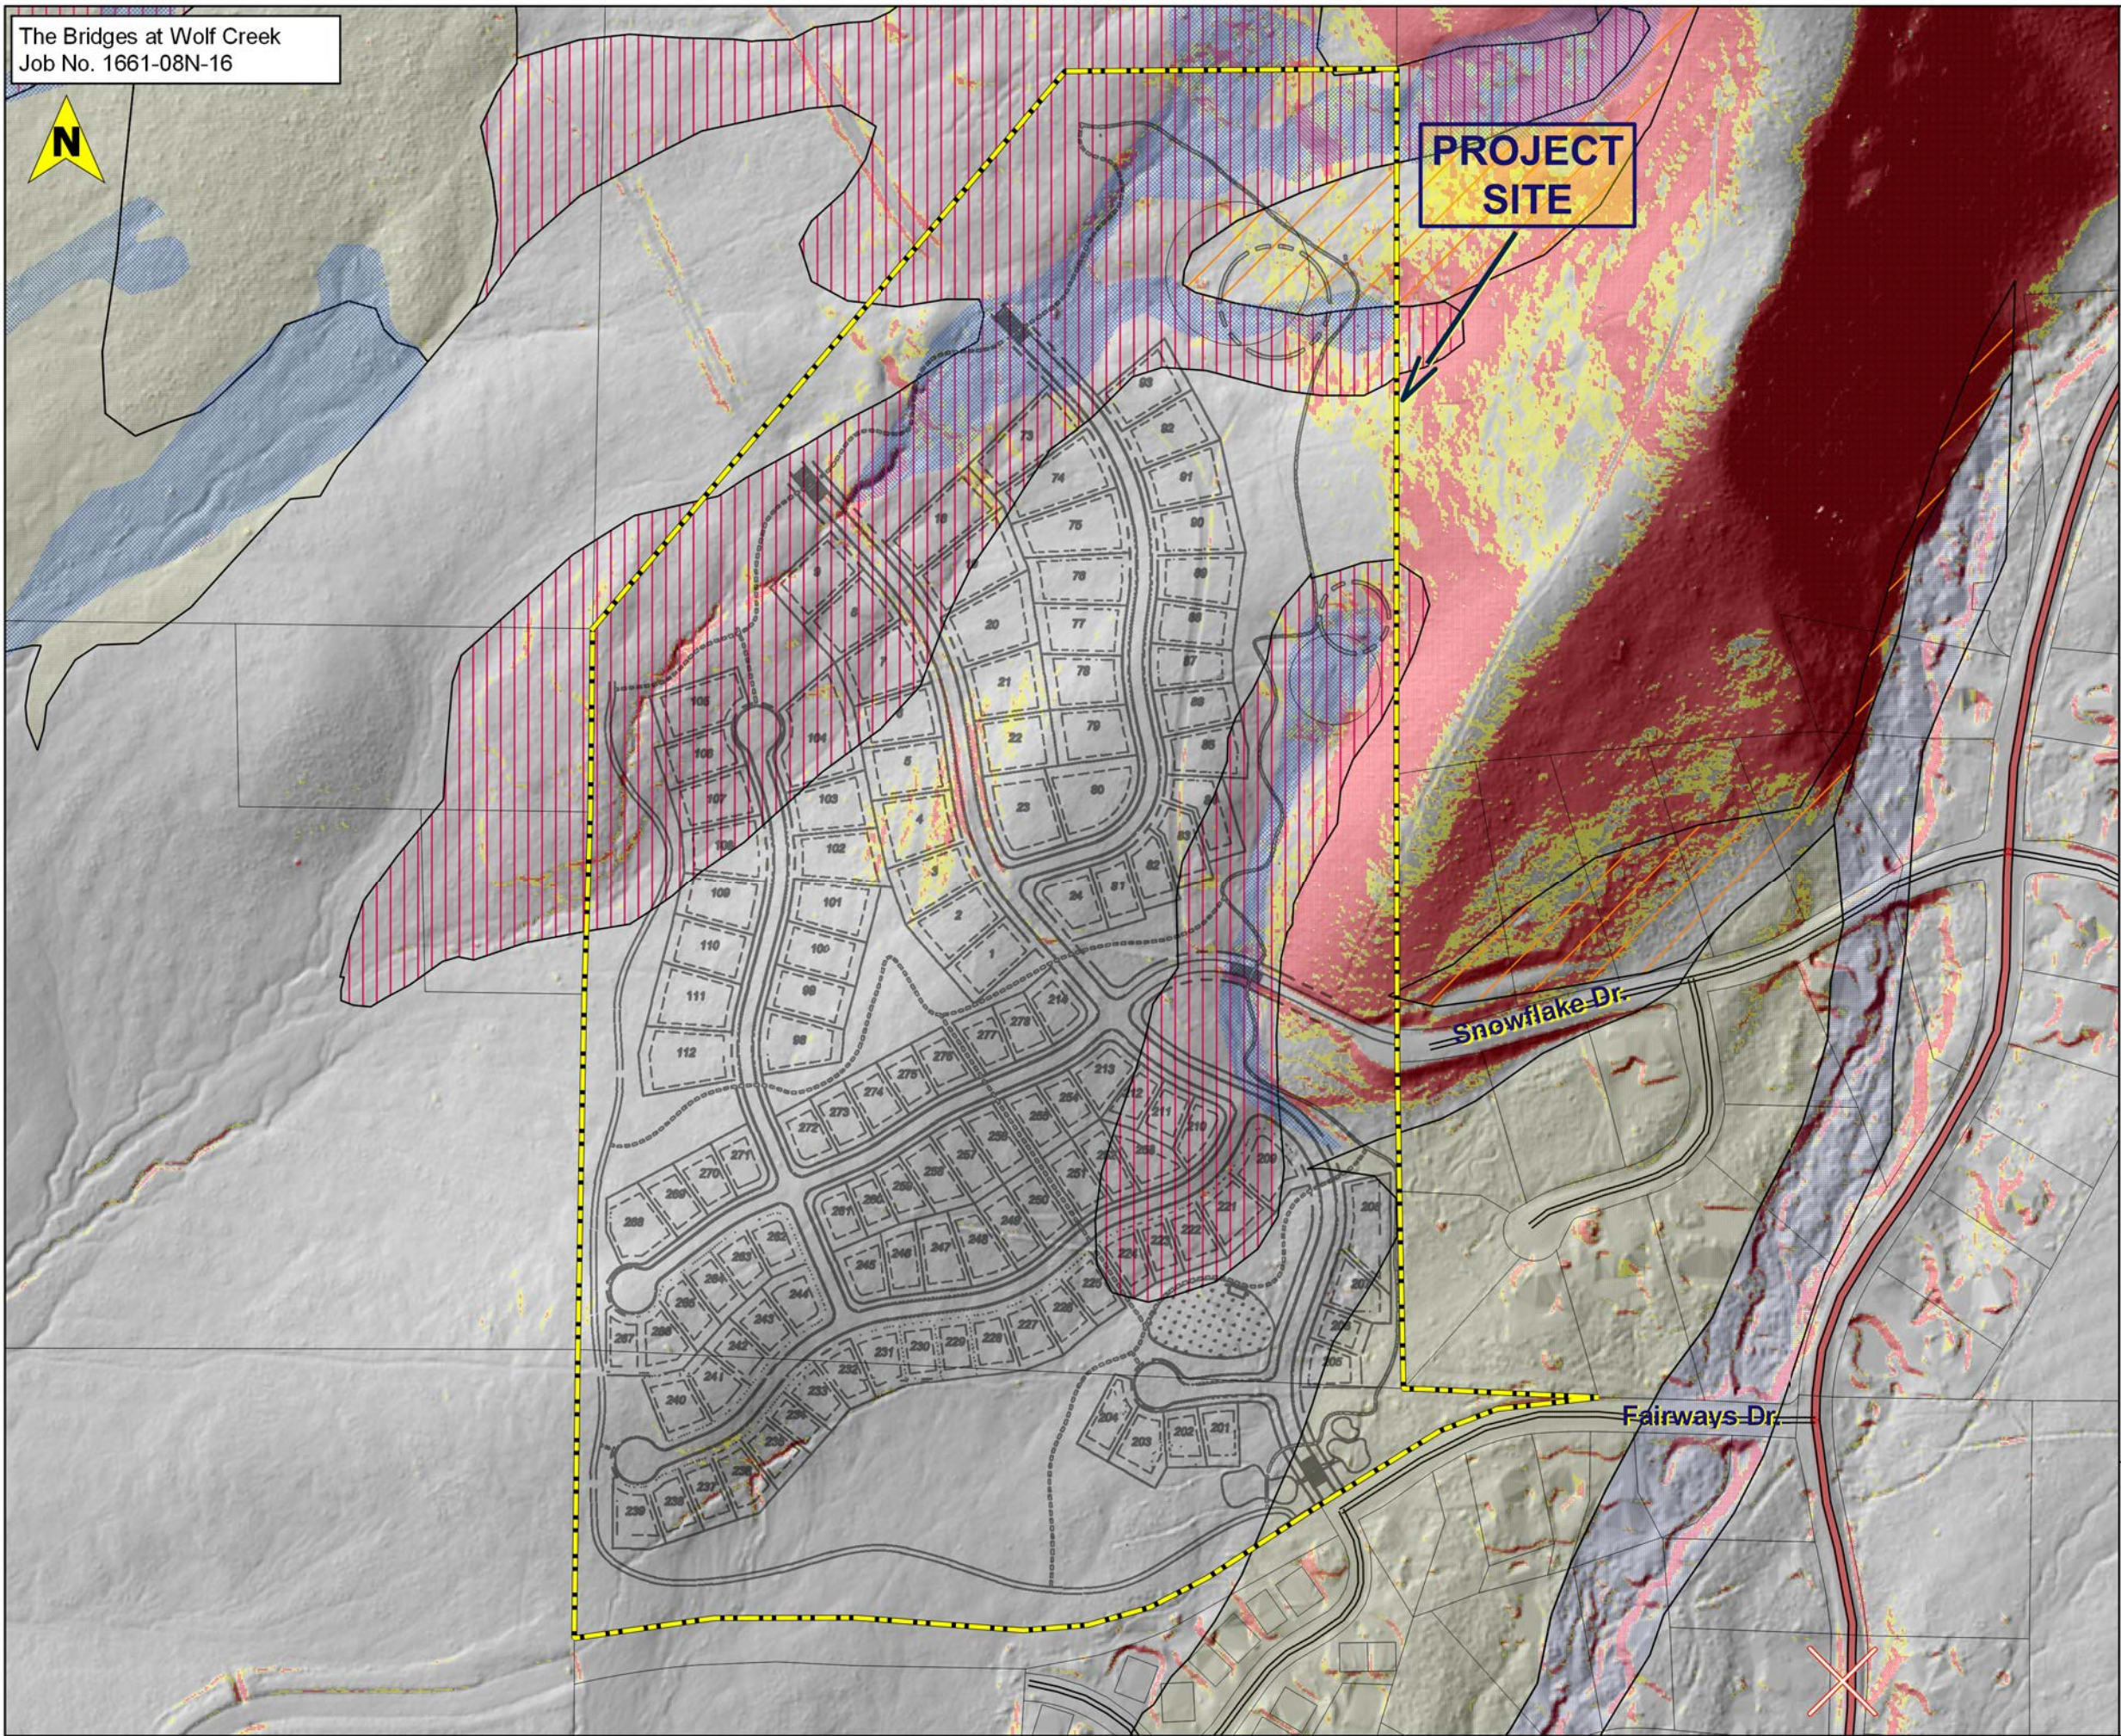
FIGURE 19
GEOLOGIC/NATURAL
HAZARD EXPOSURE

Hazards exposure for the East Phase of the Bridges at Wolf Creek is shown on Figure 19, and includes Shallow-Seasonal Groundwater areas (**Cienega**), Landslide-Mass Movement Hazard areas (**Qms**), and Alluvial Fan - Debris Flow Hazard areas (**Qafy**).

The two landslide areas described herein are complex combined earth-flow/soil creep features that have occurred on relatively low gradient slopes, and appear to be relatively shallow in thickness. Apparent from the mapping on Figure 19, is the areal relationship between Shallow-Seasonal Groundwater areas Landslide-Mass Movement Hazard areas. The location of the Shallow-Seasonal Groundwater areas over Landslide-Mass Movement Hazard areas indicates a systemic relationship between these two phenomena. As previously mentioned, the Landslide-Mass Movement Hazard areas appear to correlate to areas downslope of Maple Canyon Formation argillite beds mapped as **Zmcc2** on Figure 3. The emergence of the ground water on the surface on the same areas suggest the argillite beds may also controlling factor for the location of the groundwater emergence. The occurrence of the Shallow-Seasonal Groundwater on the Landslide-Mass Movement Hazard areas is believed to have a negative effect on the soil strength and stability of these soils, thus the removal of the water in these areas is believed to be a possible strategic measure for attaining stability in these areas.

Debris Flow Hazard areas (Qafy) are shown on Figure 19 to occur on the very southeast side of the East Phase site. These Younger Alluvial Fan Deposits (Holocene and Pleistocene) (**Qafy**), occur adjacent to the active floodplain deposits along the Wolf Creek channel. The Debris Flow Hazard area defined by the **Qafy** deposits is potentially exposed to both debris flows and clear-water flooding should Wolf Creek avulse during a future flood event. It is our understanding that no flood control or significant diversion structures on Wolf Creek exist upstream from the East Phase site, thus these hazards exist under the present conditions.

The area exposed to the debris flow hazards includes four residential development lots on the very southeast side of the East Phase, however the source of the hazard (Wolf Creek) is located off site, and is thus not feasible for hazard modification remediation. Therefore modifying what is at risk may be the only feasible approach to protect the improvements proposed for this area. Risk modification may include disclosure that exposed properties are subject to the potential debris-flow/flood hazards, and prescribed site specific grading and structural measures taken to reduce the potential impact of the hazards to the proposed improvements, which may include building setbacks, deflection berms, minimum finished floor elevations, limits to basement locations, and/or limits to door/window openings in basements.

These guidelines should be considered a basis for landslide hazards reductions where proposed improvements are exposed to landslide hazards as shown on Figure 19.

Remedial hazard risk reduction measures will need to be implemented where improvements will be exposed or potentially exposed to the hazard processes. These areas are shown on Figure 19, however more detailed and specific studies in-grading circumstances may find conditions different than presented on Figure 19. Hazard reduction measures may include site engineering measures to contain, deflect, drain or stabilize these processes, and/or include site development planning to avoid exposure to the hazards.
