GEOTECHNICAL AND GEOLOGIC HAZARD INVESTIGATION
Lot 86R of Summit Eden Phase 1C
8549 E. Spring Park
Summit Powder Mountain Resort
Weber County, Utah

IGES Project No. 03091-001

July 1, 2019

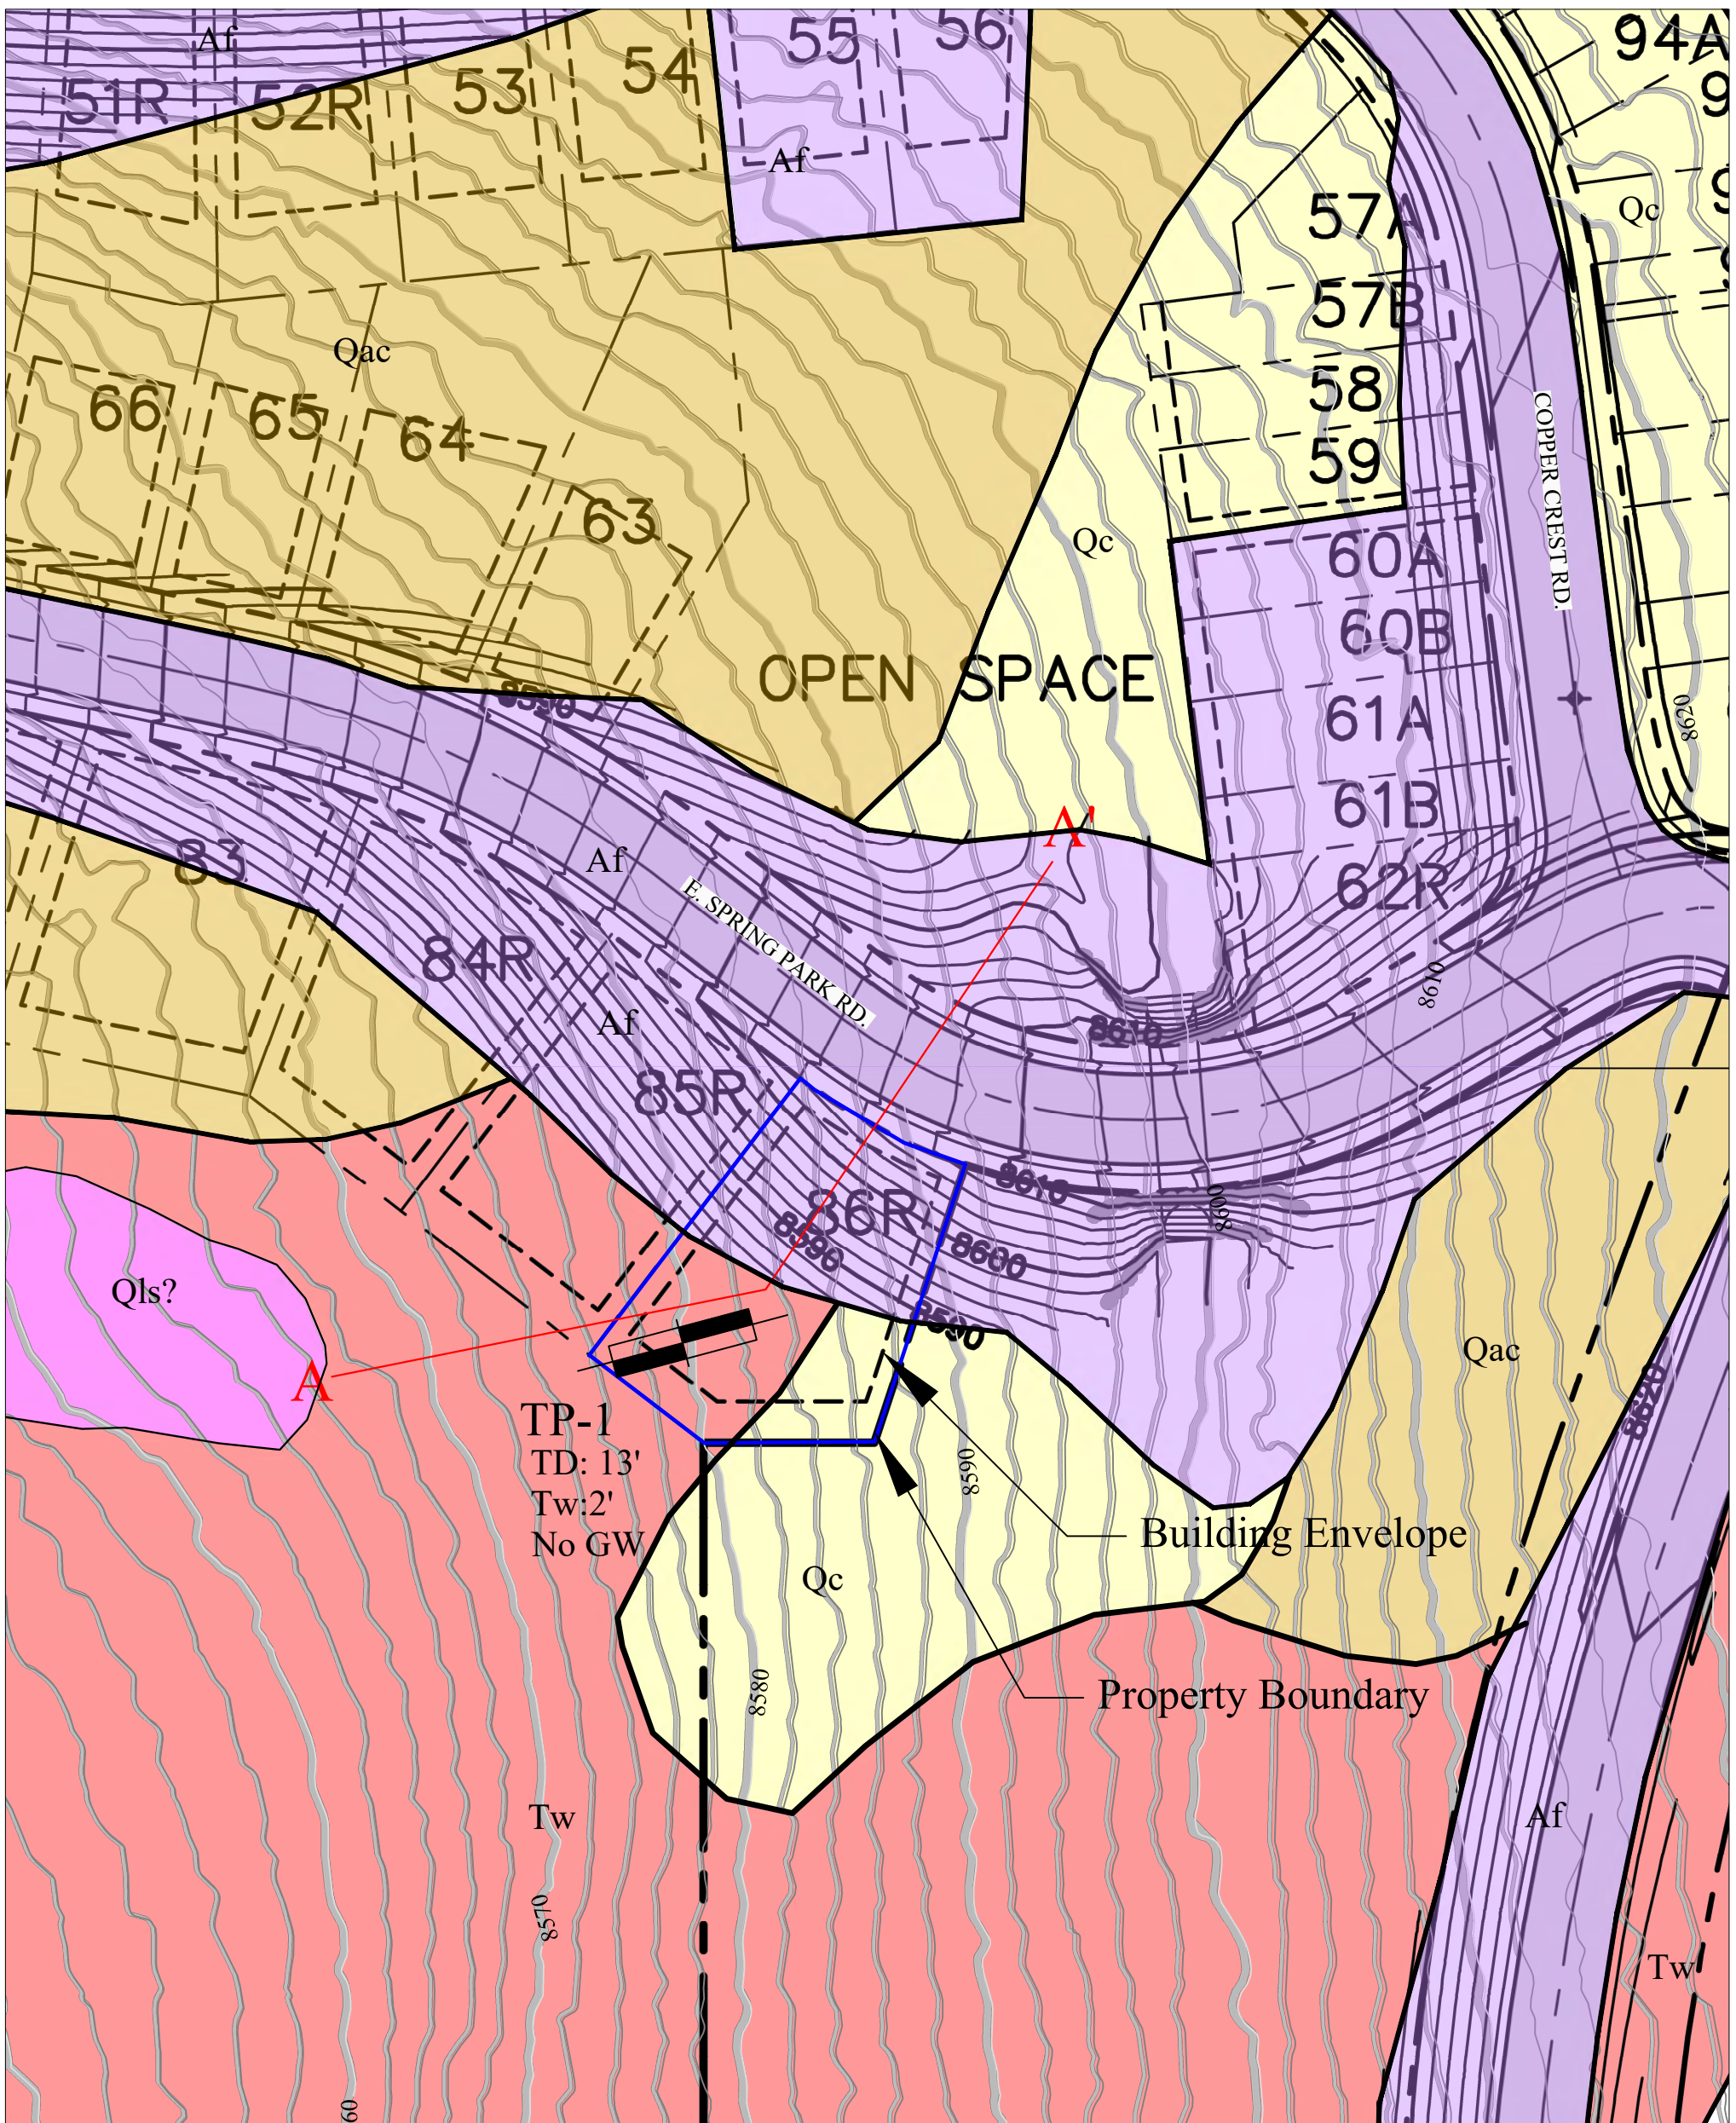
Geotechnical and Local Geology Map

Mr. Peter E. Doumit, P.G., C.P.G., of IGES conducted reconnaissance of the site and the immediate adjacent properties on June 7, 2019. The site reconnaissance was conducted with the intent to assess the general geologic conditions present across the property, with specific interest in those areas identified in the geologic literature and aerial imagery reviews as potential geologic hazard areas. Additionally, the site reconnaissance provided the opportunity to geologically map the surficial geology of the area. Figure A-2 is a site-specific geologic map of the Lot 86R property and adjacent areas.

On June 7, 2019, one exploration test pit was excavated in the southwestern portion of the lot (see Figure A-2). The test pit was excavated to a depth of 13 feet below existing grade with the aid of a Doosan DX 340 LC-HD tracked excavator. Upon completion of logging, the test pit was backfilled without engineered compaction controls. A detailed log for the test pit is displayed in Figure A-3. Two distinct geologic units were encountered in the subsurface. The soil and moisture conditions encountered during our investigation are discussed in the following paragraphs.

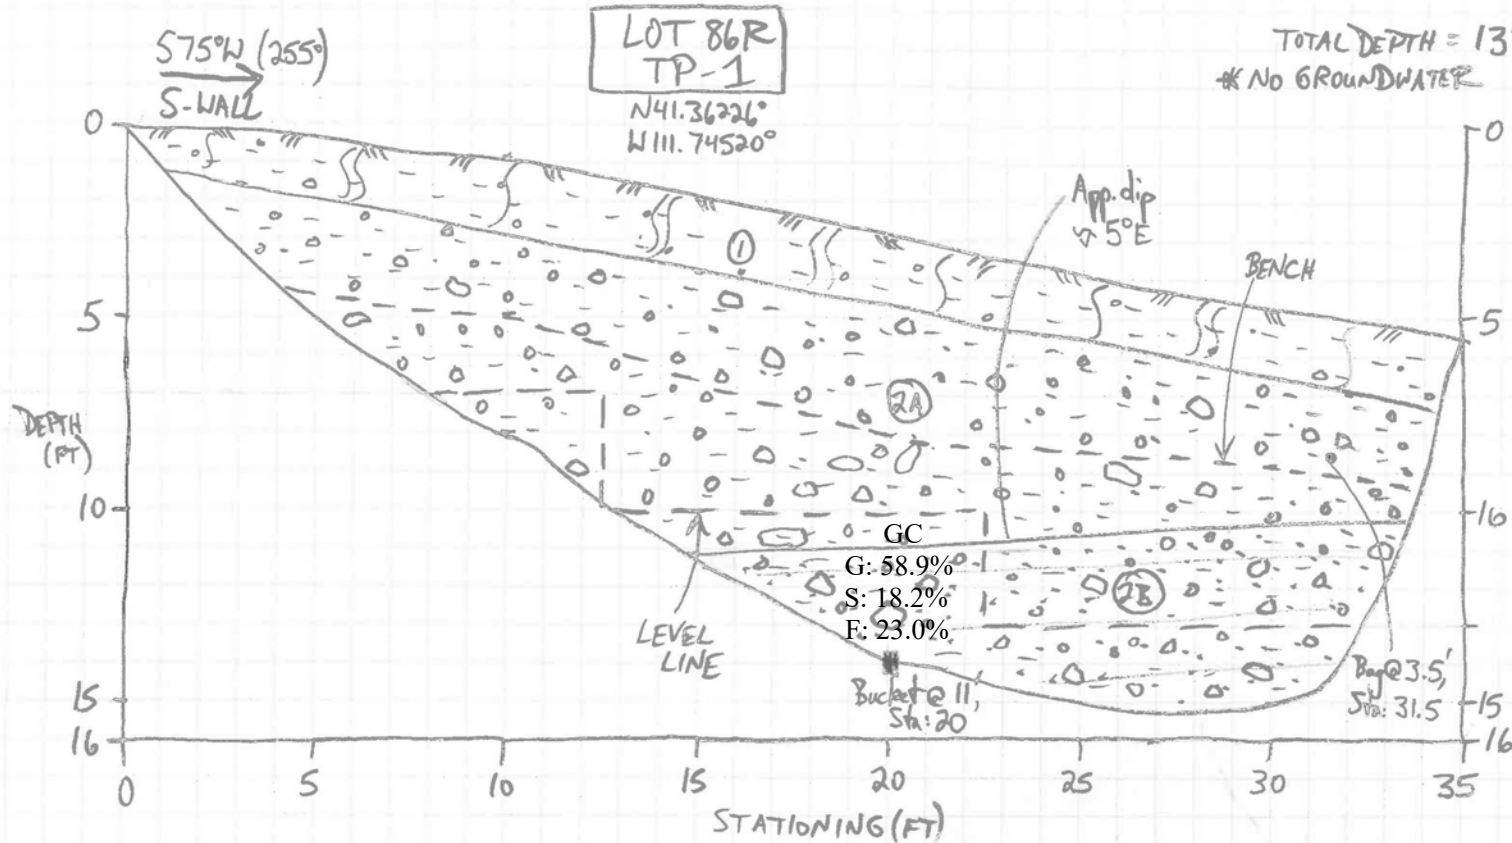
1. A/B Soil Horizon: ~1.5-2' thick; grayish brown (5Y 3/2) lean CLAY with gravel (CL), medium stiff, moist, low plasticity, massive; gravel and larger sized clasts comprise ~10-15% of the unit; clasts are entirely subrounded to subangular medium gray (N5) to pale yellowish orange (10YR 8/6) quartzite up to 7" in diameter, though mode clast size is ~1/2"; clast size increases with depth; abundant plant and tree roots; sharp, irregular basal contact.

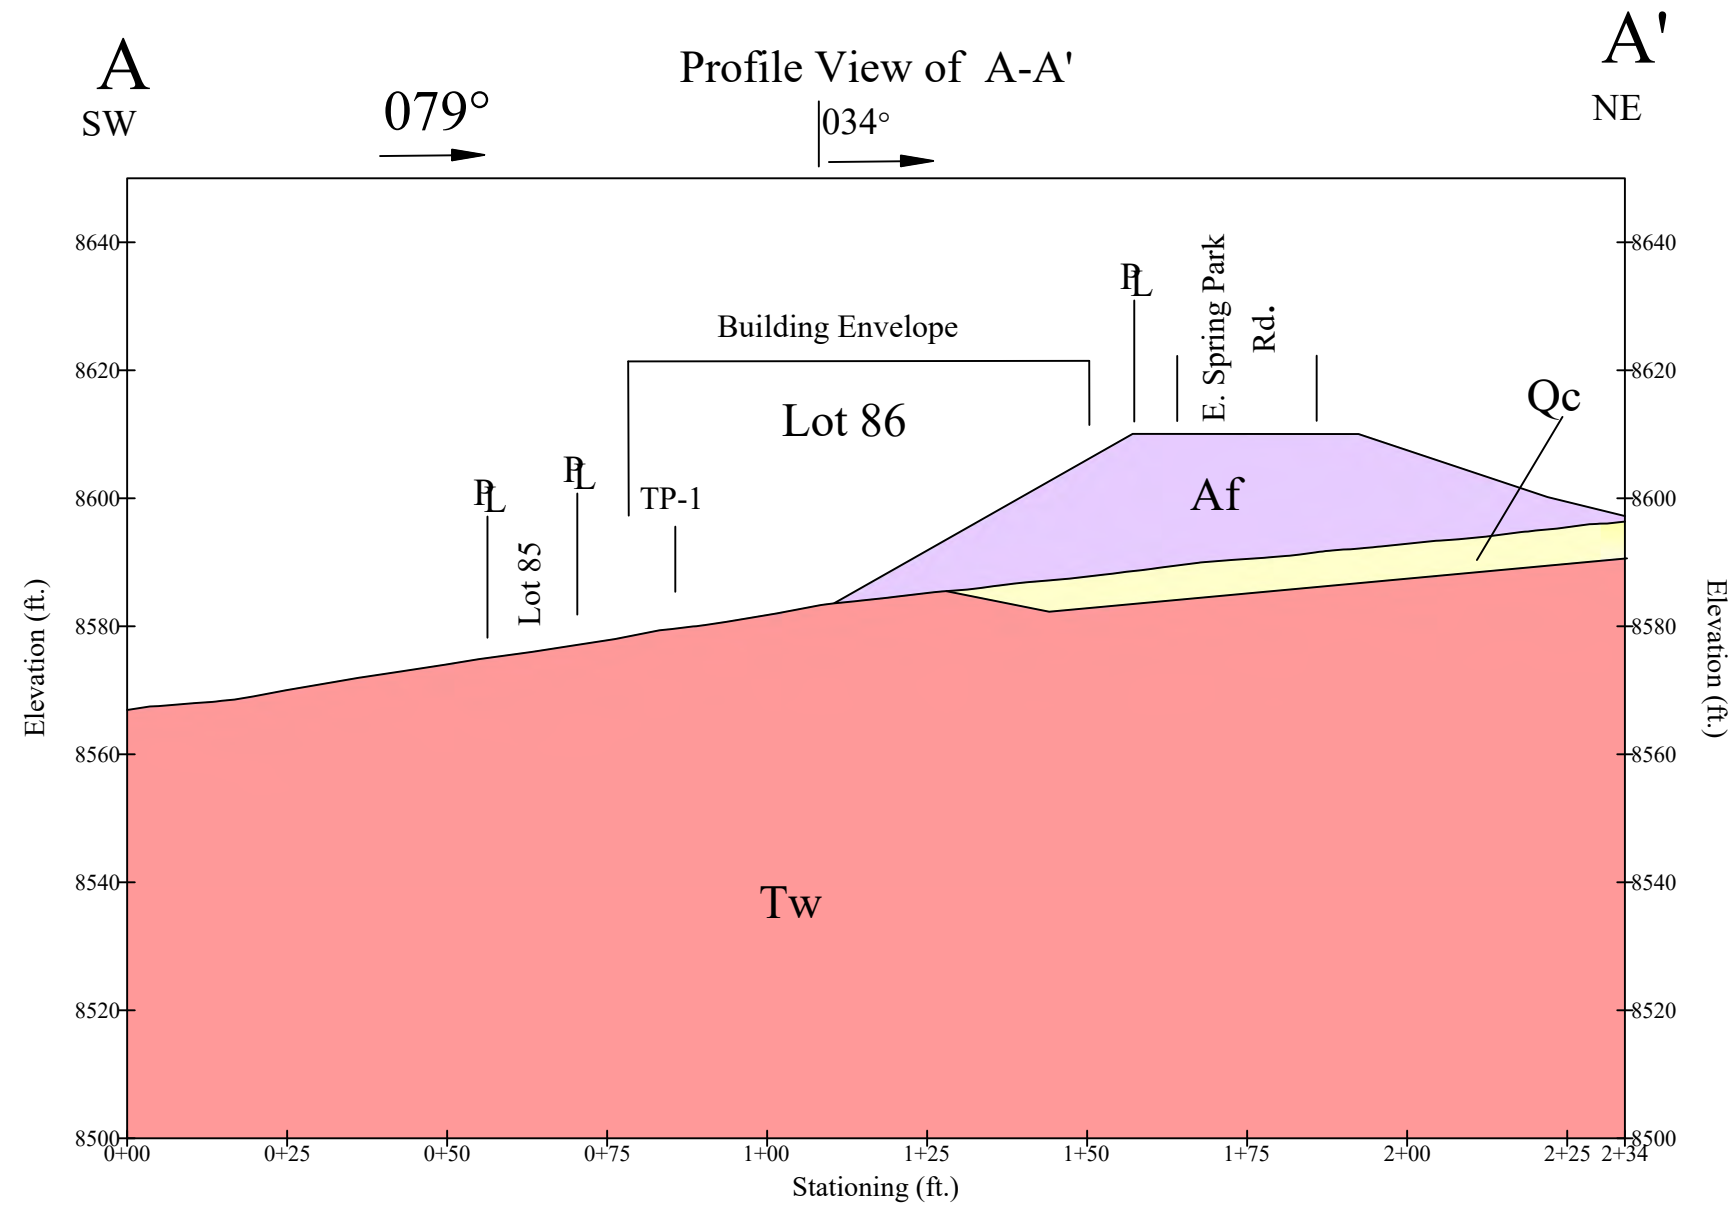
representative cross-section, illustrated on Figure D-1 in Appendix D (the section is identified in plan-view on Figure A-2). The stability of the slope was modeled using SLIDE, a computer application incorporating (among others) Spencer’s Method of analysis. Calculations for stability were developed by searching for the minimum factor of safety for a rotational-type failure occurring through the road embankment. Analysis was performed for both static and seismic (pseudo-static) cases.

The results of the analysis indicate the existing conditions meet the minimum required factors-of-safety of 1.5 and 1.0 for both the static and seismic (pseudo-static) case, respectively. A summary of the slope stability analysis is presented in Appendix D.
