Subject: Proposed Residence
8900 East 1800 South
Huntsville, Utah
Project No. 1200326

This letter presents the results of a reconnaissance-level, geologic-hazard study for proposed residential development of Parcel 21071004 at 8900 East 1800 South in Huntsville, Utah.

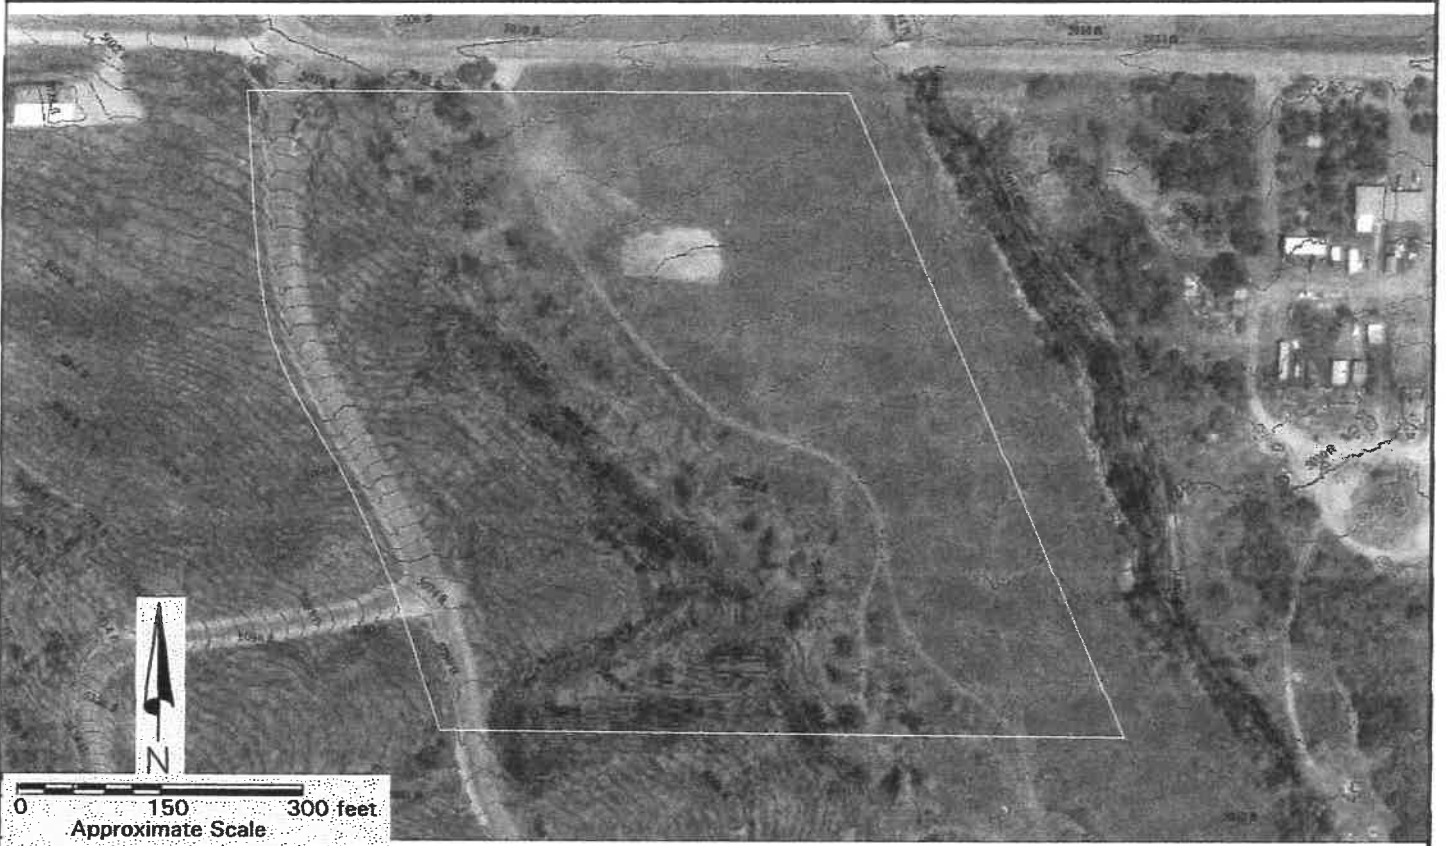
Figure 2

The slope of the ground surface at the site varies (see Figure 2). The lower portion of the site slopes down to the north-northwest at approximately 2.6 percent. The slope of Falcon way is in a similar direction and slopes down at approximately 9.3 percent. There is a steeper area

east of Falcon Way with a height of up to approximately 20 feet and a slope up to approximately 60 percent down toward Bally Watts Creek to the east. There is an abandoned irrigation ditch that extends near the crest of this slope. The slope above this area is down to the northeast at approximately 13.7 percent.
