GEOLOGIC HAZARDS REVIEW WELCOME CENTER SUBDIVISION LOT 1 3632 NORTH WOLF CREEK DRIVE EDEN, WEBER COUNTY, UTAH

September 29, 2020

SUBJECT: Geologic Hazards Review
Welcome Center Subdivision Lot 1
3632 North Wolf Creek Drive
Eden, Weber County, Utah

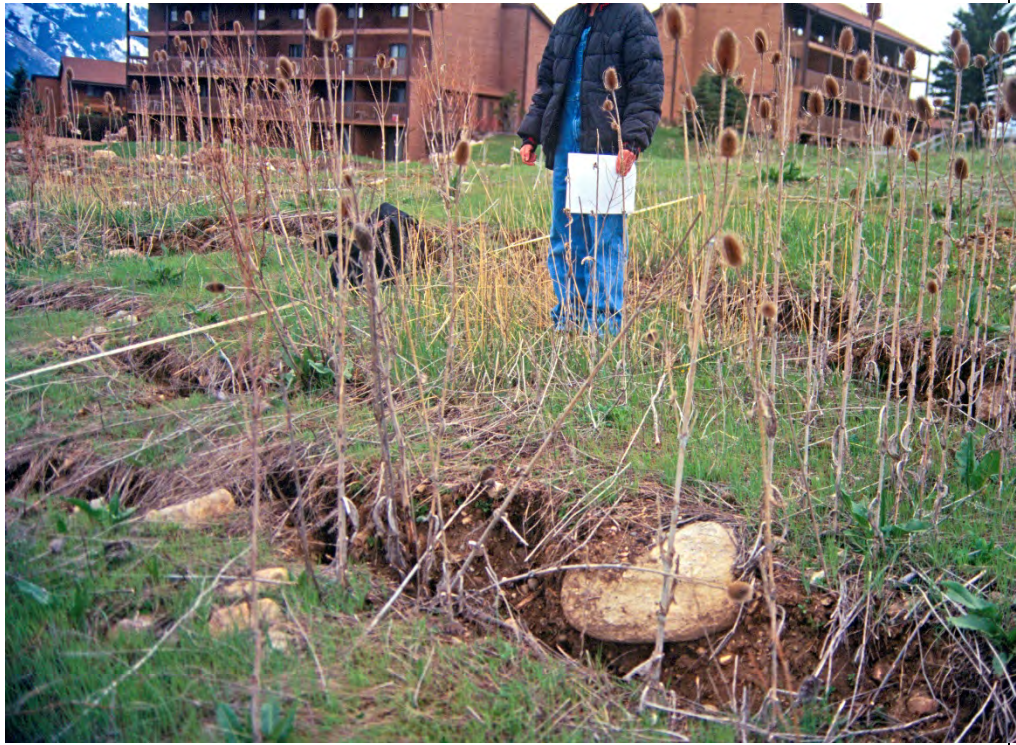
A water tank is on the northeast-adjointing property that was developed prior to 1997. The water tank reportedly experienced a clogged relief line that saturated downslope areas and produced a slope failure prior to development of the existing building at the Project (Y2 Geotechnical, 2006). The Utah Geological Survey (UGS) observed this landslide in April 1999 and informally terms it the Eden Water Tank Landslide (Appendix A - Photographic Record, Photos 1 and 2).

Photo 1. April 1999 UGS site visit. Eden Water Tank Landslide.

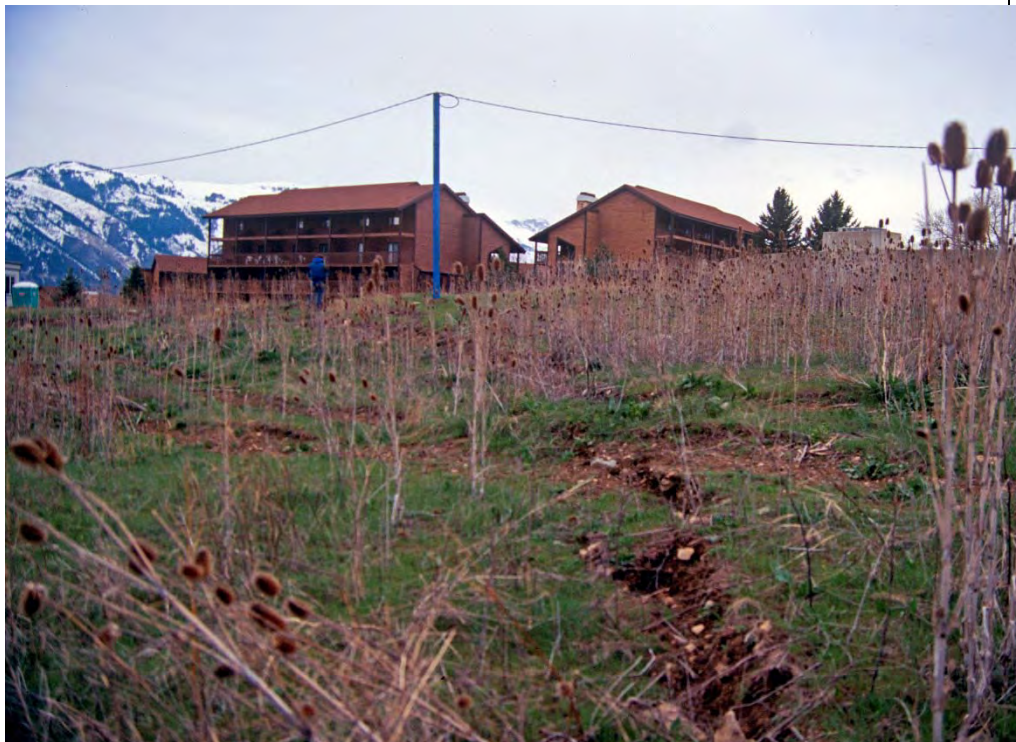
Photo 2. April 1999 UGS site visit. Eden Water Tank Landslide.

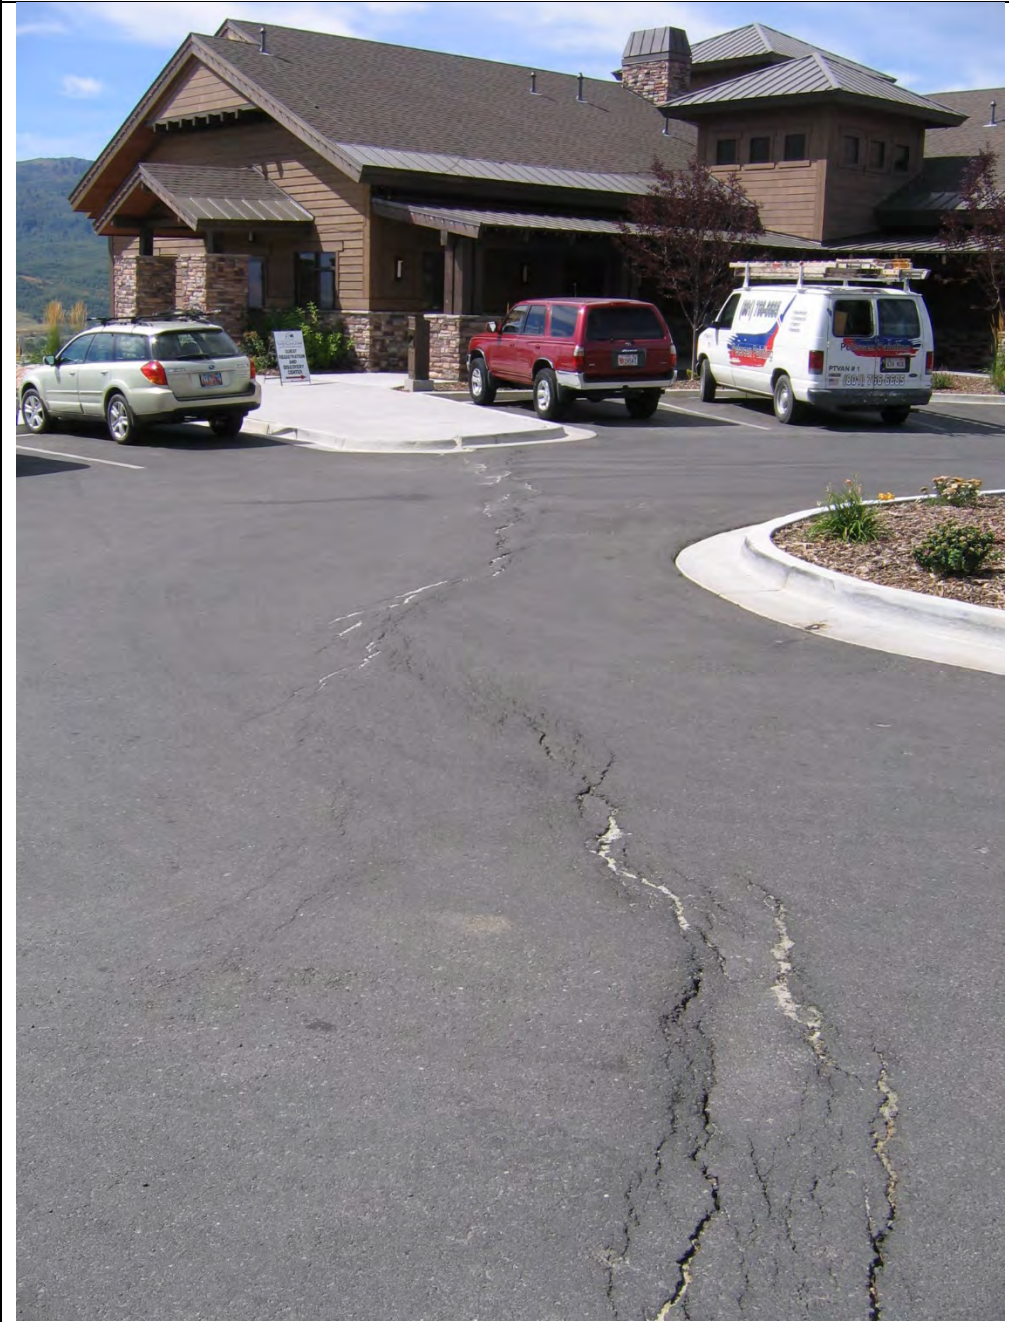
In August 2008, UGS geologists responded to additional movement of the 1999 landslide and documented evidence for damage to the parking lot at the Project (Appendix A – Photos 3 through 6), as well as to Moose Hollow Drive at the landslide toe (Photos 7 and 8). UGS geologists revisited the site in May 2009 and observed significant additional damage to the parking lot (Appendix A – Photos 9 through 12). In July 2009, UGS geologists observed settlement in the parking lot near the storm drain (Appendix A, Photo 13), a graded area and new drain below the water tank that was flowing substantially (Photo 14), and a significant toe bulge in Moose Hollow Drive (Photos 15 and 16). Curb and gutter had been installed at the toe by April 2014 (Appendix A – Photo 17). In April 2014, UGS geologists also observed backtilting in the sidewalk along the south edge of the parking lot (Appendix A - Photo 19) and damage to the pad for the air conditioning (AC) units southeast of the building (Photo 21). UGS geologists revisited the site three times again in June 2015, June 2018, and April 2019, but noted no indications for new movement or damage (Appendix A – Photos 22 through 26).

Photo 3. August 2008 UGS site visit. Displacement across parking lot at site.

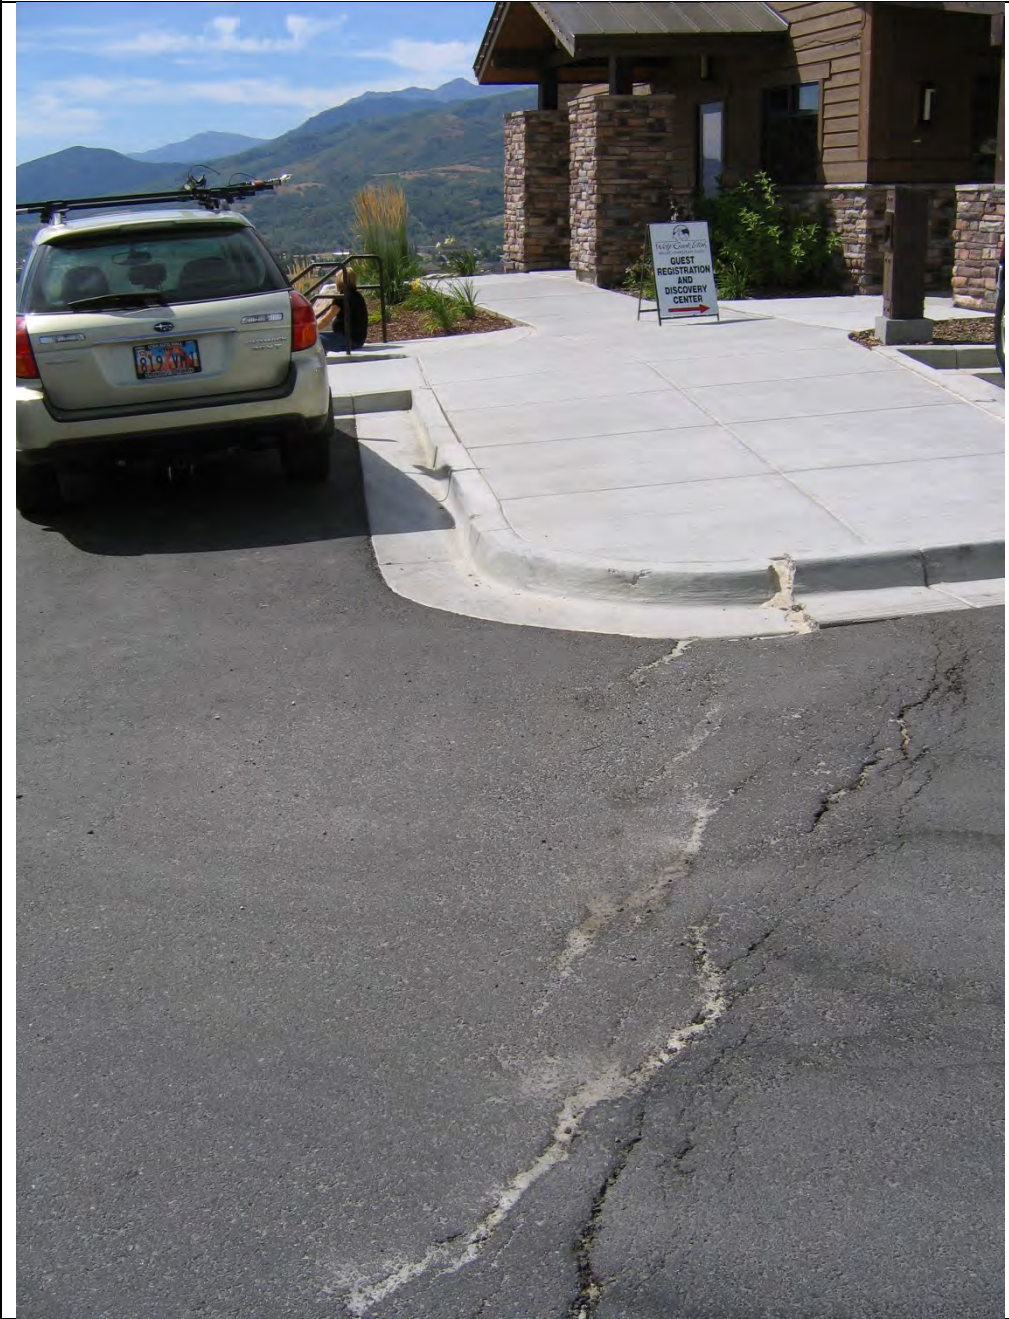
Photo 4. August 2008 UGS site visit. Displacement in side walk and pavement.

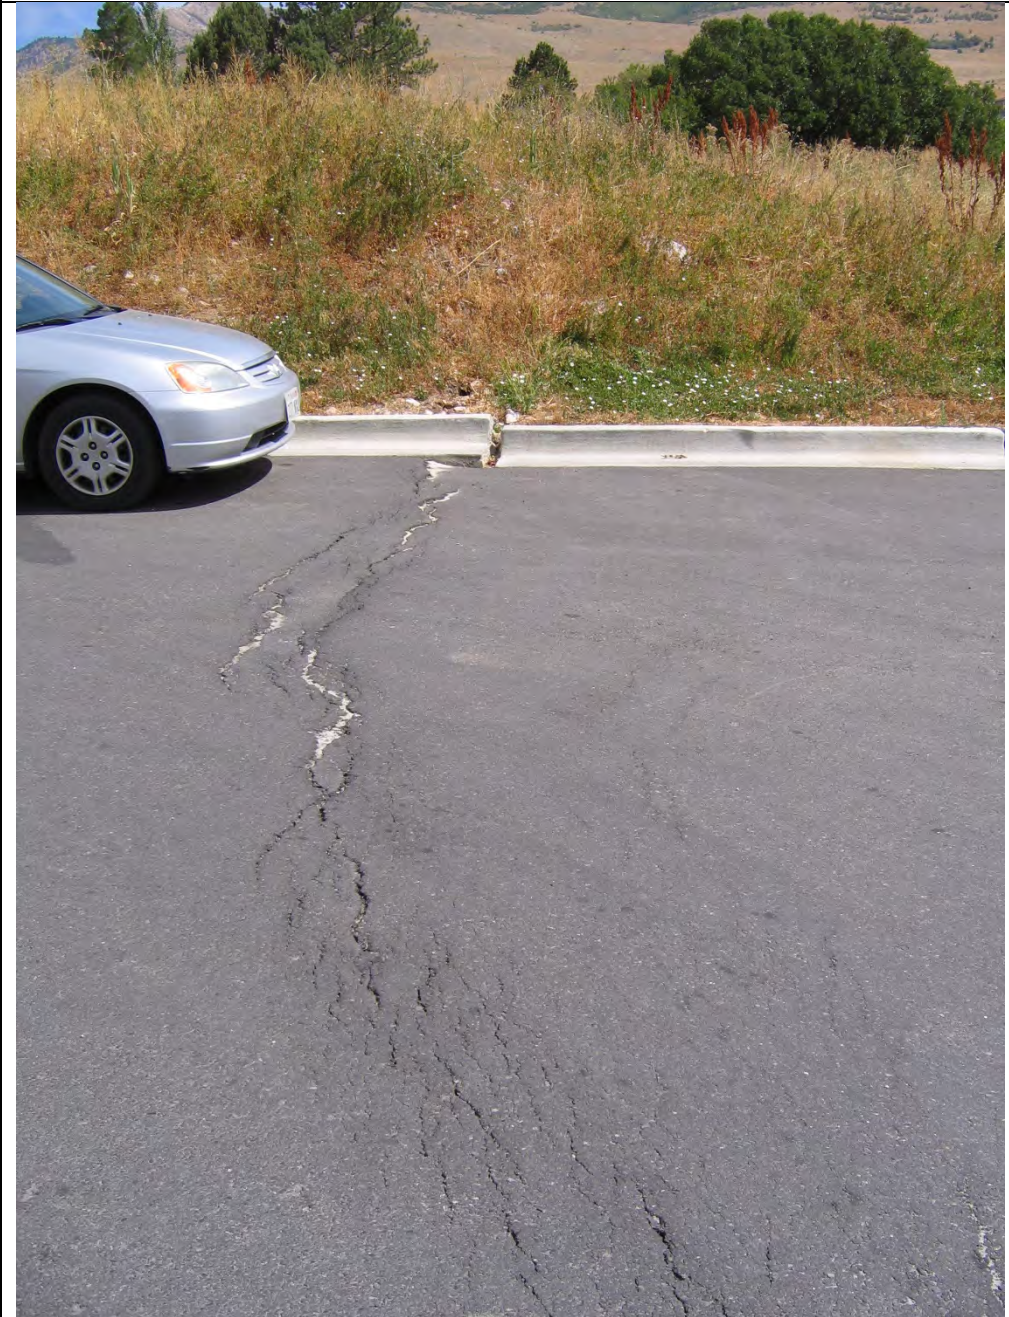
Photo 5. August 2008 UGS site visit. Cracking and displacement in curb and gutter.

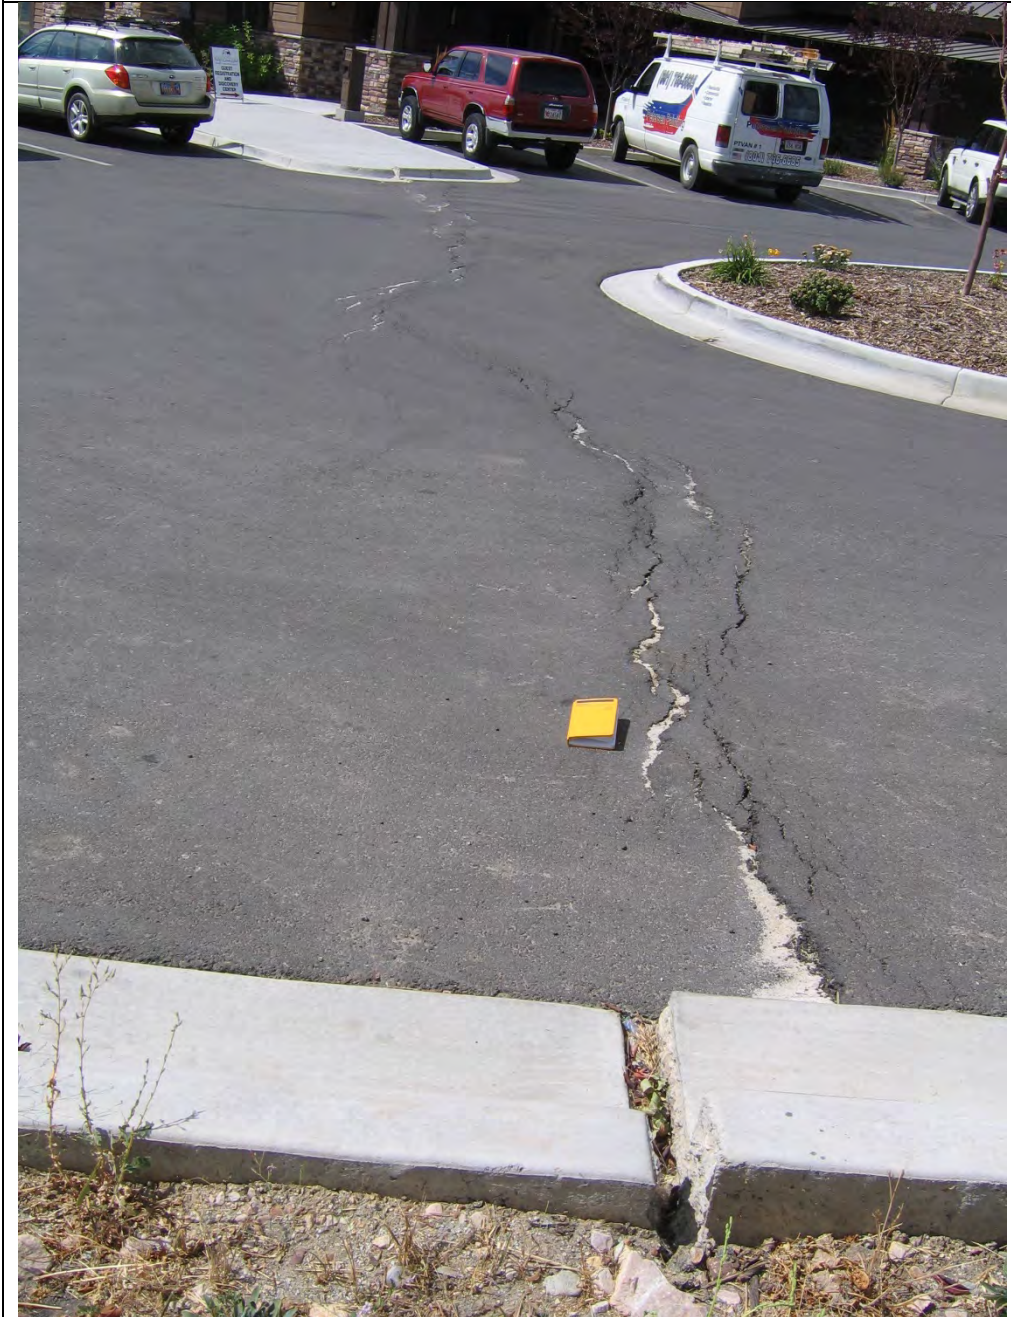
Photo 6. August 2008 UGS site visit. Displacement in parking lot at site.

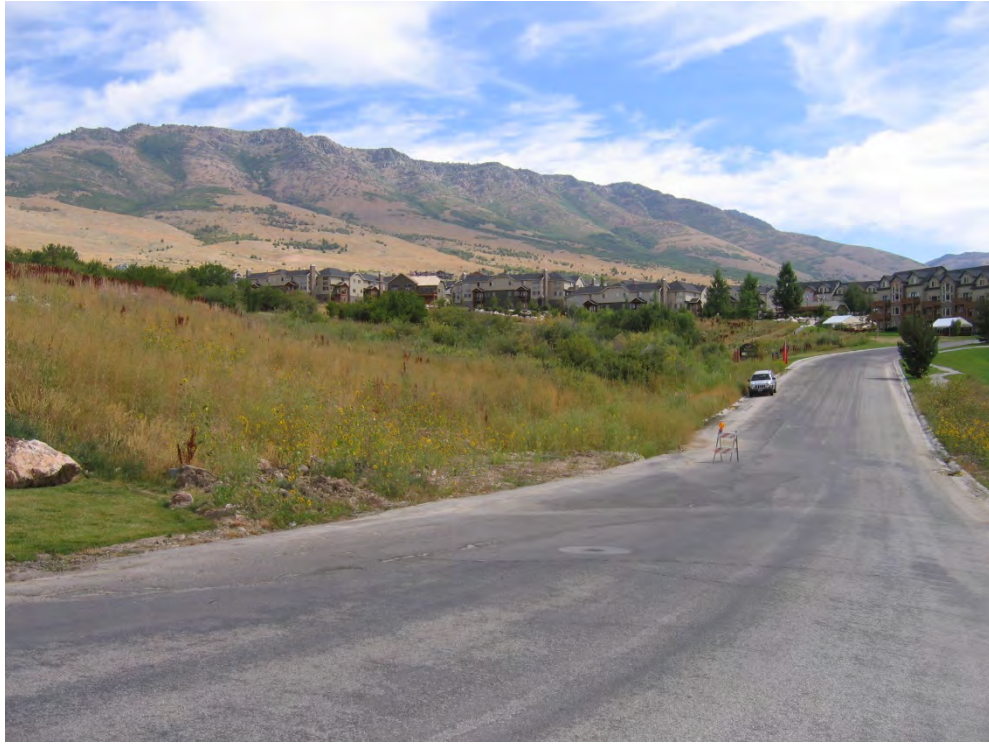
Photo 7. August 2008 UGS site visit. Landslide toe at Moose Hollow Drive.

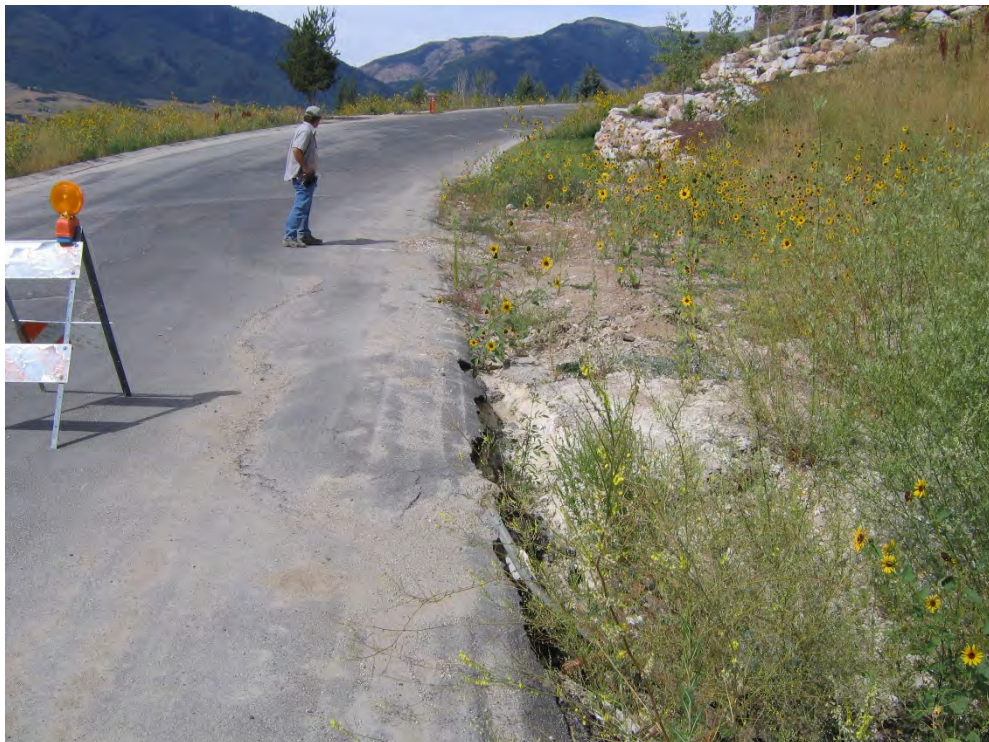
Photo 8. August 2008 UGS site visit. Subtle toe bulge in Moose Hollow Drive.

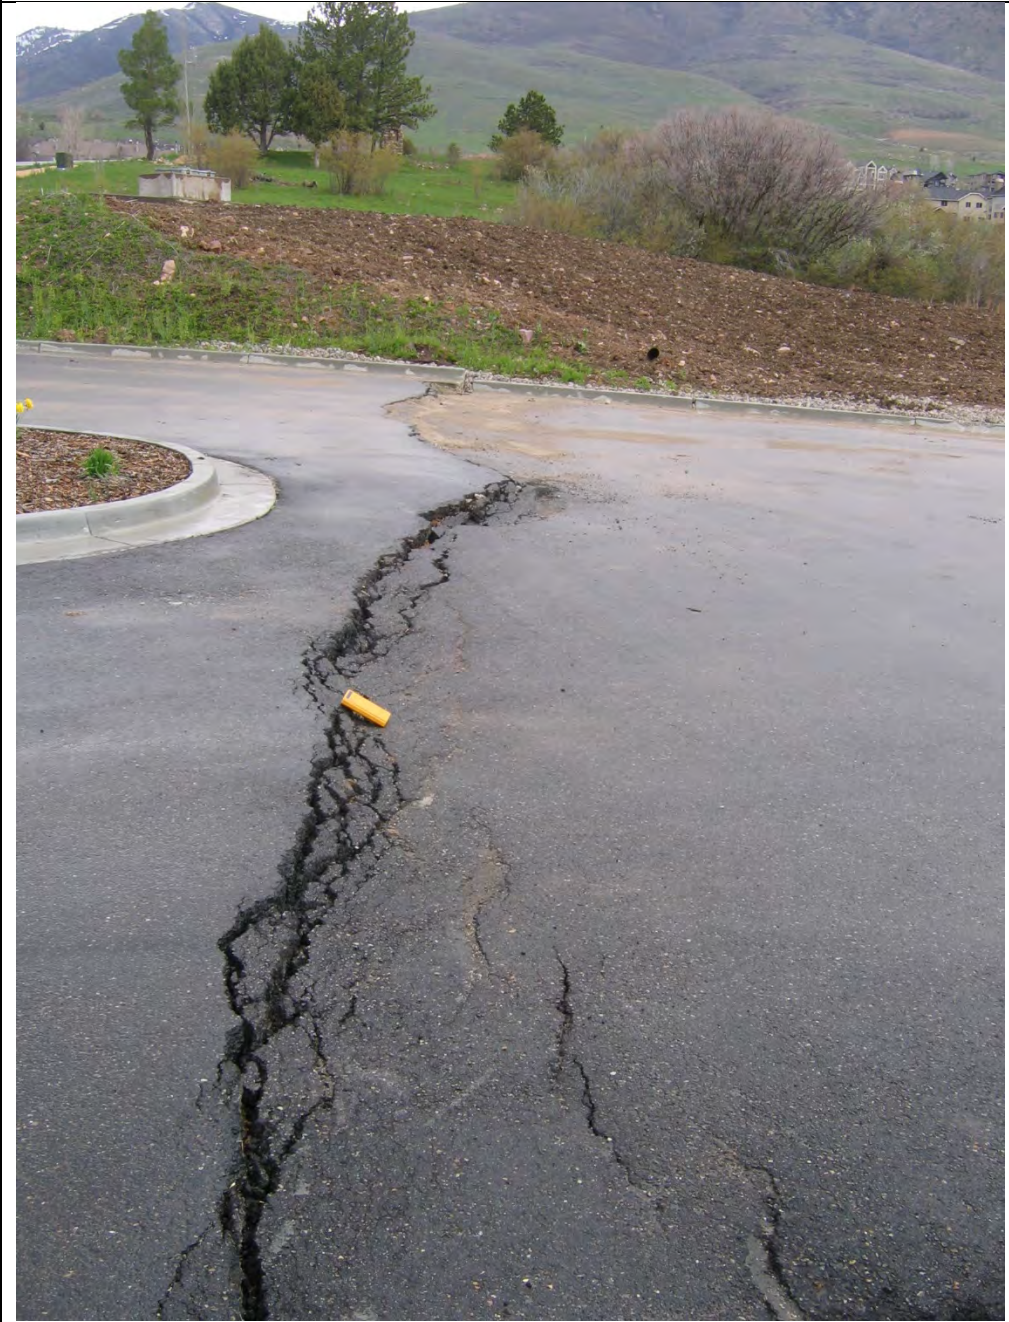
Photo 9. May 2009 UGS site visit. More displacement in parking lot at site.

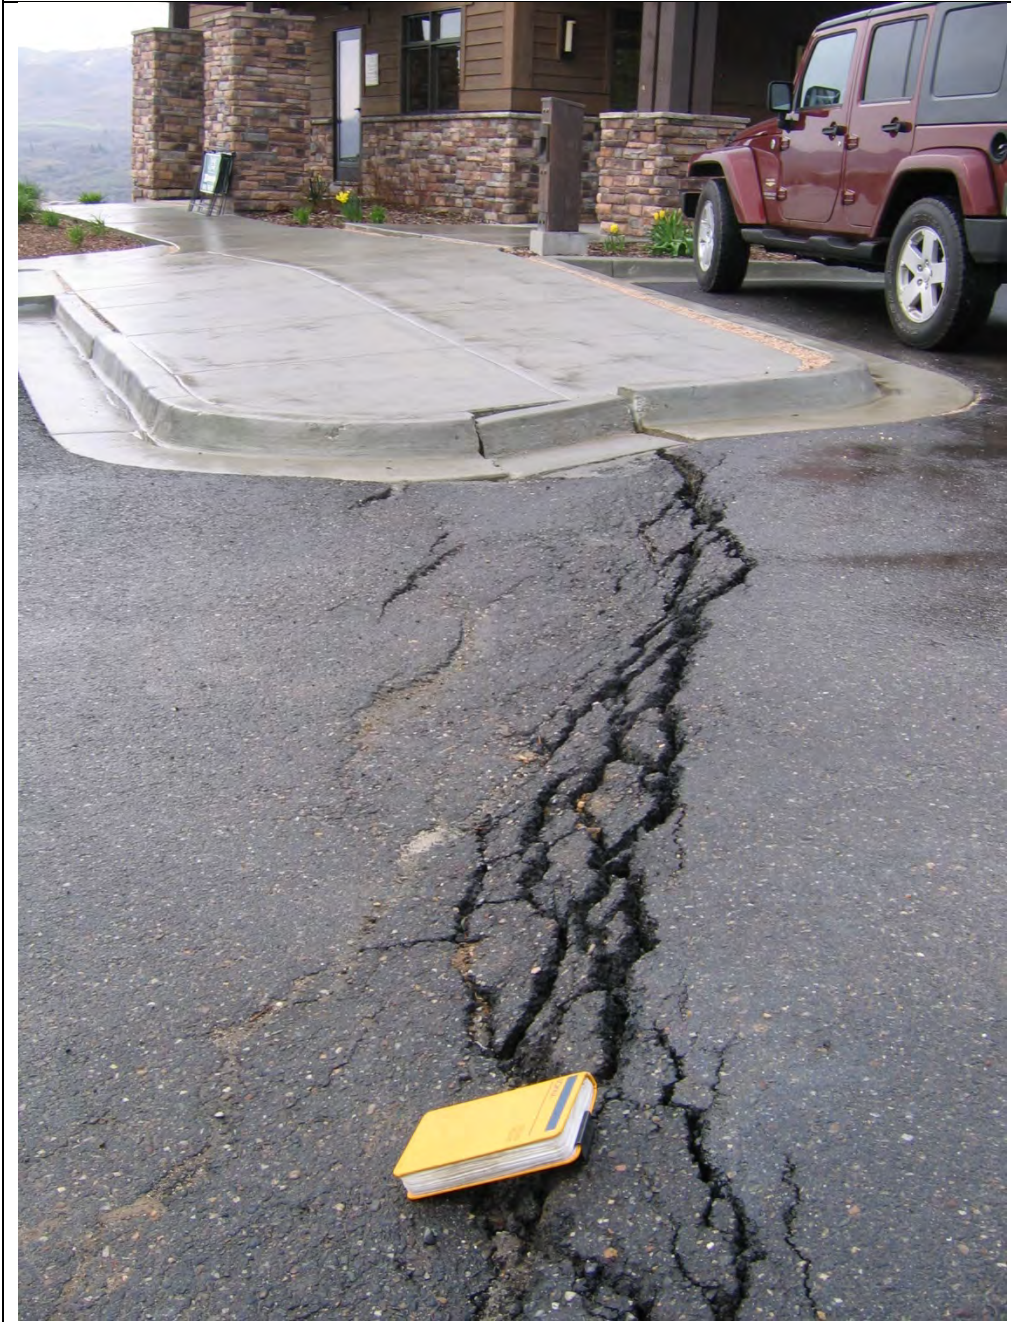
Photo 10. May 2009 UGS site visit. More displacement in parking lot at site.

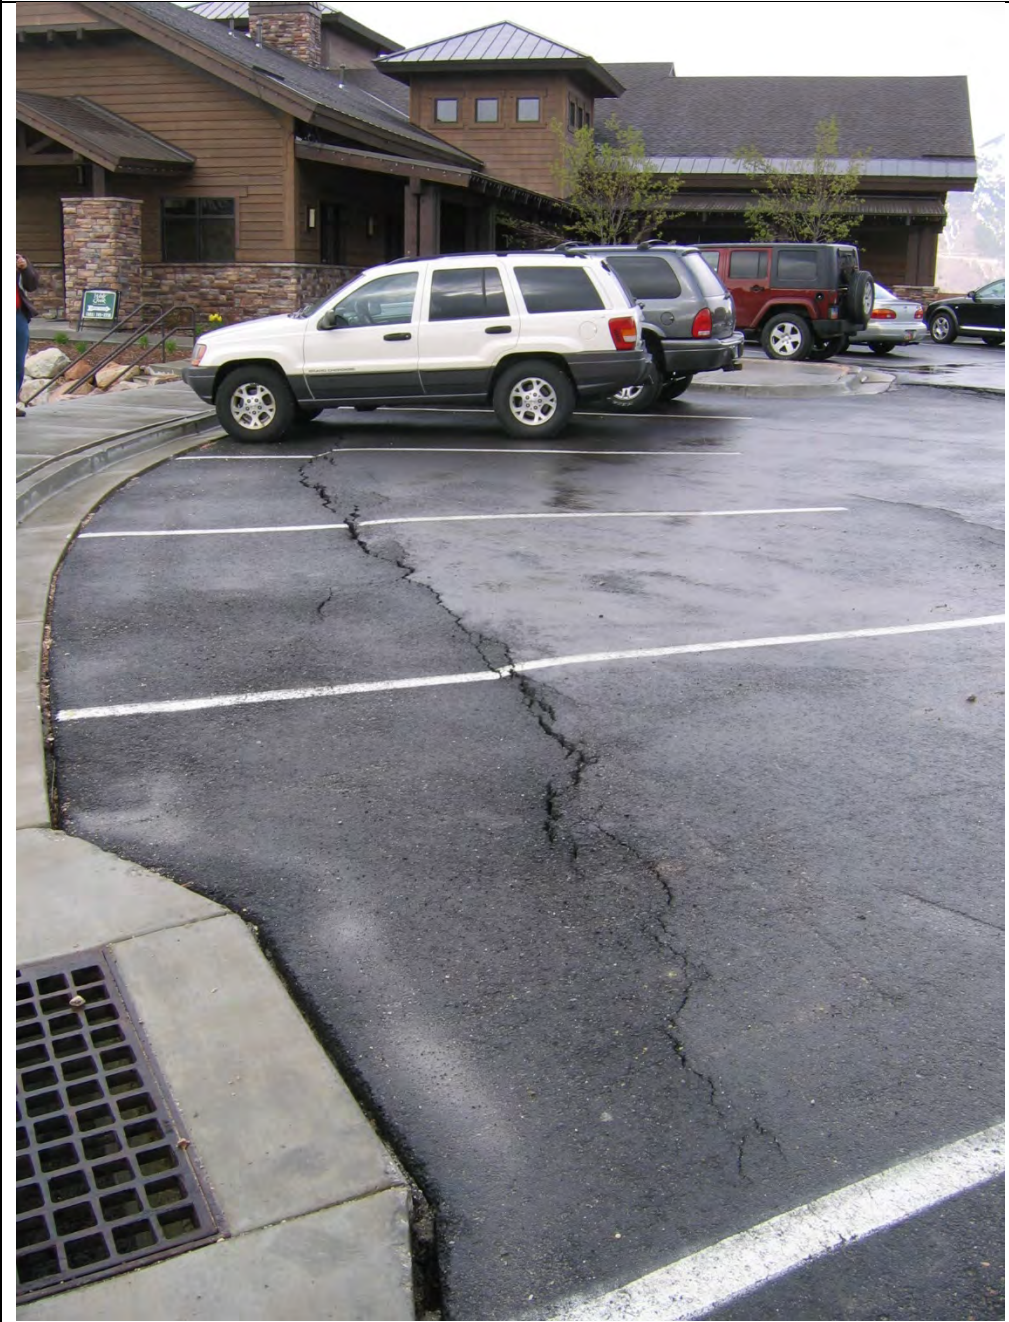
Photo 11. May 2009 UGS site visit. Cracking near storm drain in parking lot.

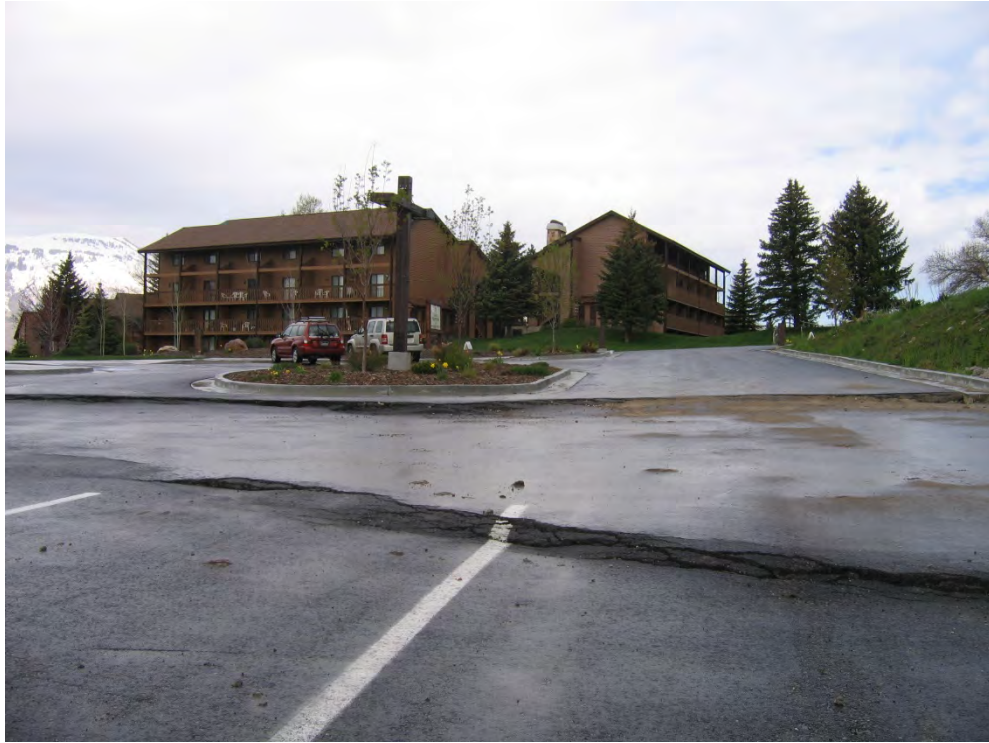
Photo 12. May 2009 UGS site visit. Scarps in parking lot pavement.

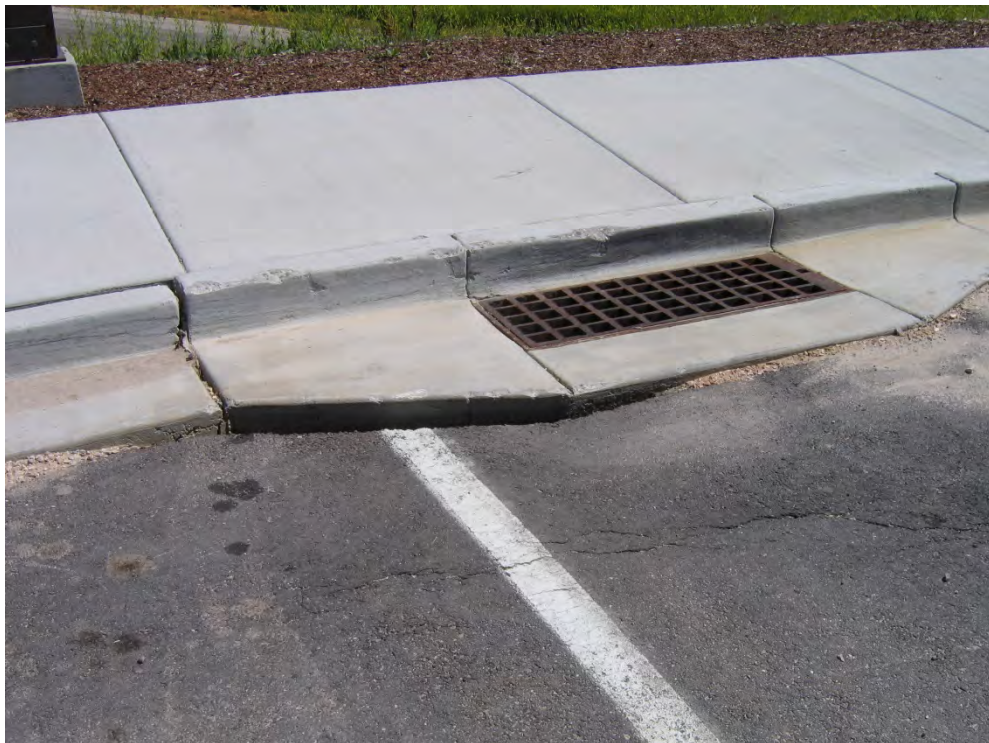
Photo 13. July 2009 UGS site visit. Displacement between gutter and pavement near storm drain.

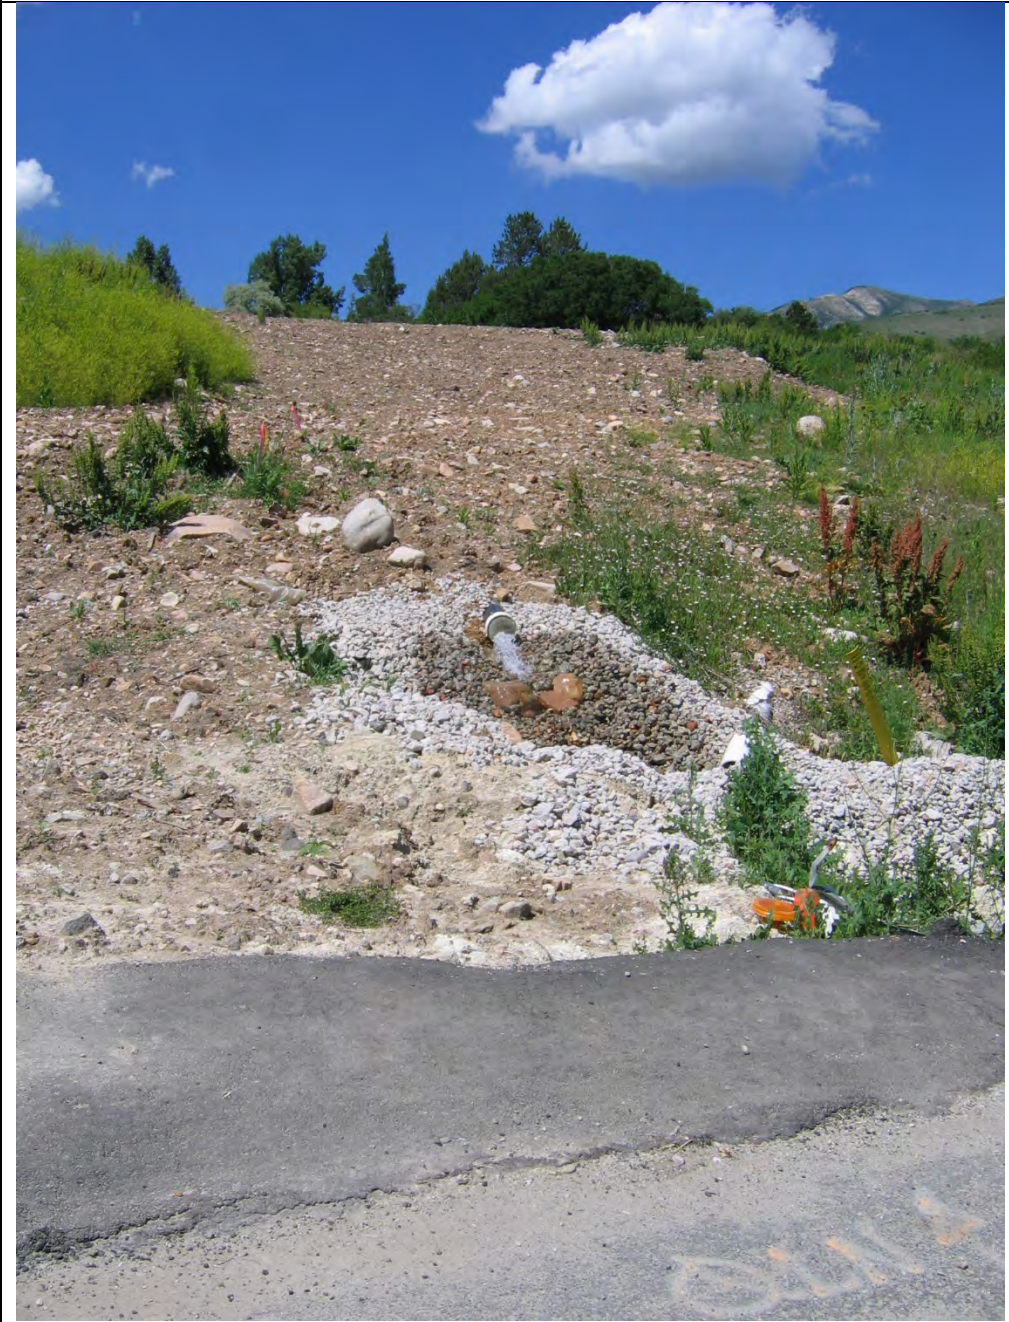
Photo 14. July 2009 UGS site visit. Regraded area with new drain.

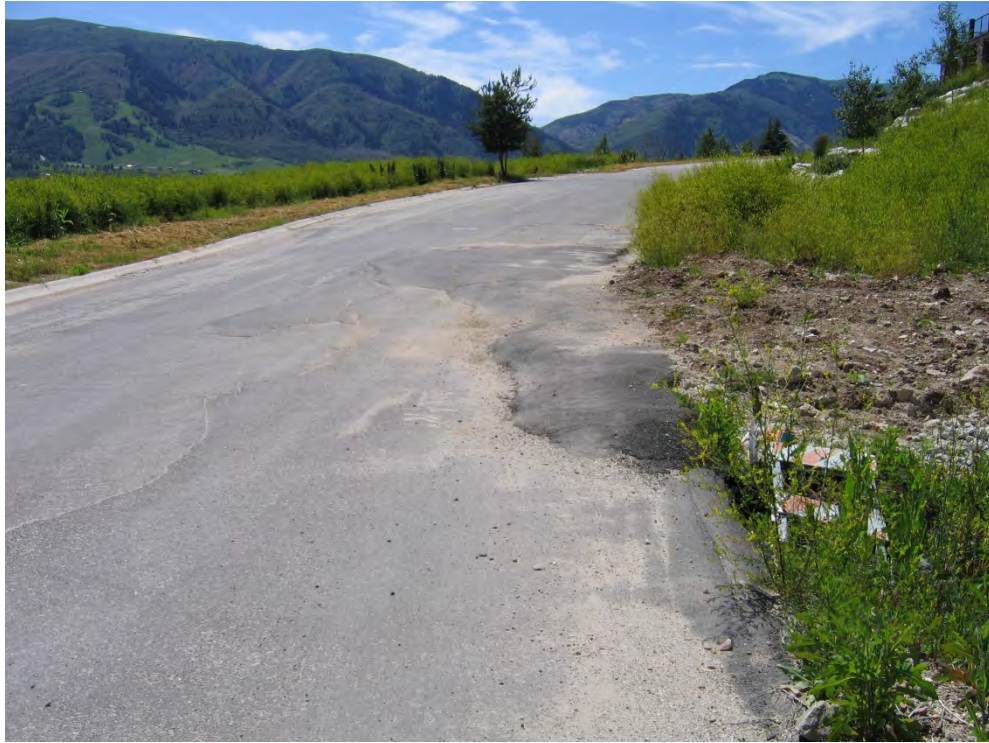
Photo 15. July 2009 UGS site visit. Toe bulge in Moose Hollow Drive.

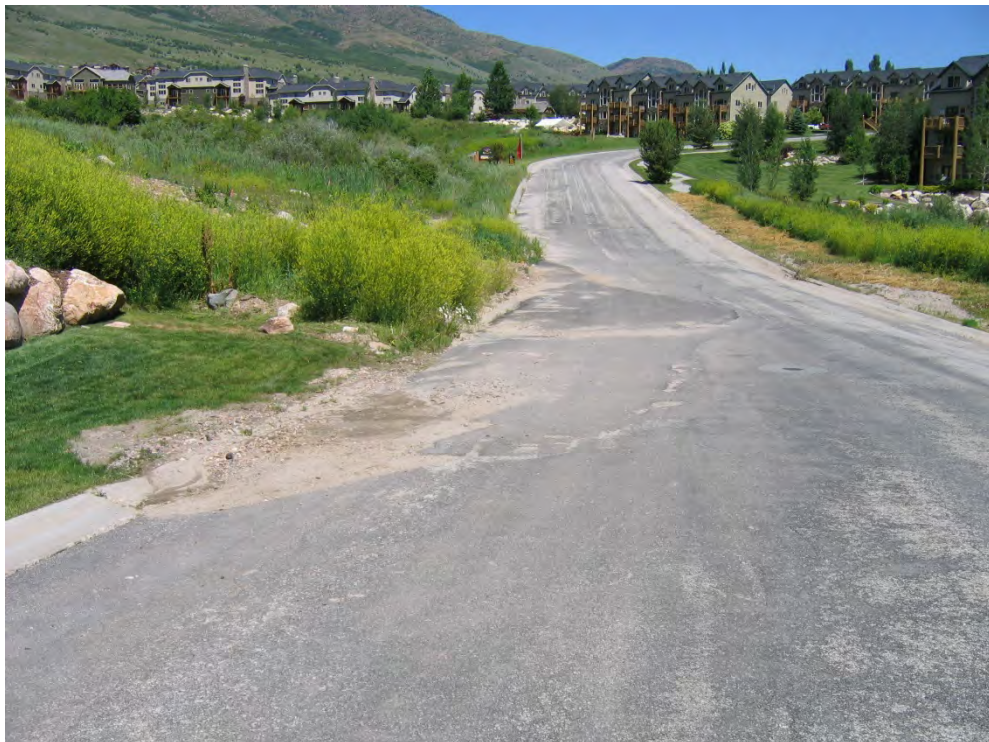
Photo 16. July 2009 UGS site visit. Obvious toe bulge in Moose Hollow Drive.

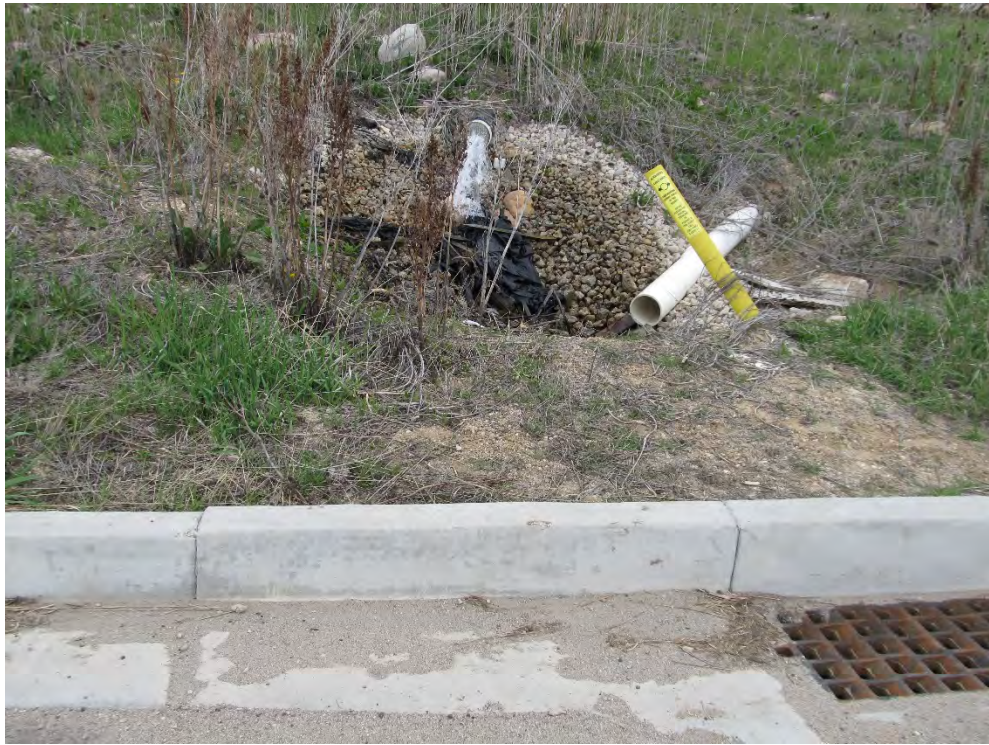
Photo 17. April 2014 UGS site visit. Drain and new curb and gutter.

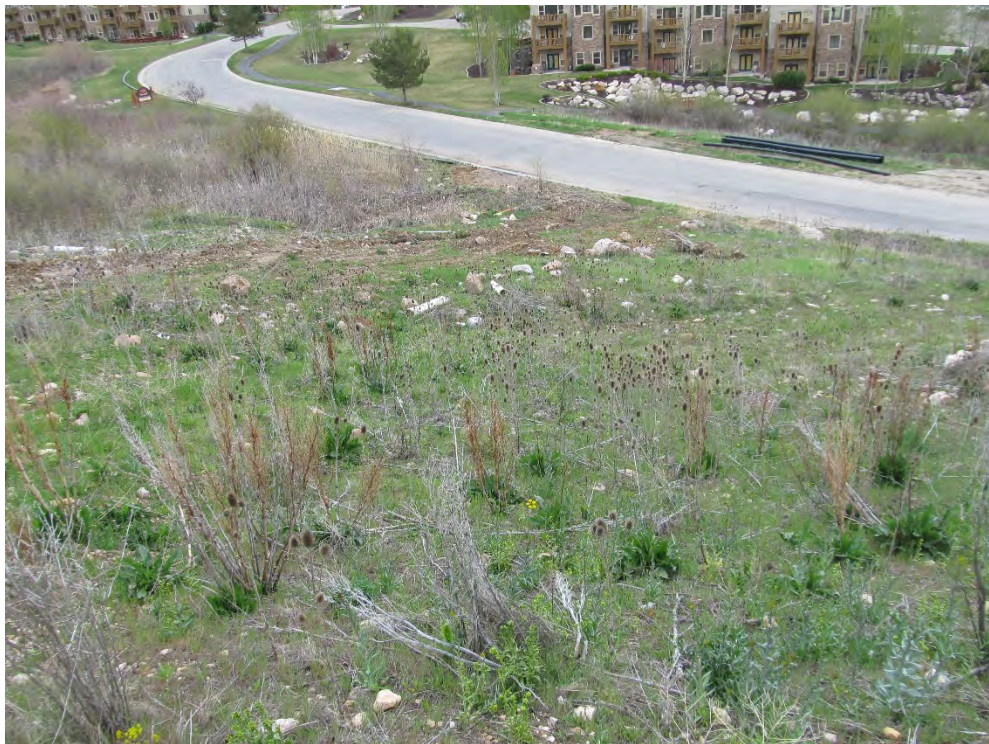
Photo 18. April 2014 UGS site visit. Overview of landslide.

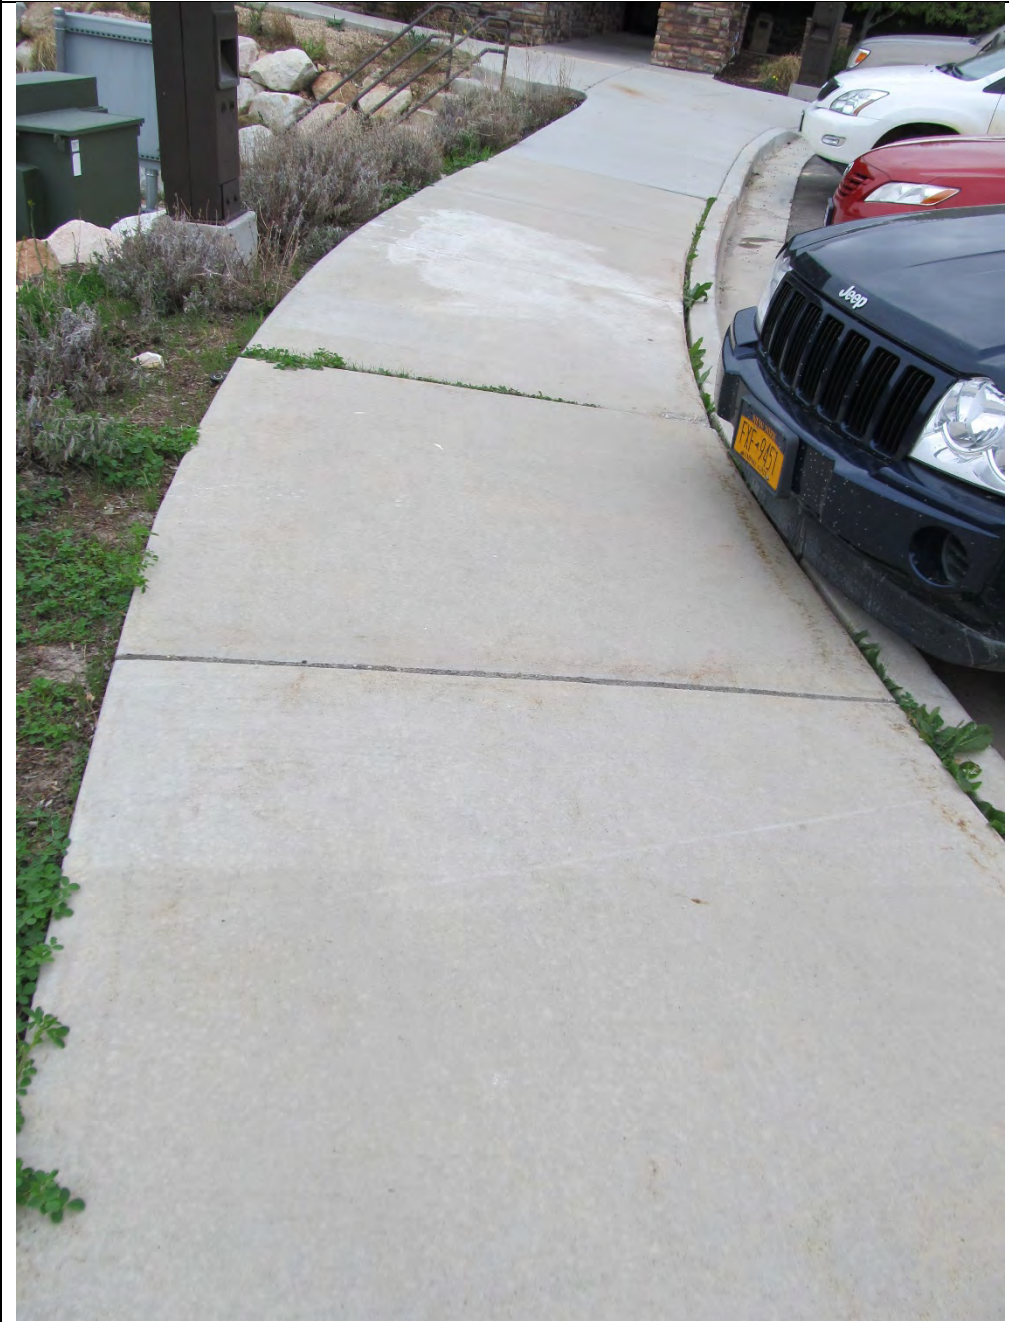
Photo 19. April 2014 UGS site visit. Back tilting in sidewalk at site.

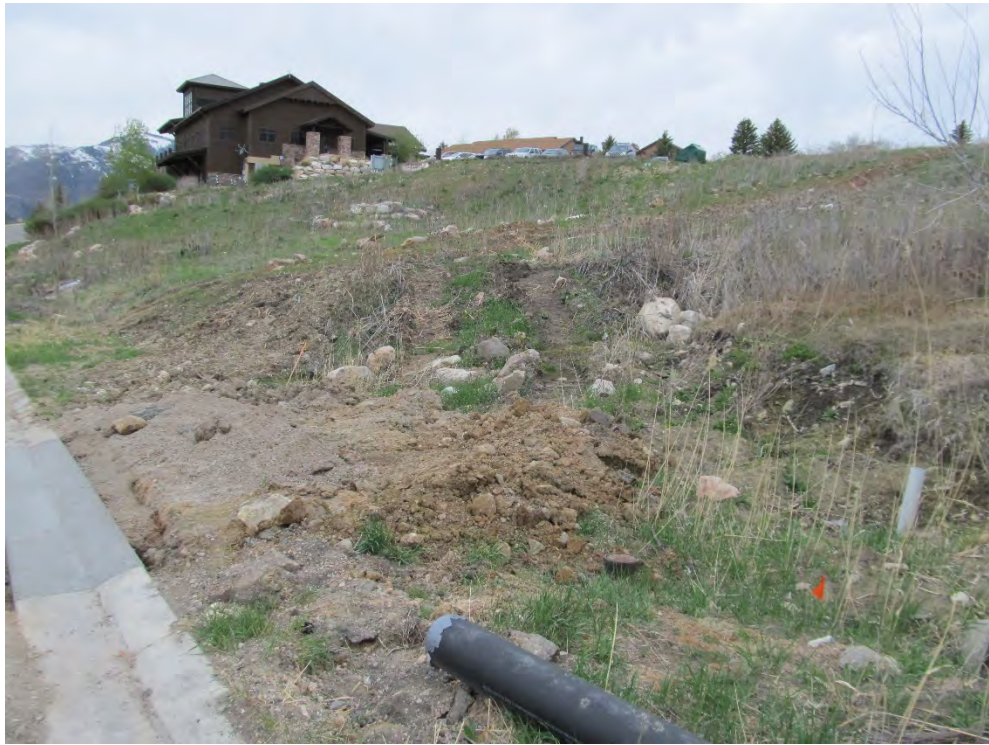
Photo 20. April 2014 UGS site visit. Seepage at toe below water tank.

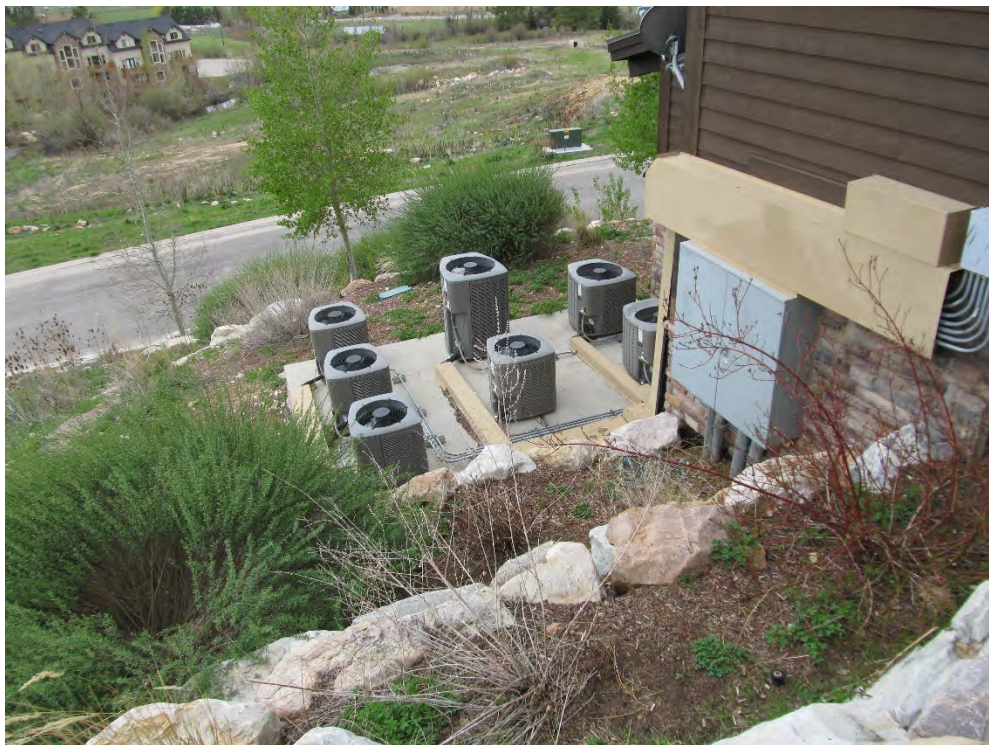
Photo 21. April 2014 UGS site visit. Repairs? to AC pad.

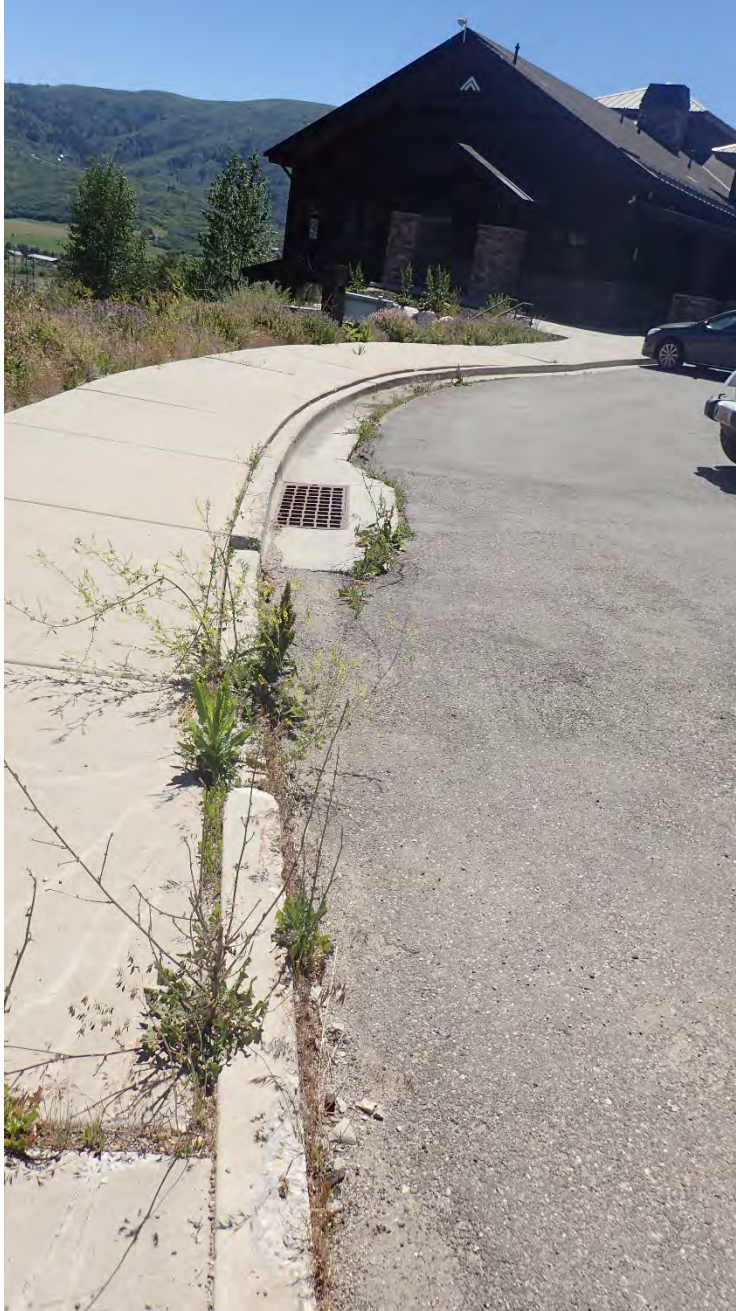
Photo 23. June 2018 UGS site visit. No new movement at site.
