GEOLOGIC HAZARDS REVIEW WELCOME CENTER SUBDIVISION LOT 1 3632 NORTH WOLF CREEK DRIVE EDEN, WEBER COUNTY, UTAH

September 29, 2020

SUBJECT: Geologic Hazards Review
Welcome Center Subdivision Lot 1
3632 North Wolf Creek Drive
Eden, Weber County, Utah

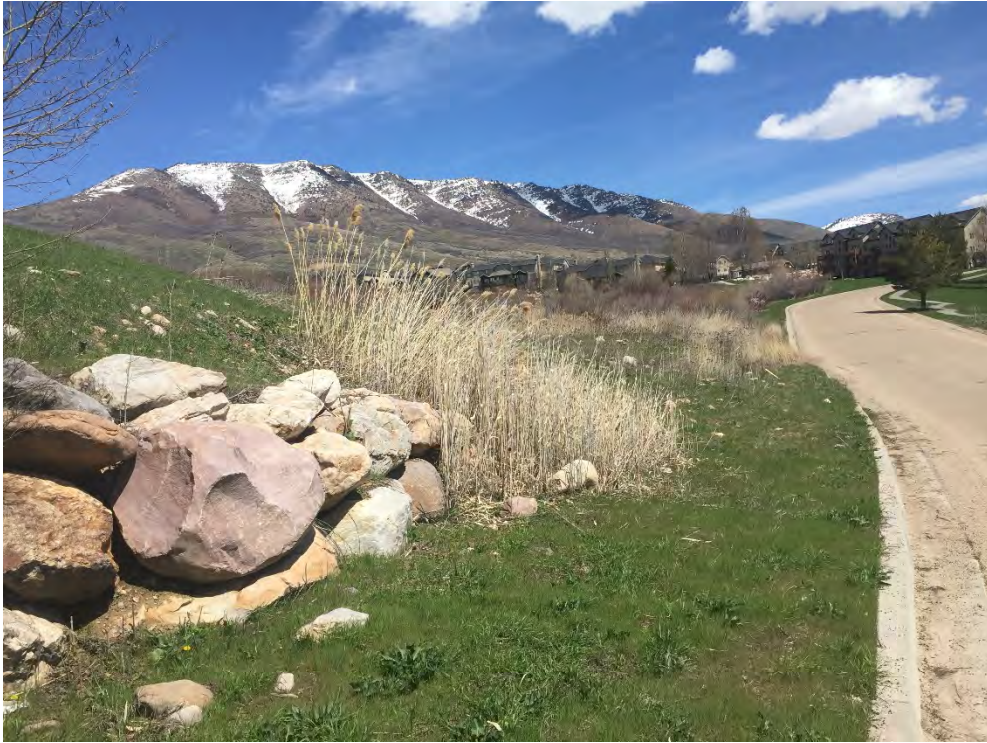
In August 2008, UGS geologists responded to additional movement of the 1999 landslide and documented evidence for damage to the parking lot at the Project (Appendix A – Photos 3 through 6), as well as to Moose Hollow Drive at the landslide toe (Photos 7 and 8). UGS geologists revisited the site in May 2009 and observed significant additional damage to the parking lot (Appendix A – Photos 9 through 12). In July 2009, UGS geologists observed settlement in the parking lot near the storm drain (Appendix A, Photo 13), a graded area and new drain below the water tank that was flowing substantially (Photo 14), and a significant toe bulge in Moose Hollow Drive (Photos 15 and 16). Curb and gutter had been installed at the toe by April 2014 (Appendix A – Photo 17). In April 2014, UGS geologists also observed backtilting in the sidewalk along the south edge of the parking lot (Appendix A - Photo 19) and damage to the pad for the air conditioning (AC) units southeast of the building (Photo 21). UGS geologists revisited the site three times again in June 2015, June 2018, and April 2019, but noted no indications for new movement or damage (Appendix A – Photos 22 through 26).

Photo 24. April 2019 UGS site visit. No new movement observed.

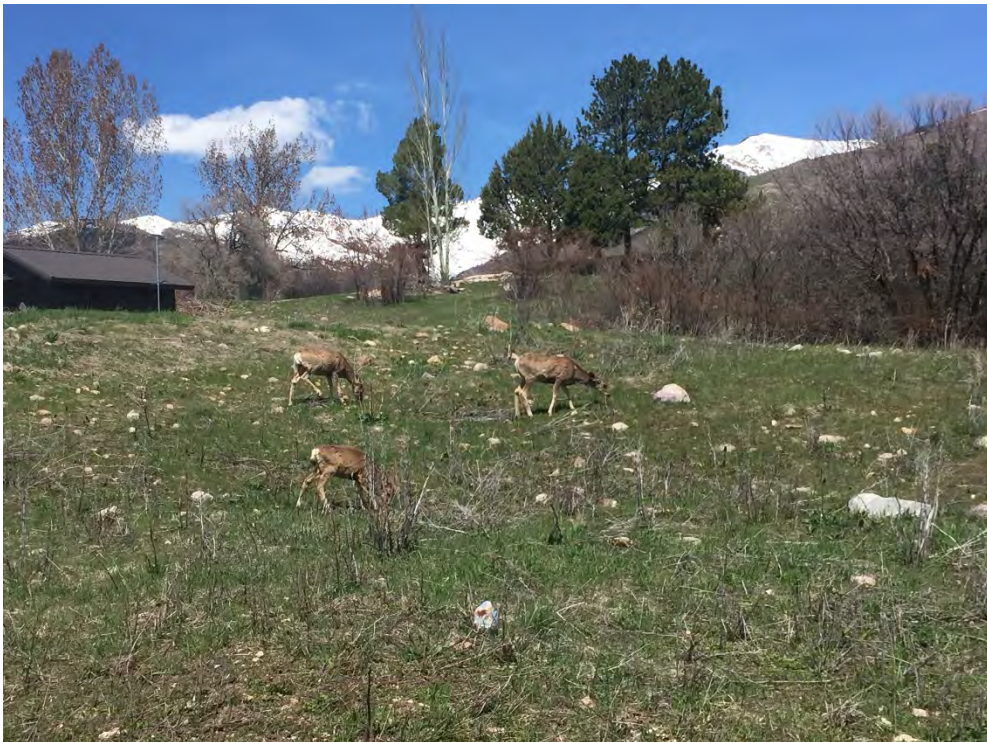
Photo 25. April 2019 UGS site visit. No new movement observed.

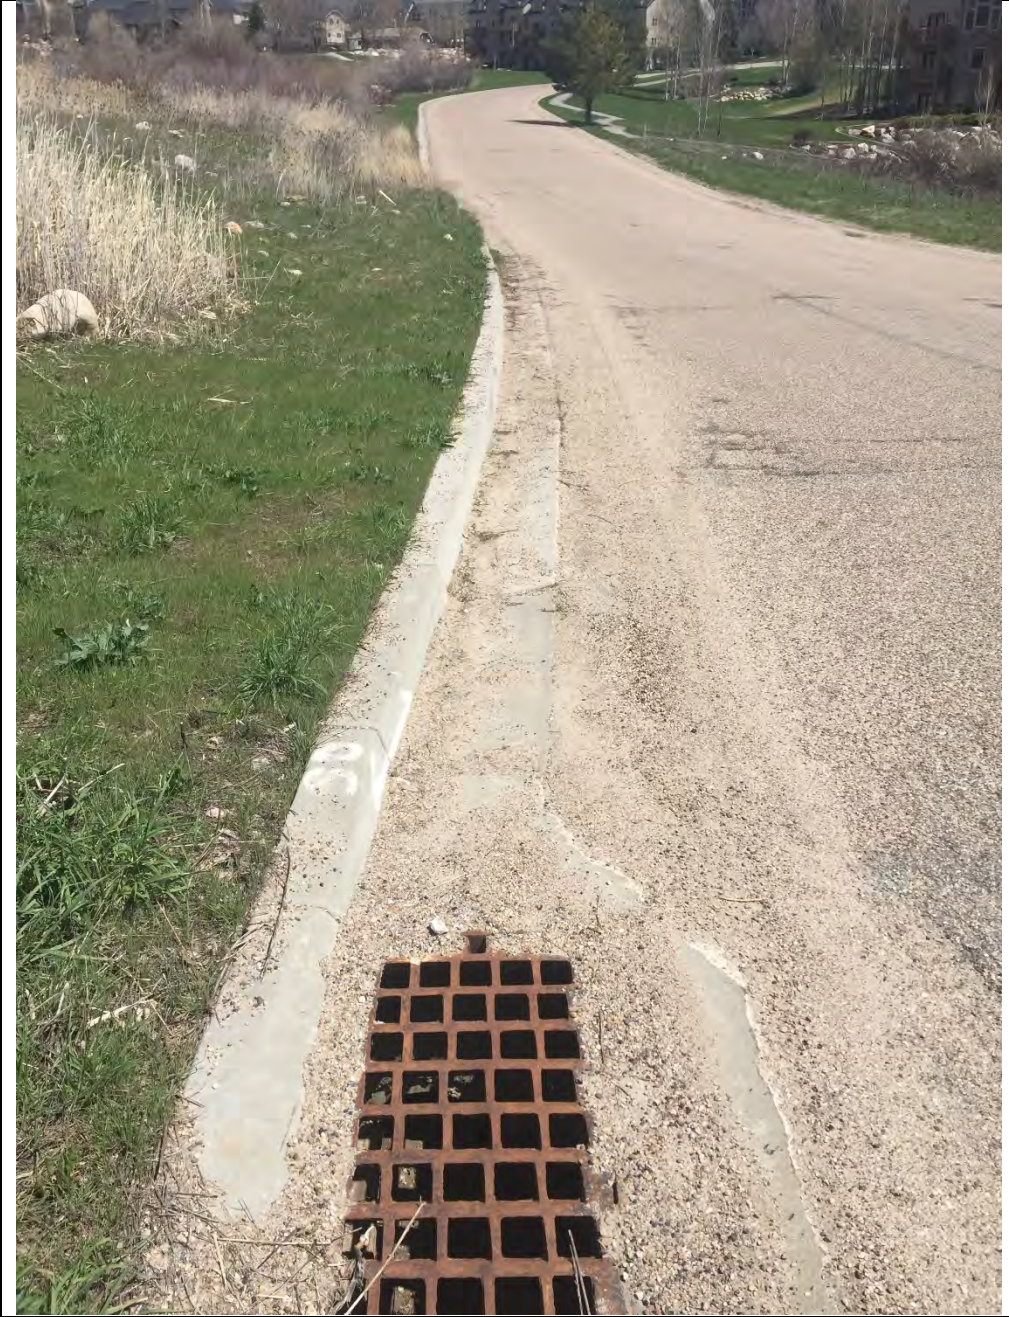
Photo 26. April 2019 UGS site visit. No new movement observed.

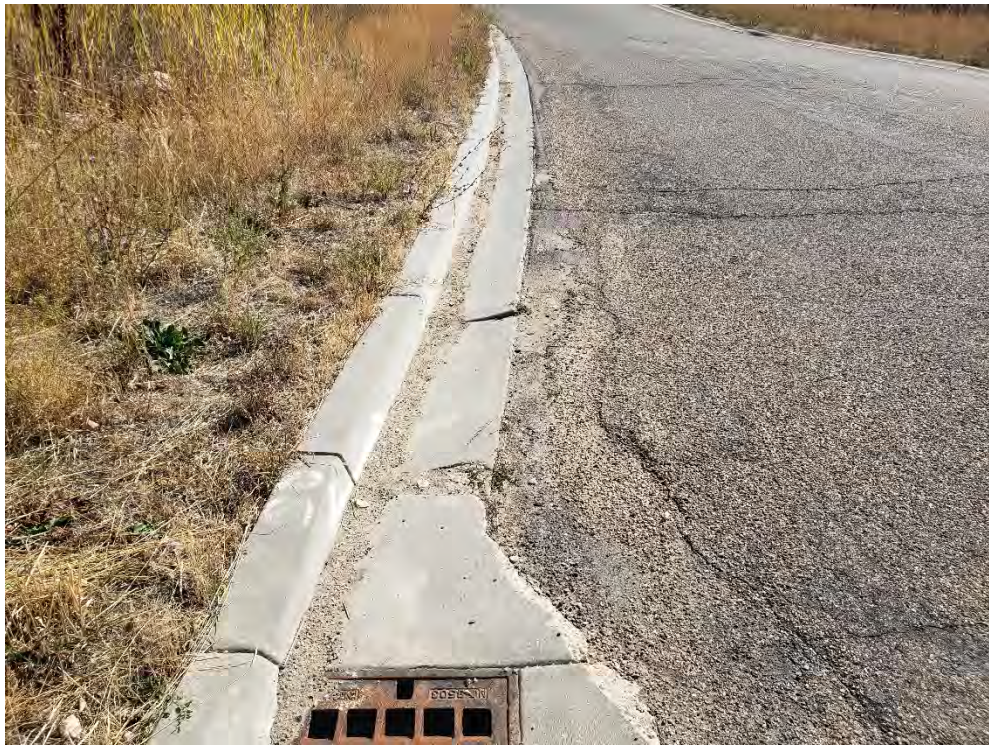
No evidence for new movement was noted in Moose Hollow Drive at the toe of the landslide (Photo 27) compared to 2019, and the parking lot pavement appeared to have been repaired since 2012 (Photo 28). Some evidence for either slope instability or settlement was observed at the property during our reconnaissance, but we are uncertain if this evidence was previously present or occurred after the last UGS visit in April 2019. Appendix A – Photo 29 shows displacement in the pad for the transformer; Photo 30 shows a pull-apart gap between the sidewalk and curbing adjacent to the parking lot; Photo 31 shows a cracked support beam for the roof overhang at the entrance, which is likely from shearing/tilting (about 1-2 inches of lateral displacement is shown in the unpainted area); Photos 32 and 33 show a pull-apart gap between the AC pad and building, and a lateral displacement in the pad; Photo 34 shows slight differential settlement in the sidewalk near the building entrance; Photo 35 shows tilting in a concrete patio and minor rock veneer spalling in a support column on the west side of the building; and Photo 36 shows a gap beneath the concrete patio and underlying soils, which may be from downward slope movement or washout erosion beneath the pad.

Photo 27. Toe area. No new movement compared to Photo 26.

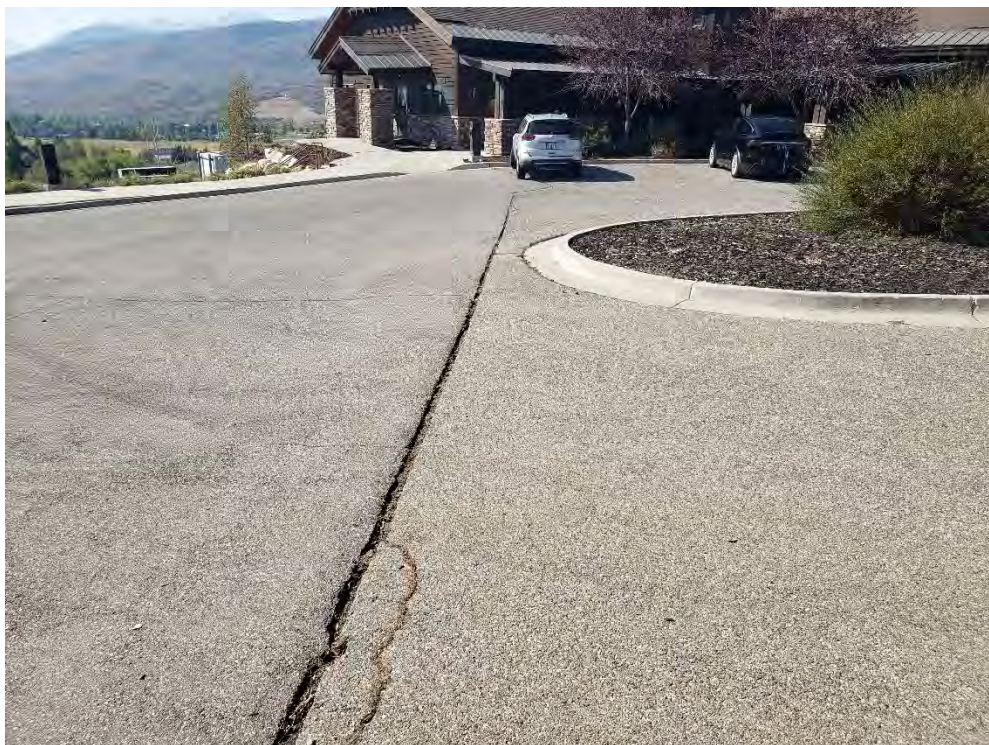
Photo 28. Saw cut pavement repair.

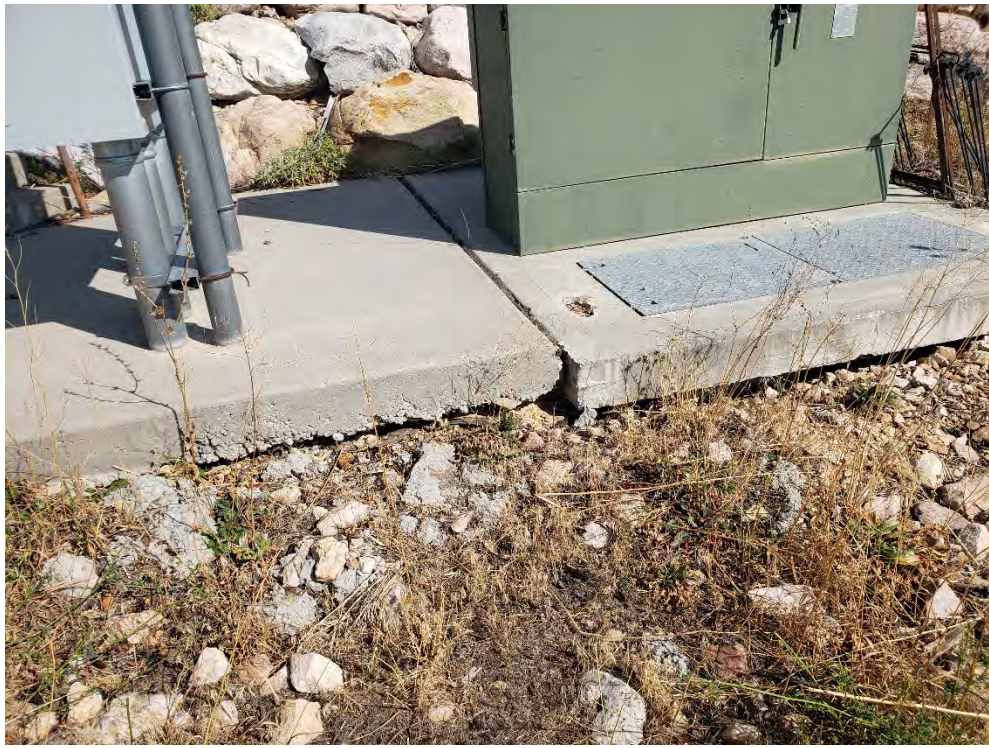
Photo 29. Displacement in transformer pad.

- **Structural Engineering Inspection** – A structural engineer should inspect interior and exterior areas of the building for evidence of damage from slope instability or settlement. Any damage noted by the structural engineer should be repaired prior to property transfer.

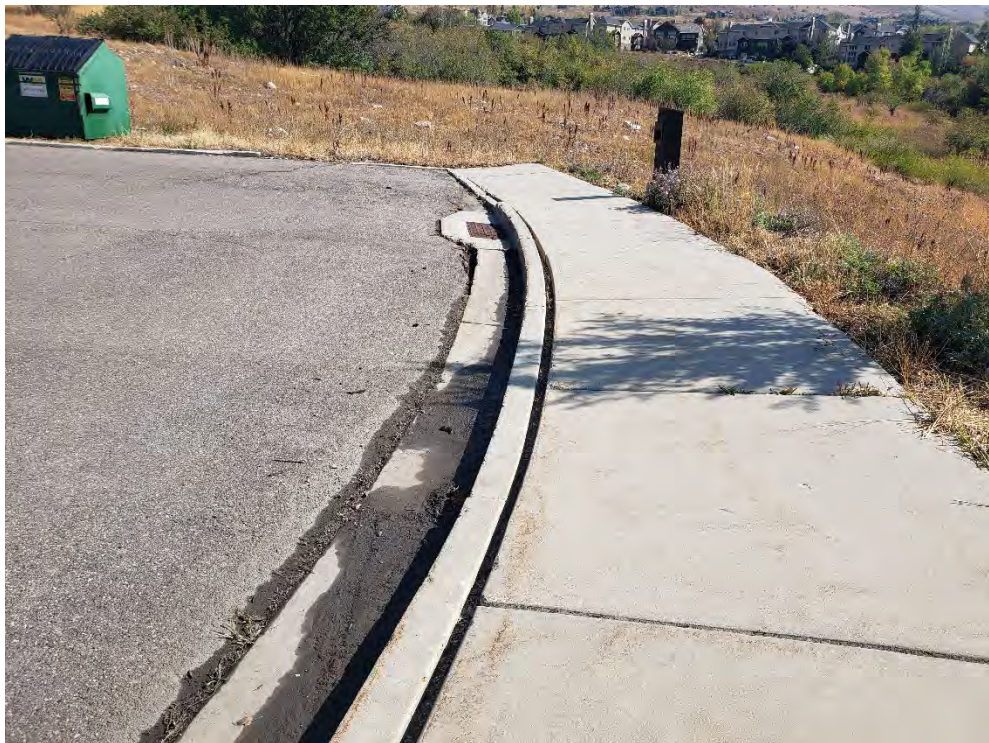
Photo 30. Pull apart between curbing and sidewalk. Compare to Photo 19.

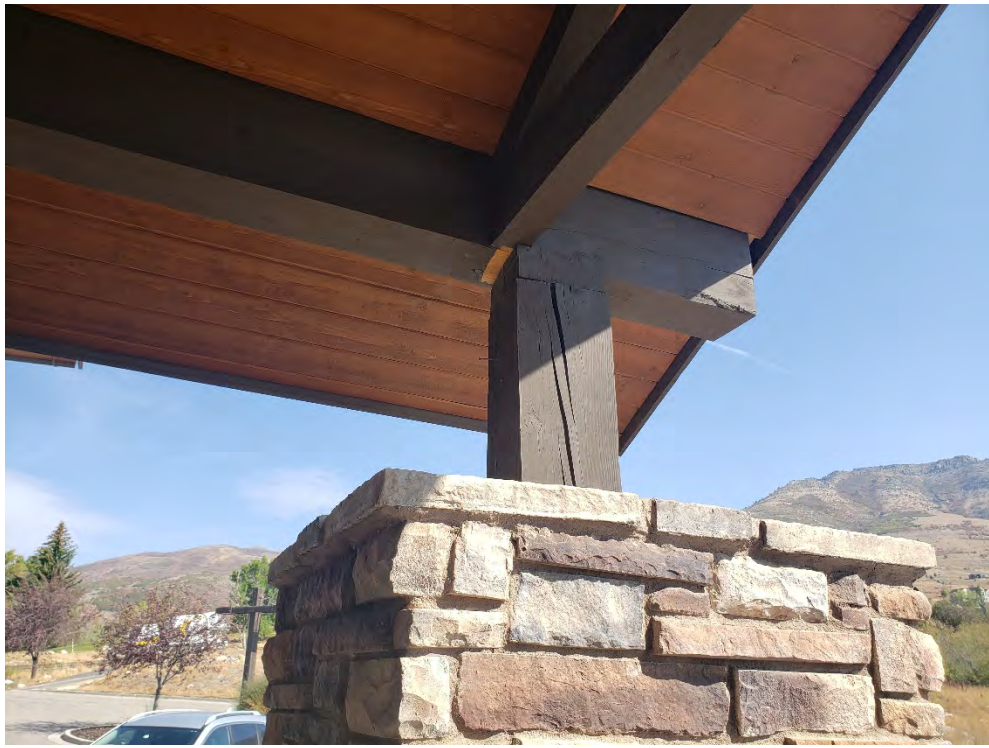
Photo 31. Cracked and displaced roof support.

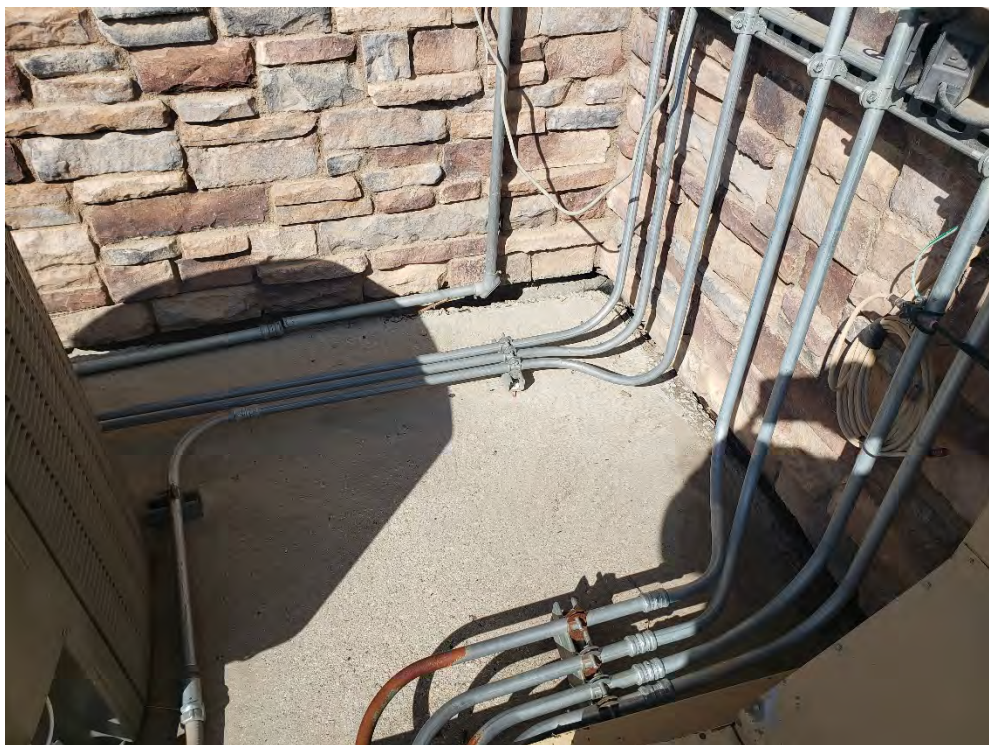
Photo 32. Pull apart between AC pad and building.

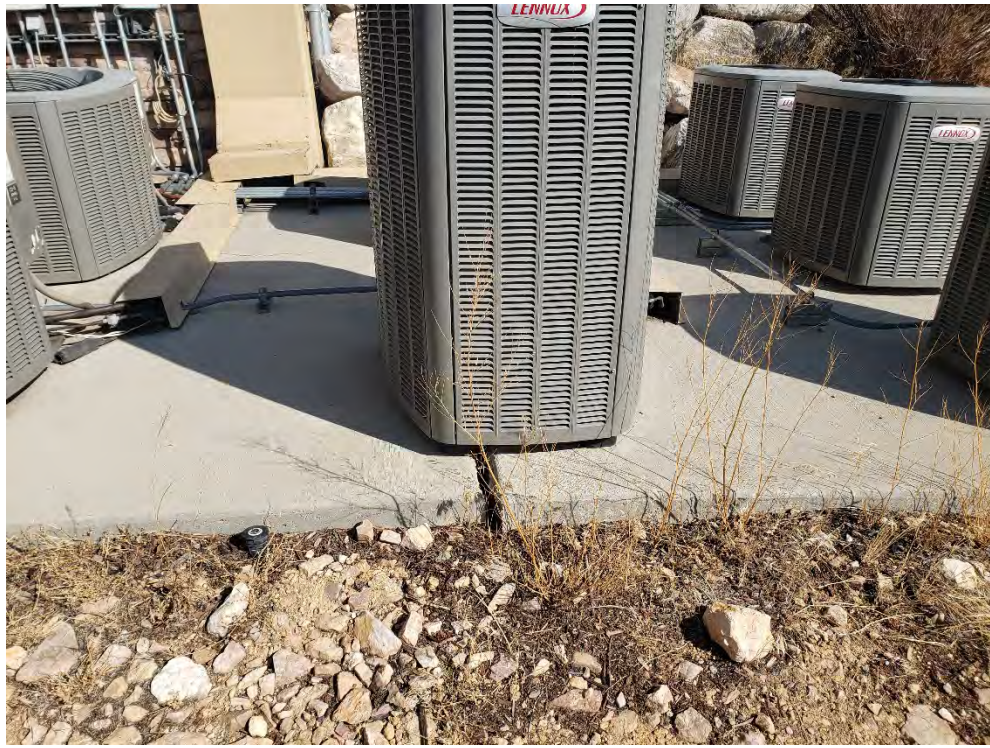
Photo 33. Displacement in AC pad.

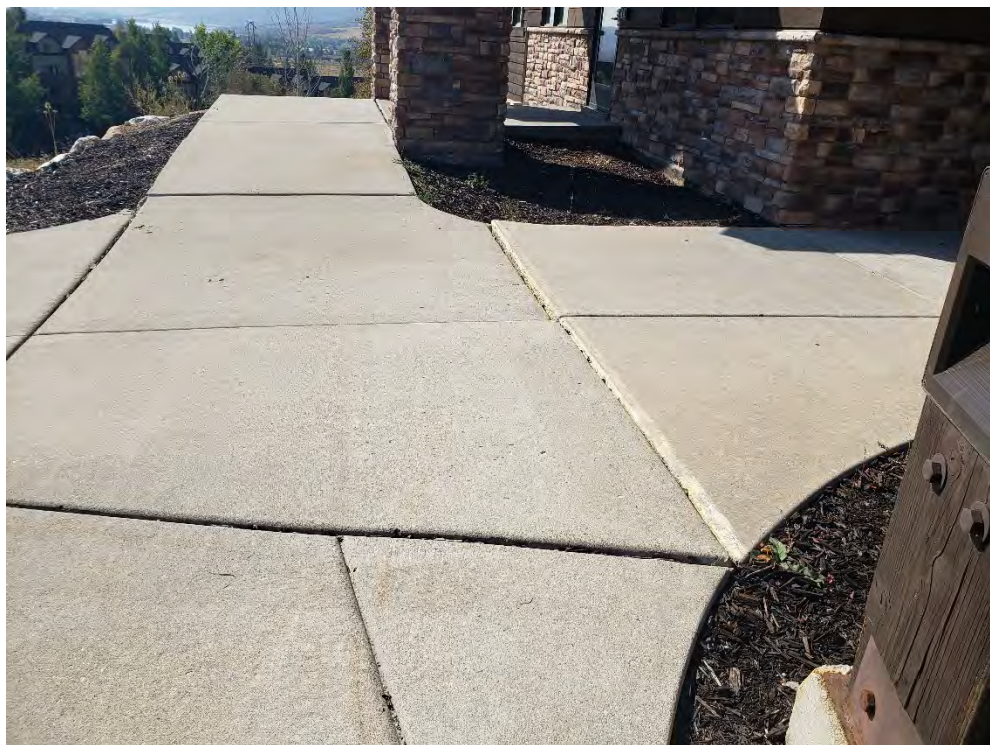
Photo 34. Settlement in sidewalk near entrance, but no concrete cracking.

- **Roof Downspout Discharge** – The roof downspouts should discharge at least 10 feet away from the building, as recommended by Y2 Geotechnical, to minimize water beneath the building and in disturbed subsurface areas around the building.

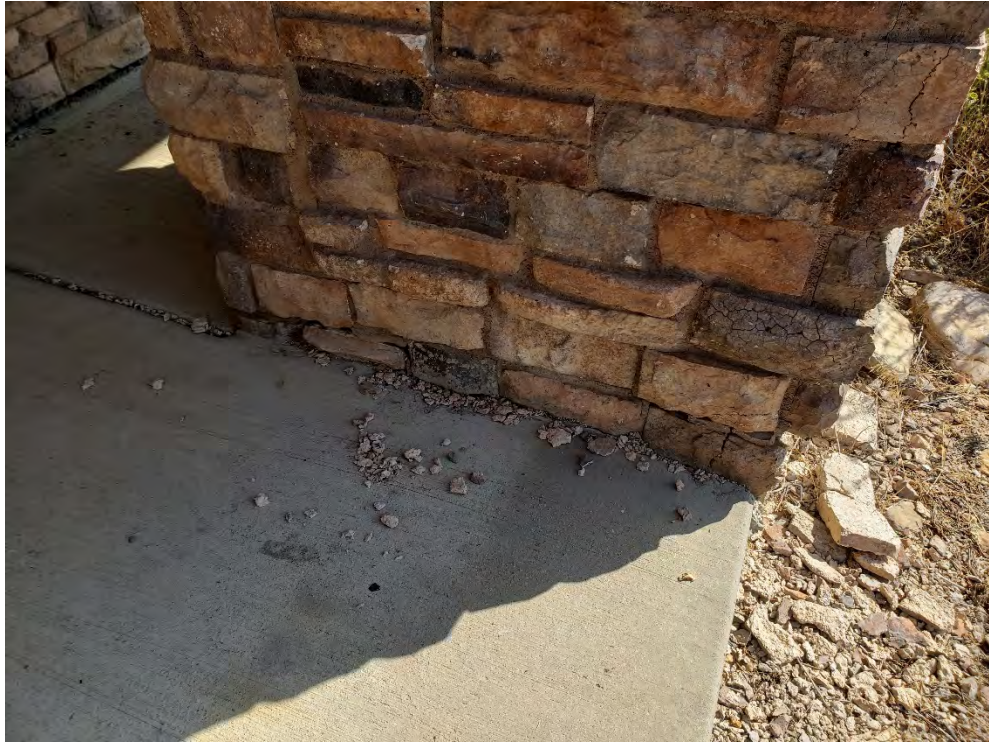
Photo 35. Settlement (tilting) in concrete pad on west side of building.

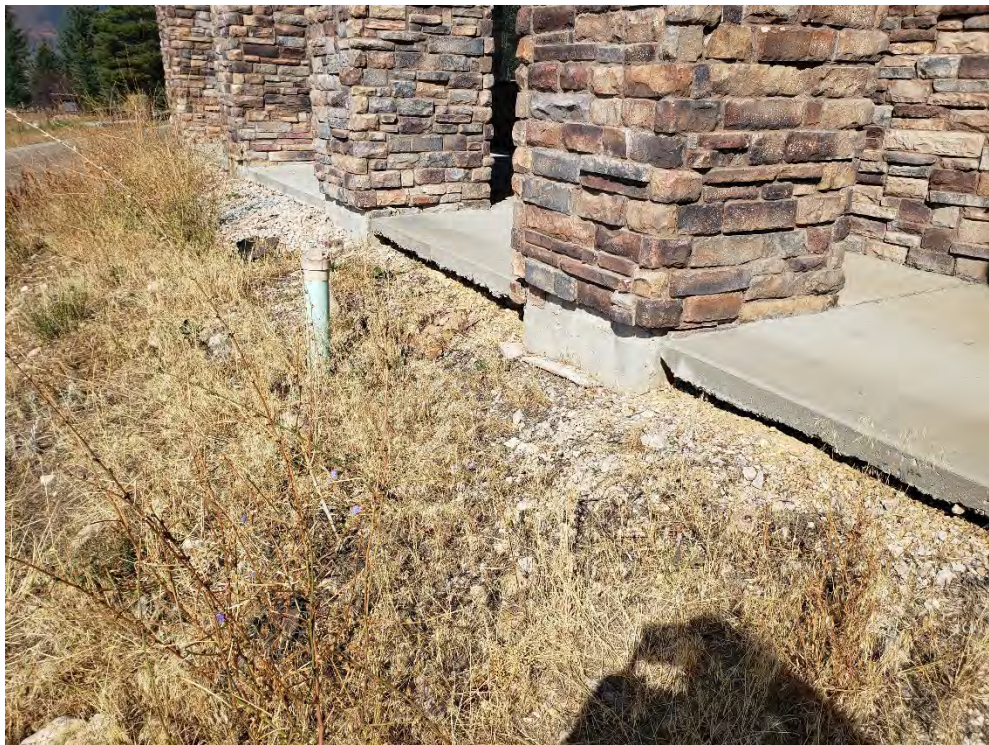
Photo 36. Gap beneath concrete pad on west side of building.
