March 4, 2021

Subject: Reconnaissance-level Geologic-hazards Study
Proposed Gateway Estates Subdivision
Approximately 10700 East Highway 39
Huntsville, Utah
Project No. 1210067

This letter presents the results of a reconnaissance-level geologic-hazards study for the proposed Gateway Estates subdivision at approximately 10700 East Highway 39 in Huntsville, Utah.

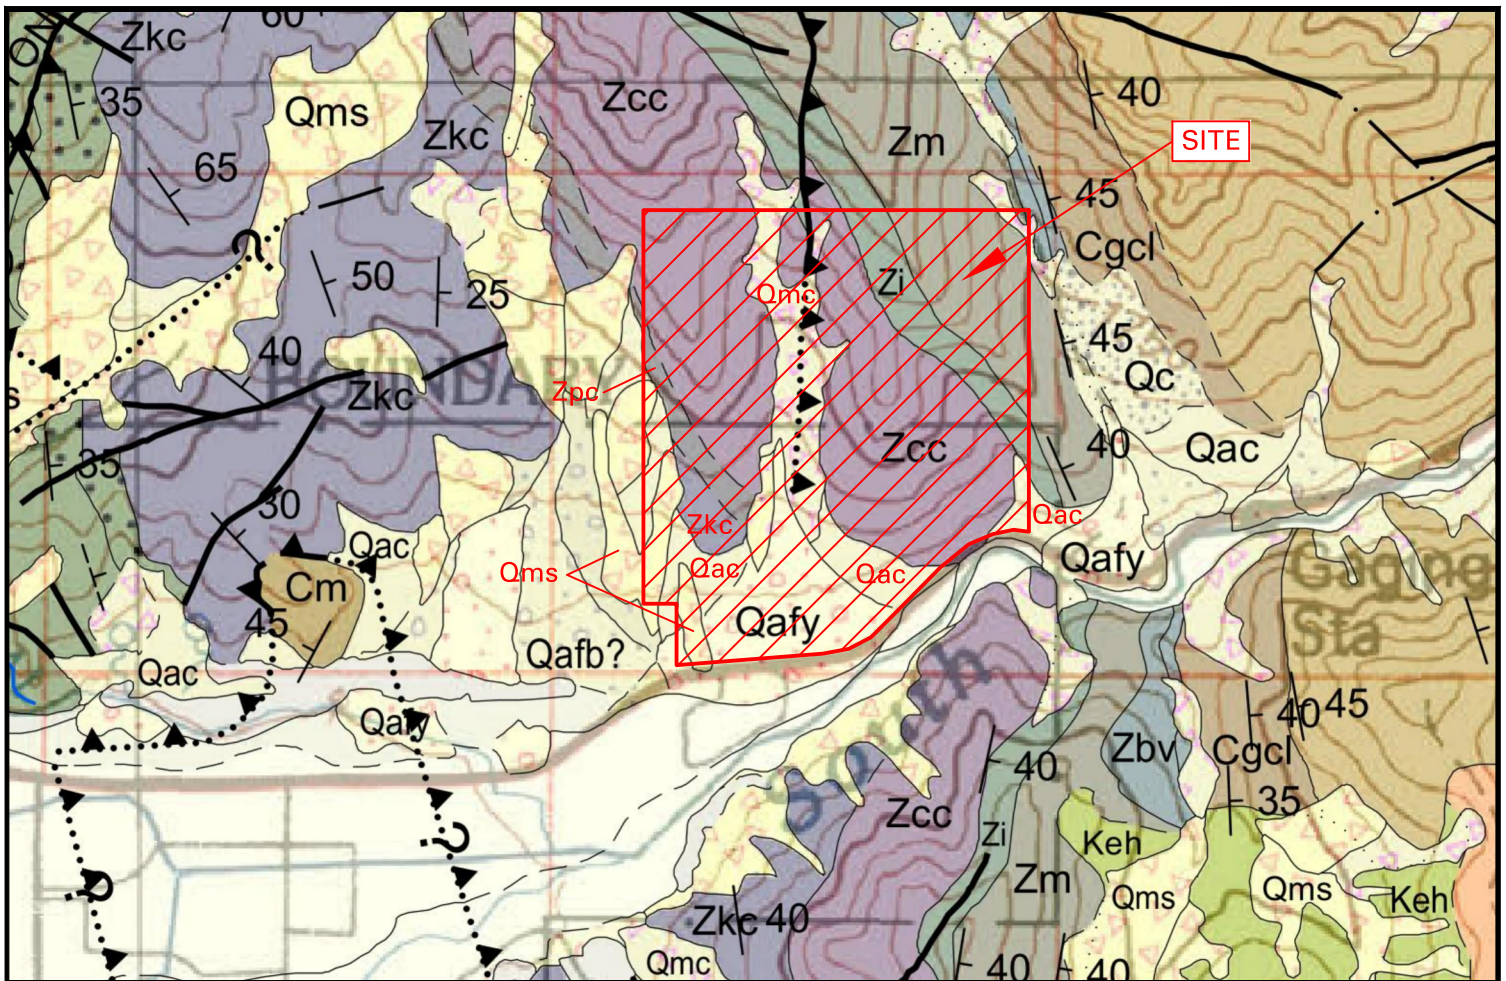
Bedrock is exposed through most of the steep parts of the site. The bedrock is mapped by Coogan and King (2016) to consist of Neoproterozoic metamorphic rocks classified as quartzites, meta-sandstone and argillites with dip down to the east-northeast at approximately 40 degrees (See Figure 1). The surface deposits in drainages consist of alluvium with colluvial deposits along the margin of drainages. There are landslide deposits mapped for the southwest corner of the property. The landslide map of Elliott and Harty (2010) shows no additional landslides for the property. The landslides appear to have relative shallow-depth slide planes and may be associated with springs in the area.

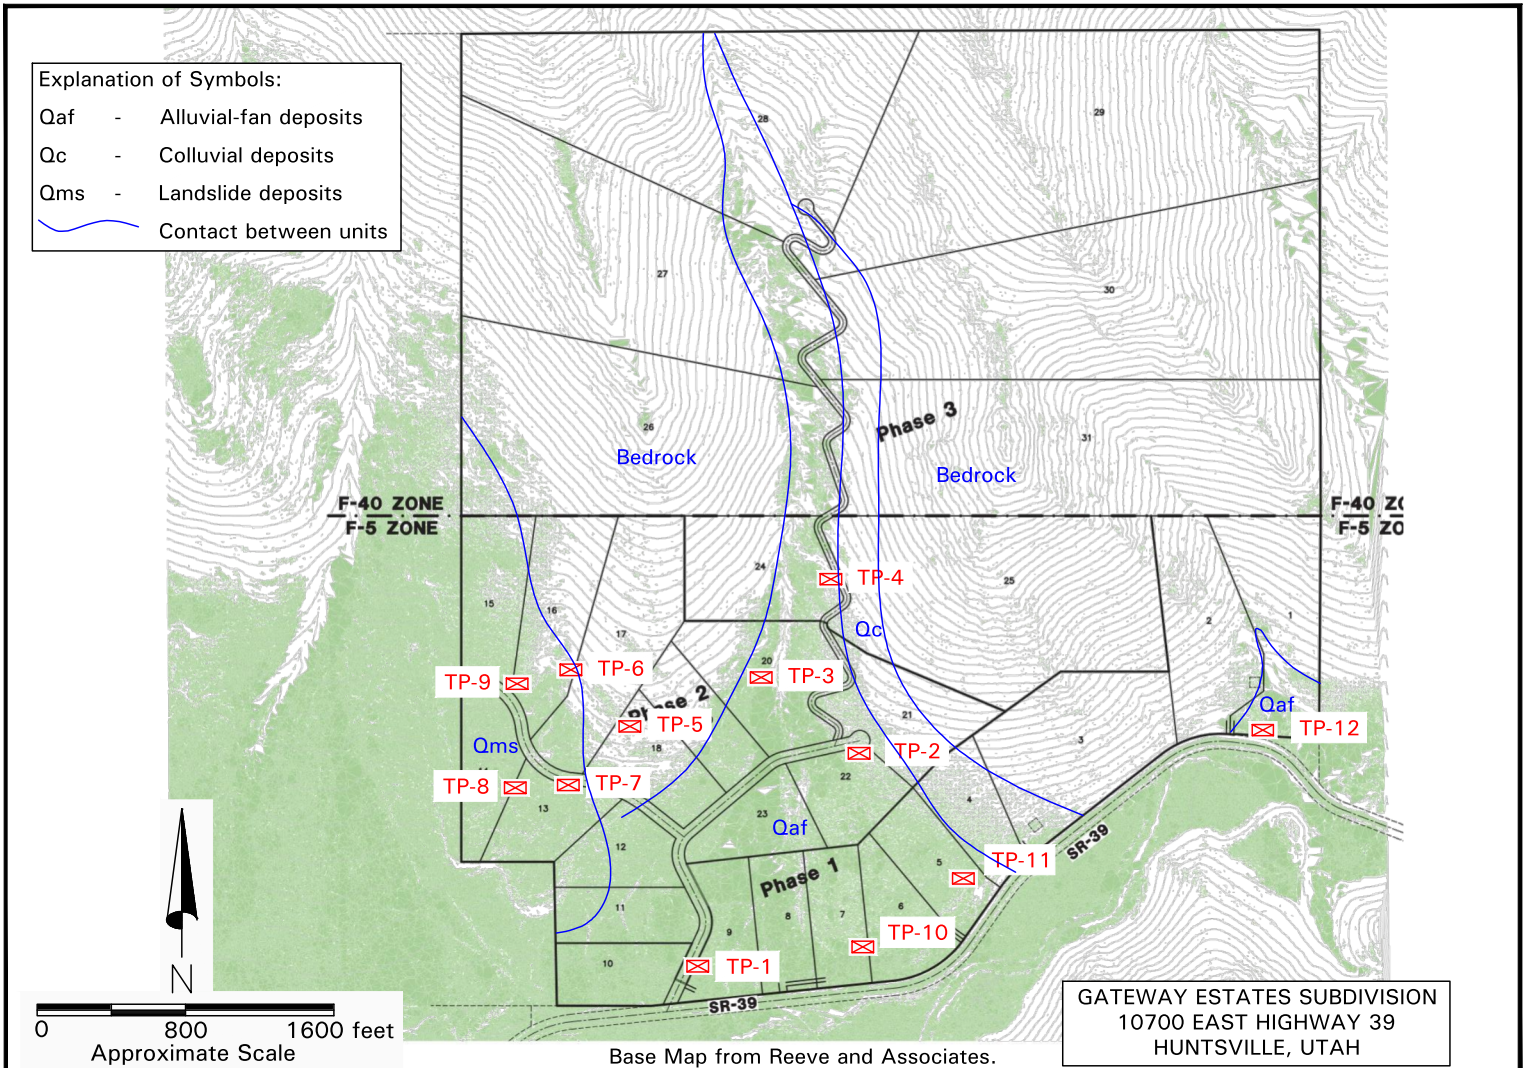
Based on review of the aerial photographs and lidar data, the landslide deposits are mapped on Figure 2.

A site visit was made on February 10, 2021 by a geologist from AGECE. The site was snow covered and thus evidence of geologic hazards could be obscured by the snow cover. There is surface evidence of the landslides mapped on Figure 2 and potential evidence that rockfall could be a hazard for development below bedrock outcrops above or on Lots 1, 2, 3, 4, 21, 25, 28, 29, 30 and 31. Rockfall should be evaluated for these lots once the snow has melted.

Landslide is a potential hazard for development of the area mapped as landslide deposits on Figure 2. Additional subsurface investigation and stability analysis is recommended for lots planned to be developed in this area. Slope stability could also be a concern where slopes are steepened and should be evaluated for individual residences planned to be constructed. Rockfall is a potential hazard for the lots indicated above and should be further evaluated. It is our professional opinion that debris flow, surface fault rupture, tectonic subsidence and liquefaction are not significant hazards at the site.
