September 12, 2016

IGES Project No. 02348-001

Subject: Geologic Hazards Assessment
The Ridge Subdivision Phases 3, 4, and 5
Eden, Utah

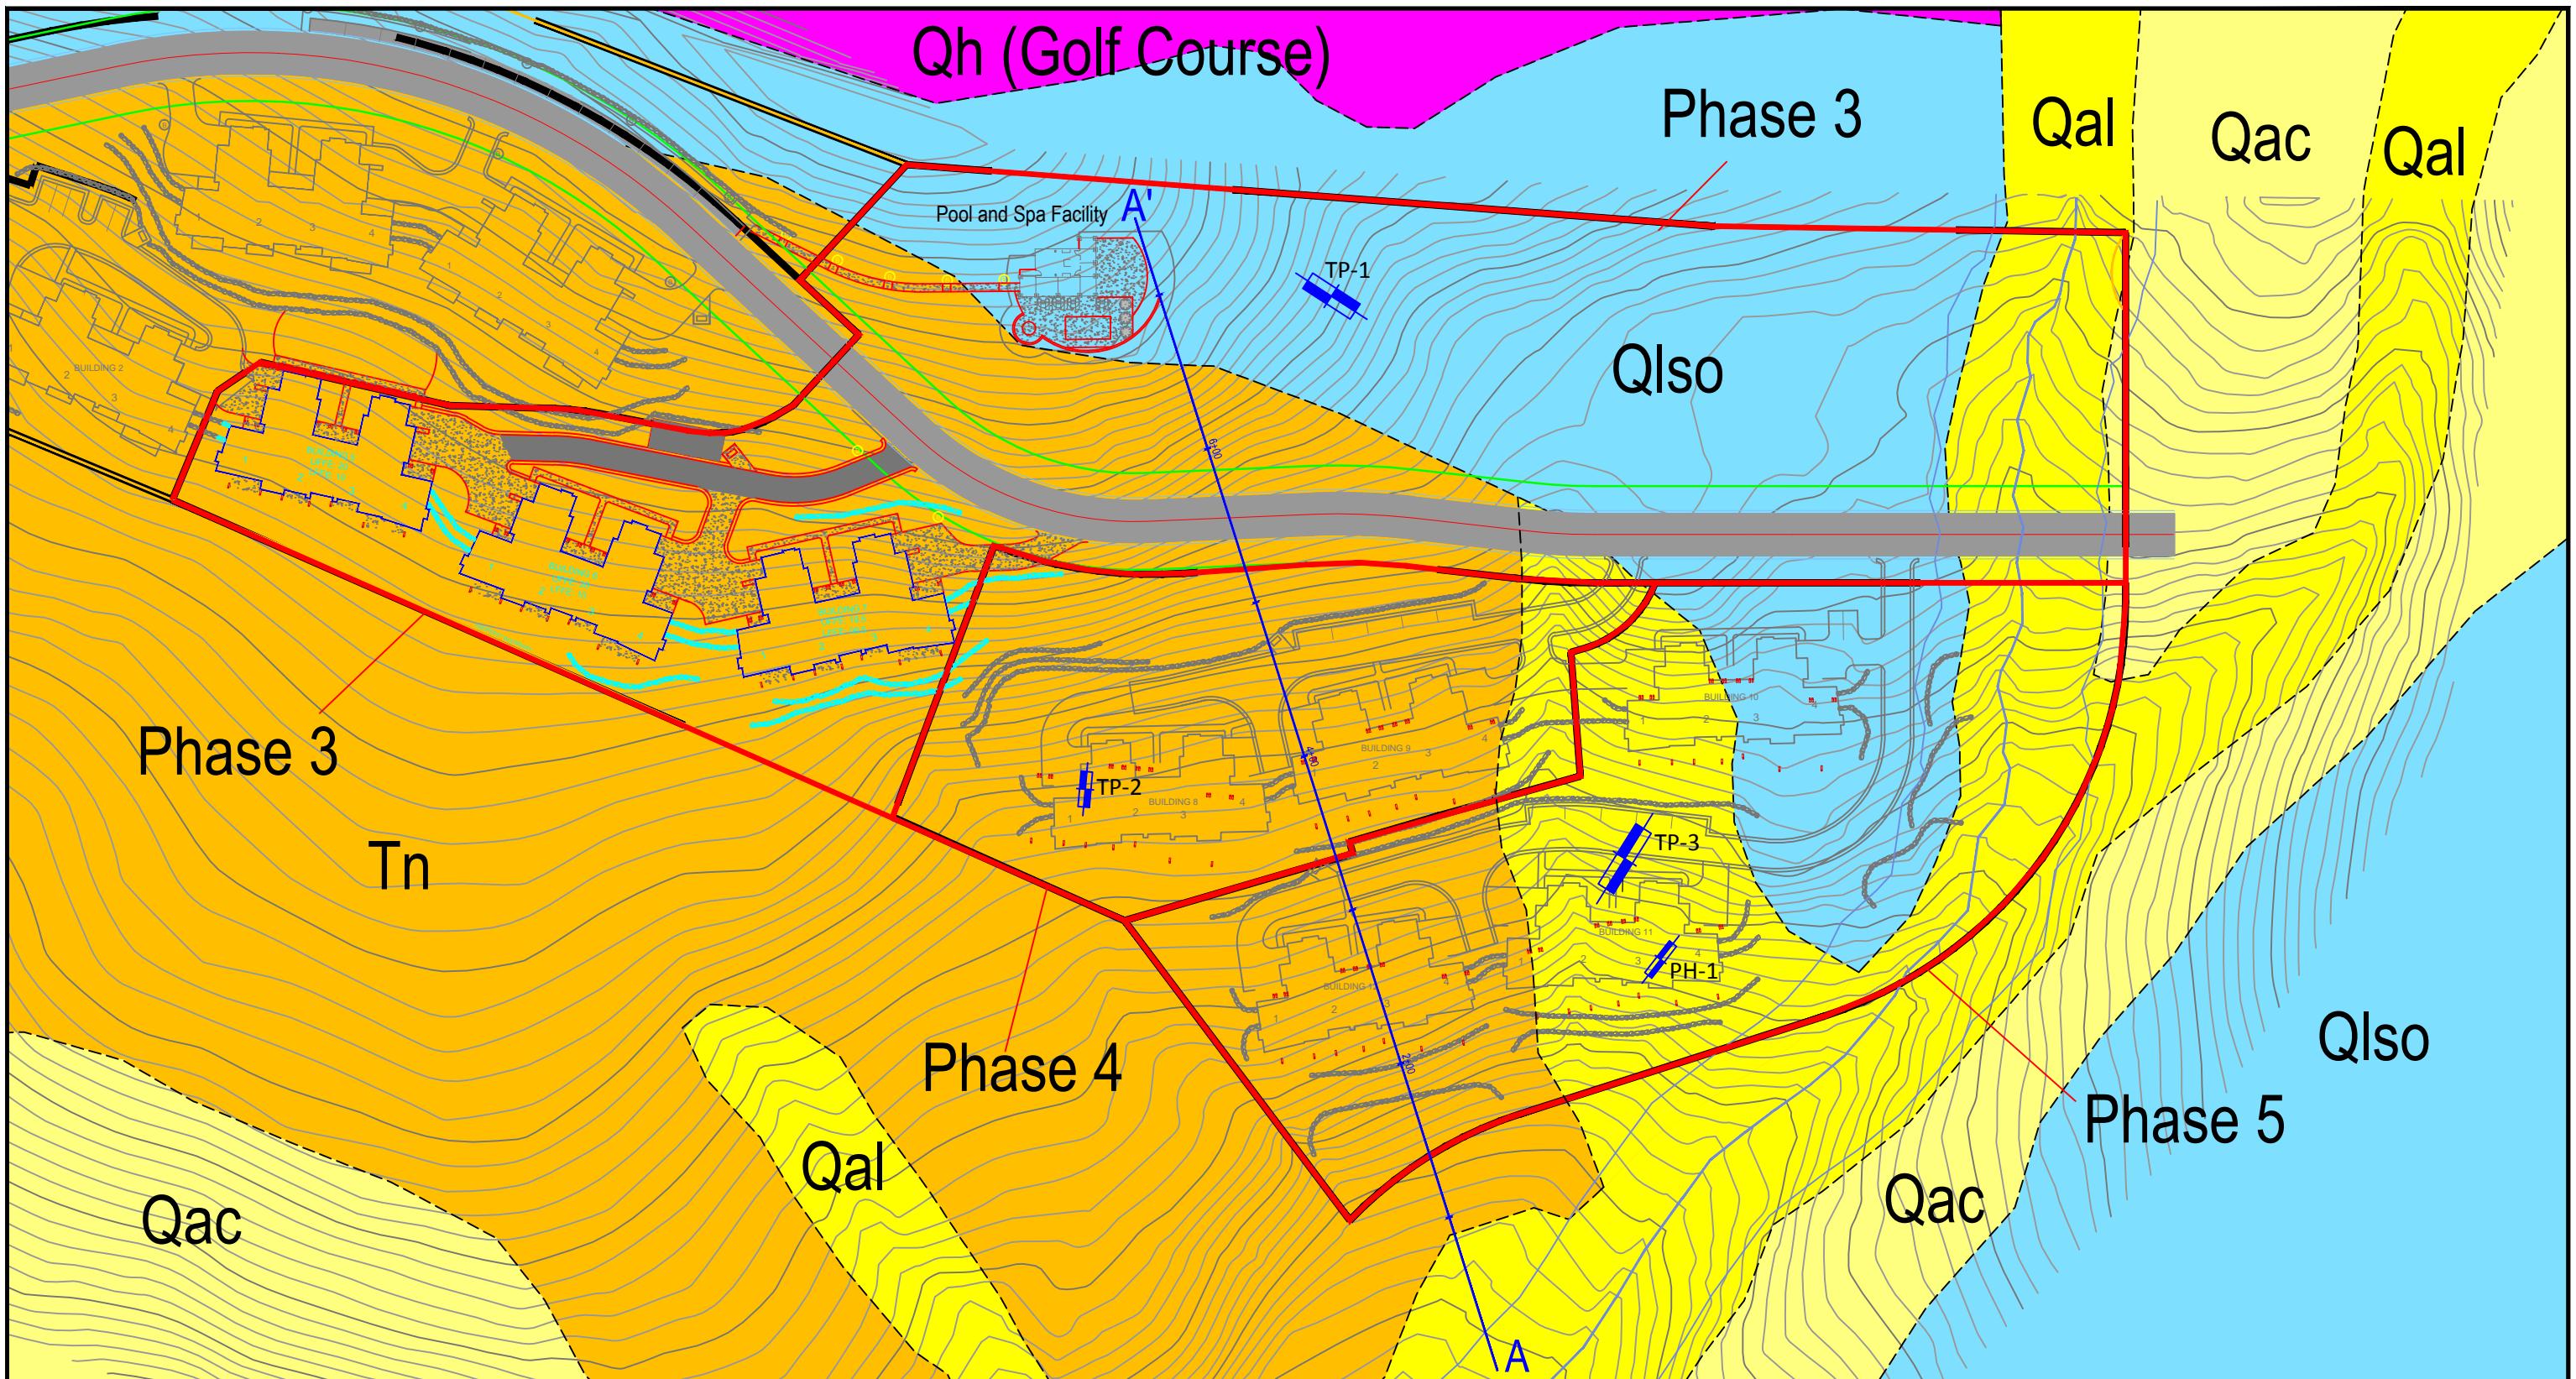
FIGURE A-4

The subsurface investigation, however, showed the landslide deposits to be limited to the northern part of the Phase 3 area and the northeastern part of the Phase 5 area (see Figure A-4). Of the four subsurface excavations, explicit landslide evidence was only observed in TP-1 in the form of irregular, chaotic bedding and multiple slide planes exhibiting slickensides. The landslide deposits were estimated to be Pleistocene-aged due to the presence of a rounded morphology and well-developed topsoil (up to 3 feet thick). However, there may be smaller areas within the mapped landslide lobe where more recent movement has taken place, evidenced by topsoil as thin as 3 inches in some places along the road cut.

Our slope stability analysis indicates that areas outside of the mapped landslide areas (designated as Q_{LSO} on Figure A-4) meet the minimum acceptable factors-of-safety of 1.5 (static) and 1.0 (seismic or pseudo-static). It should be noted that our model only took into consideration the existing grade and not proposed topography (e.g., the finish grade after the townhomes are built). The results of the stability analyses are presented in Appendix C.

- Debris-flow and flooding hazards are considered to be moderate for all areas mapped as Qal and Qac on Figure A-4. The only affected proposed structures with regard to the debris-flow and flooding hazards are the two easternmost 4-Plex units in the Phase 5 area. The debris-flow and flooding hazard is considered to be low for all other proposed structures for the property.

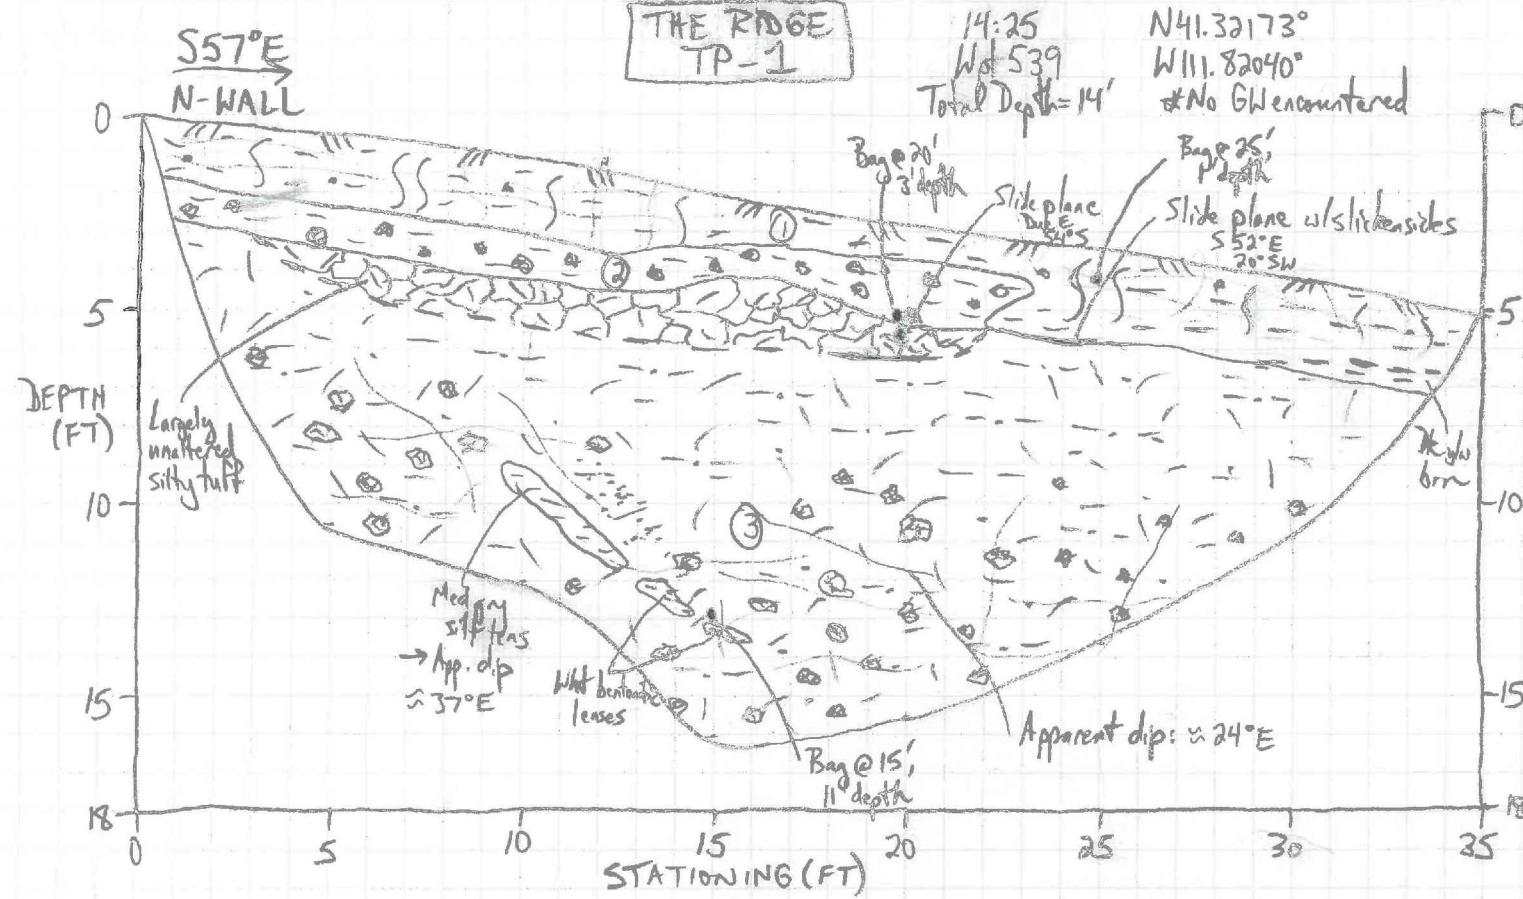
1. A/B Soil Horizon: ~1-3' thick; brownish black (5YR 2/1) fat CLAY, very stiff, slightly moist, moderate to high plasticity, massive, though blocky appearance due to abundant desiccation cracks; very similar to A/B horizon seen in TP-3, except slightly moist and therefore does not exhibit as large, wide, and prevalent desiccation cracks as seen in other test pits; surrounded quartzite clasts up to 2" diameter; abundant plant and tree roots, especially uppermost ~6"; irregular, sharp basal contact exhibits slickensides in places.

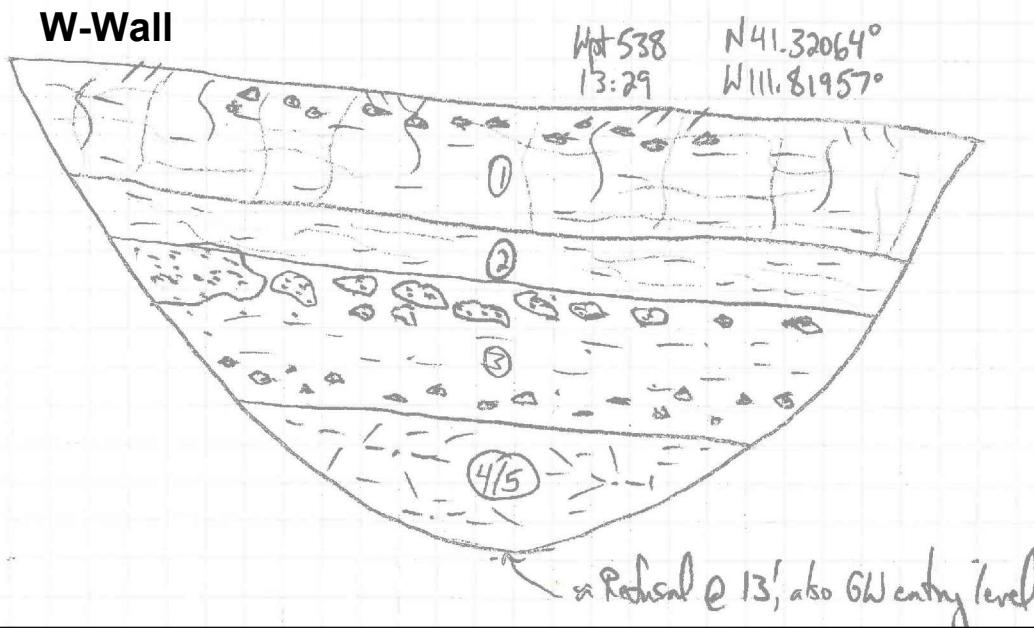
PH-1

- Located ~60' E of TP-1, in an attempt to hit bedrock
- GW present @ 13', water ~3" deep
- Pothole TD = 13', ~25' long, oriented @ 538°W

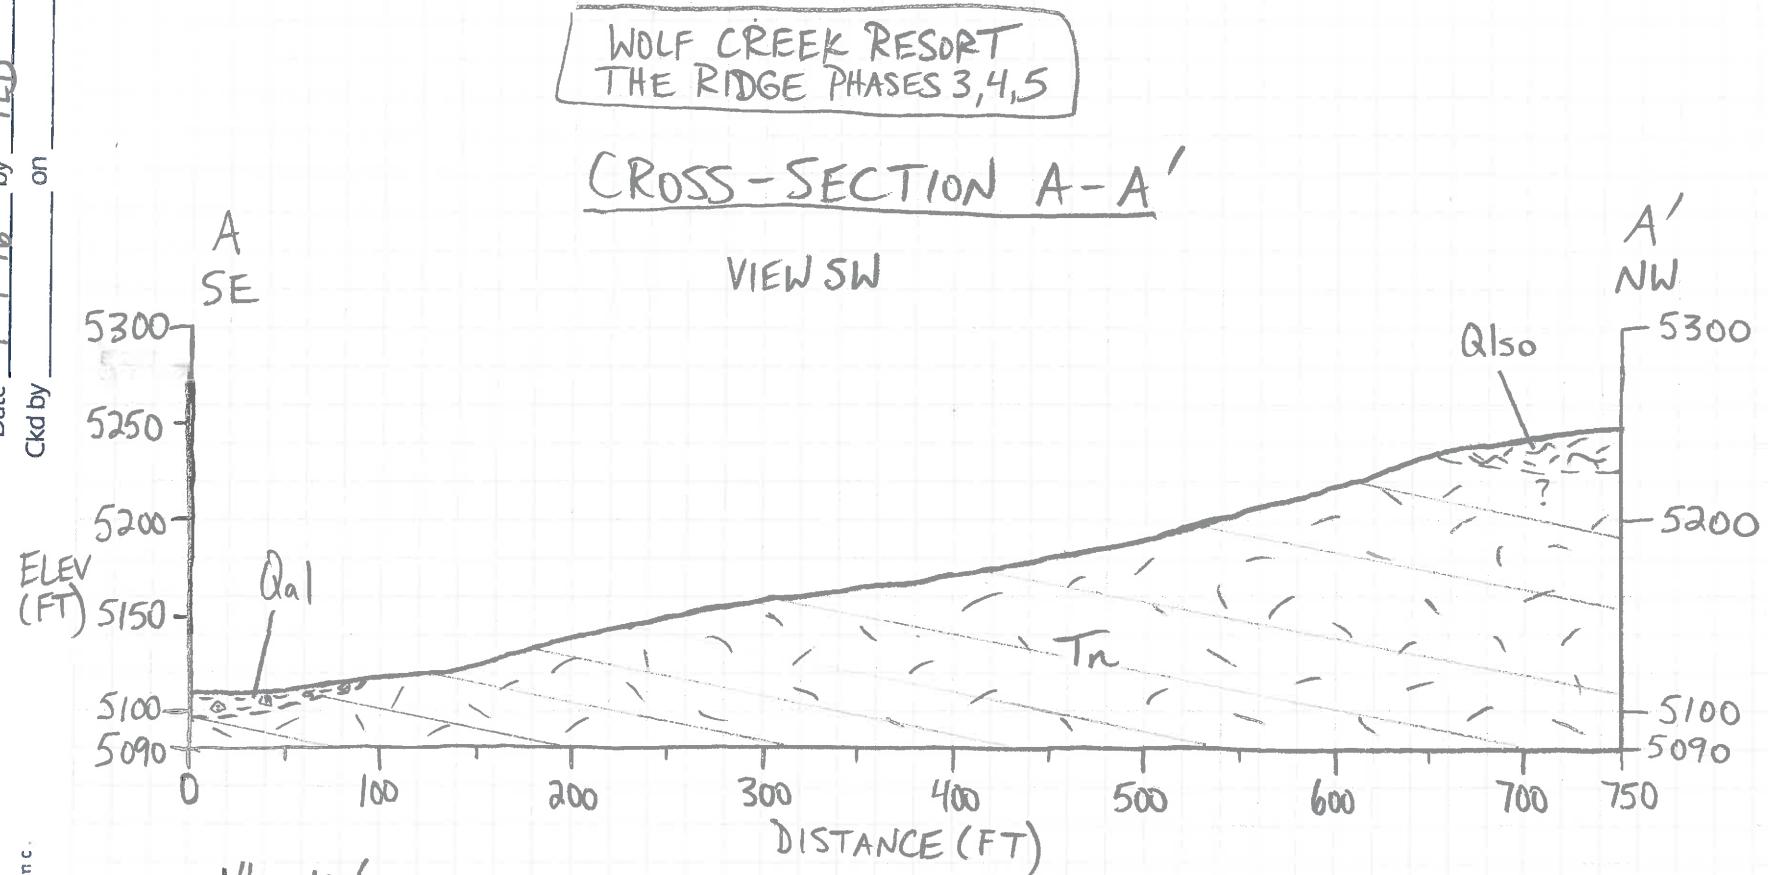
- [Solid black box] Qal RECENT ALLUVIUM
- [Dashed box] QIso PLEISTOCENE LANDSLIDE
- [Cross-hatched box] Tr NORWOOD TUFF

*SEE FIGURE A-4 FOR CROSS-SECTION LINE.
