Construction Observation Report # 1

Project	Uintah Bybee Water Tanks	Project Number	20218
Location	6393 Bybee Dr, Ogden, UT	Date & Time	02/24/2023 1:30PM
Civil Engineer	Jones and Associates	Weather	Clear
Contractor	FX Construction	Observer	Jami Havens

Construction Observation Report # 2

Construction Observation Report #3

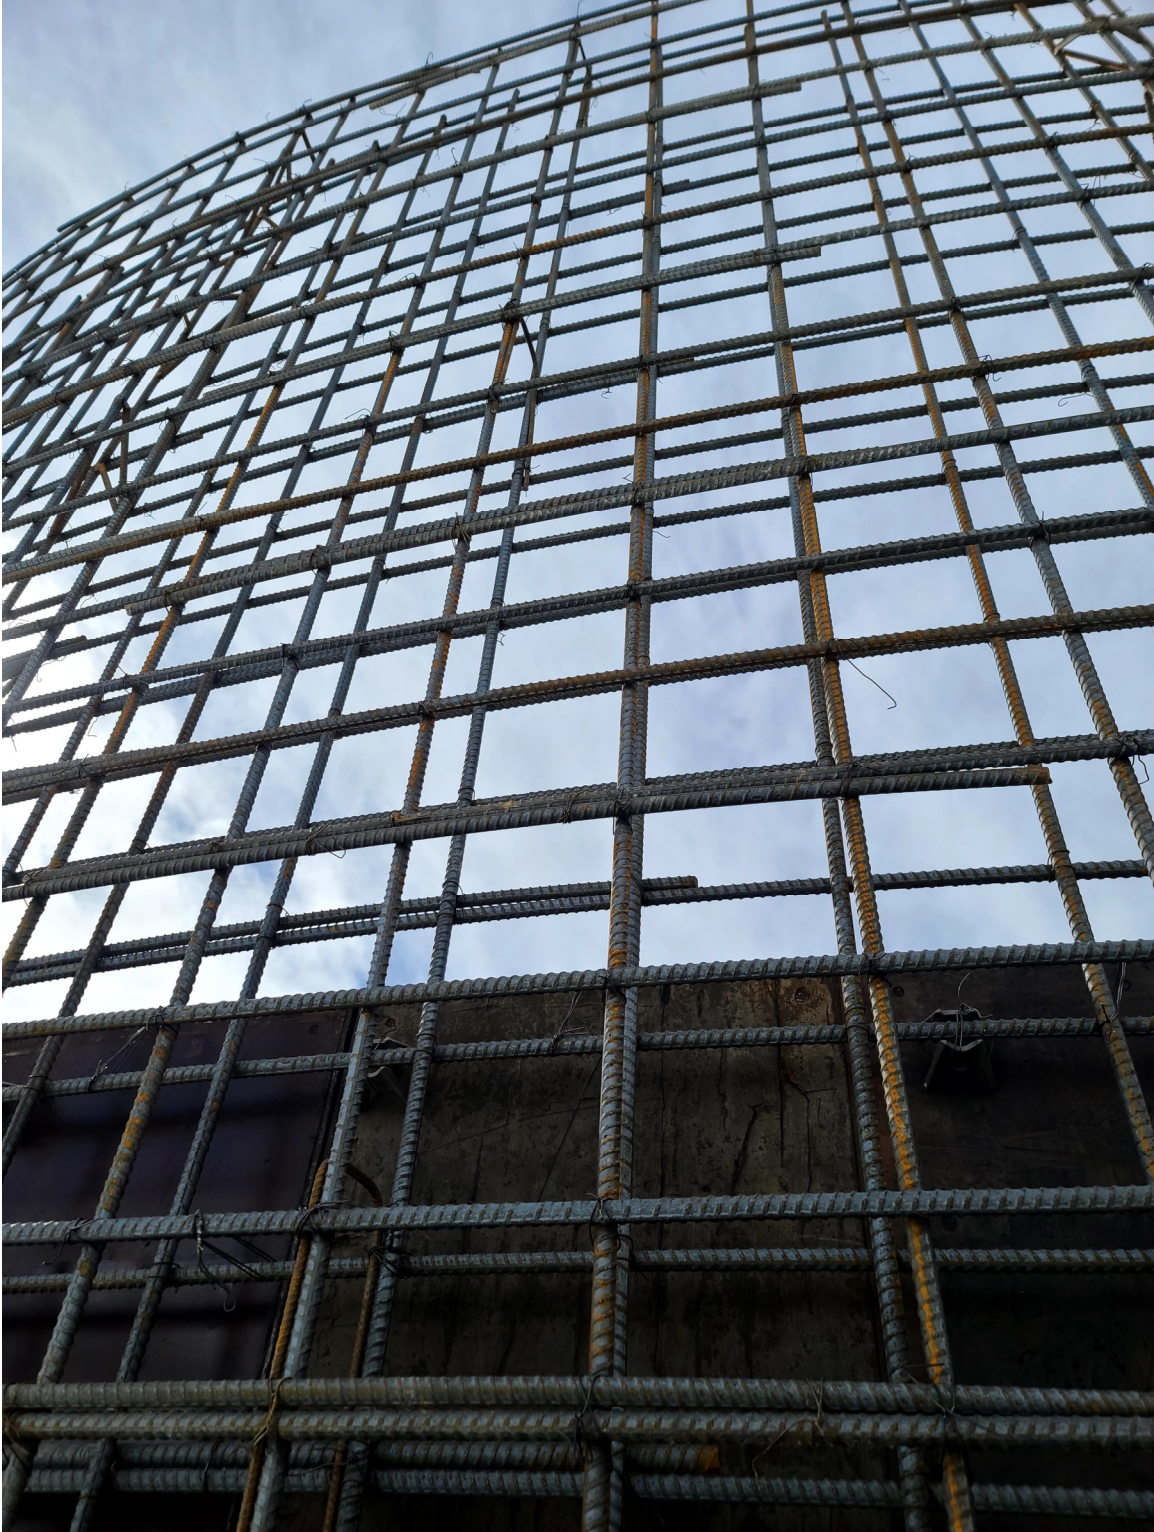
Photo 1

Items of Note:				
Item No.:	Item:	Follow-Up / Action Required:	Initials	Photo:
1-1	The dowels between the top of the wall and the roof slab shown in detail 1 on sheet S3 have not been placed.	Ensure that dowels are installed with the compressible insulation prior to placement of wall concrete.		1

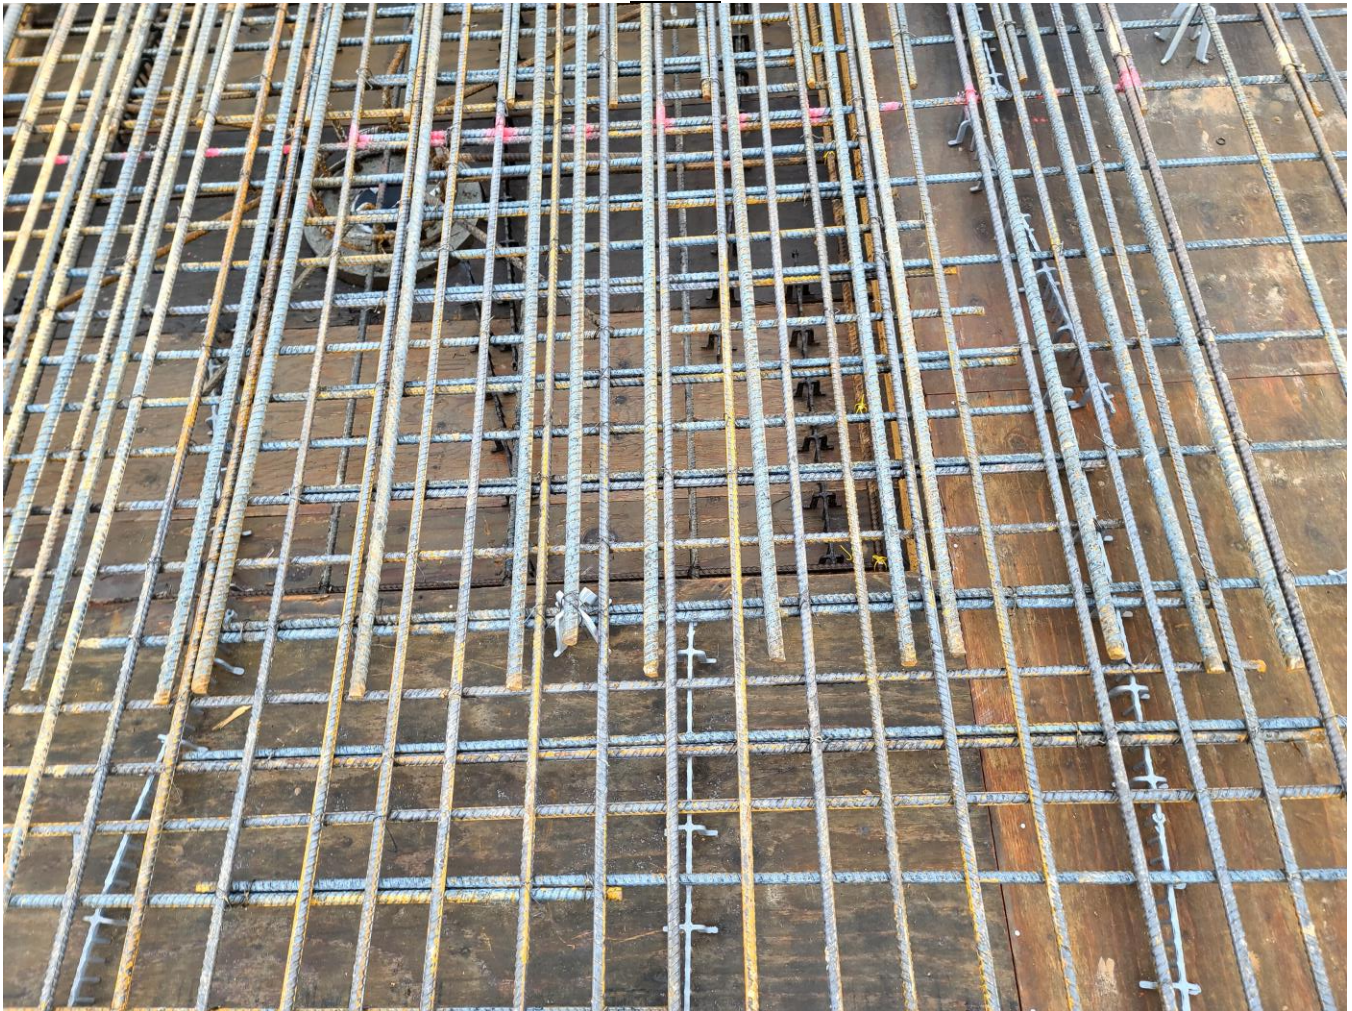
Photo 1

Items of Note:				
Item No.:	Item:	Follow-Up / Action Required:	Initials	Photo:
1-1	The #7 bars in the top layer of the column strips are 1 foot short on each end.	Replace the rebar with the correct length or add additional an additional #7 bar spliced on to each #7 bar that is short. See detail 2/S1 for the required splice lengths.		1
