IGES Project No. 04434-002

RE: **Construction Observations**
Powder Point Subdivision Rockeries
Summit Powder Mountain Resort
Weber County, Utah

Construction Observation Report

Project: Powder Point
Project Number: 04434-002
Project Location: Powder Mountain, Utah
Client: Overlook Point, LLC

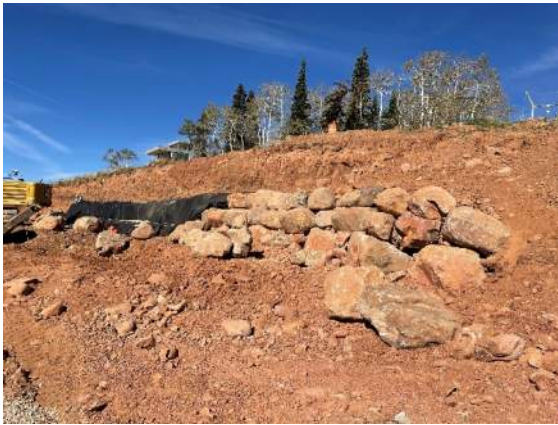
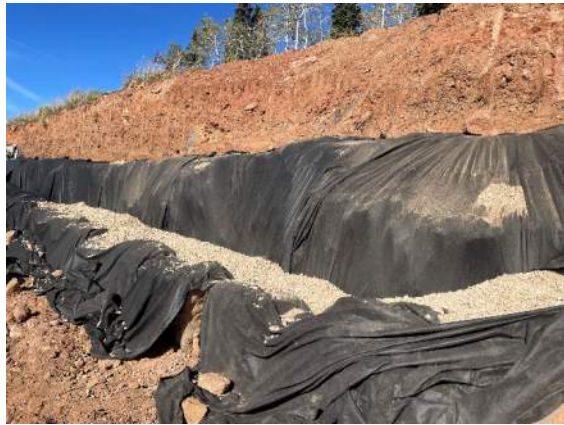
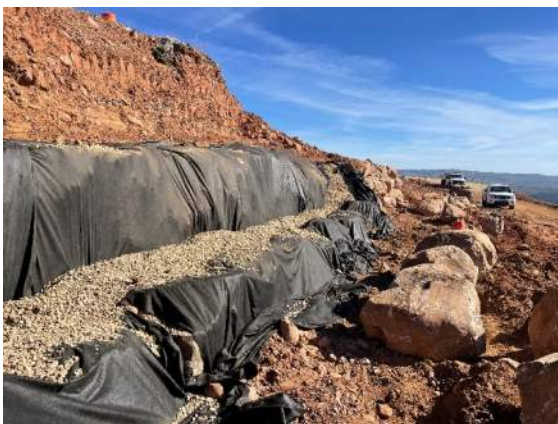
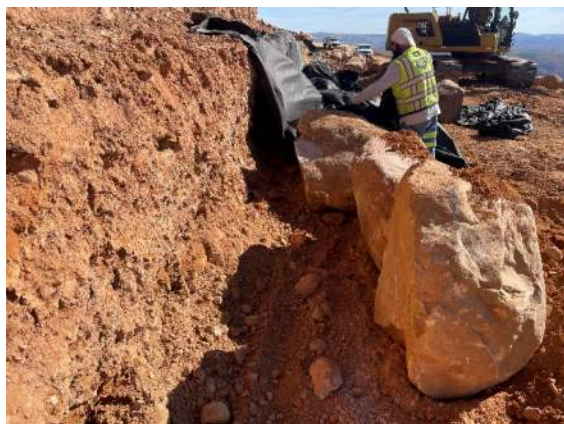
9-29-2023, CO #1

The single tier rockery had been constructed up to 3 boulder courses tall for approximately 50 linear feet. The base course of boulders had been set for an additional 75 linear feet. Behind the boulders the contractor was placing a zone of fabric wrapped gravel. A drainpipe was observed at the base of the gravel drainage zone and was daylighting at the rockery ends. The rockery had a batter of at least 1H:2V and the boulders were set with good rock to rock contact. The boulders observed met the minimum required dimensions.

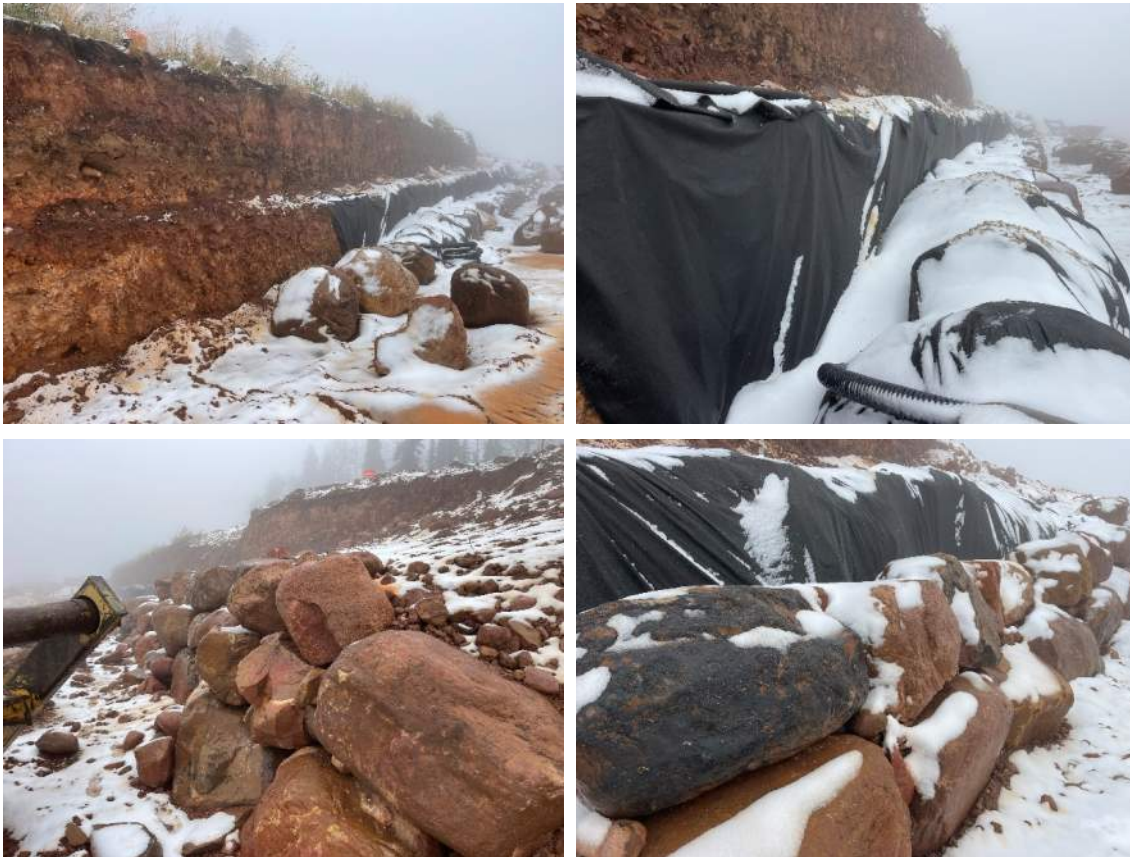
10-3-2023, CO #2

The single tier rockery had been constructed up to 3 boulder courses tall for approximately 50 linear feet. Up to 2 boulder courses tall for an additional 50 linear feet. And the base course of boulders had been set for an additional 50 linear feet. Behind the boulders the contractor was placing a zone of fabric wrapped gravel. A drainpipe was observed at the base of the gravel drainage zone and was daylighting at the rockery ends. The rockery had a batter of at least 1H:2V and the boulders were set with good rock to rock contact. The boulders observed met the minimum required dimensions.

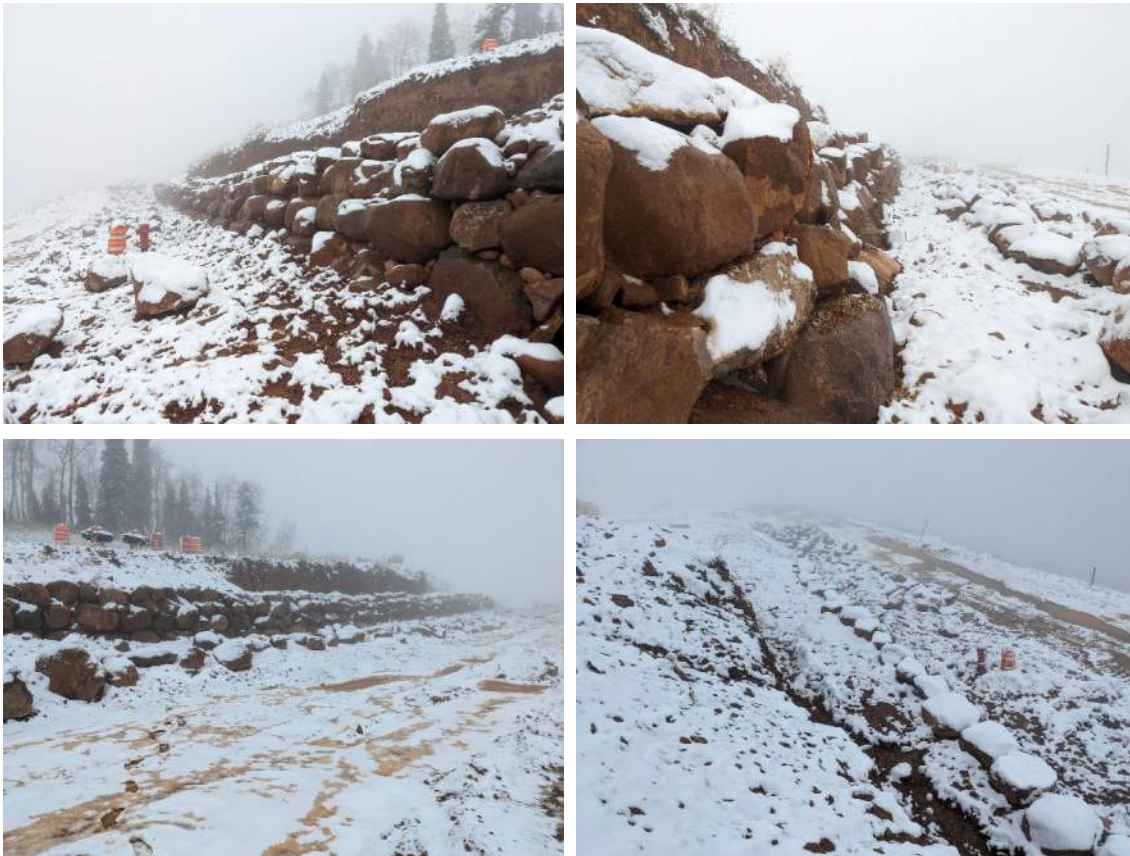
10-12-2023, CO #3

All boulders had been placed the single tier rockery. The rockery was constructed up to 4 boulder courses tall and was approximately 8 feet tall. Behind the boulders the contractor was placing a zone of fabric wrapped gravel. A drainpipe was observed at the base of the gravel drainage zone and was daylighting at the rockery ends. The rockery had a batter of at least 1H:2V and the boulders were set with good rock to rock contact. The boulders observed met the minimum required dimensions.

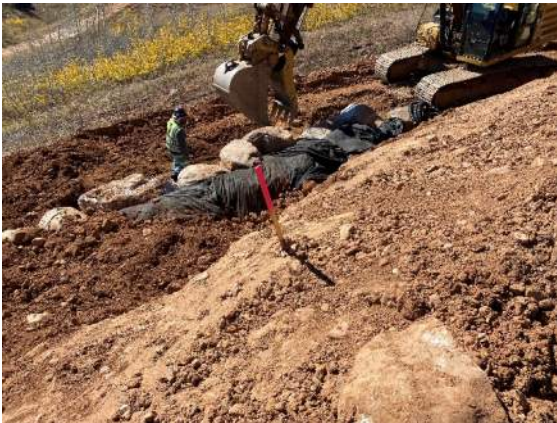
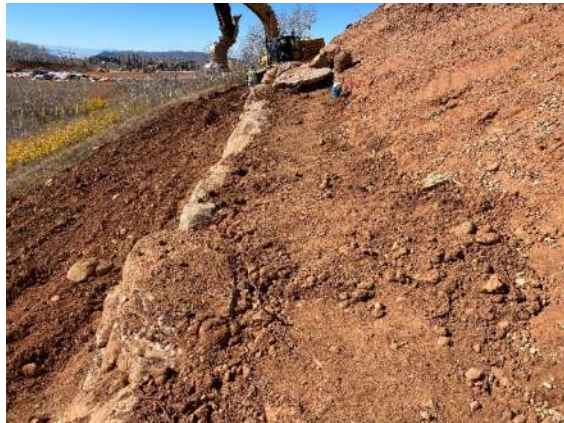
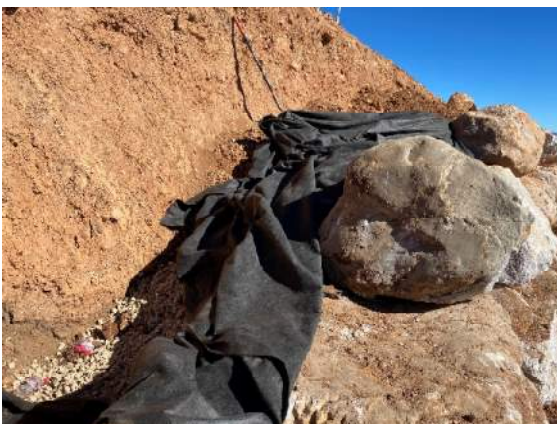
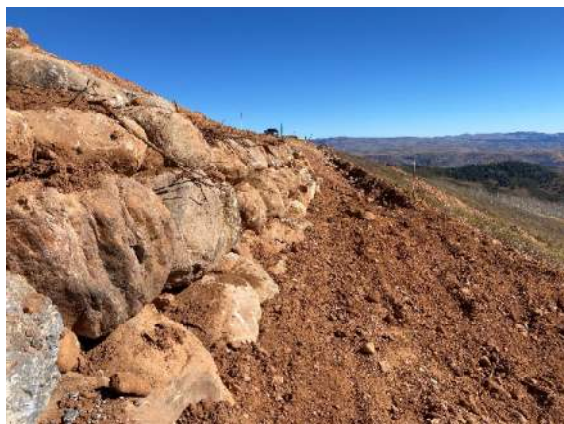
10-18-2023, CO #4

The bottom rockery tier of the two-tiered system had been constructed up to 4 boulder courses tall for approximately 50 linear feet. Behind the boulders the contractor was placing a zone of fabric wrapped gravel. A drainpipe was observed at the base of the gravel drainage zone and was daylighting at the rockery ends. The rockery had a batter of at least 1H:2V and the boulders were set with good rock to rock contact. The boulders observed met the minimum required dimensions.

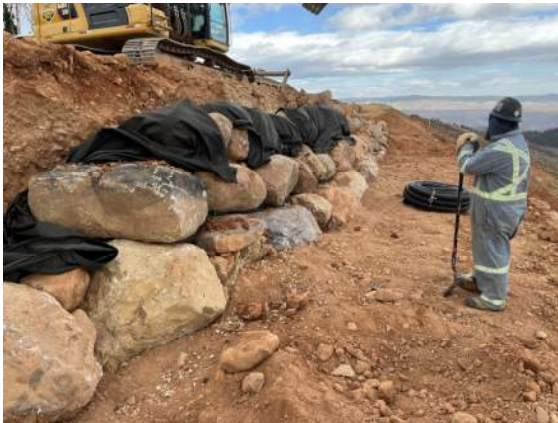
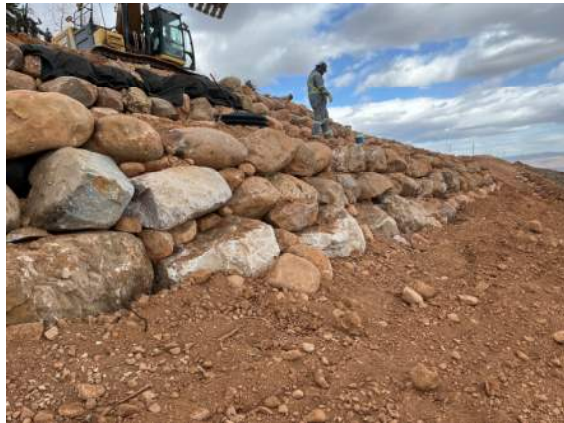
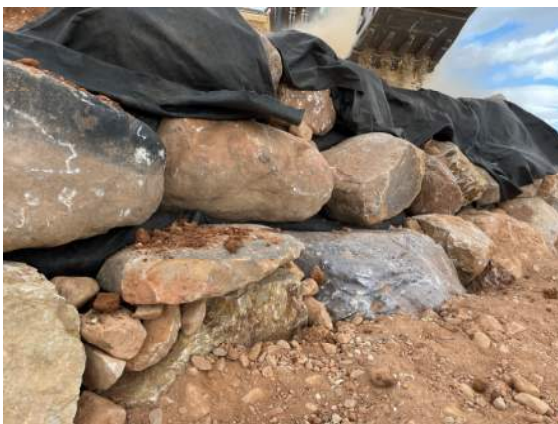
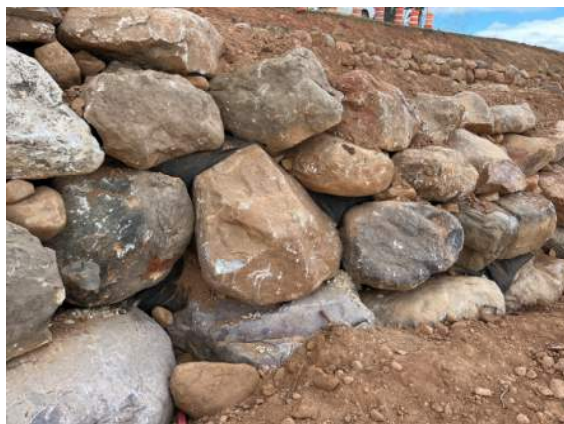
10-25-2023, CO #5

All boulders had been placed for the bottom rockery tier; the upper rockery tier had been constructed up to 3 boulder courses tall with the base course of boulders set across the entire rockery alignment. The bench width was measured to be at least 8 feet. Non-woven geotextile fabric was observed behind the back of the boulders. A drainpipe was observed daylighting at the rockery ends. The rockery had a batter of at least 1H:2V and the boulders were set with good rock to rock contact. The boulders observed met the minimum required dimensions.

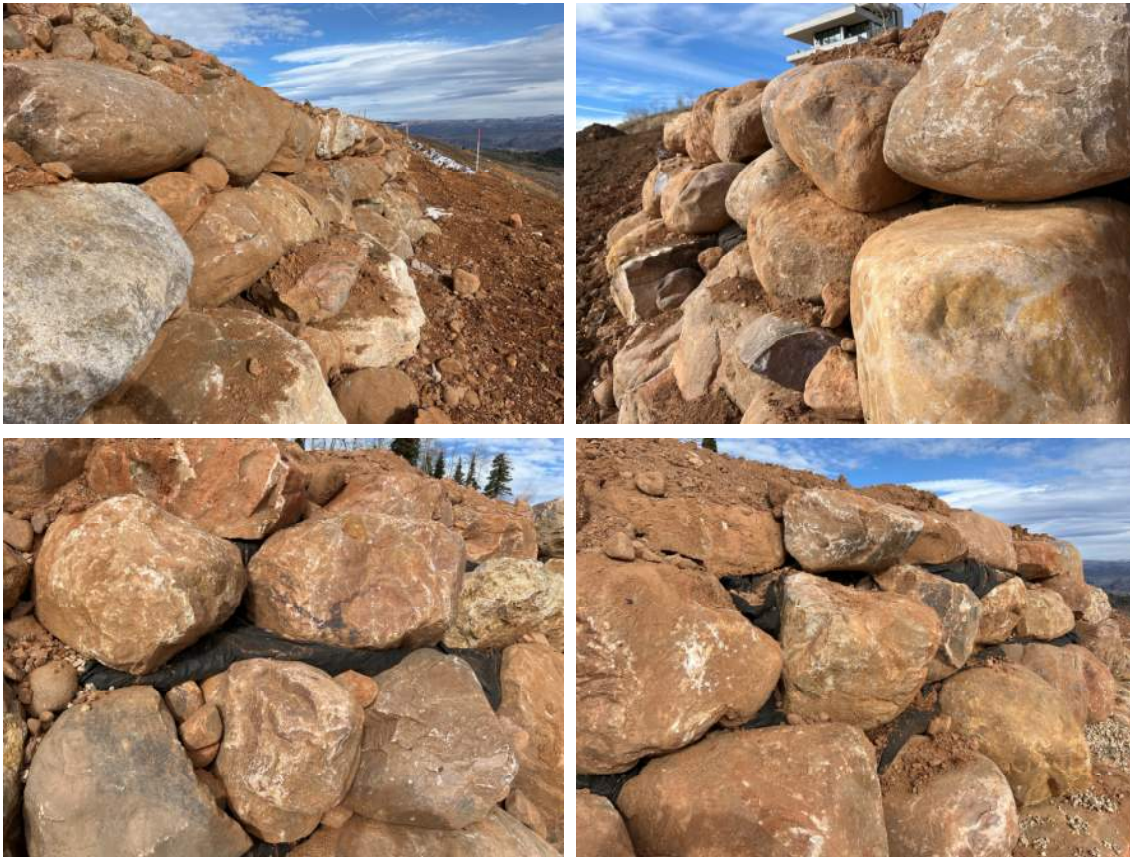
11-1-2023, CO #6

All boulders had been placed for the upper rockery tier. Non-woven geotextile fabric was observed behind the back of the boulders. Near the west end of the upper rockery tier there were several boulders that were not stacked with good rock to rock contact. the boulders were sitting on the backfill material behind the rockery. IGES recommended this area be restacked to have better rock to rock contact.

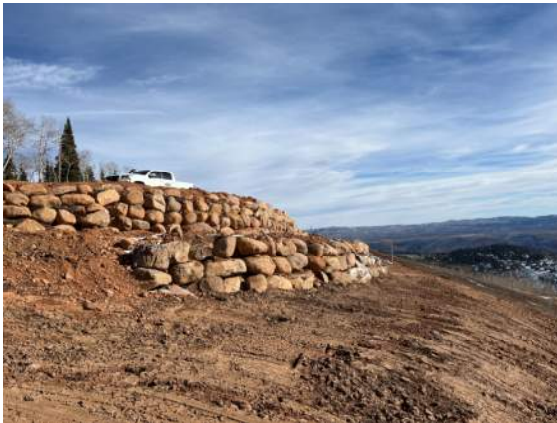
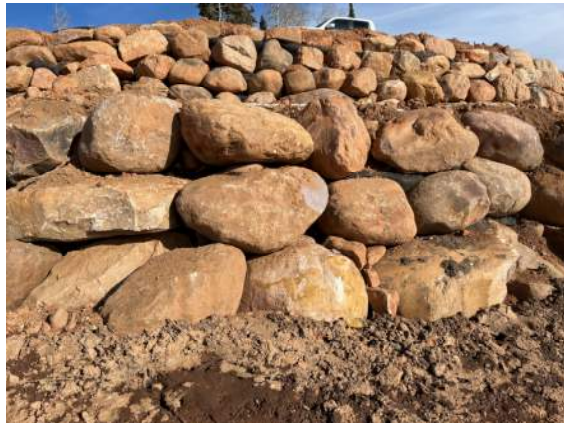
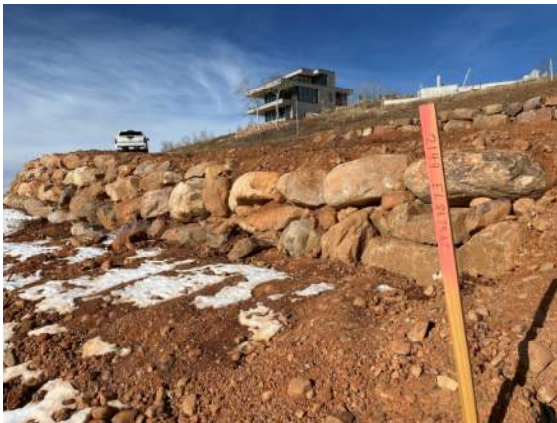
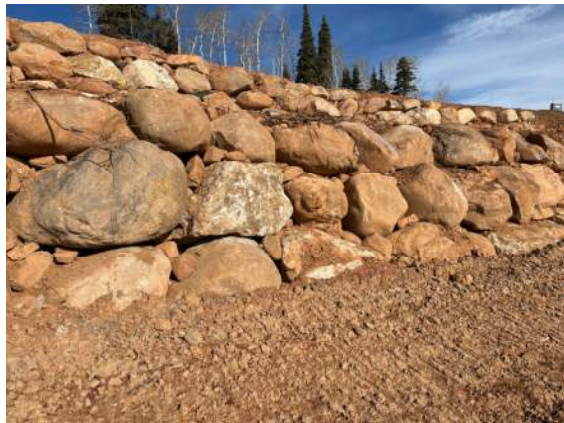
11-13-2023, CO #7

The west end of the upper rockery tier had to be reconstructed to have better rock to rock contact between the boulder courses. Non-woven geotextile fabric was observed behind the back of the boulders. A drainpipe was observed daylighting at the rockery ends. The rockery had a batter of at least 1H:2V.
