October 9, 2015

**Re: Engineering Geology Assessment-Revised
Lot 15, Ski Lake Estates No. 3
6640 East 1100 South
Huntsville, Utah
Job No. 145150**

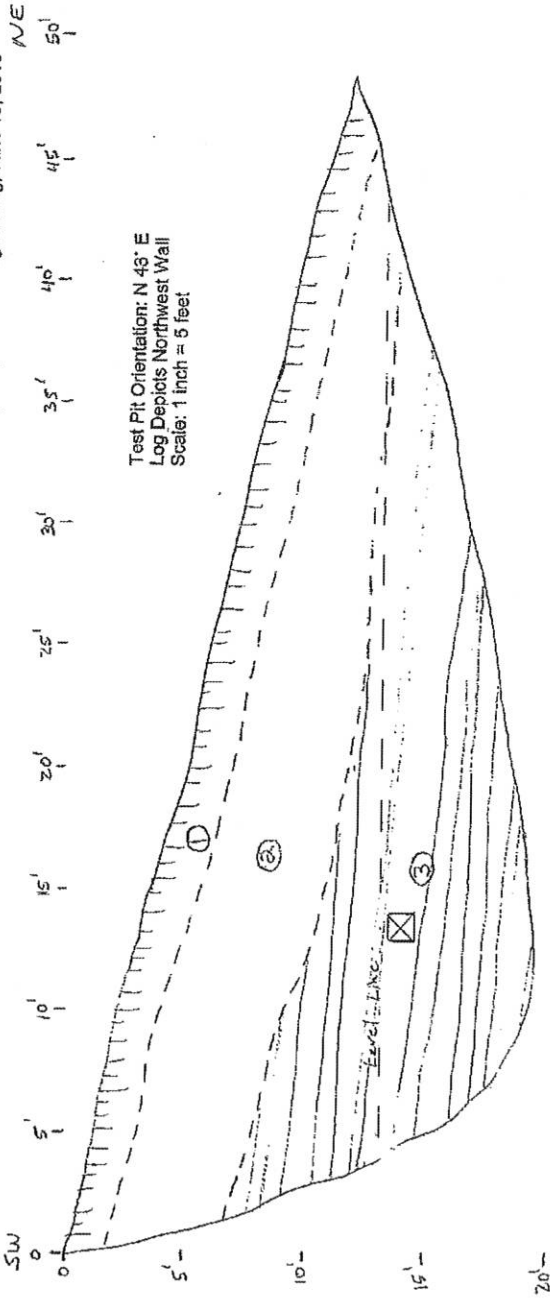
Test Pit Log, TP-3, Lot 15, Ski Lake Estates No. 3
 6640 East 1100 South, Huntsville, Utah
 Logged by: Mark Larsen, P.G., Earthtec Engineering, June 19, 2015

As shown on Figure No. 4, TP-3 exposed approximately 1½ to 2 feet of relatively well-formed,

modern topsoil (Soil "A" Horizon) at the surface (Unit 1, Figure No. 4). The topsoil was formed on what is interpreted to be slope wash deposits consisting of sandy Lean Clay (CL) (Unit 2, Figure No. 4) observed to be approximately 2½ to 5 feet thick at the location of the test pit. No significant internal stratification was observed within the slope wash deposits and the in-situ soils were estimated to be soft to medium stiff. Underlying the slope wash deposits, and extending to the base of the test pit which was approximately 16½ feet below the surface at its deepest point, we observed thin to moderately bedded deposits of Silty Sand (SM) with thin layers of interbedded Silt (ML) and occasional Lean Clay (CL) layers. These deposits (Unit 3, Figure No. 4) are interpreted to be lacustrine deposits of the Bonneville lake cycle and correlate with mapped Unit Qlf mapped by King and others (2008). Bedding within Unit 3 was measured to dip (apparent) down to the northeast at between approximately 3 and 8 degrees. The Bedding was observed to be continuous and relatively undisturbed through the length of the test pit. Bedding in the upper portion of Unit 3 at the contact with Unit 2 was observed to be truncated by the overlying material of Unit 2 suggesting that the contact is likely an erosional unconformity. No planes of shearing or zones of gouge suggesting past slope movements were observed within TP-3. It should be noted that TP-3 was excavated just down-slope of the location of the previous TP-2. In TP-2 a layer of gravel (logged as "sandstone" in the referenced geotechnical report) was encountered between the near-surface slope wash deposits and the underlying lacustrine deposits. However, this gravel bed was not encountered in TP-3. It is our interpretation that the gravel bed observed in TP-2 may be a lense of granular slope wash material or older debris flow deposits placed on the underlying lacustrine deposits.

The extension of TP-3 down-slope to the elevation of TP-4 on the lot showed that the lacustrine sands (Unit 3, Figure No. 4) thinned down slope and eventually pinched out at the elevation of TP-4 where the gravel bed (Unit 3, Figure No. 5) was encountered below the overlying slope wash deposits. TP-5 excavated adjacent to the southwest side of the footprint of the proposed

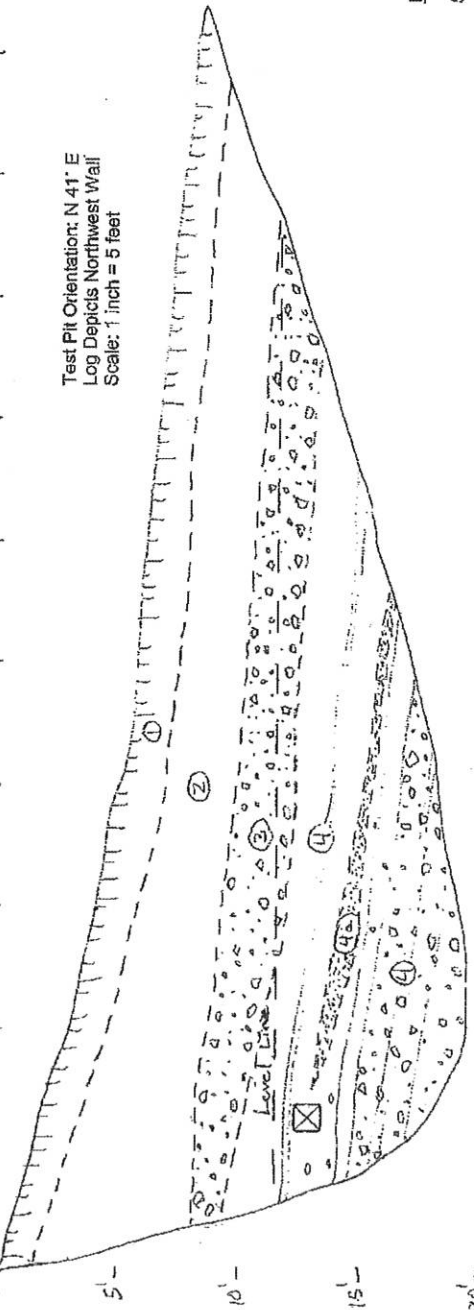
As shown on Figure No. 5, TP-4 exposed similar near surface topsoil and slope wash deposits (Units 1 and 2, Figure No. 5) as those observed in TP-3. Underlying the slope wash deposits in TP-4 we observed an approximately 1 to 2½ foot thick gravel bed (Unit 3, Figure No. 5). According to the engineer who logged the gravel bed (logged as "sandstone") in TP-2, this gravel bed in TP-4 appeared very similar to the gravel bed in TP-2. The gravel bed was comprised predominantly of angular to subangular, pebble to small cobble sized sandstone clasts that were generally clast supported. The matrix of the gravel bed included some pinhole voids. Unit 3 was observed to thin up-slope in the test pit suggesting it may pinch out upslope from the test pit. As with the gravel bed observed in TP-2, Unit 3 in TP-4 is interpreted to be a bed or lense of granular slope wash material or older debris flow deposits. This gravel bed was not encountered in TP-1 down-slope of TP-4. Underlying Unit 3 in TP-4 we encountered beds of the Norwood Formation (Unit 4, Figure No. 5) extending to the base of the test pit at approximately 16½ feet below the surface at its deepest point. The beds of the Norwood formation observed in TP-4 consisted of sandy Lean Clay (CL) and sandy Elastic Silt (MH) grading downward to Poorly Graded Gravel with Silty Sand (GP-GM). The gravels in the lower portion of the test pit may be a weathered sandstone bed and displayed some weak bedding structure. A lense of Silty Sand (SM) (Unit 4a, Figure No. 5) was observed in the exposed Norwood Formation Deposits. Bedding in the observed Norwood Formation deposits was measured to dip (apparent) down to the northeast at between 10 and 13 degrees. The bedding in the exposed Norwood Formation deposits in TP-4 was observed to be continuous and relatively undisturbed through the length of the test pit. No evidence of slip or shearing, or zones of gouge, was observed in the exposed soils and bedrock (Norwood Formation). None of the beds or bedding contacts within the exposed Norwood Formation appeared to be a slip plane.

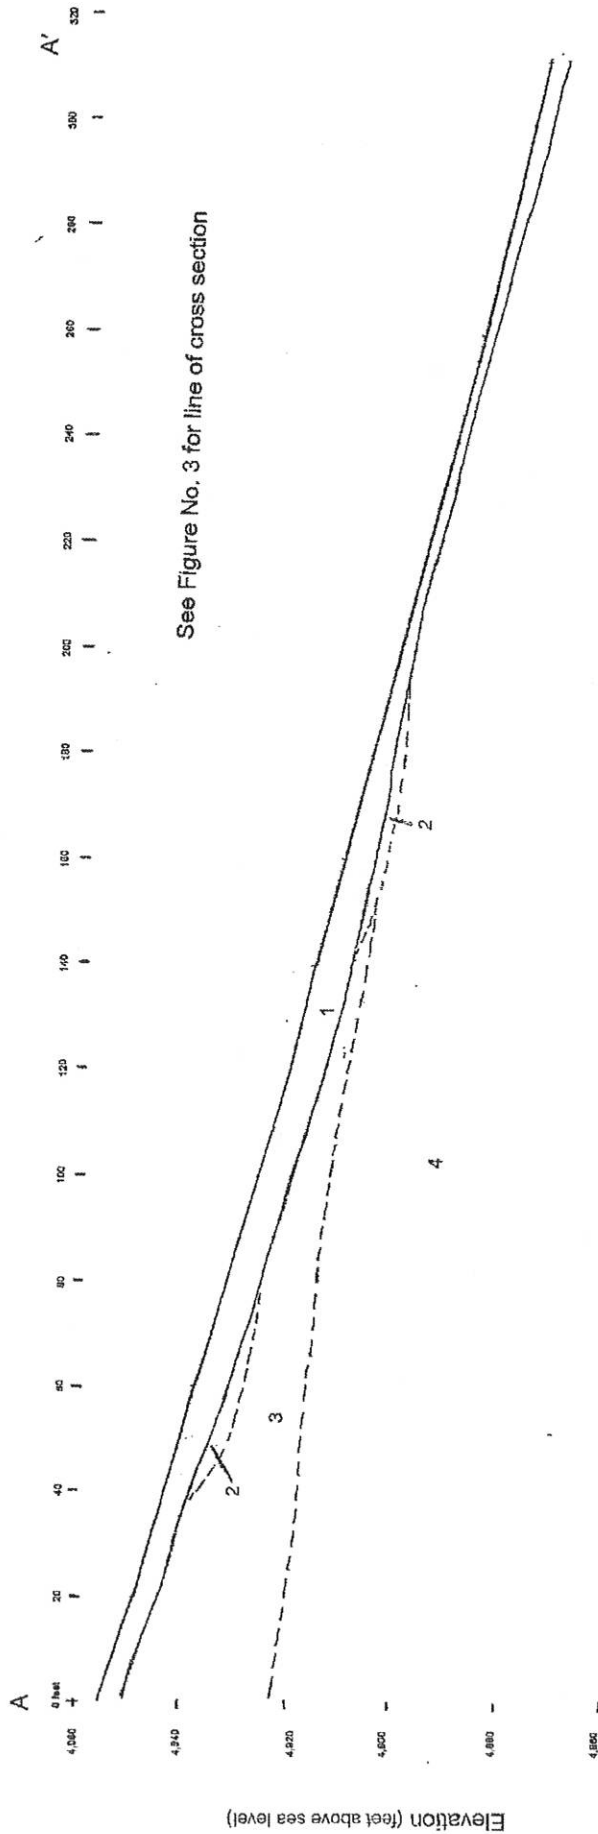
Geologic Cross Section
 Lot 15, Ski Lake Estates No. 3
 6840 East 1100 South, Huntsville, Utah

Based on the subsurface information obtained from the test pits and our geologic interpretations, a geologic cross section through the subject lot was produced. The cross section is included at the end of this report as Figure No. 6, Geologic Cross Section. The line of cross section through the lot is shown on Figure No. 3 as A – A'. Several assumptions were made in the completion of the cross section. First, due to the fact that the gravel beds/lenses observed immediately below the near-surface slope wash deposits in TP-2 and TP-4 were not observed in any of the other test pits we decided to show the gravels as two separate lenses at the elevations of TP-2 and TP-4. It is our opinion, that, due to relatively small thickness of the gravels and their apparent lack of lateral continuity across the lot, the gravels will not likely have significant influence on slope stability on the lot. Second, the depth of the lacustrine sands encountered in TP-2, TP-3, and TP-5 was not determined as none of these test pits penetrated the sands. We did observe that the sands thinned and pinched out down-slope of TP-3. As such, the base of the lacustrine sands shown on the cross section is inferred primarily based on the depth of TP-3 and the grade of the slope, however, the sands may be thicker than shown below the southwestern portion of the lot. And lastly, the thickness of the Norwood Formation below the lot could not be determined. So, for the purposes of the cross section, it was assumed that the Norwood formation extends through the remainder of the profile shown on Figure No. 6.

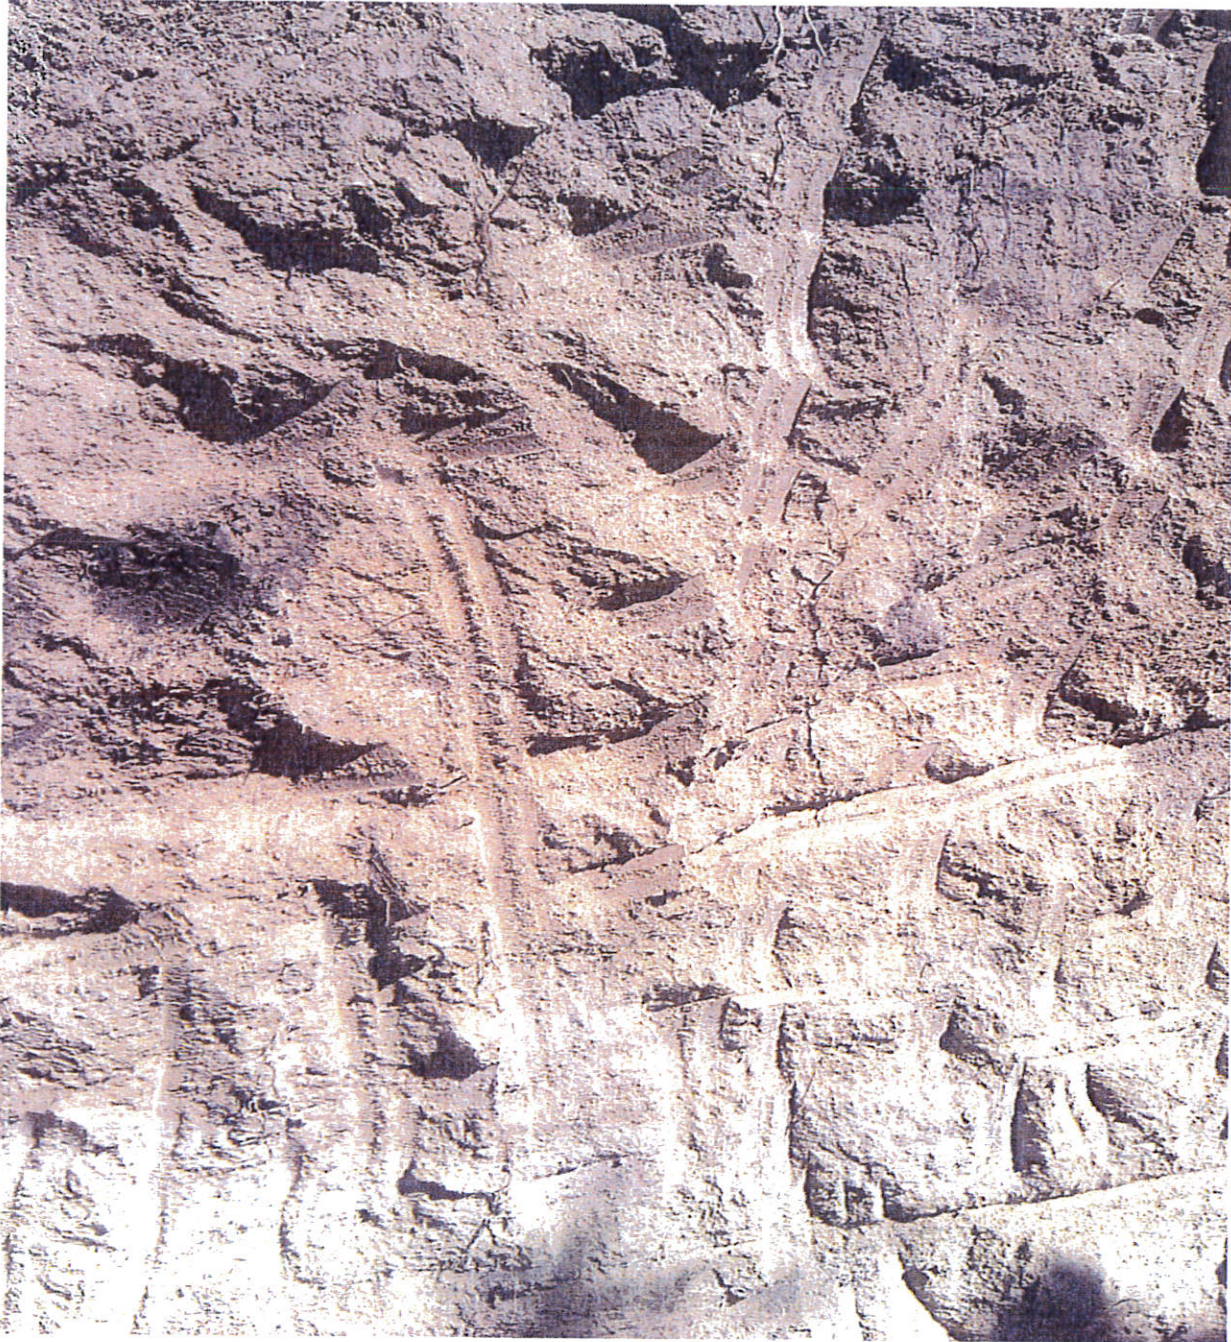
PHOTO EXHIBIT 1

Test Pit 3- West side, middle of the trench.

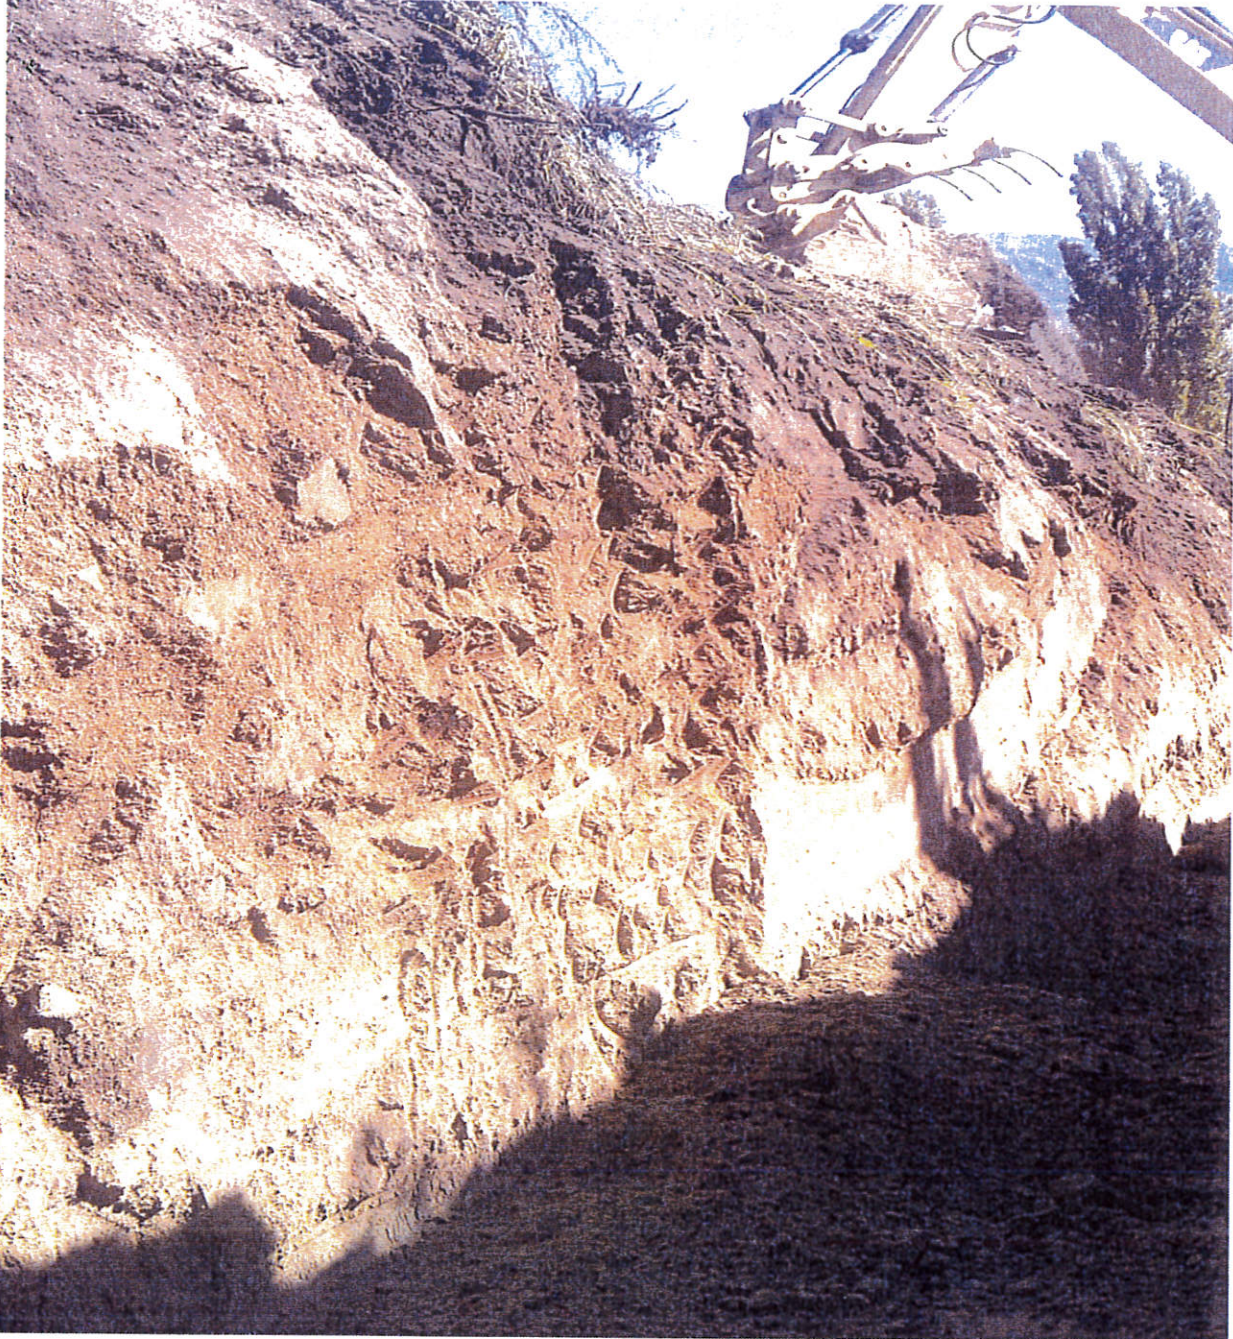
PHOTO EXHIBIT 2

Extension of Test Pit 3- West side of sidewall.

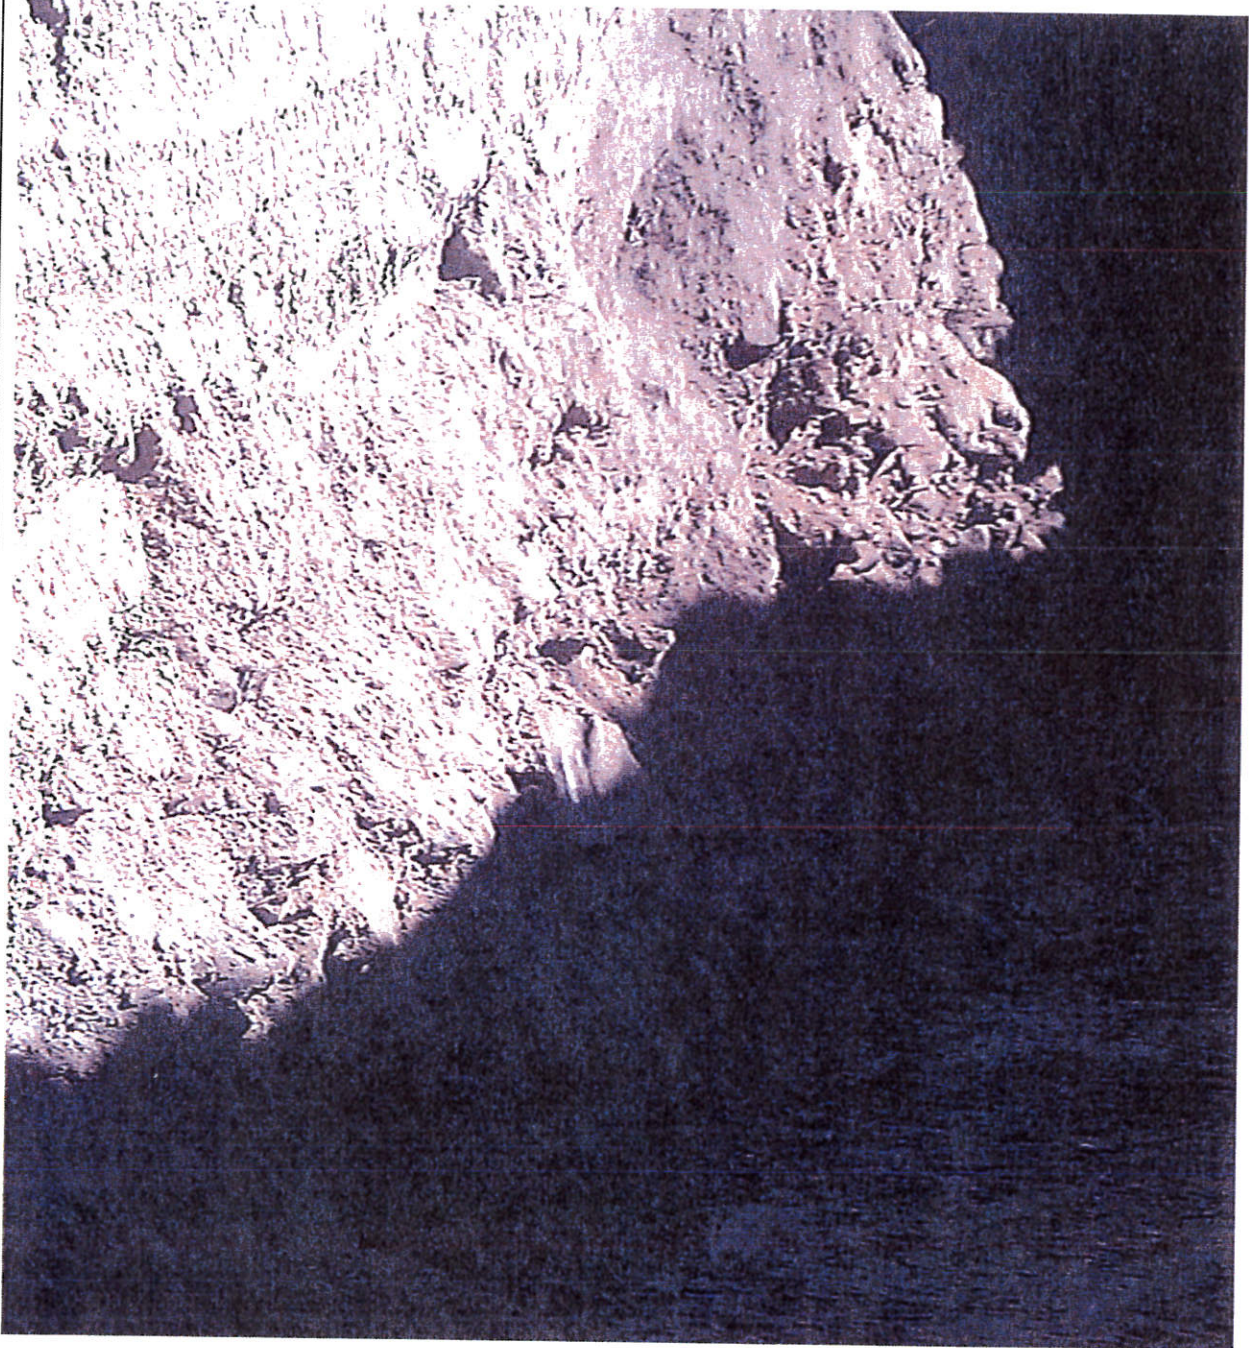
PHOTO EXHIBIT 3

Test Pit 3- West side of sidewall at the north end of the trench. Showing the gravel in the sidewall.
