November 4, 2015

IGES Project No. 01628-008

Subject: Response to Additional Review Comments - Geology
Geotechnical Investigation
The Ridge Nests Development
Powder Mountain Resort
Weber and Cache Counties, Utah

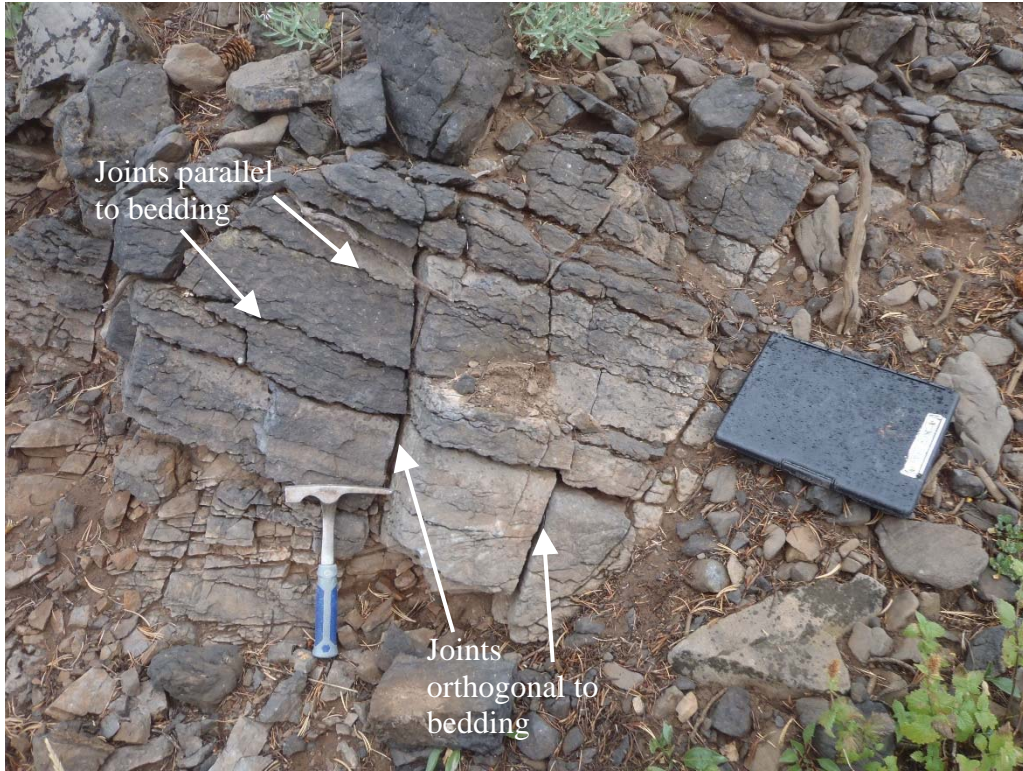
In response to the comment, the following additional details are provided: bedrock was found to be largely moderately fractured (distance between fractures ~0.5-1.0 feet) to little fractured (distance between fractures ~1.0-4.0 feet), with localized areas of intense fracturing (distance between fractures ~0.05-0.1 feet). Joint spacing was largely found to be a product of the lithology. The finer-grained dolomite lithologies were more thinly bedded, and therefore had a smaller distance (approximately 1 to 4 inches) between bedding plane joints. These lithologies also tended to fracture into rectangular blocks generally between 4 and 18 inches in length and width, and contained both bedding-confined and through-going fractures (Photo 1). Coarser-grained dolomite lithologies were more thickly bedded to massive, with bedding plane joints separated by between 6 inches to as much as several feet. These lithologies tended to fracture into rectangular blocks with highly variable dimensions, ranging in width and length from between a couple inches to several feet, though larger blocks (with dimensions of several feet x several feet x several feet) were most common (Photo 2). Most fracturing associated with the coarser-grained dolomite lithologies consisted of large through-going fractures.

Nearly all of the joints encountered in the field investigation were open, had slightly rough to rough surfaces, and did not contain a secondary mineralization, except rare calcite infilling in places. No slickensides were observed on any joint surface. Joint apertures varied from between a few millimeters to a couple inches in width. Joints with smaller apertures tended to be devoid of any sort of fill, while the larger aperture joints were often filled with soil. In the cases of the two identified faults, reddish gray silty gouge was found to be the fill material.

Photo 1. Finer-grained dolomite lithology, exhibiting thinner beds and blocky jointing.

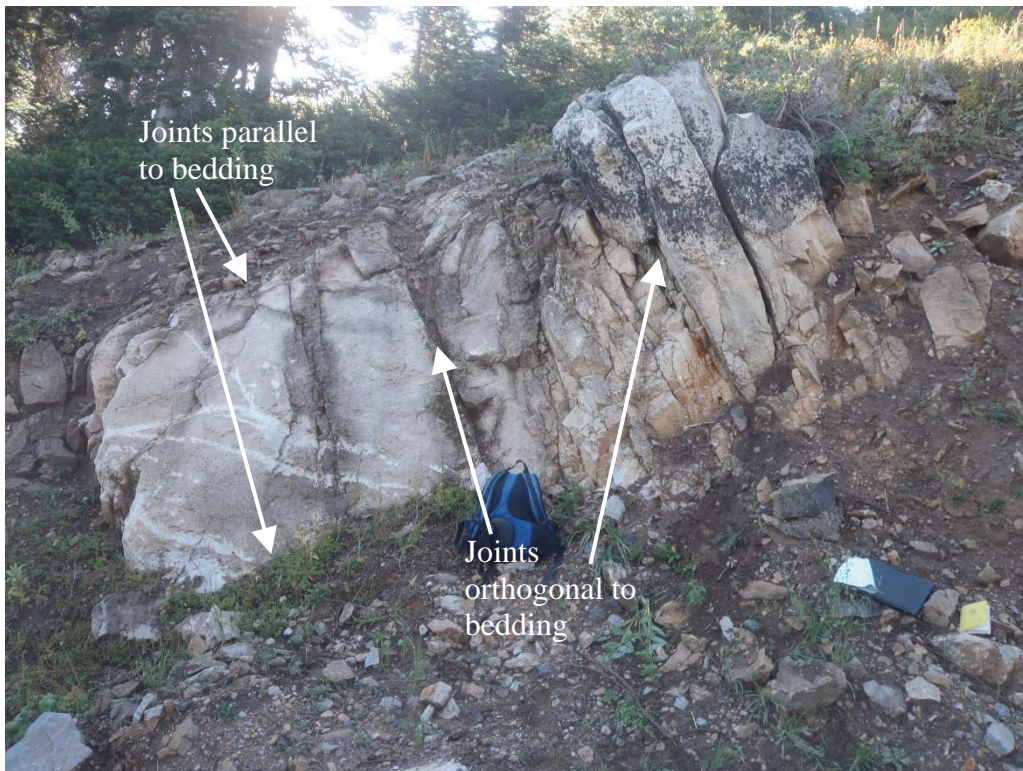
Photo 2. Coarser-grained dolomite lithology, exhibiting thicker beds and wider jointing.
