IGES Project No. 01855-007

Subject: Reconnaissance-Level Geologic Hazards Assessment
Fairways at Wolf Creek Subdivision Phases 4 and 5
Eden, Utah

FAIRWAYS AT WOLF CREEK
 SUBDIVISION PHASES 4 AND 5
 GEOLOGIC HAZARDS ASSESSMENT

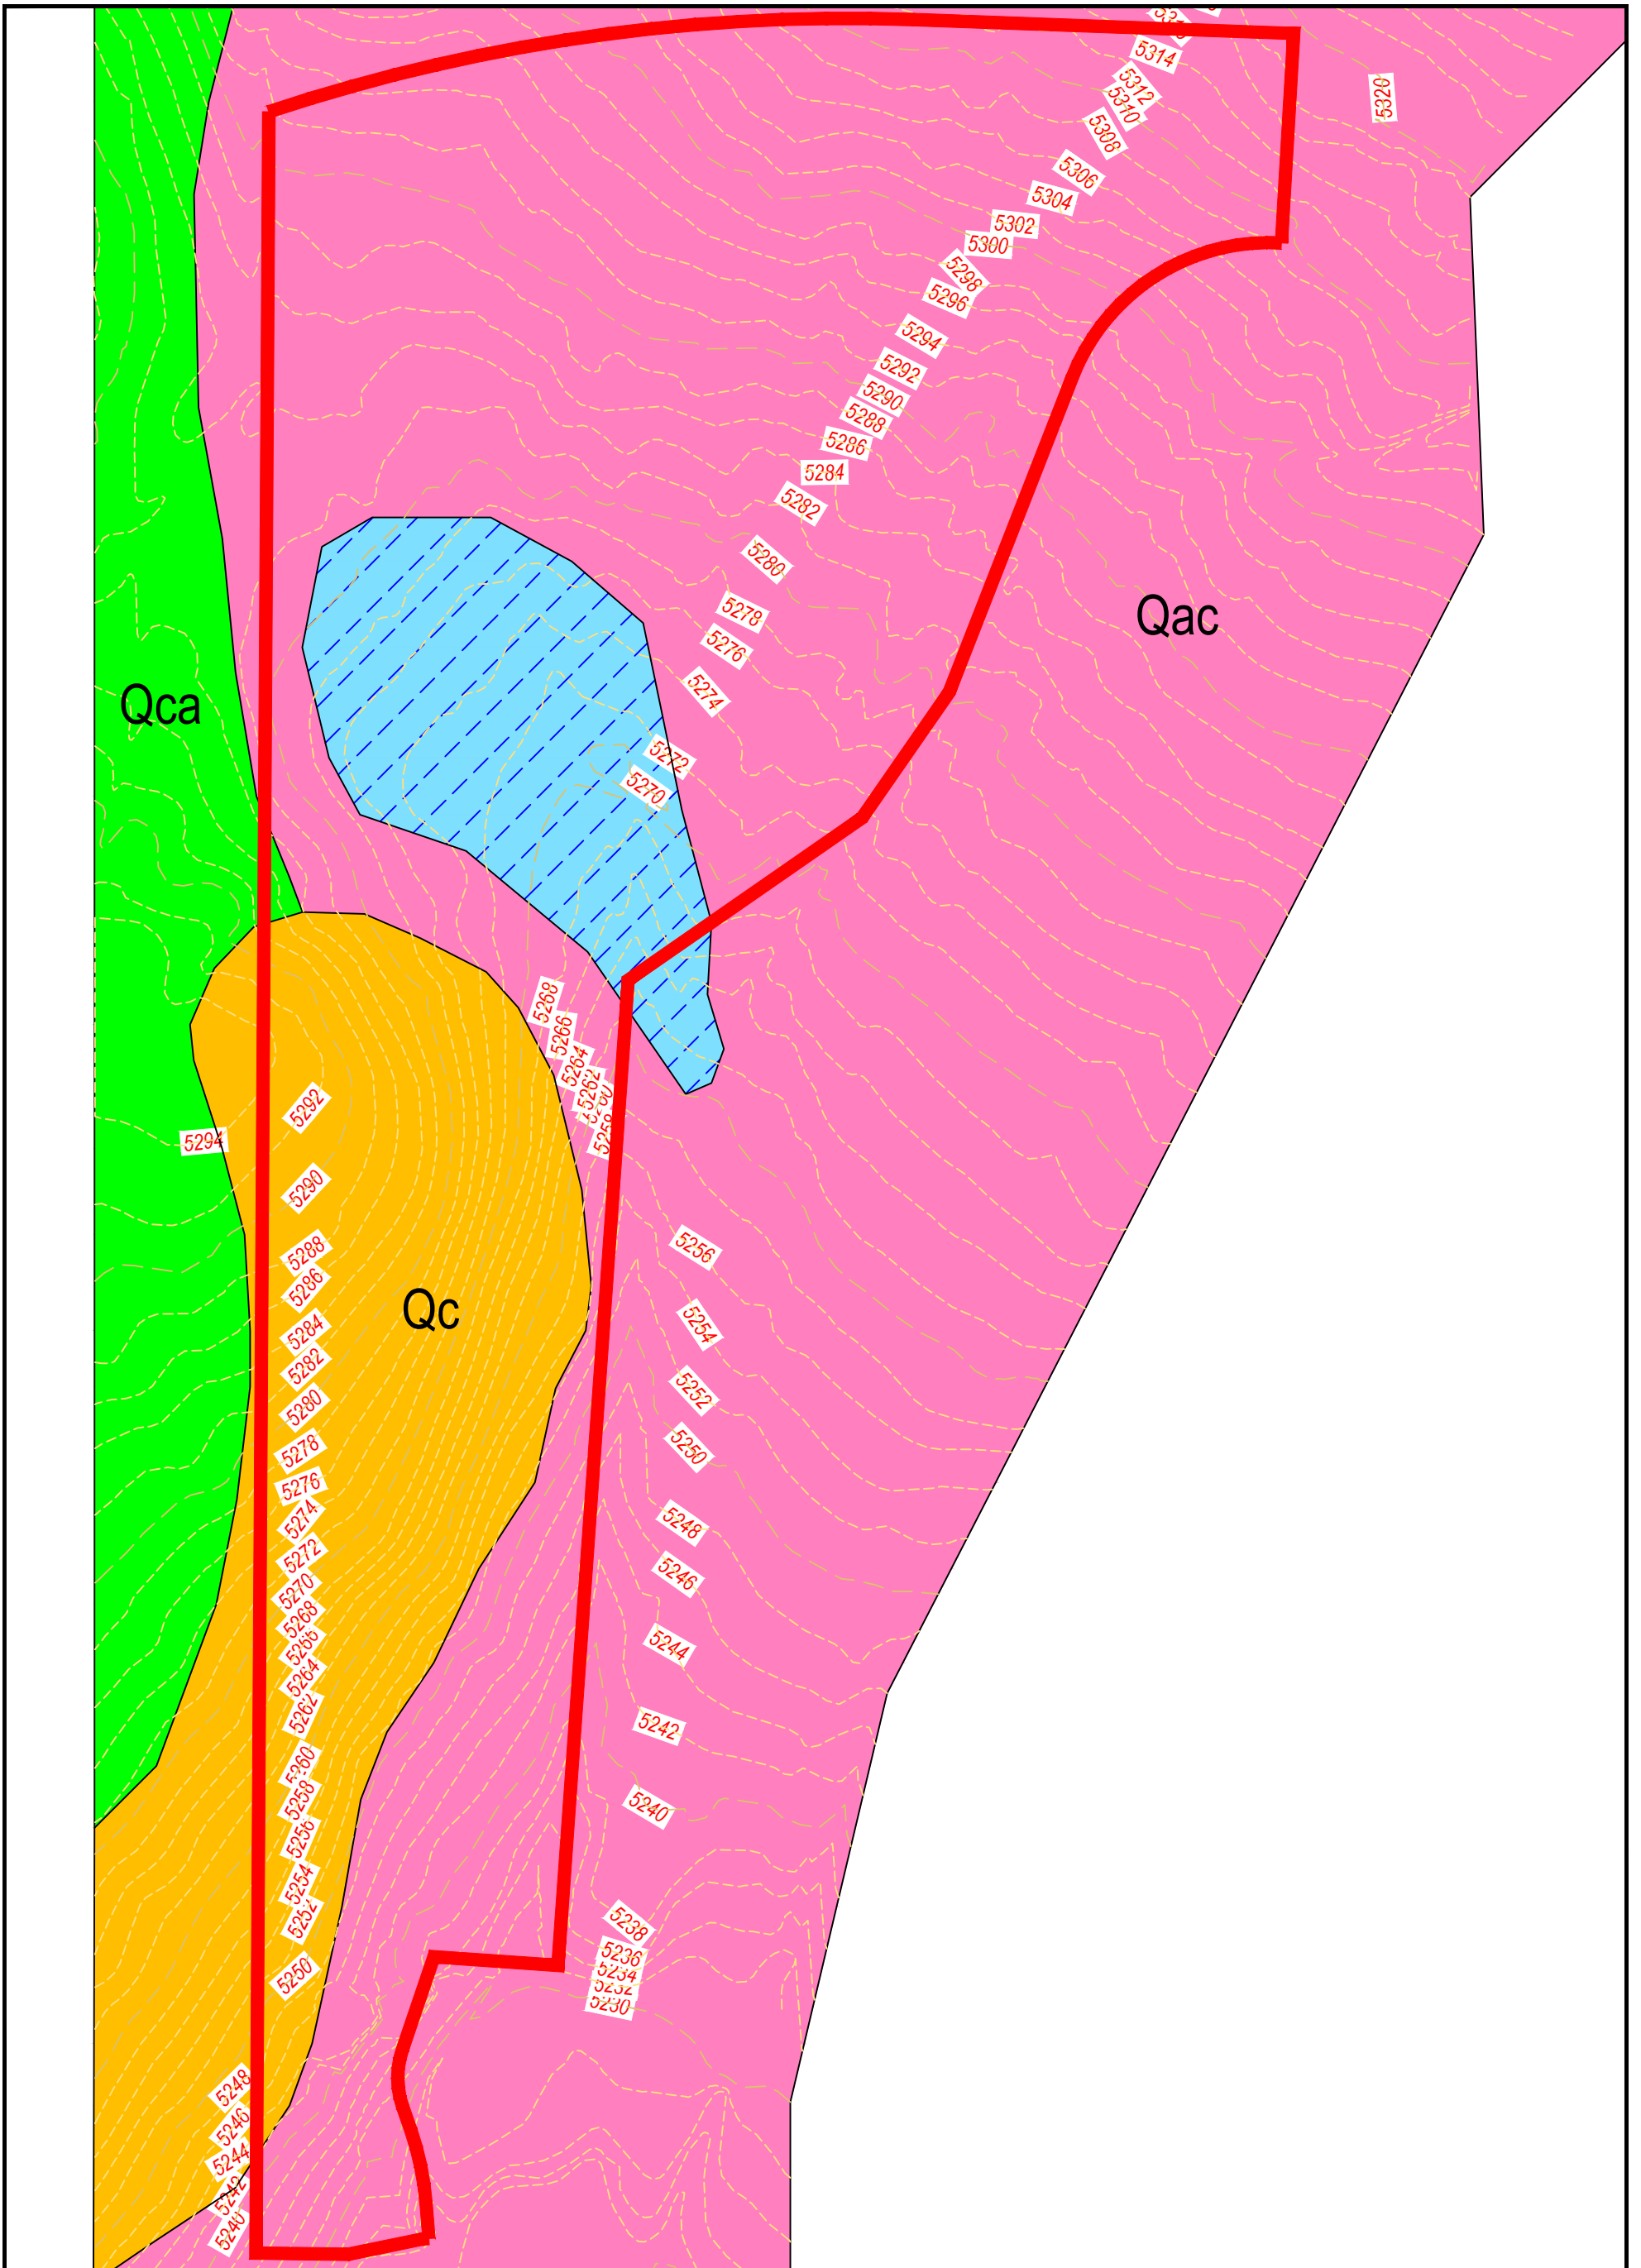
The presence or absence and setting within which these boulders were encountered provided the means by which the surficial geology was able to be mapped across the property. Three largely gradational geologic units were differentiated on the property. Each of these units are discussed in turn below.

This unit was mapped in generally low-lying areas and straddling the multiple ephemeral stream drainages where there was a significantly greater proportion of alluvial (running water-deposited) material present than colluvial (gravity-deposited with the aid of rain; slopewash) material. This unit underlies nearly all of the northern half of the property, and consists of both areas in which boulders are found in abundance and areas where few boulders are encountered. The northern half of the property was found have intermittent boulder fields and patches of fine sediment, having the appearance of intertwining braided stream deposits. Where present, boulders were typically found to be rounded to subrounded, and up to 5 feet in diameter.

This unit was generally mapped in areas with gentle slopes, and represents a transitional unit between the predominantly alluvial deposits of the Qac unit and the almost exclusive colluvial deposits of the Qc unit. The unit was gradational in terms of the proportion of alluvial and colluvial material, with some areas having slightly more alluvial material than colluvial material, and vice versa. Much of the area west and south of the property is underlain by the Qca unit.

This unit was mapped in areas with steeper slopes with concentrated boulder fields and was characterized by a general absence or the minor presence of fine-grained soils (silts and clays). Typically, this unit comprised the higher elevation knobs encountered during the mapping exercise, including along the southwestern margin of the property and the small hills to the north of the property. Boulders in the boulder fields in this unit were commonly subangular to subrounded, could be as much as 3 feet in diameter, and exhibited extensive desert varnish, indicative of remaining stationary for an extended period of time.

At the time of the site visit, the ephemeral stream drainage that runs along the southeastern margin of the property was found to be flowing with water, with a larger volume of water and stronger current further to the south. The low-lying central portion of property contained several small gullies with flowing water and also ponded, marshy conditions (see Figure A-4). The EarthTec Test Pits 1 and 3 were completely filled with water. Approximately 415 feet north of the northern margin of the property, the main north-south ephemeral drainage was found to be moist but did not display any flowing water.

No springs were identified on the property, though a shallow water table was found to be present across much of the northern half of the property.
