Minerals Inspection Report

Mine Name: Western Zirconium Pit	Permit Number: S/057/0009	Mine Status: Active
Operator Name: WW Clyde & Co.	Inspection Date: 10/24/2013	Permit Fees: Paid
Inspector(s): M. Bradley	Inspection Time: 2:00pm	Bond Amount: \$50,000
Attendee(s): Brent Sumsion & Bryson Clyde, WW Clyde; <input checked="" type="checkbox"/>	Weather:	Bond Escalation: 05/10/2015
Inspection Purpose: Operator requesting bond release		Prior Inspection: none

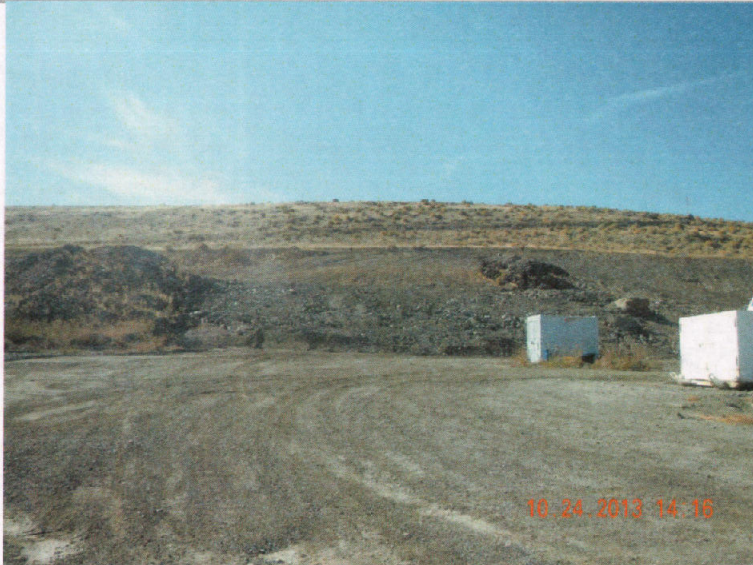
7. <i>Backfilling/Grading (trenches, pits, roads, highwalls, shafts)</i> Grading of excavated hillside slope is complete. There are a few remaining rock outcrops that were not disturbed and are stable.	<input checked="" type="checkbox"/>	<input type="checkbox"/>

Regraded cut in hill slope; undisturbed rock outcrops remaining; utility shed

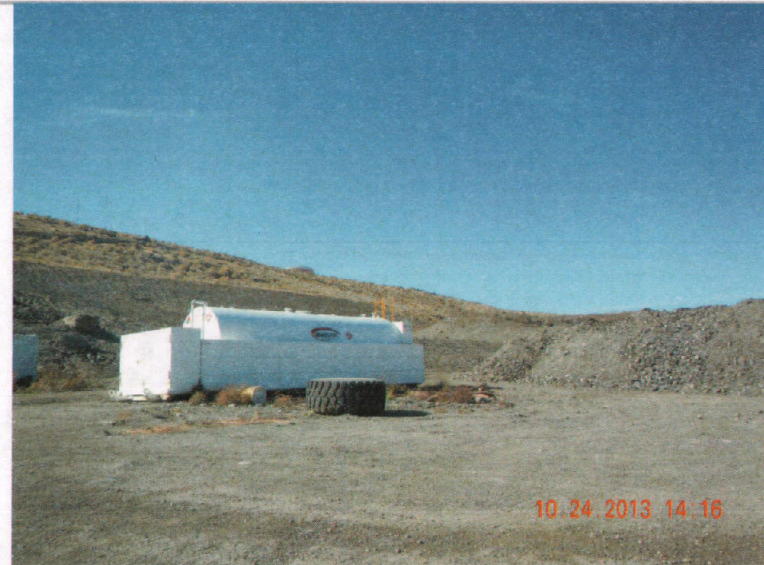
4. <i>Deleterious Material</i> Facility still has a fuel tank on site that needs to be removed prior to bond release.	<input checked="" type="checkbox"/>	<input type="checkbox"/>

View of remaining fuel tank and portion of rock/gravel stockpile

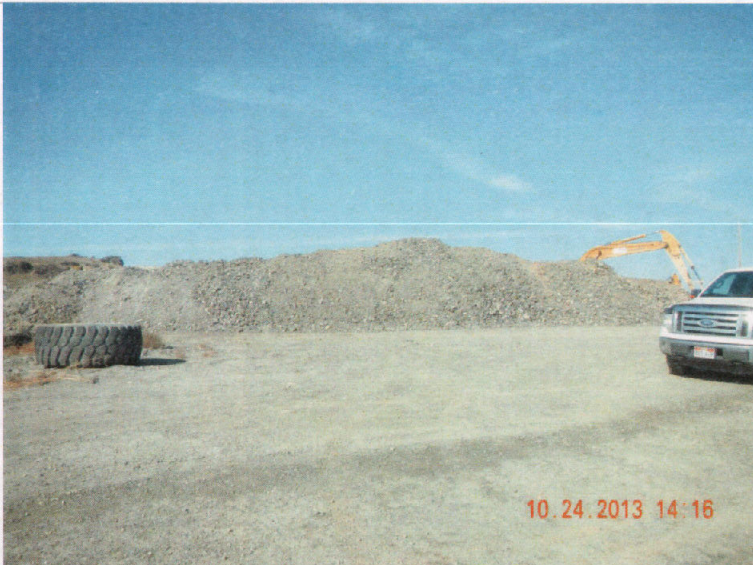
Remaining rock stockpile with trackhoe for loading

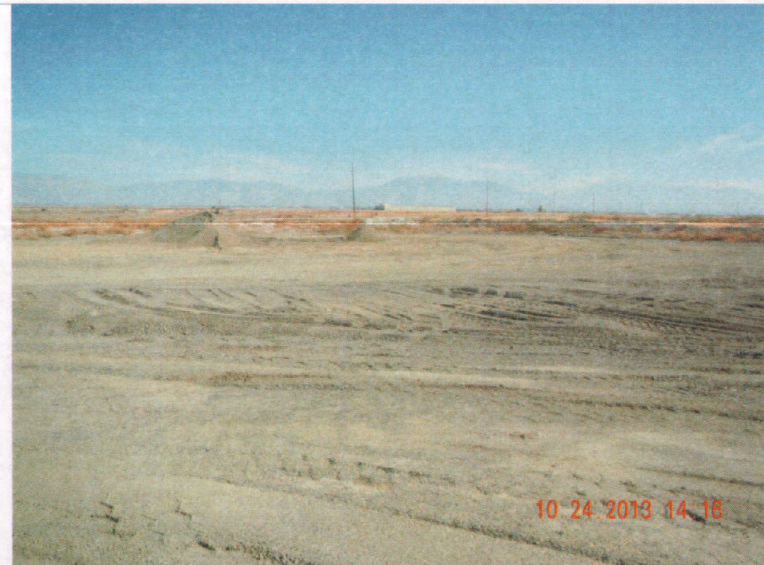
8. <i>Soils</i> Topsoil stored in perimeter berms needs to be redistributed over disturbed surface prior to seed application. Most of topsoil should be applied to the regraded slope.	<input checked="" type="checkbox"/>	<input type="checkbox"/>

Disturbed flat area with remaining gravel piles and perimeter topsoil berms

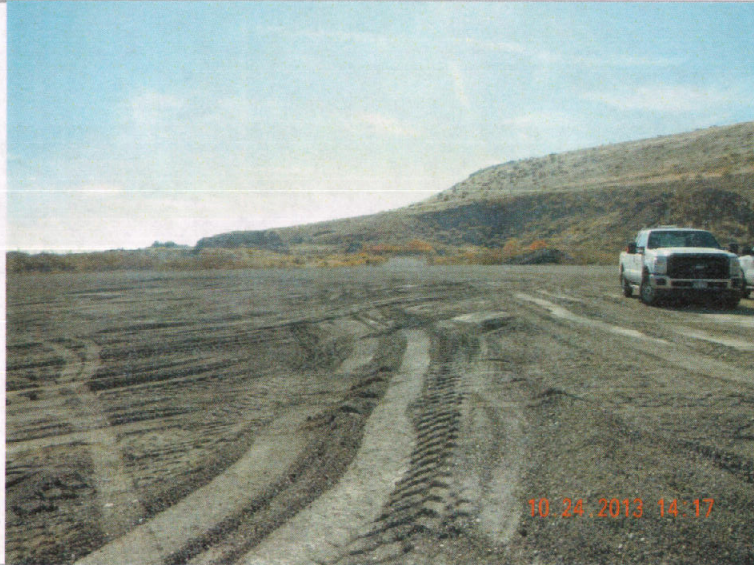
Disturbed flat area with perimeter topsoil berms; excavation in background is pre-existing, not related to this site

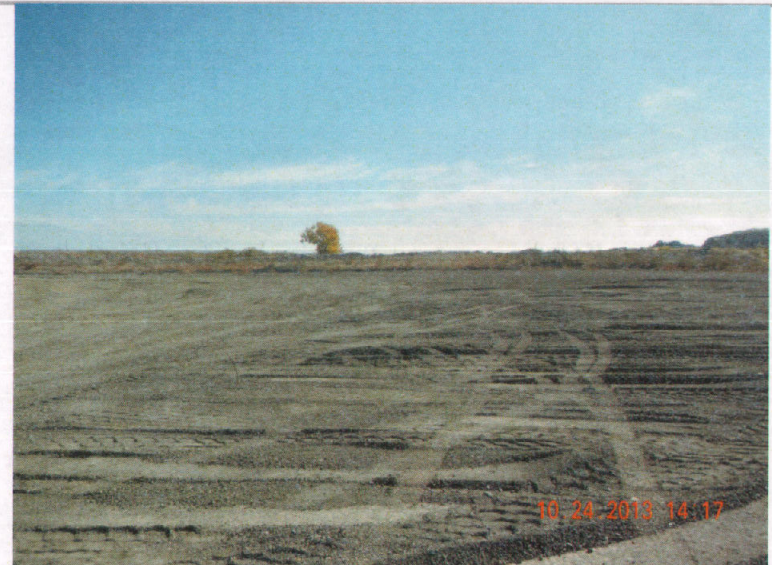
View from center of site to the southeast with topsoil perimeter berms and heavily trafficked flat area.

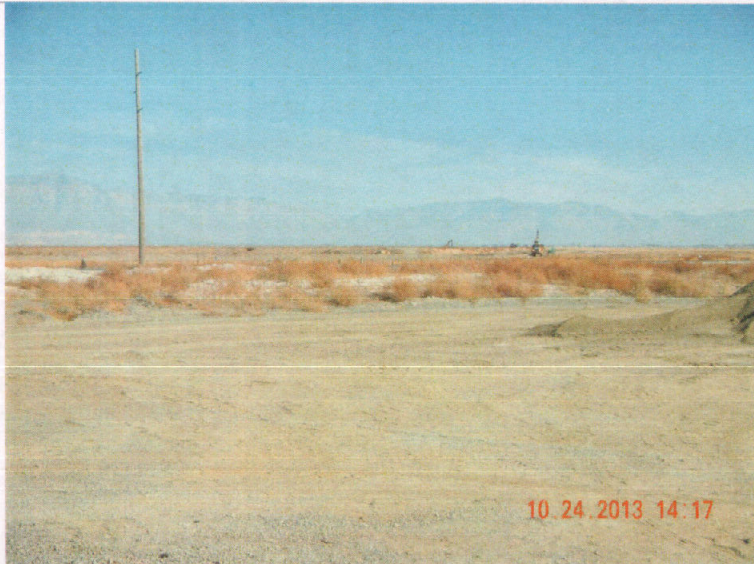
View across road to where material was used to create dikes for ponds related to Western Zirconium production

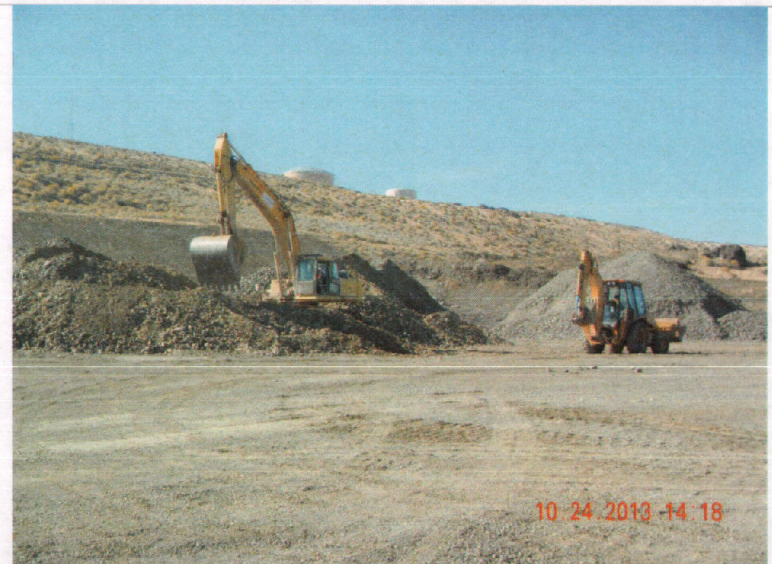
Remaining stockpiles of rock and gravel, with loading equipment
