**Geologic Hazards Screening Assessment
Lot 70R Summit Eden Phase 1C
8492 East Spring Park Road
Eden, Utah
Parcel # 23-130-0037**

GeoStrata Job No. 594-005

July 17, 2018

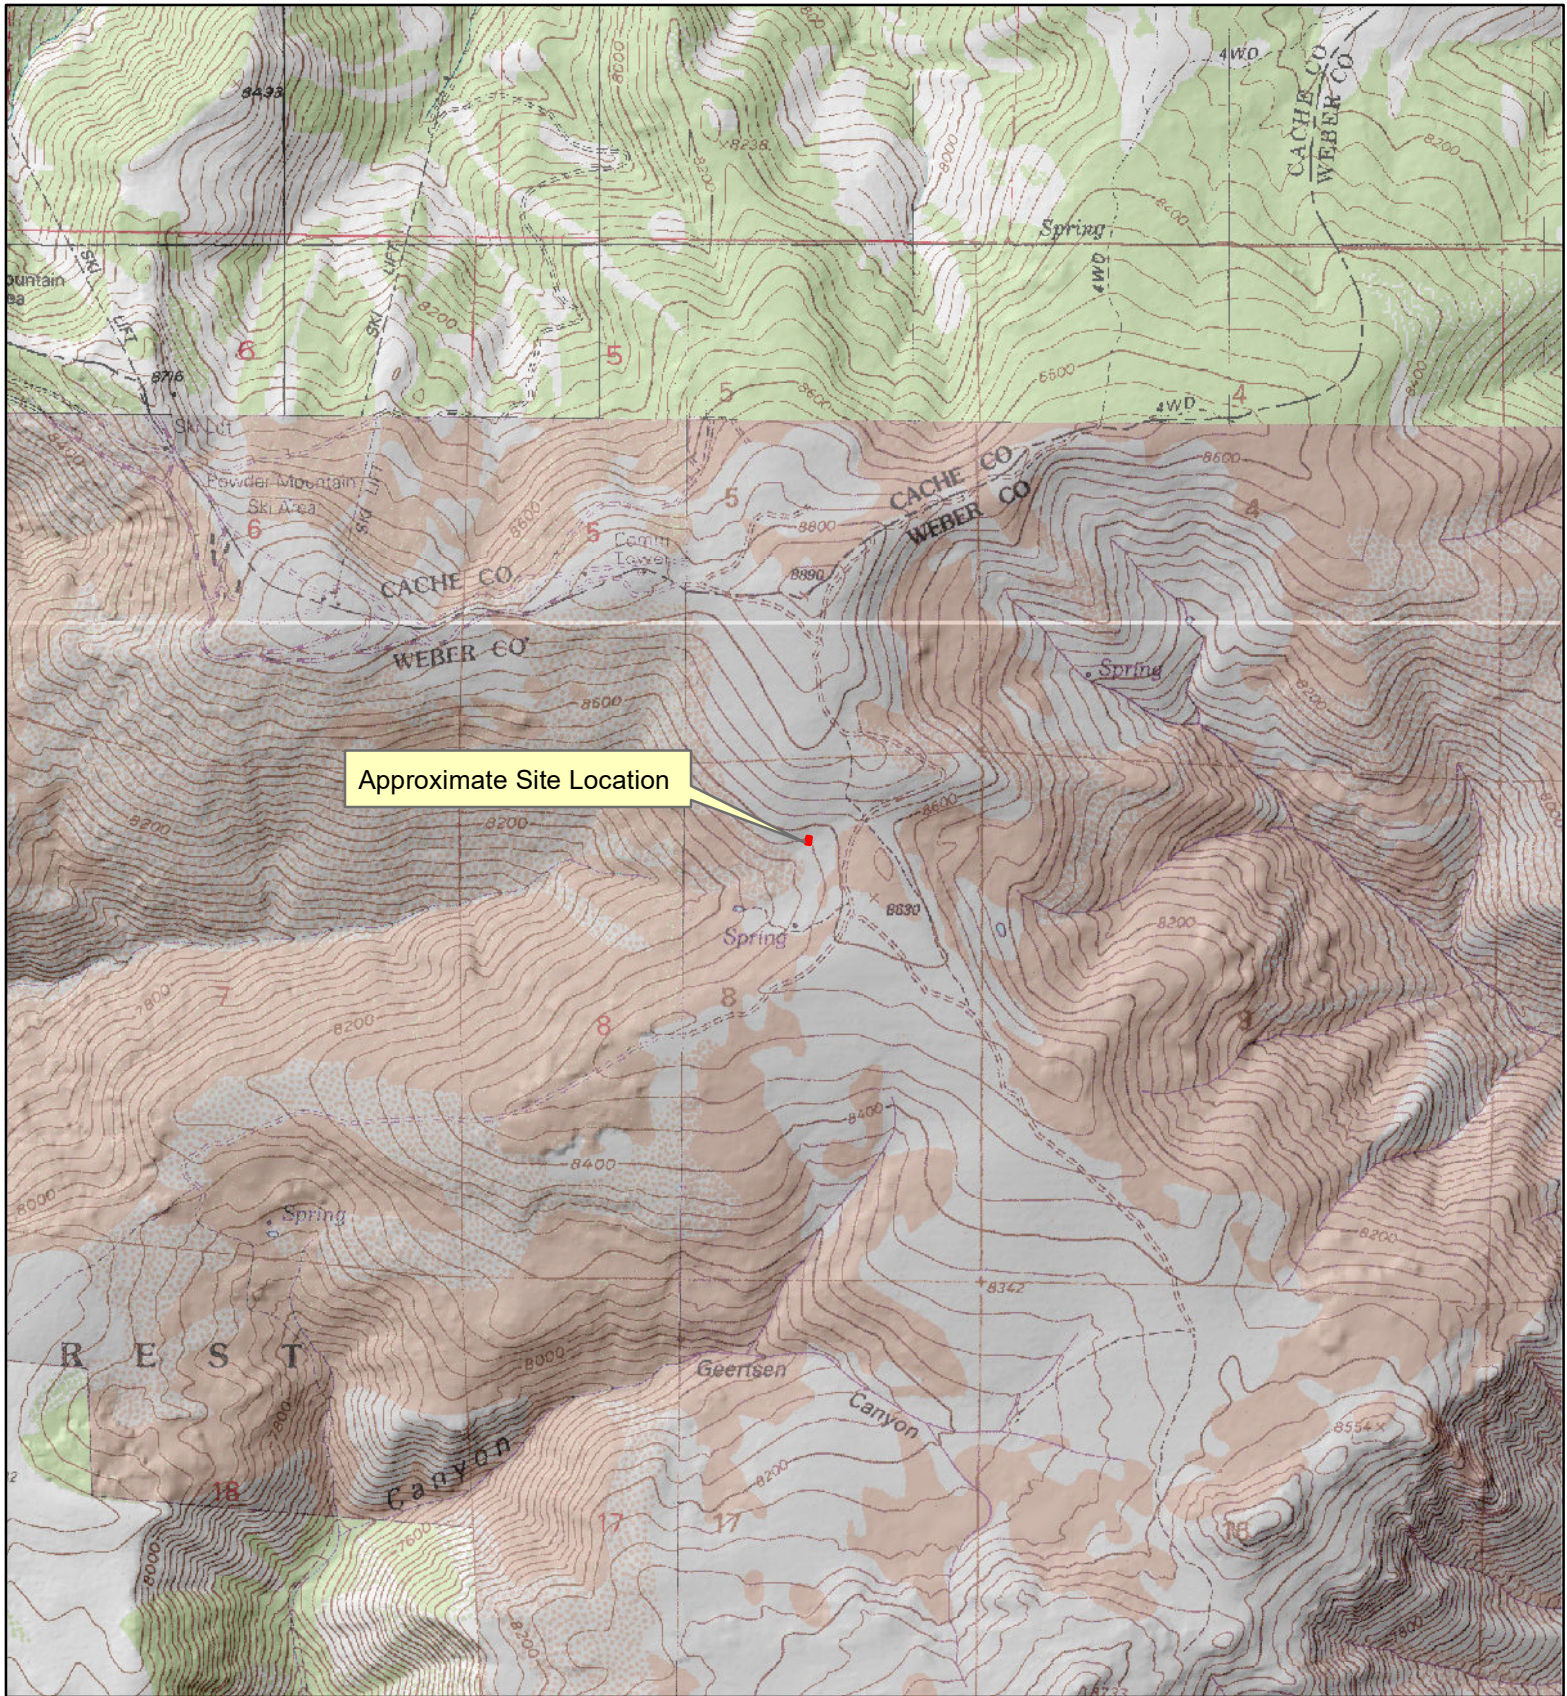
Plate
2

Slope stability of the subject site was not assessed as part of this geological hazard assessment. The subject site was observed to be moderately to steeply sloping to the south toward a nearby drainage (Plate 2 Topographic Map). The possibility that development of the site could negatively affect slope stability within the subject site is increased if development is planned for areas of the site with slopes steeper than approximately 3 horizontal: 1 vertical. It should be noted that grading or development adjacent to the subject site could potentially impact the stability of the area within the subject site and assessment of that hazard is out of the scope of this assessment.

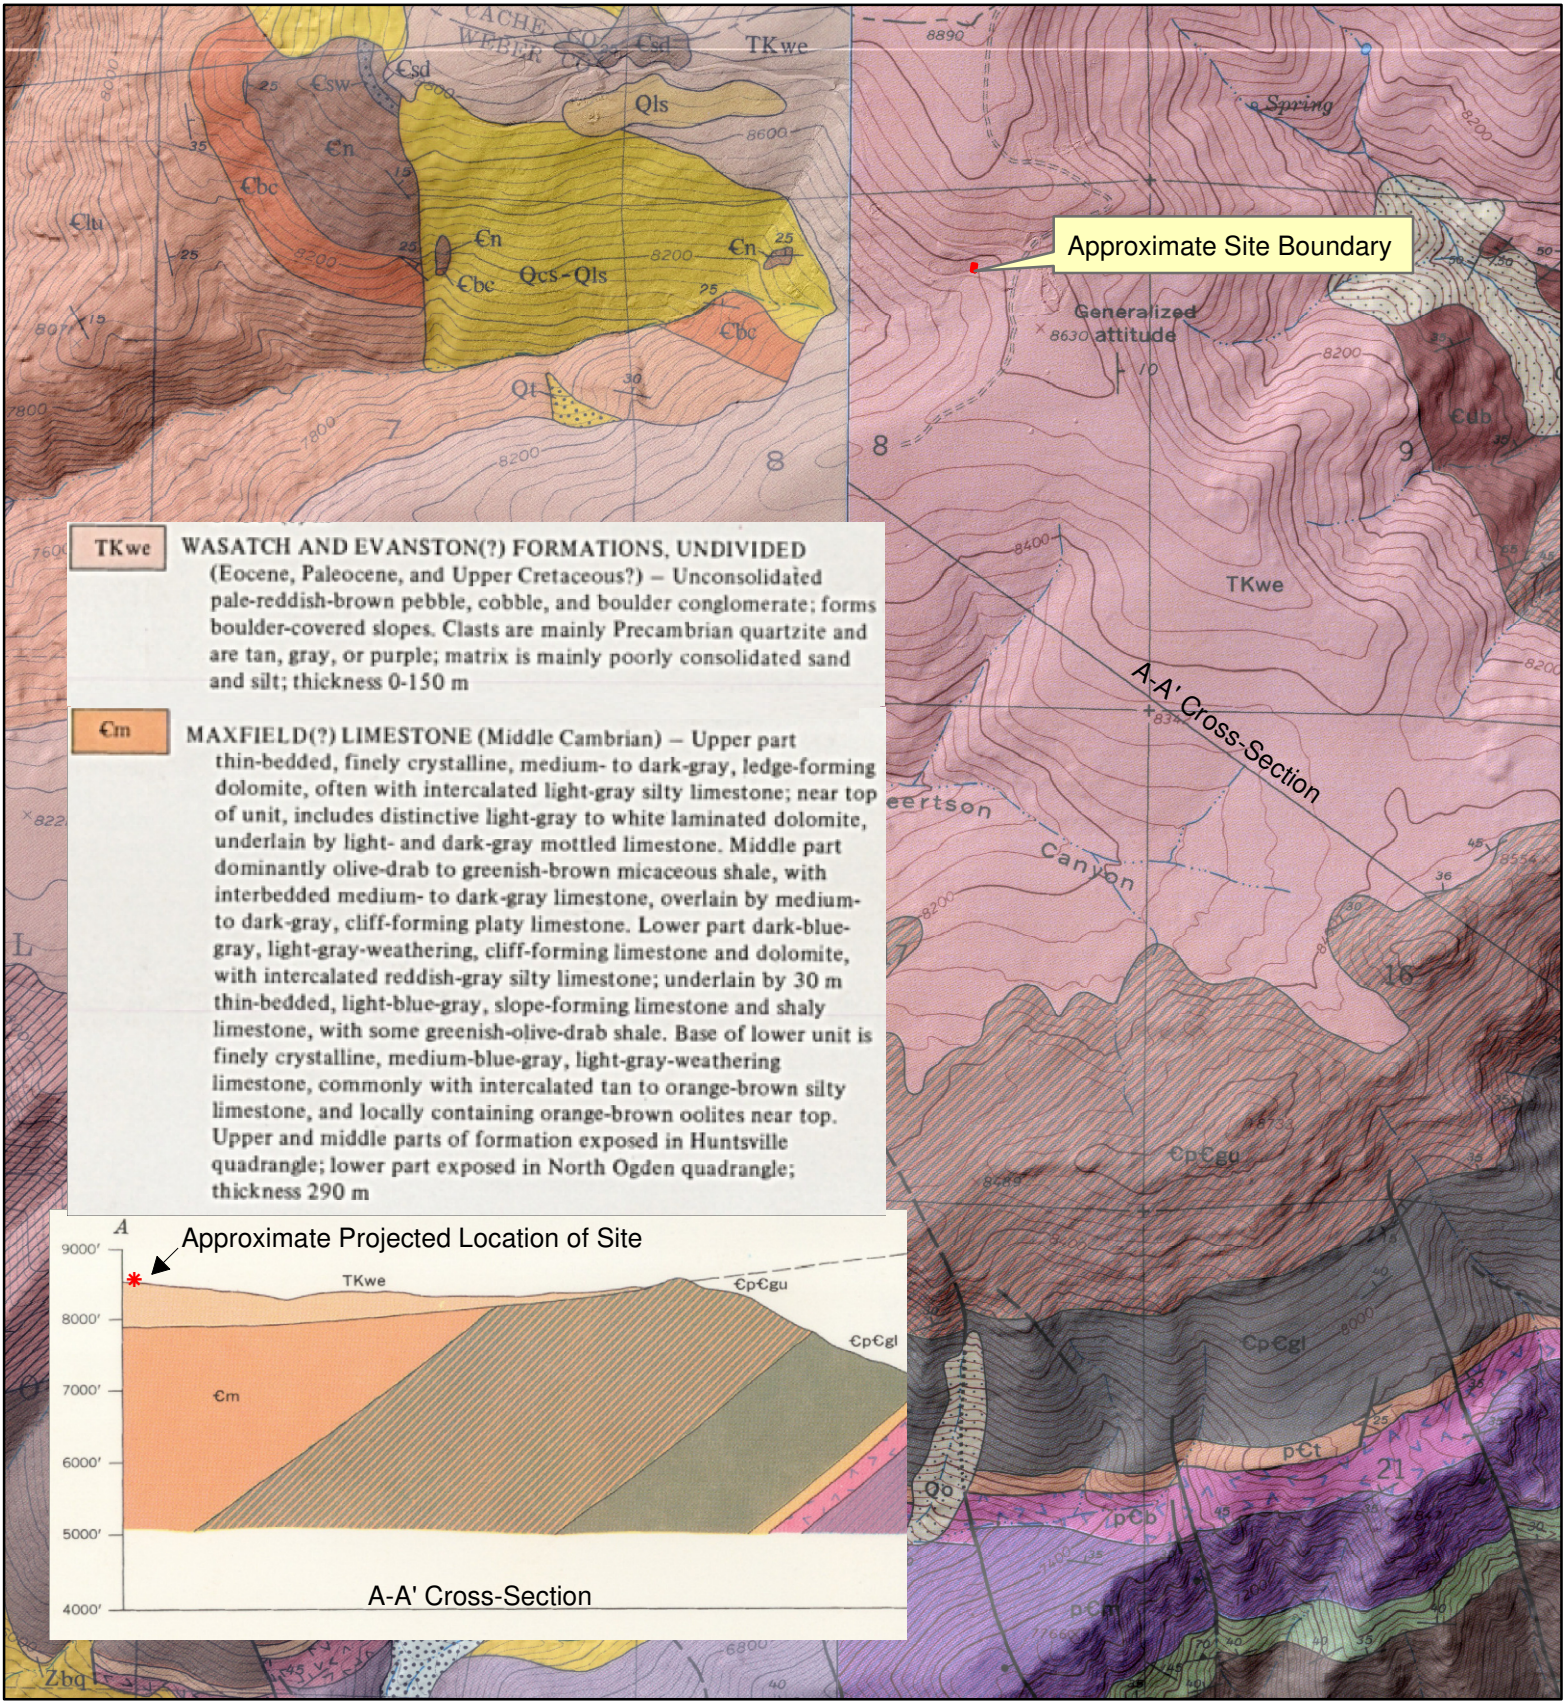
Plate
4

Based on review of published geologic maps, review of stereographic aerial photographs and hillshades derived from 2016 0.5 meter LiDAR, no Holocene age alluvial fan deposit is mapped within or adjacent to the subject site (Plate 4 Site Vicinity Geologic Map; Plate 5 Site Vicinity 30’ X 60’ Geologic Map). Given our field and office investigations, the alluvial fan flooding hazards within subject site is considered low and it is considered unlikely that debris flows will

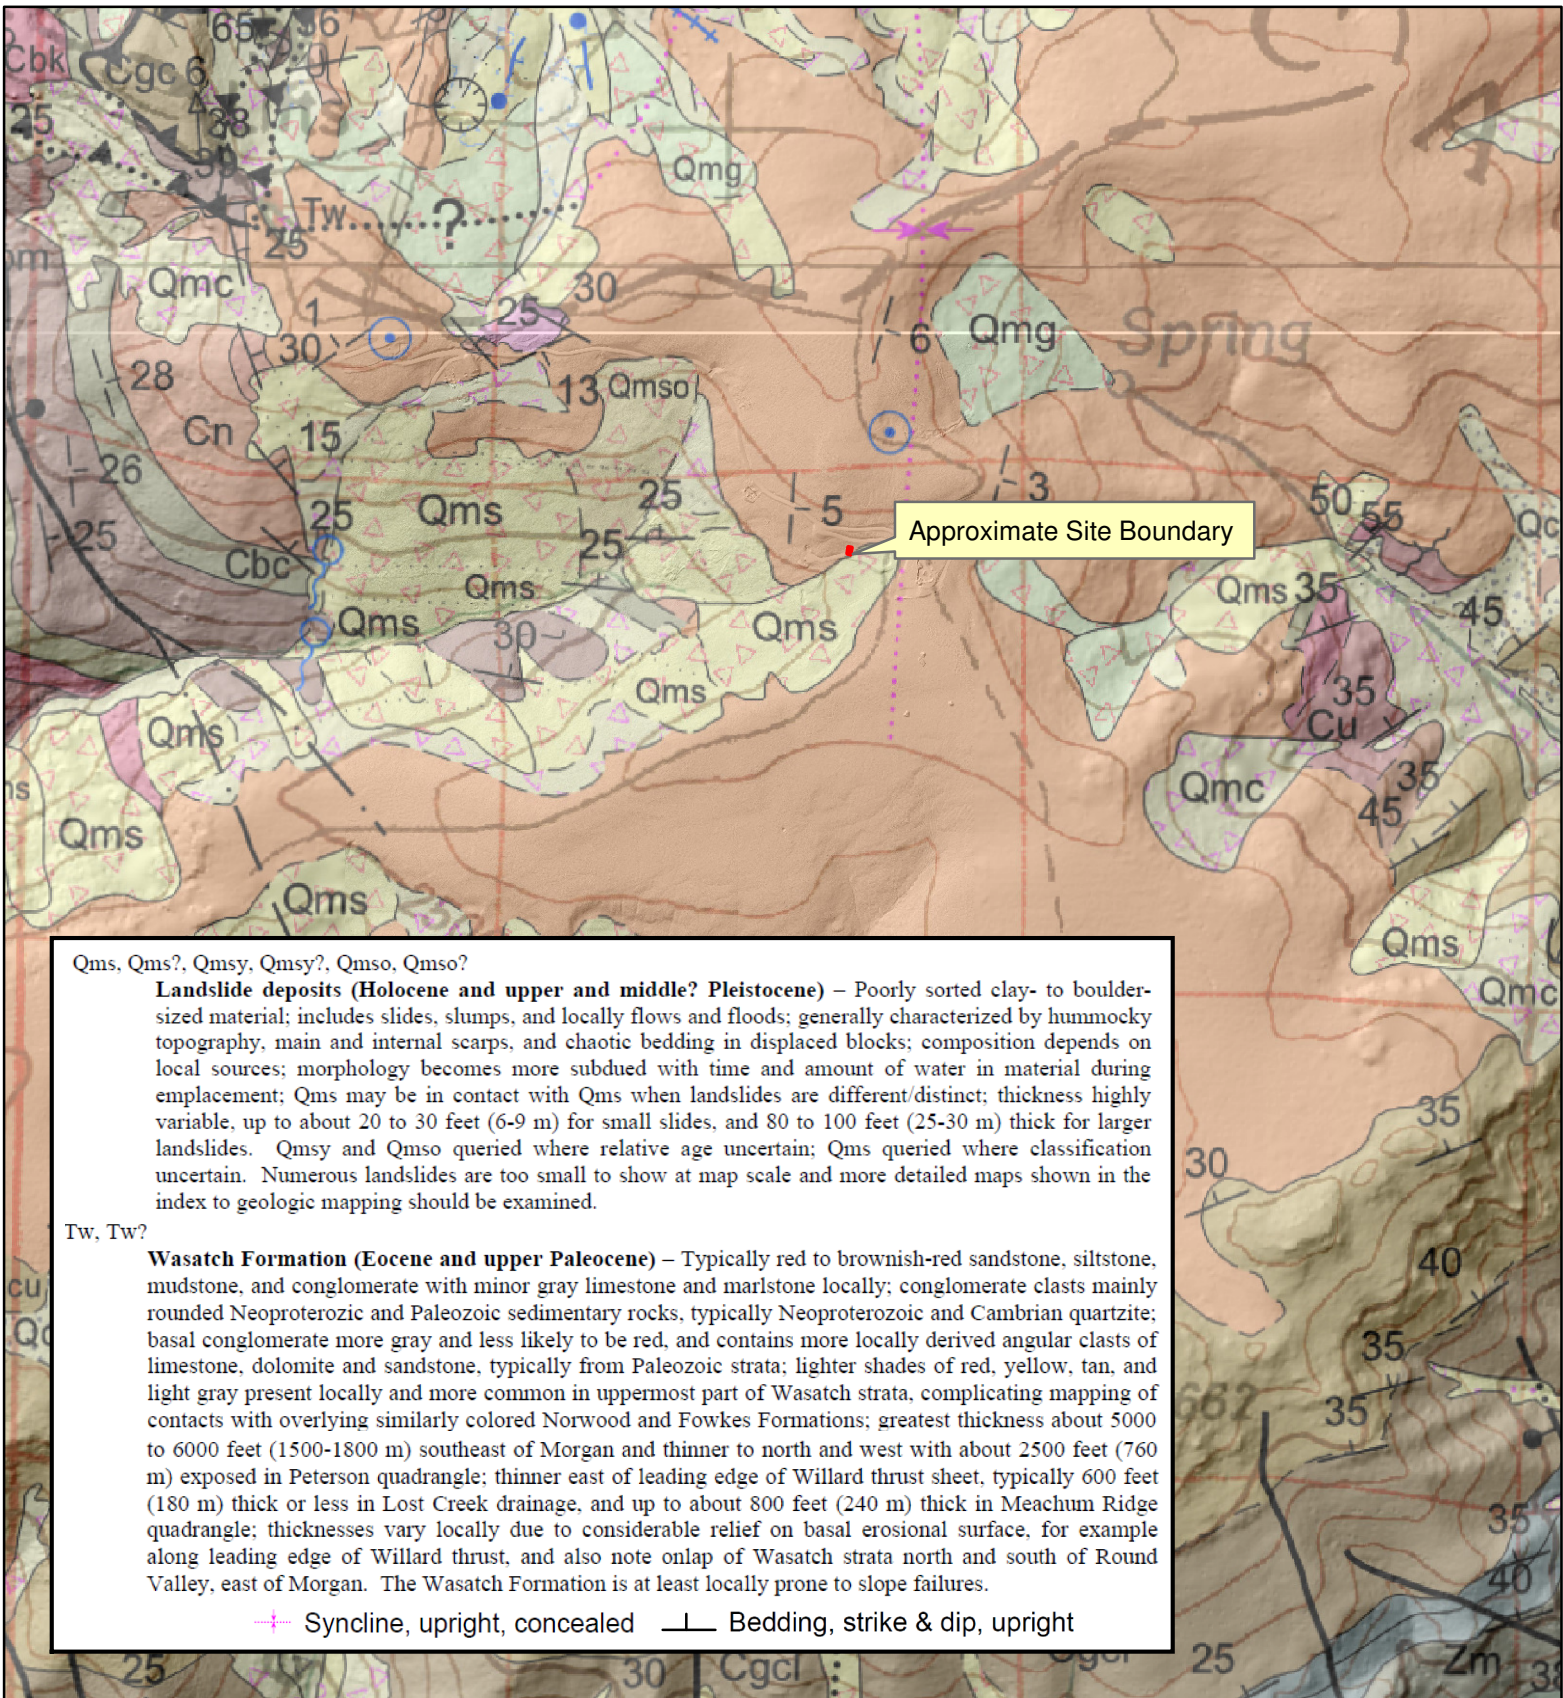
**Plate
5**

Based on review of the Interim Geologic Map of the Ogden 30x60 Quadrangle, a landslide deposit (Qms) is mapped immediately south of the subject site (Plate 5 Site Vicinity 30x60 Geologic Map). A deposit described as landslide undifferentiated from talus and/or colluvial is mapped south and in the vicinity of the subject site as shown on Plate 7 Landslide Hazard Map. No landslide deposit is mapped within or immediately adjacent to the subject site on the Geologic Map of the Browns Hole and Huntsville Quadrangles as indicated on and Plate 4 Site Vicinity Geologic Map. A trench trending north-northwest to south-southeast through the middle of the subject site and at a depth of approximately 5 to 9 feet below existing site grade was excavated as part of the geotechnical study compiled for the subject site. Geologic observations of the near surface geology in the trench exposure were made during our site visit. It is the opinion of GeoStrata that the soils observed in the trench were observed to comprise of colluvium deposits. No shears or deformation features related to a landslide deposit were observed in the trench. Based on our stereographic aerial photograph interpretation, our review of the hillshades derived from 2016 0.5 meter LiDAR and our field observations, no landslide features such as hummocky topography, slumps or scarps were identified within the subject site or observed in the trench excavation. The subject site was observed to be moderately to steeply sloping and to contain outcroppings of well-rounded quartzite cobbles and boulders that were partially buried. Based on the landslide mapped south of the subject site and the moderate to steep grade within the subject site, it is the opinion of GeoStrata that the landslide hazard within the subject site is considered low to moderate. GeoStrata recommends that a slope stability analysis be performed by a professional engineer as part of a comprehensive site specific geotechnical investigation to assess the potential for slope failure. Slope stability modeling should take landslide deposits and potential landslide deposits into consideration and evaluate all portions of the subject site being considered for development to provide recommendations for construction that will aid in reducing the risk for mass movement within the subject site.

Due to the presence of a mapped landslide deposit near the subject site and the steep grade observed within the subject site, GeoStrata recommends that a geotechnical report that evaluates the slope stability within the subject site is conducted prior to any development. It is the opinion of GeoStrata that landslide hazards should not preclude development at the subject site as long as
