**GEOTECHNICAL AND GEOLOGIC HAZARD INVESTIGATION**  
**Lot 79R of Summit Eden Phase 1C**  
**8469 E. Spring Park Road**  
**Summit Powder Mountain Resort**  
**Weber County, Utah**

IGES Project No. 02904-001

October 30, 2018

**Kelsey Klinefelter and Josh Klinefelter**

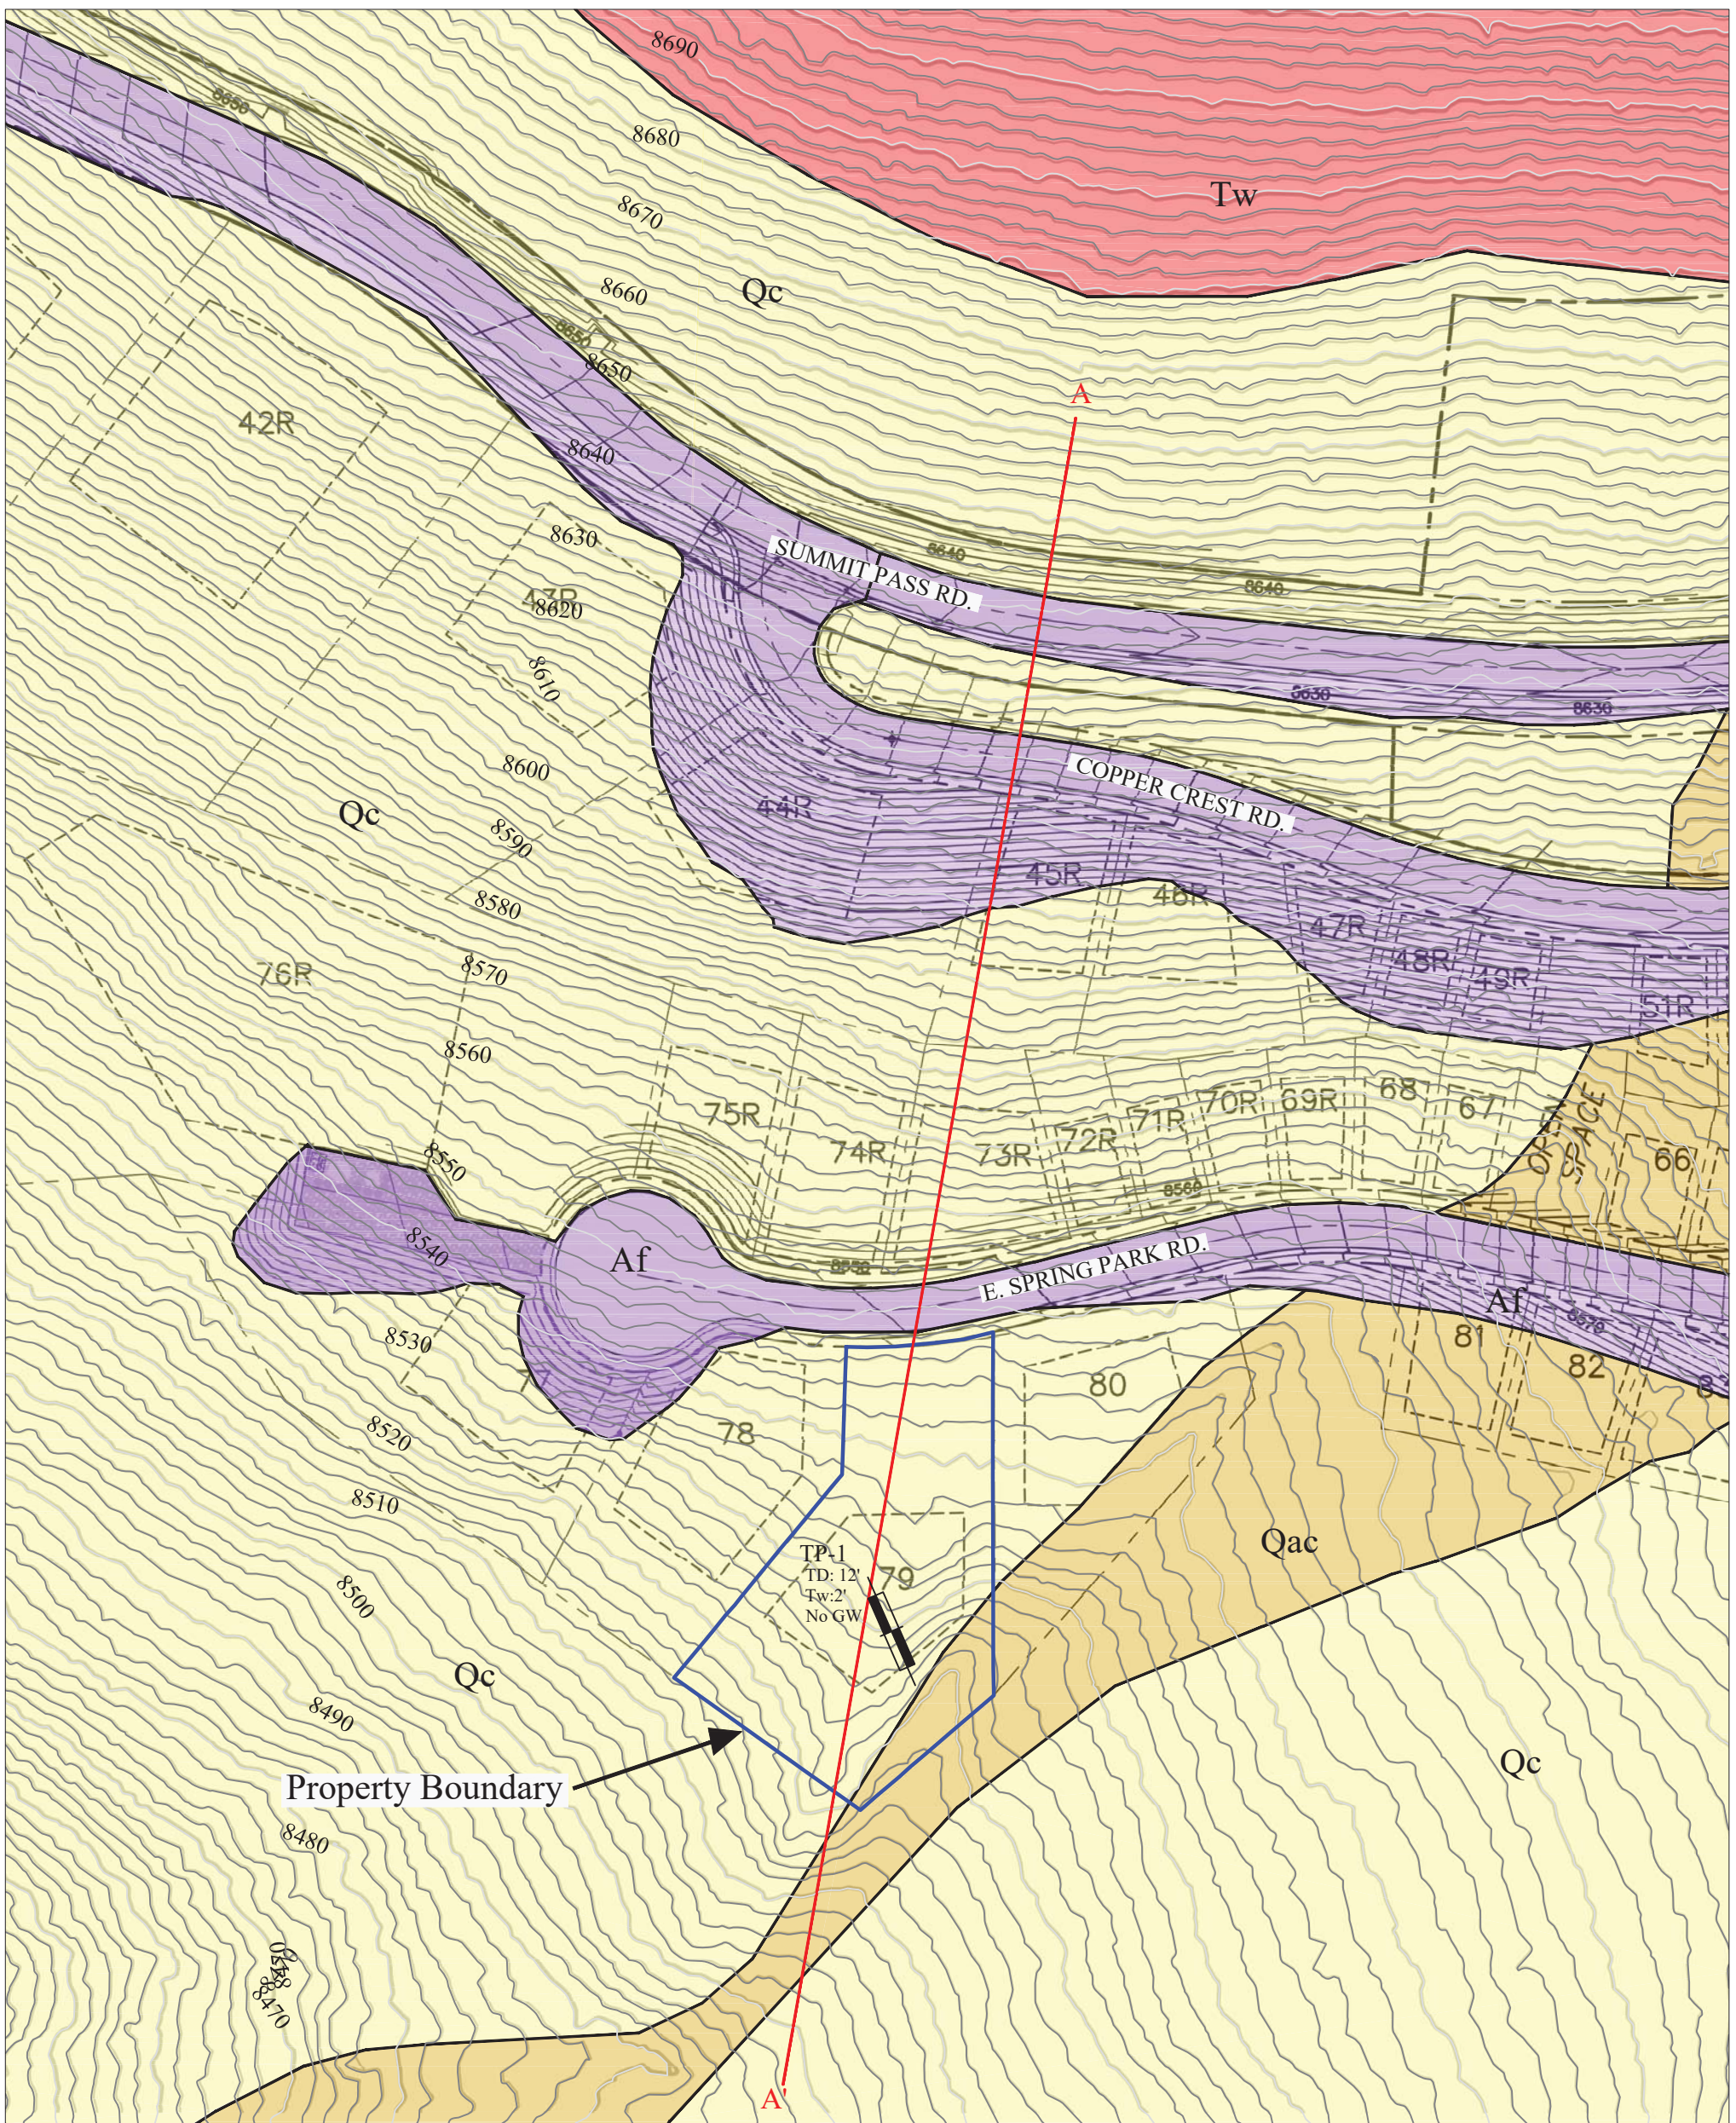
**Geotechnical and Local Geology Map**

At the time of the site reconnaissance, the lot was in a relatively natural state and was largely covered with vegetation, including aspens, grasses and shrubs. Common variously-sized quartzite cobbles and boulders were observed across the site, with the maximum clast size observed to be approximately 3 feet in diameter. The surface topography was observed to consistently slope downhill to the southwest.

No springs, seeps, or running water were observed on the property at the time of the site visit. No adverse geologic conditions were observed on the property at this time.

On August 29, 2018, a single exploration test pit was excavated in the south-central portion of the lot (see Figure A-5). The test pit was excavated to a depth of approximately 12 feet below existing grade with the aid of a Caterpillar 315C tracked excavator. Upon completion of logging, the test pit was backfilled without compactive effort. A detailed log of the test pit is displayed in Figure A-6. Three distinct geologic units were encountered in the subsurface. The soil and moisture conditions encountered during our investigation are discussed in the following paragraphs.

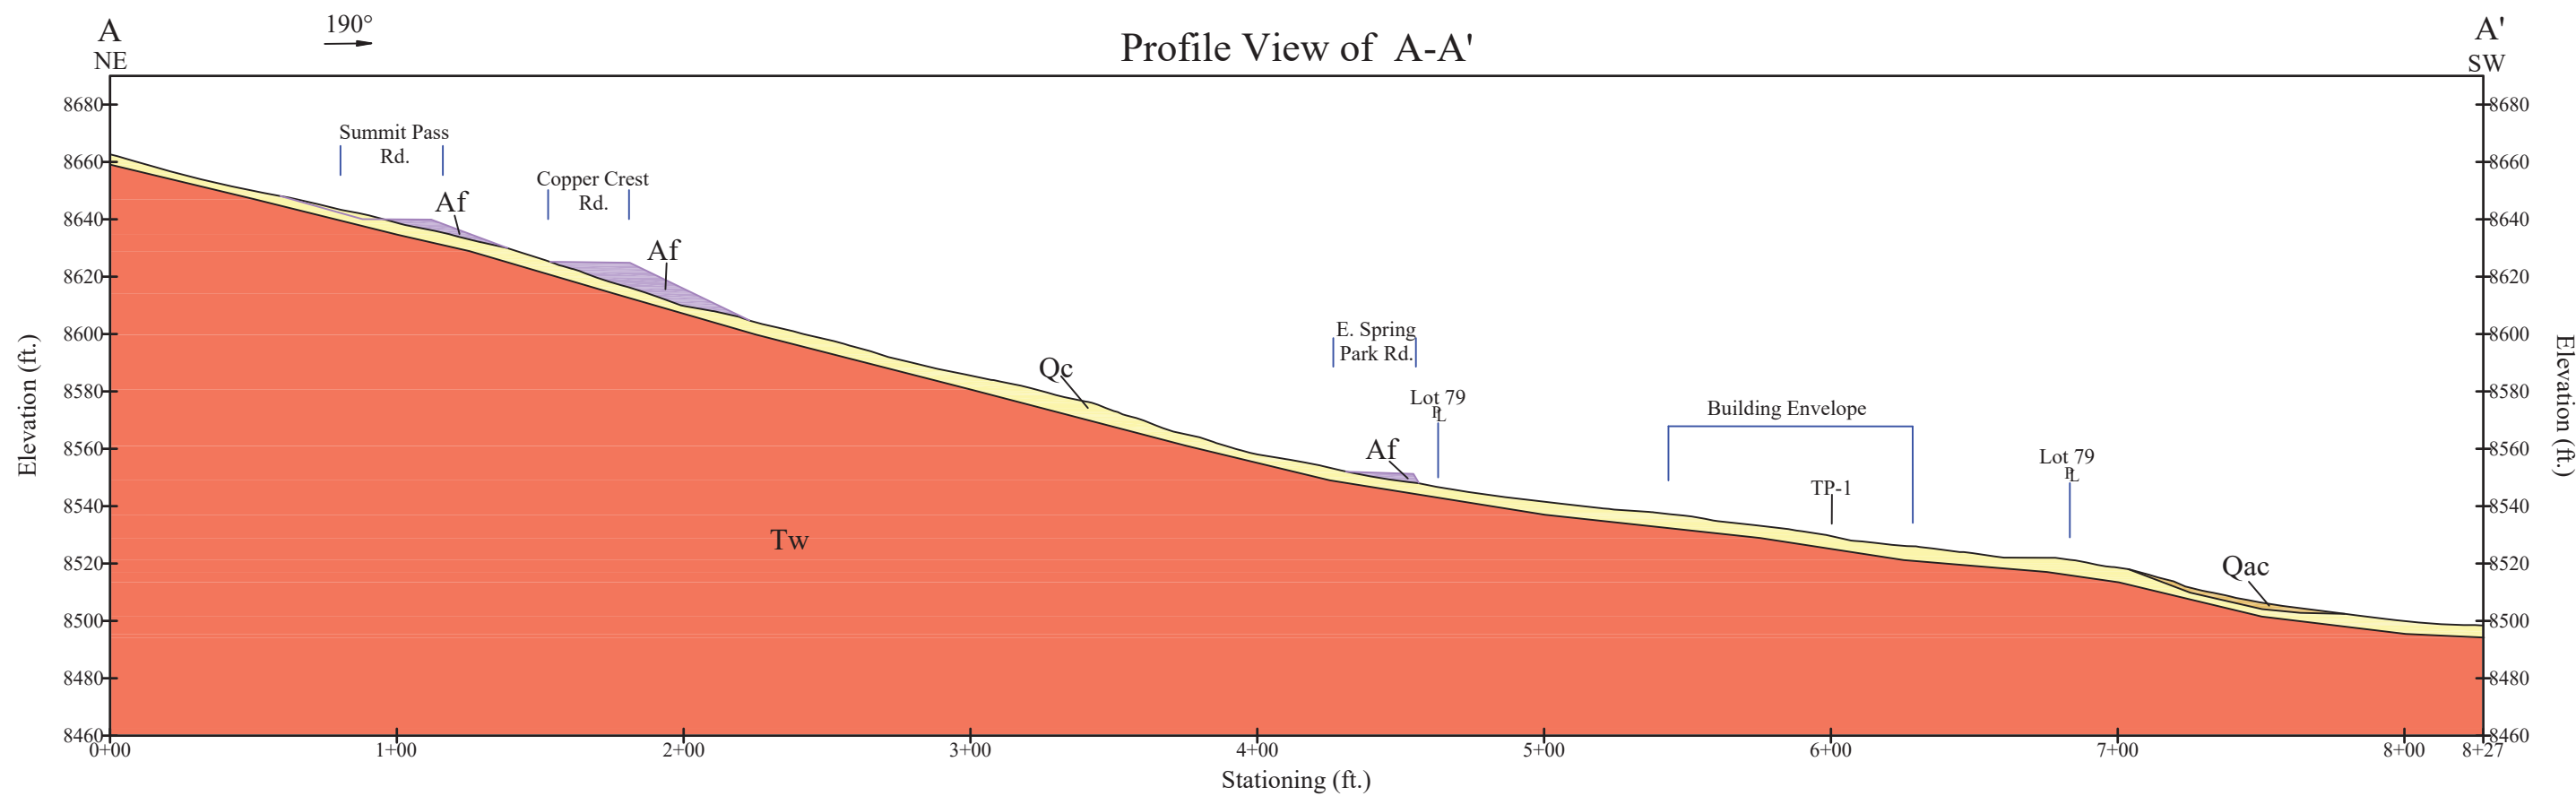
### Profile View of A-A'

The results of the analysis indicated the existing conditions meet the minimum required factors-of-safety of 1.5 and 1.0 for both the static and seismic (pseudo-static) case, respectively. The planned improvements will likely include a basement level, which would tend to unload the slope and further improve the stability of the slope; significant fill placement on the slope, which would tend to load the slope and decrease stability, is not anticipated. A summary of the slope stability analysis is presented in Appendix D.

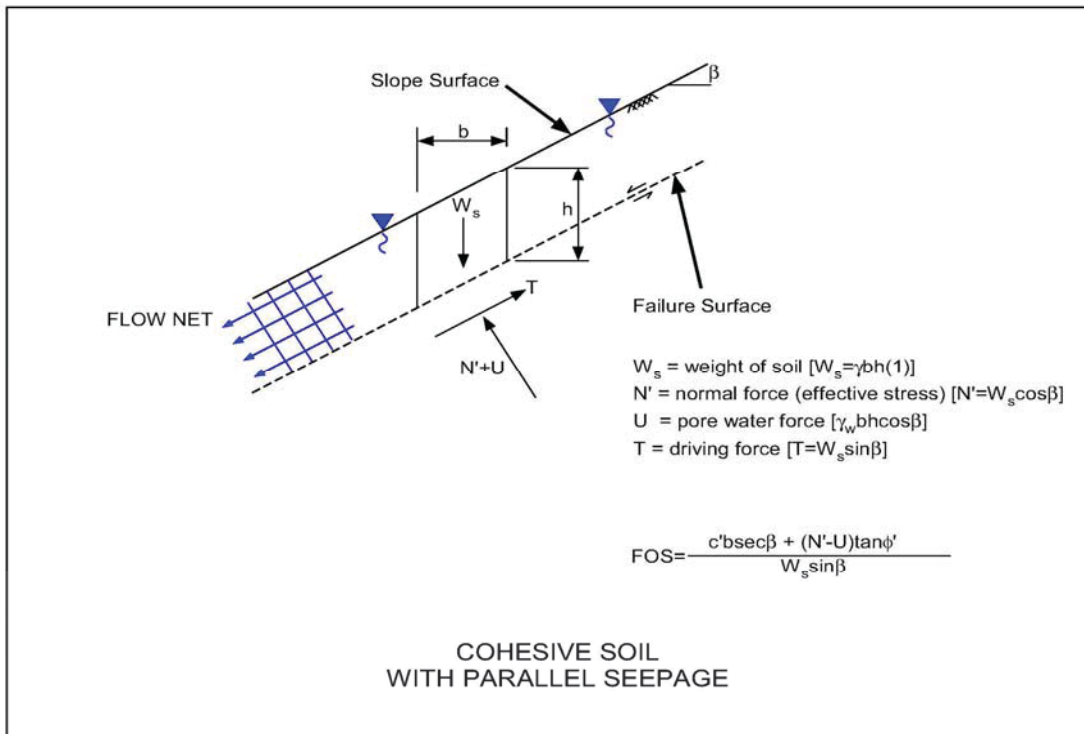
Figure D-2

IGES assessed the potential for the upper 2 feet to become mobilized under saturated parallel seepage conditions. Our assessment assumes 2 feet of clayey colluvium and/or topsoil, fully saturated, and a 3H:1V slope (this would be a transient condition that could occur during primary spring run-off and snowmelt). Our model assumes an estimated effective friction angle of 30 degrees and a cohesion of 50 psf, and a saturated unit weight of 136 pcf. Based on this model, a factor-of-safety of 1.55 results. Sample calculations are presented in Appendix D.

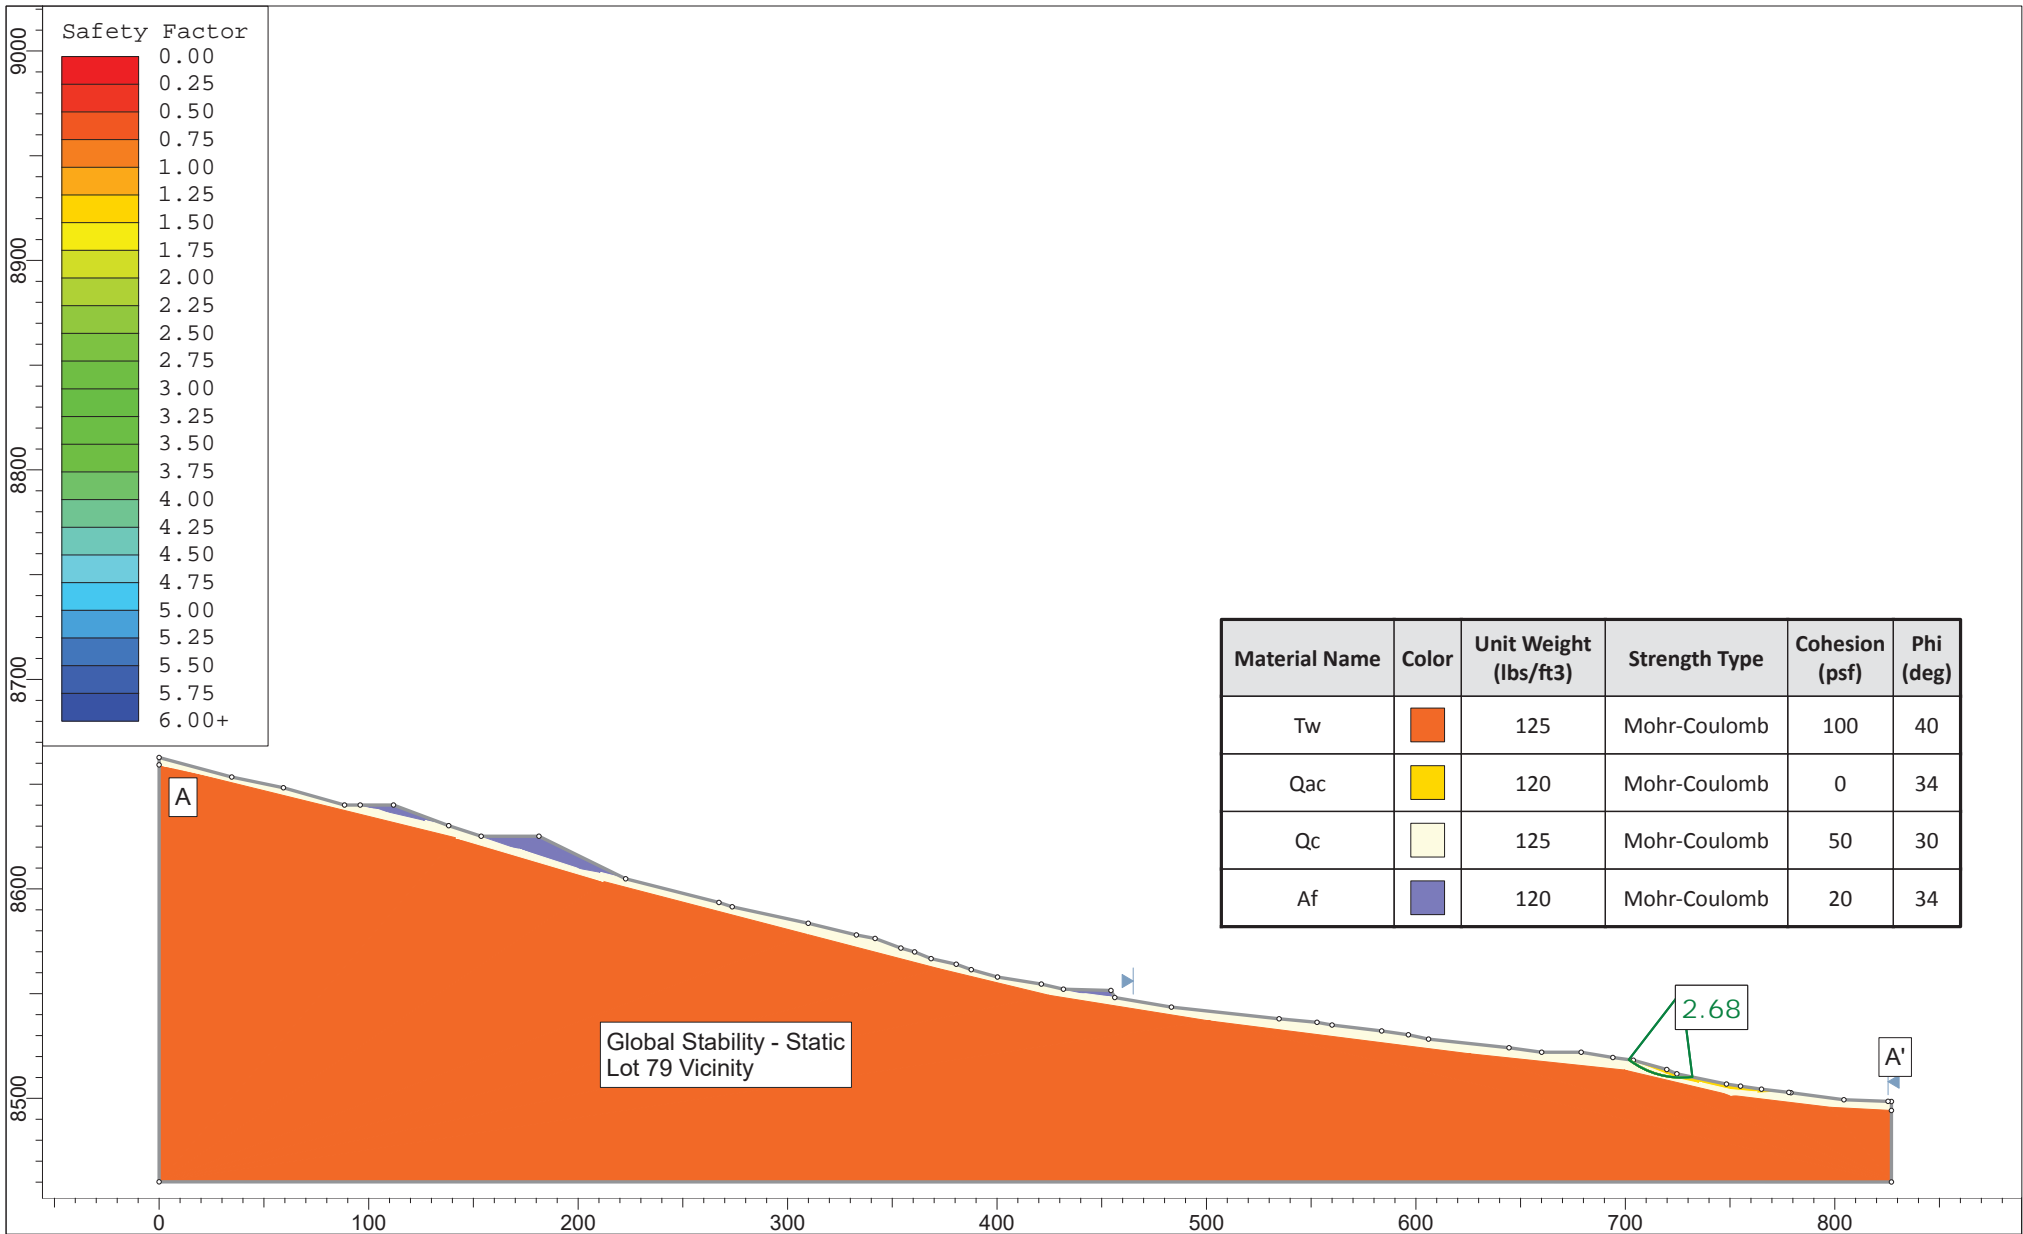
Project				Lot 79R of Summit Eden Phase 1C	
	Analysis Description				A-A' 02904-001	
	Drawn By	EBF	Scale	1:1100	Company	IGES Inc
	Date	10/30/2018	File Name	A-A'.slim

Analysis	Static Factor of Safety	Pseudo-Static Factor of Safety
Existing Condition, circular	2.68	1.53
