**GEOTECHNICAL AND GEOLOGIC HAZARD INVESTIGATION**  
**Lot 86R of Summit Eden Phase 1C**  
**8549 E. Spring Park**  
**Summit Powder Mountain Resort**  
**Weber County, Utah**

IGES Project No. 03091-001

July 1, 2019

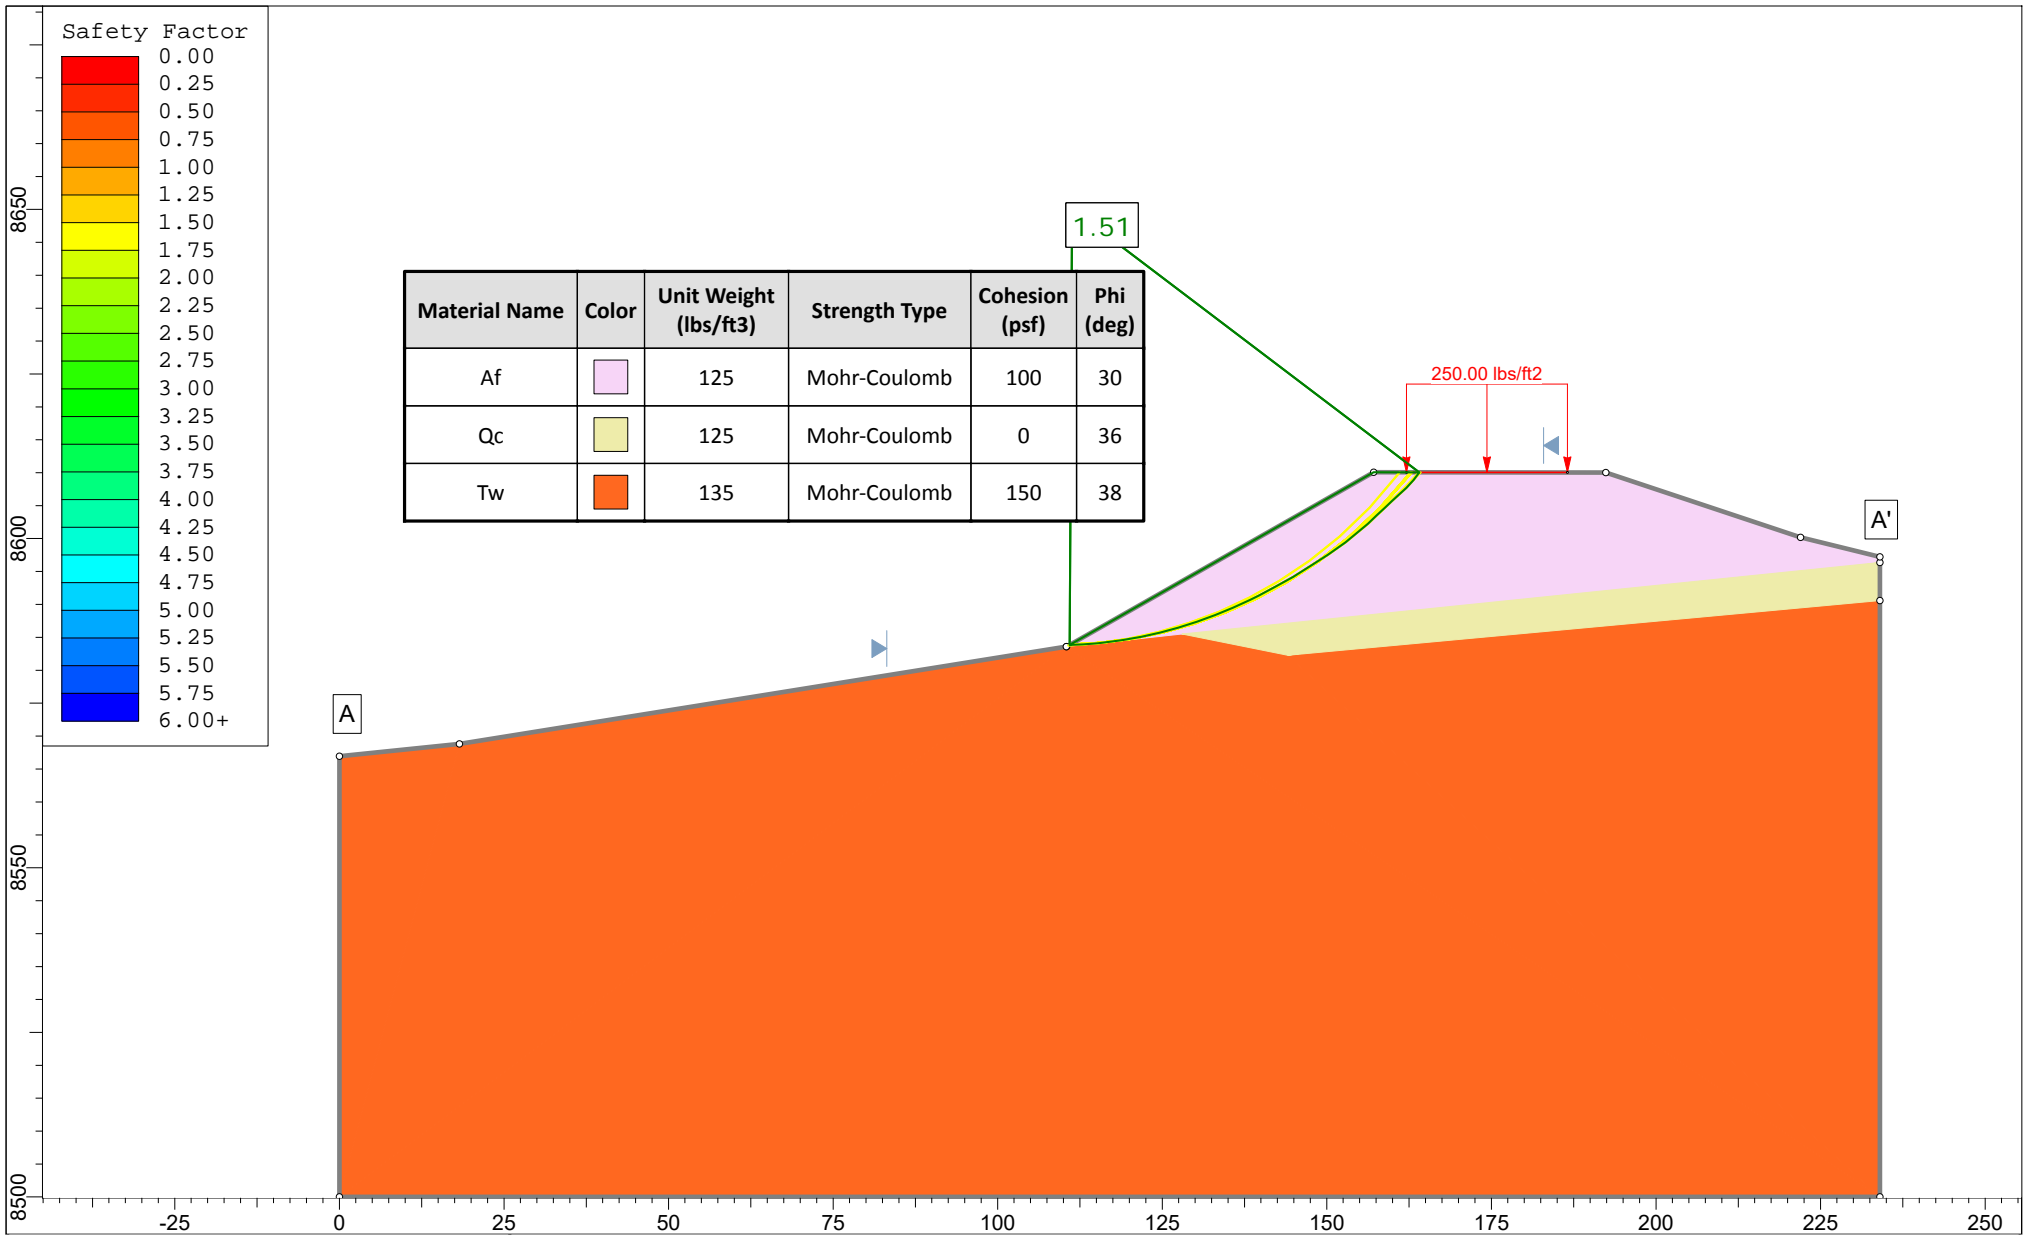
Project			Lot 86R - Kingsbury	
	Analysis Description			Method : Spencer	
	Drawn By	EBF	Scale	1:350	Company
	Date	07/01/2019	File Name	A-A'.slim

Spring Park is located at the top of the slope; accordingly, a traffic surcharge of 250 psf has been modeled for static conditions. The new home is expected to have a subterranean component, constructed *into* the slope, not on the slope; therefore, hence a surcharge load from the home was not included in the analysis.

Soil strength parameters were selected based on soil types observed, local experience, correlation with index properties (Atterberg Limits, clay content), and comparisons with soil strength laboratory data from a nearby sites. Based on this assessment, the following soil strength parameters were selected for this analysis:

Section	Static Factor of Safety	Pseudo-Static Factor of Safety
Existing Condition	1.51	1.02

The results of the analysis indicate the existing conditions meet the minimum required factors-of-safety of 1.5 and 1.0 for both the static and seismic (pseudo-static) case, respectively. A summary of the slope stability analysis is presented in Appendix D.
