## UPDES STORM WATER INSPECTION FORM

RE: The Summit at Ski Lake 10

Random Storm Water Inspection performed of the site on September 23, 2010.

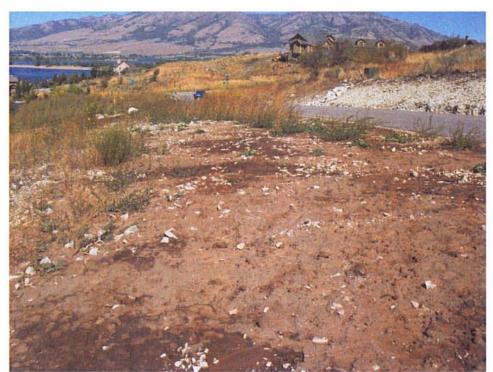
Downhill side of road is not stable

Site Name: The SUMMIT at 94 Lake 10 Date of Evaluation:	923/2010					
Detail Report Identify the problem and its location. If appropriate, describe (in general terms) what needs to be completed. However, only if qualified (e.g., you are a designer) should you be mandating specific BMPs to install.	Correction due by:					
"post swppp wil required documentation (b)-weekly's inspections)	9/23/2010					
Estabaltie enosion on downill side of va	9/23/2010					
3

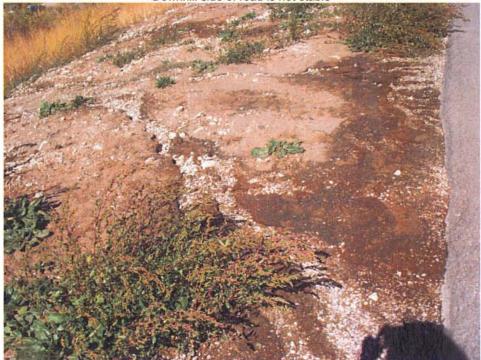
Erosion is evident

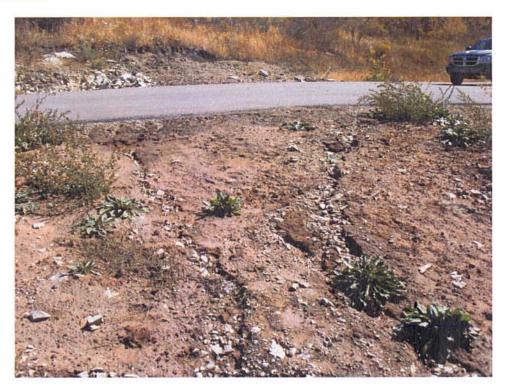
6. Are off-site flows entering the construction site?		X	
7. Is there evidence of, or the potential for, increased pollutant (i.e., sediment, fuel, concrete waste, portable toilet waste, etc.) loading to enter the storm water conveyance system as a result of the lack of maintenance or improper BMP installation?	X		reels have formed on the down hill side of ragsediments

Reels have formed due to the erosion

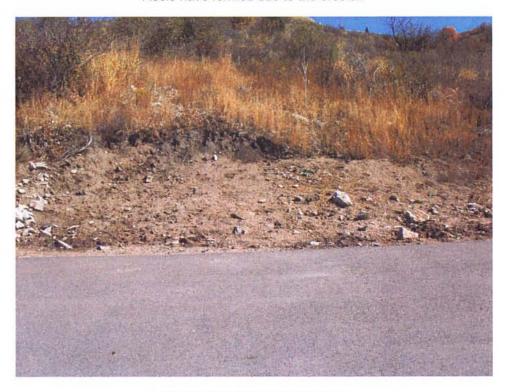
Uphill side of road is not stable

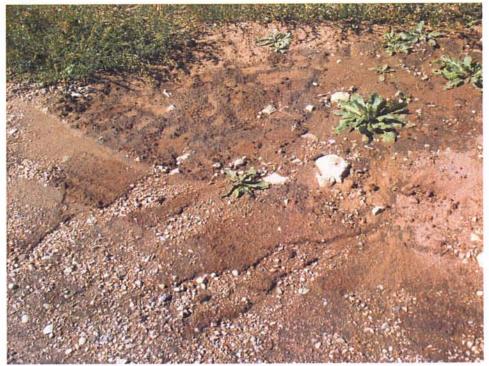
Sediment has occurred from the erosion
