REPORT # 1

SHB Job No. E92-2167

Re: Report  
Slope Stability Reconnaissance  
Lots 7, 8, 9, 10, and 11  
Eastwood Subdivision No. 8  
Uintah, Weber County, Utah  
For Ms. Janet B. Bean

Re: Report - Addendum  
Slope Stability Reconnaissance  
Lots 7, 8, 9, 10, and 11  
Eastwood Subdivision No. 8  
Uintah, Weber County, Utah  
For Ms. Janet B. Bean

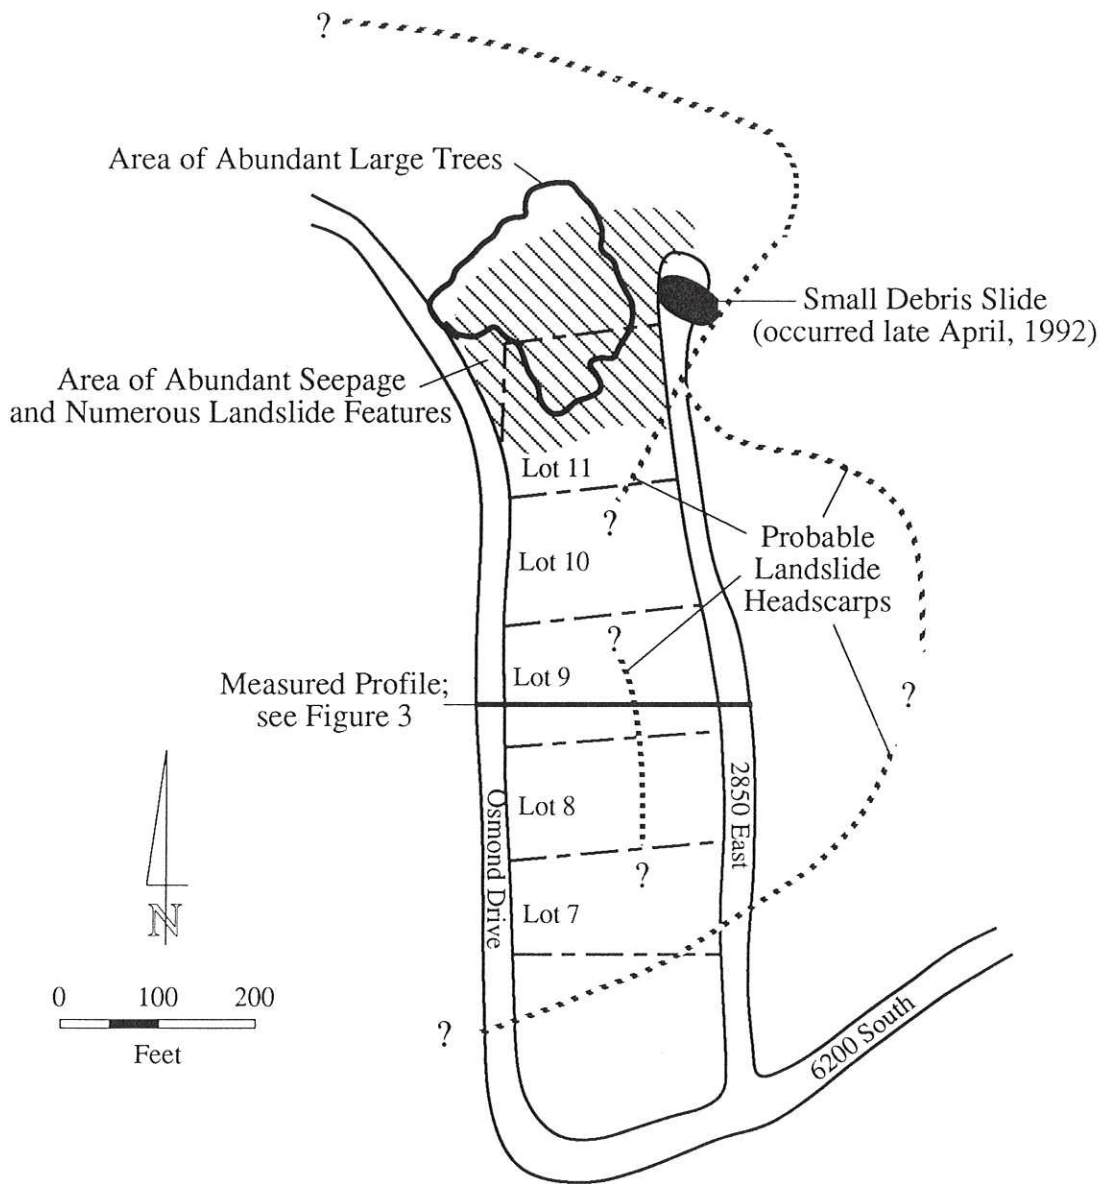
Figure 2  
Location Map

At the time of our reconnaissance, the cul-de-sac at the north end of 2850 East Street had been blocked by a small debris slide, as indicated on Figure 2. Mr. Vanorden informed us that this slide occurred in late April, 1992. A portion of a steep cut at the cul-de-sac slid down the cut slope and out onto the pavement of 2850 East Street. Landslide headscarps are shown on the geologic map by Nelson and Personius (1990) in the vicinity of the site. Our interpretation of stereoscopic aerial photographs generally conforms with the landslide features mapped by them.

Groundwater was not encountered in the 8- to 12-foot deep test pits on the site. However, seepage was observed and water-tolerant vegetation is abundant in Lot 11, as shown by the hachured pattern on Figure 2. The vegetation includes large cottonwood trees and "snake grass".

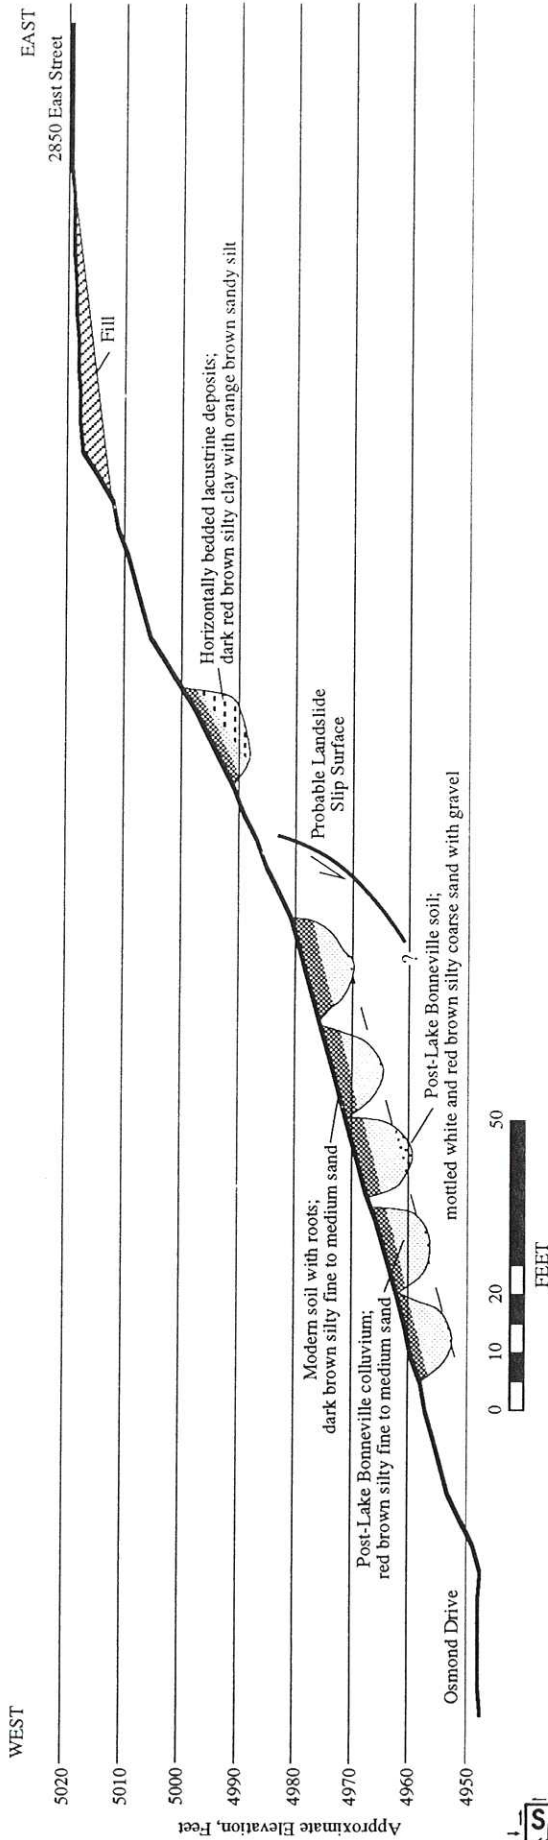
Figure 3  
 Profile Across Southern Part of Lot 9,  
 Eastwood Subdivision No. 8,  
 Uintah, Weber County, Utah

The subsurface information collected from the six test pits on the profile (Figure 3) indicate that landsliding has occurred on this site in the past. Published geologic information (Nelson and Personius, 1990) indicates that the site is underlain by landslide deposits and the eastern-most headscarp is considerably east of the site; farther than suggested on Figure 2. The uppermost test pit, shown on Figure 3, displayed nearly horizontally-bedded silty clay deposited in Lake Bonneville. Since this material is nearly horizontal, it probably indicates that no substantial rotational landslide movement has occurred above it. Some movement could have occurred, but not enough to rotate the lake-deposited sediments appreciably.

The uppermost test pit is on the steepest part of the slope, as shown on Figure 3. The next test pit is below a break in slope and exposes different sediments. In this test pit, silty coarse sand and gravel weakly cemented with carbonate was encountered at a depth of about eight feet. This carbonate-cemented material is interpreted to be soil formed after the decline of Lake Bonneville and before burial by the overlying red brown silty fine to medium sand. A dark brown silty fine sand with abundant roots is present at the ground surface and represents the modern soil.

The test pit information is interpreted to indicate that a slump with relatively minor movement occurred after formation of the buried soil and largely before accumulation of the red brown silty sand. The scarp of the landslide is subdued with uniform vegetation type and density across it. Minor scarplets, on the order of four to six inches high, were observed in one small area of Lot 8 in the position of the dashed line indicating "probable landslide headscarp". These minor scarps expose bare soil and could have occurred during the wet period of 1983 and 1984.
