Subject: Proposed Residence
8900 East 1800 South
Huntsville, Utah
Project No. 1200326

This letter presents the results of a reconnaissance-level, geologic-hazard study for proposed residential development of Parcel 21071004 at 8900 East 1800 South in Huntsville, Utah.

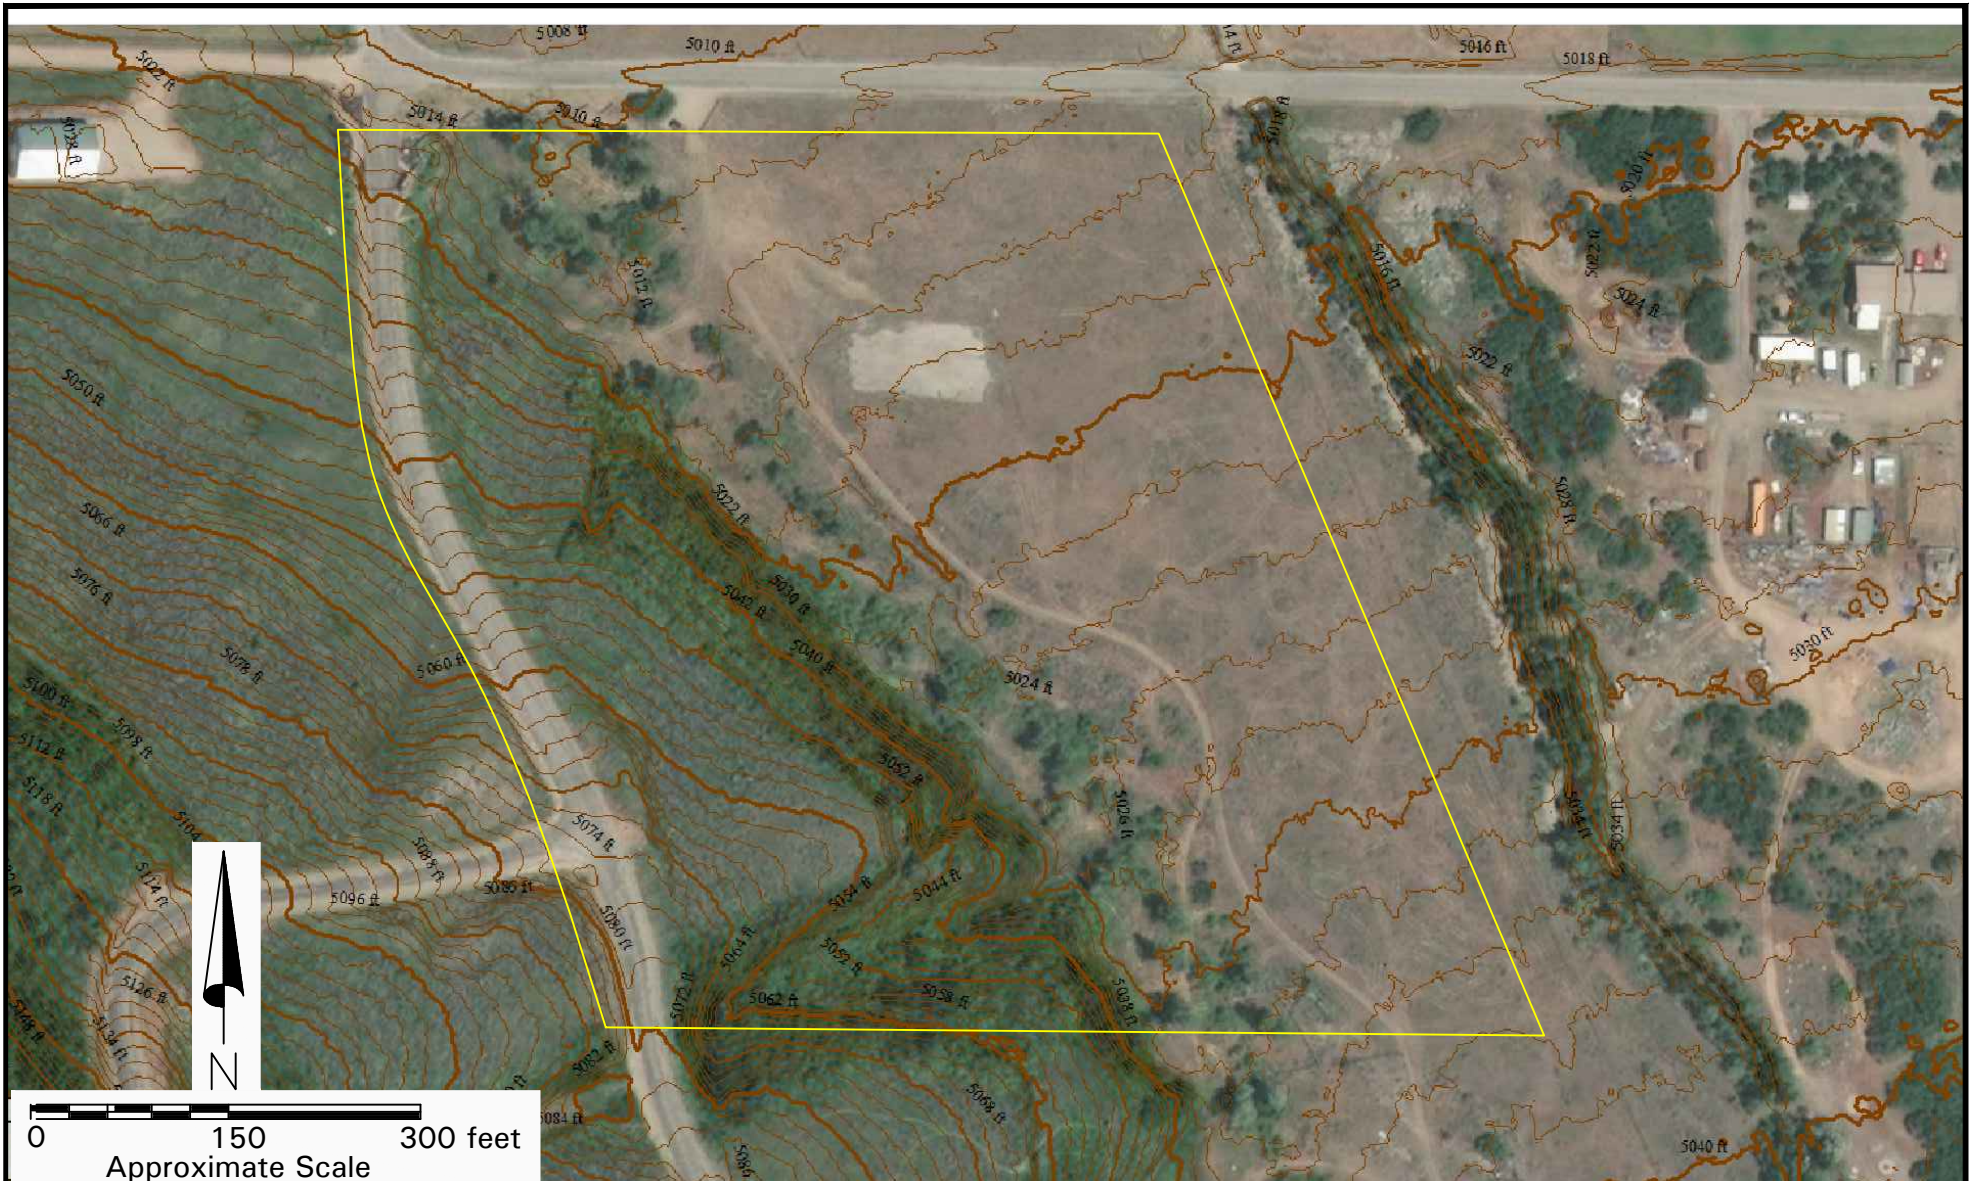
The slope of the ground surface at the site varies (see Figure 2). The lower portion of the site slopes down to the north-northwest at approximately 2.6 percent. The slope of Falcon way is in a similar direction and slopes down at approximately 9.3 percent. There is a steeper area

east of Falcon Way with a height of up to approximately 20 feet and a slope up to approximately 60 percent down toward Bally Watts Creek to the east. There is an abandoned irrigation ditch that extends near the crest of this slope. The slope above this area is down to the northeast at approximately 13.7 percent.
