Subject: Reconnaissance-level Geologic-hazards Study
Proposed Gateway Estates Subdivision
Approximately 10700 East Highway 39
Huntsville, Utah
Project No. 1210067

This letter presents the results of a reconnaissance-level geologic-hazards study for the proposed Gateway Estates subdivision at approximately 10700 East Highway 39 in Huntsville, Utah.

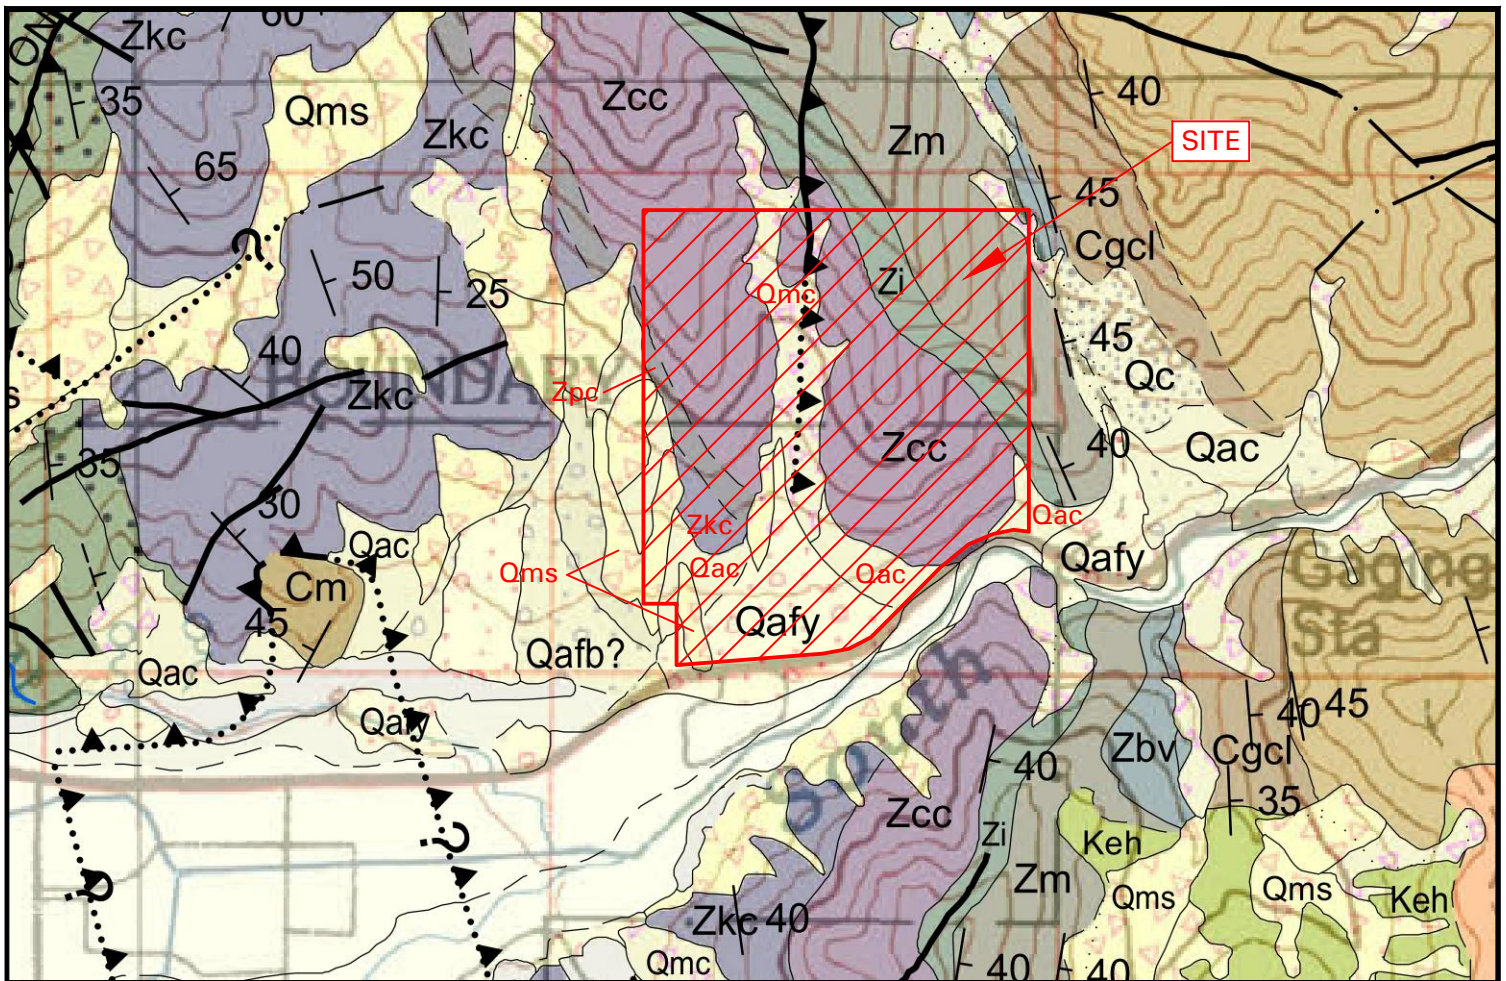
Bedrock is exposed through most of the steep parts of the site. The bedrock is mapped by Coogan and King (2016) to consist of Neoproterozoic metamorphic rocks classified as quartzites, meta-sandstone and argillites with dip down to the east-northeast at approximately 40 degrees (See Figure 1). The surface deposits in drainages consist of alluvium with colluvial deposits along the margin of drainages. There are landslide deposits mapped for the southwest corner of the property. The landslide map of Elliott and Harty (2010) shows no additional landslides for the property. The landslides appear to have relative shallow-depth slide planes and may be associated with springs in the area.

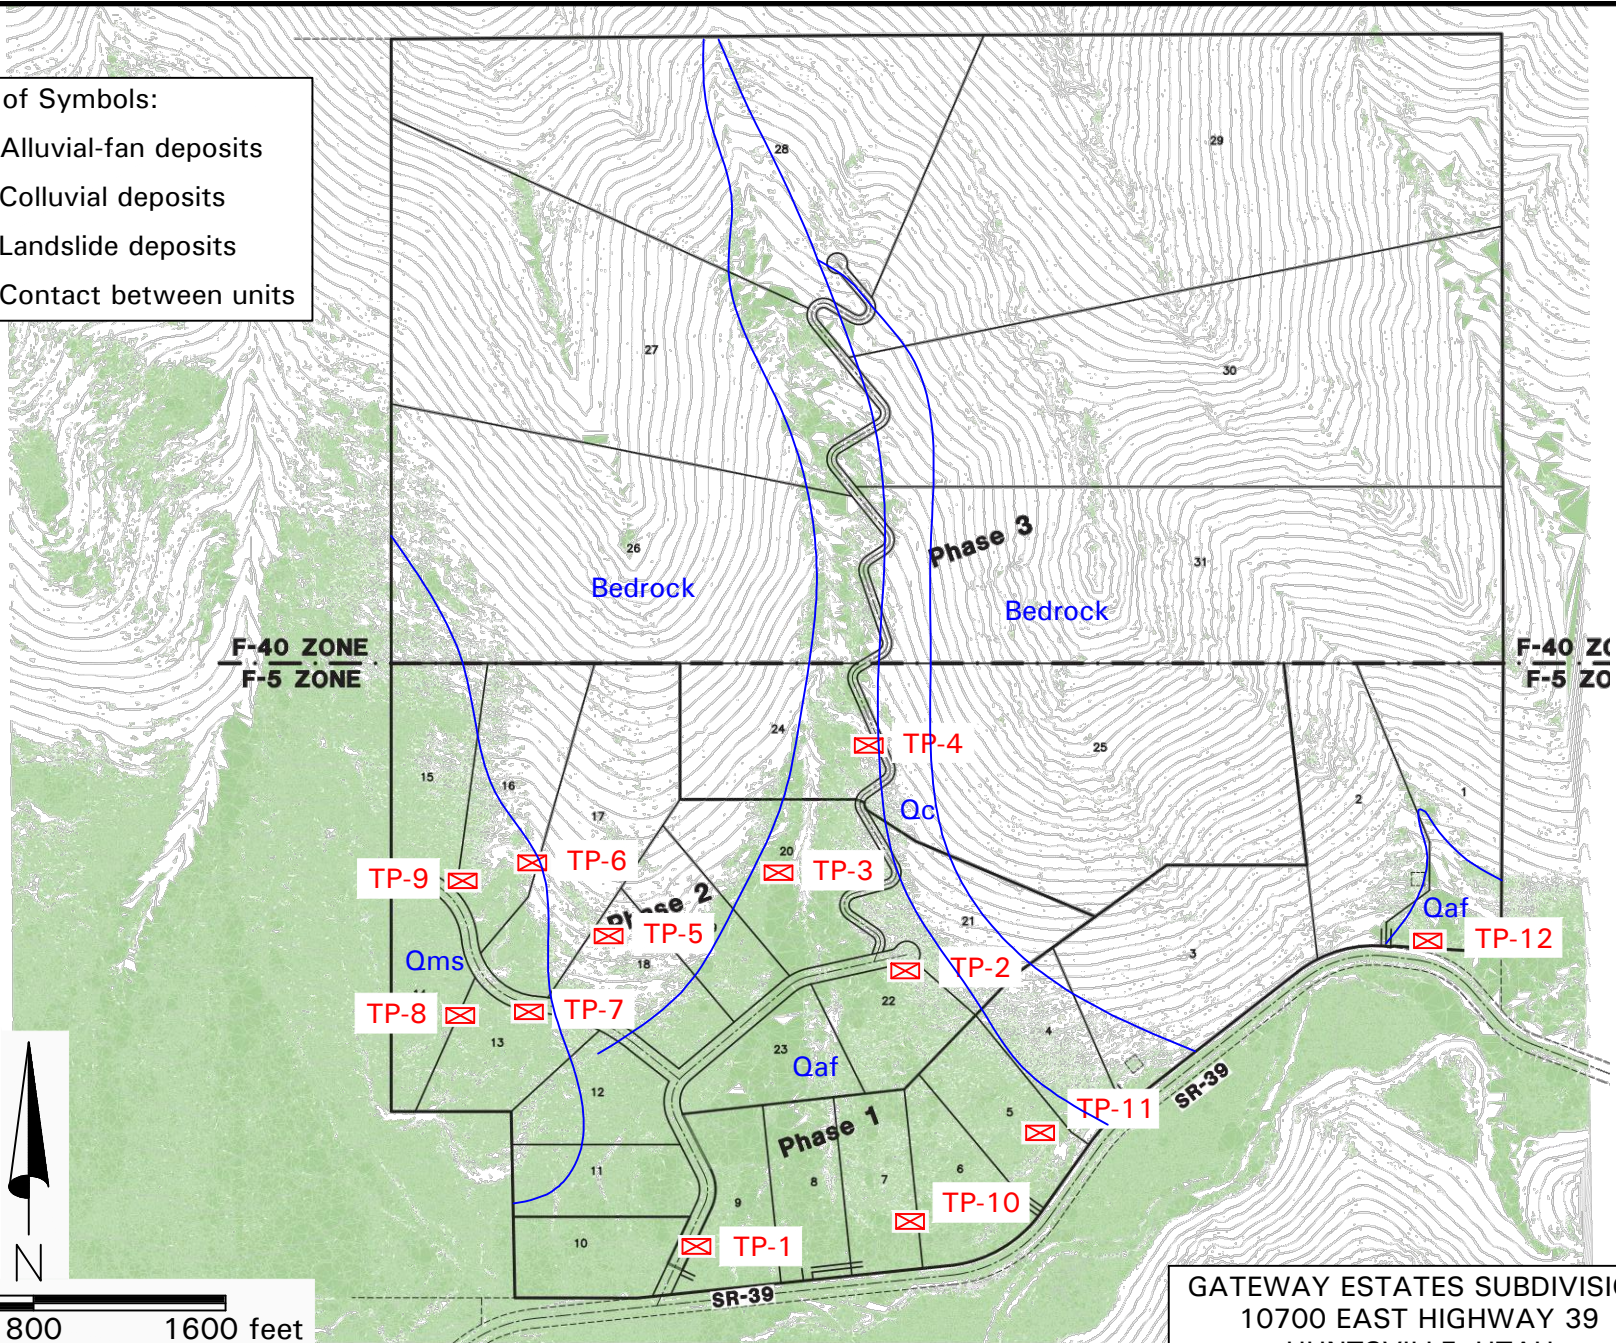
The general topography of the site is presented on Figure 2. There is a dry drainage that extends generally north-south through the west central portion of the property, which fans out into an alluvial fan. There are other minor drainages on the east and west sides of the property. Ridges with bedrock outcrops extend through much of the north half of the property and into parts of the south-central part of the property.

Based on review of the aerial photographs and lidar data, the landslide deposits are mapped on Figure 2.

A site visit was made on February 10, 2021 by a geologist from AGECE. The site was snow covered and thus evidence of geologic hazards could be obscured by the snow cover. There is surface evidence of the landslides mapped on Figure 2 and potential evidence that rockfall could be a hazard for develop below bedrock outcrops above or on Lots 1, 2, 3, 4, 21, 25, 28, 29, 30 and 31. Rockfall should be evaluated for these lots once the snow has melted.

Landslide is a potential hazard for development of the area mapped as landslide deposits on Figure 2. Additional subsurface investigation and stability analysis is recommended for lots planned to be developed in this area. Slope stability could also be a concern where slopes are steepened and should be evaluated for individual residences planned to be constructed. Rockfall is a potential hazard for the lots indicated above and should be further evaluated. It is our professional opinion that debris flow, surface fault rupture, tectonic subsidence and liquefaction are not significant hazards at the site.
