MEYER DEVELOPMENT AND ENGINEERING

Preliminary Engineering Report

RE: Evaluation of Ruby Resort Bridge Post-2023 Flooding

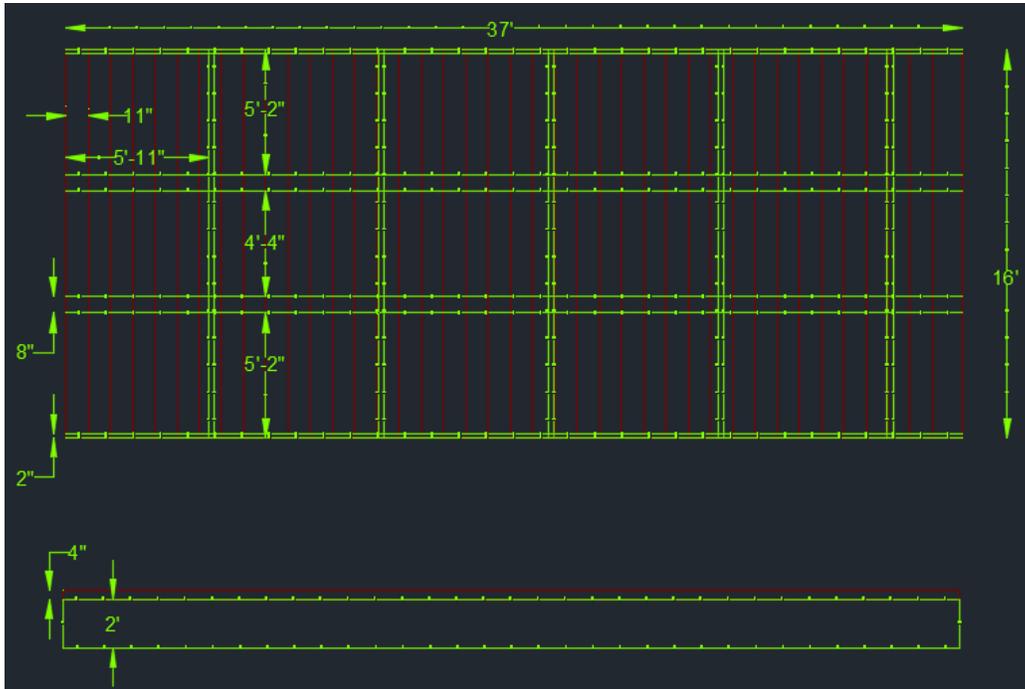
Figure 2. Measurements of bridge deck and beams taken by this engineer on October 12, 2022 (before 2023 flooding).

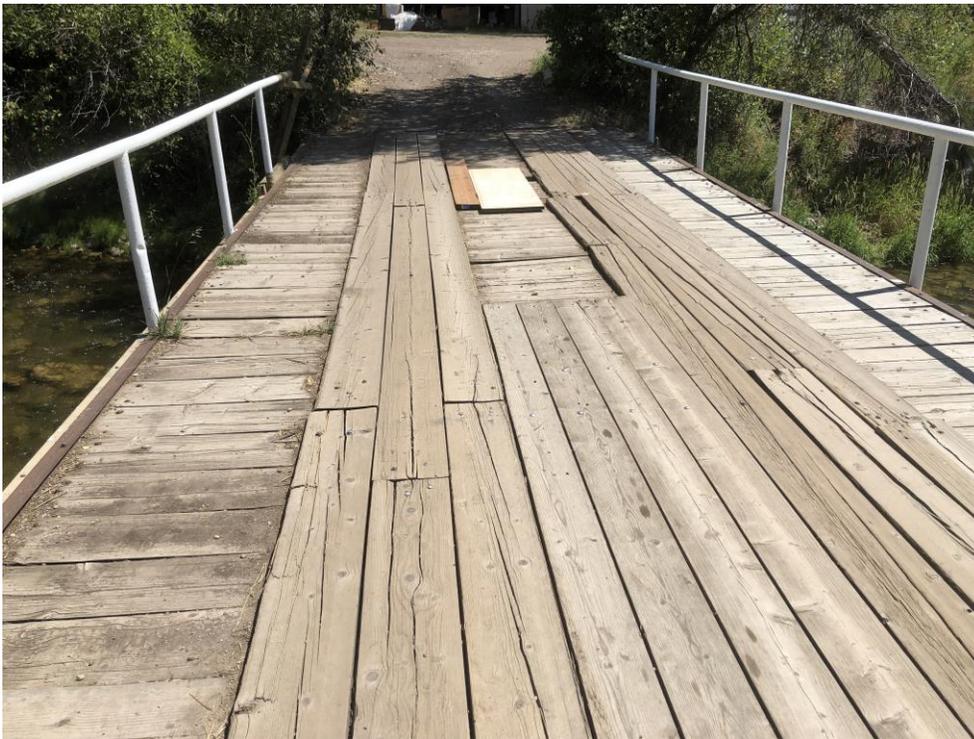
Figure 3. Bridge condition on October 12, 2022 looking west (before 2023 flooding).

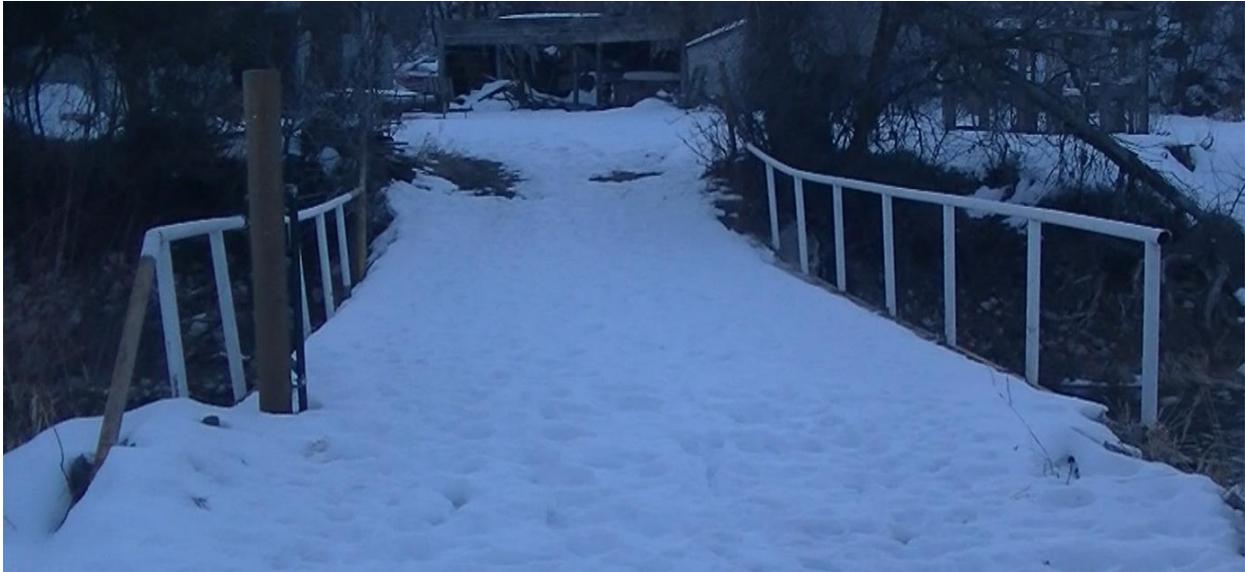
The major structural components of the bridge (steel beams, concrete abutments, concrete decking, and the connections between these elements) appeared sound and undamaged. The bridge structure showed no sign of movement and excessive cracking of the concrete abutments, broken welds, or bending of the steel structural members was observed. This engineer would recommend additional backfill and an extension of the northwest wingwall to prevent erosion of backfill in possible future flooding events. Further, the removal of vegetation near the west bridge abutment is recommended to eliminate the possibility of degradation of the abutment.

Figure 4. Bridge condition on January 1, 2024 looking west (after 2023 flooding and bridge repair).

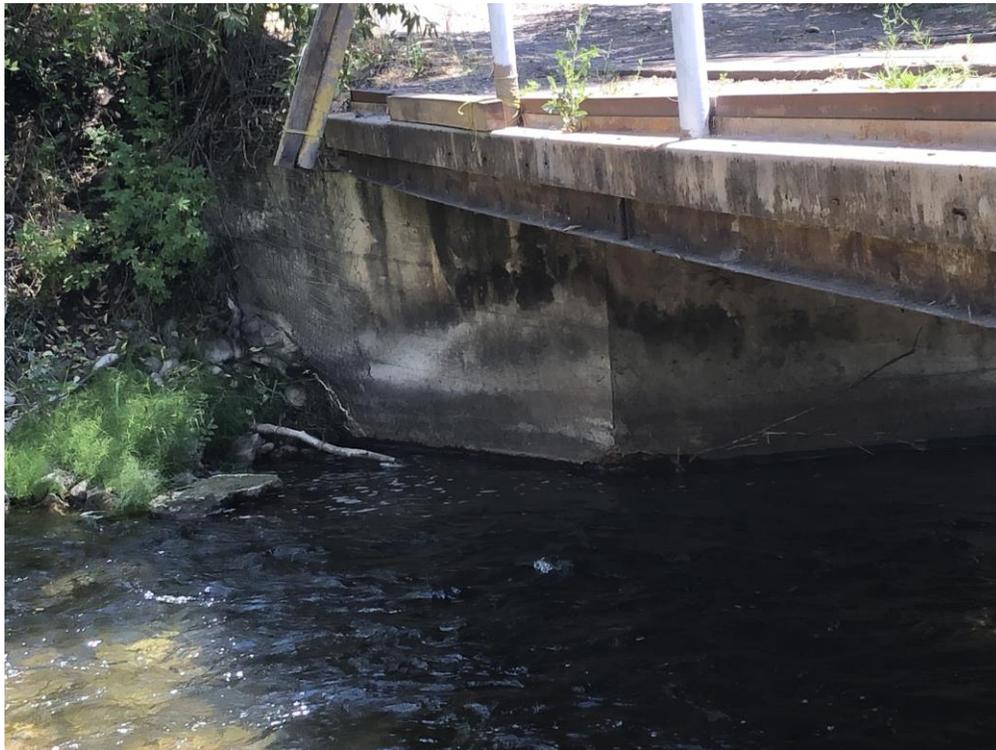
Figure 5. NW bridge abutment on October 12, 2022 looking west (before 2023 flooding).

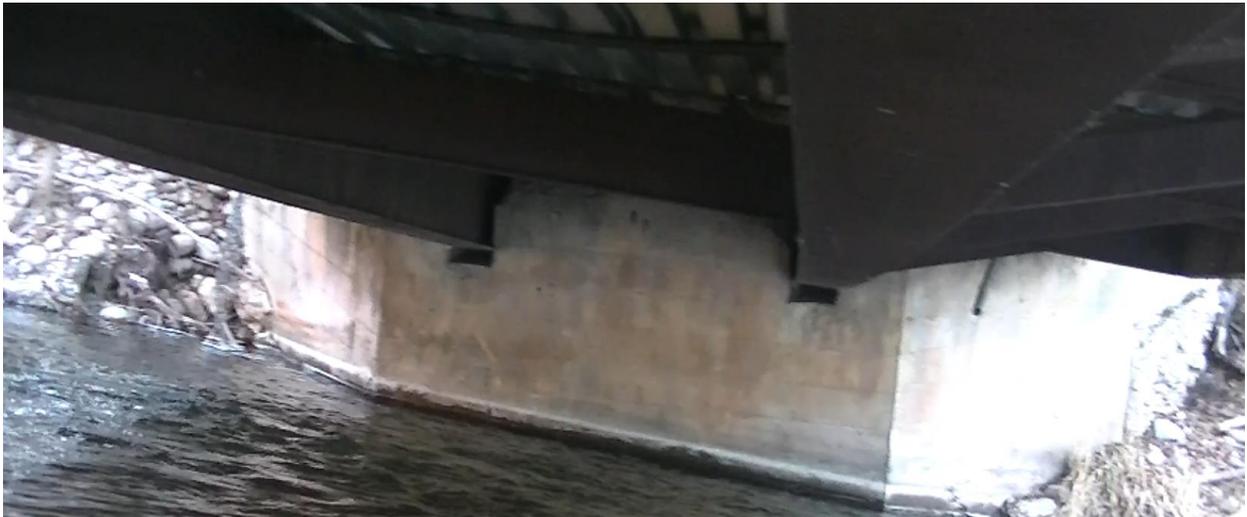
Figure 6. Post-flooding and repair photograph of west bridge abutment.

- No signs of significant structural damage were found on the bridge.
- Additional backfill and an extension of the northwest wingwall is recommended.
- Removal of vegetation near the west bridge abutment is recommended.

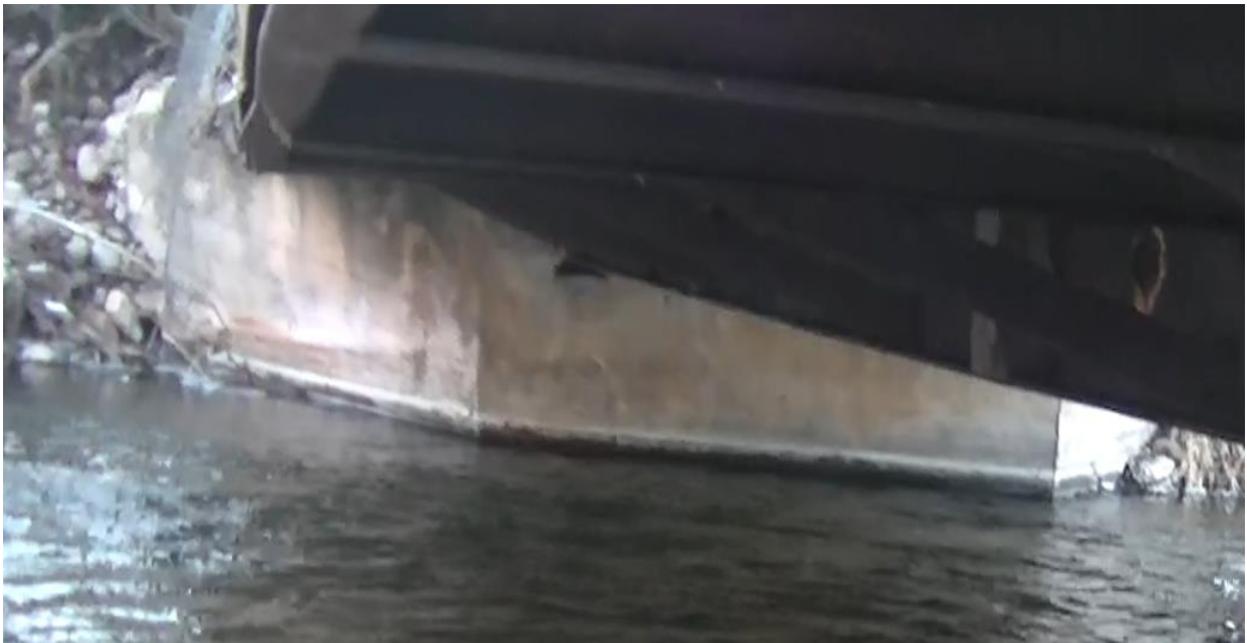
Figure 7. Post-flooding and repair photograph of northwest bridge abutment.
