**REPORT  
GEOTECHNICAL STUDY  
LOT 43 SUMMIT AT SKI LAKE NO. 11  
6785 EAST VIA CORTINA STREET  
HUNTSVILLE, UTAH**

Job No. 2063-01N-16

Re: Report  
Geotechnical Study  
Lot 43 Summit at Ski Lake No. 11  
6785 East Via Cortina Street  
Huntsville, Utah  
(41.2429 N; 111.7850 W)

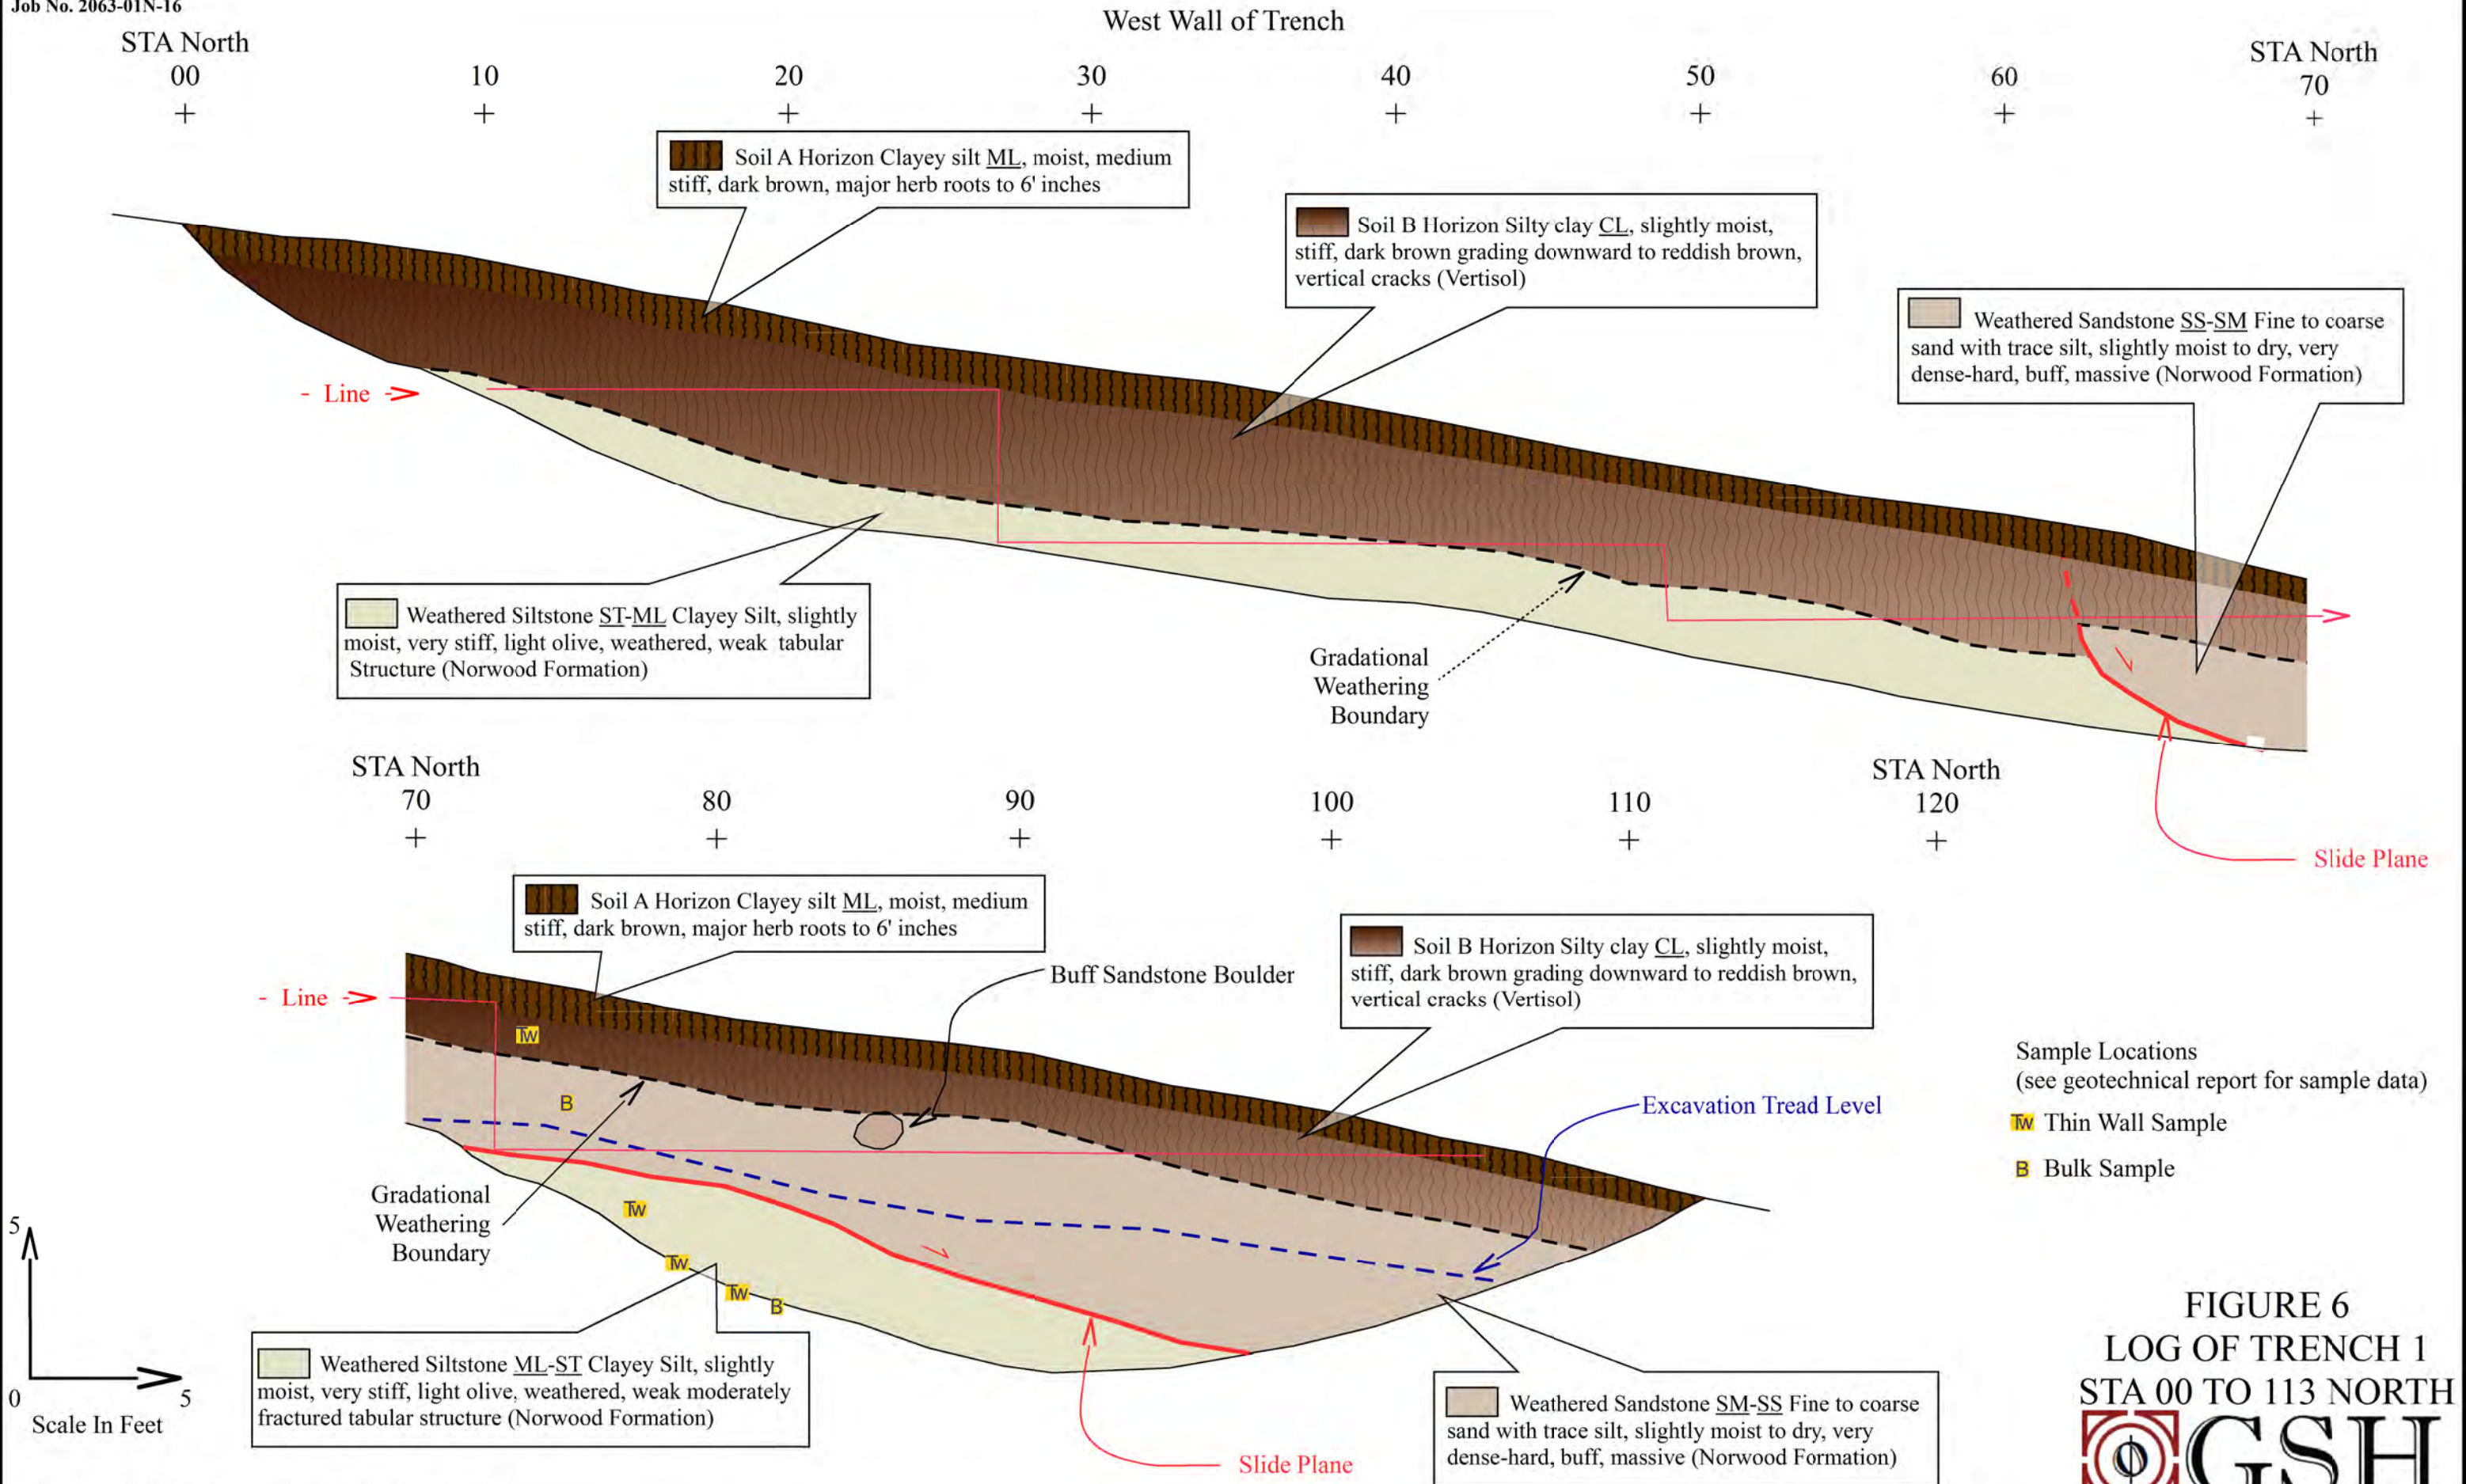
FIGURE 6  
 LOG OF TRENCH 1  
 STA 00 TO 113 NORTH

Silty Clay CL slightly moist, stiff, reddish brown, massive

Soil A Horizon Clayey silt ML, moist, medium stiff, dark brown, major herb roots to 6' inches

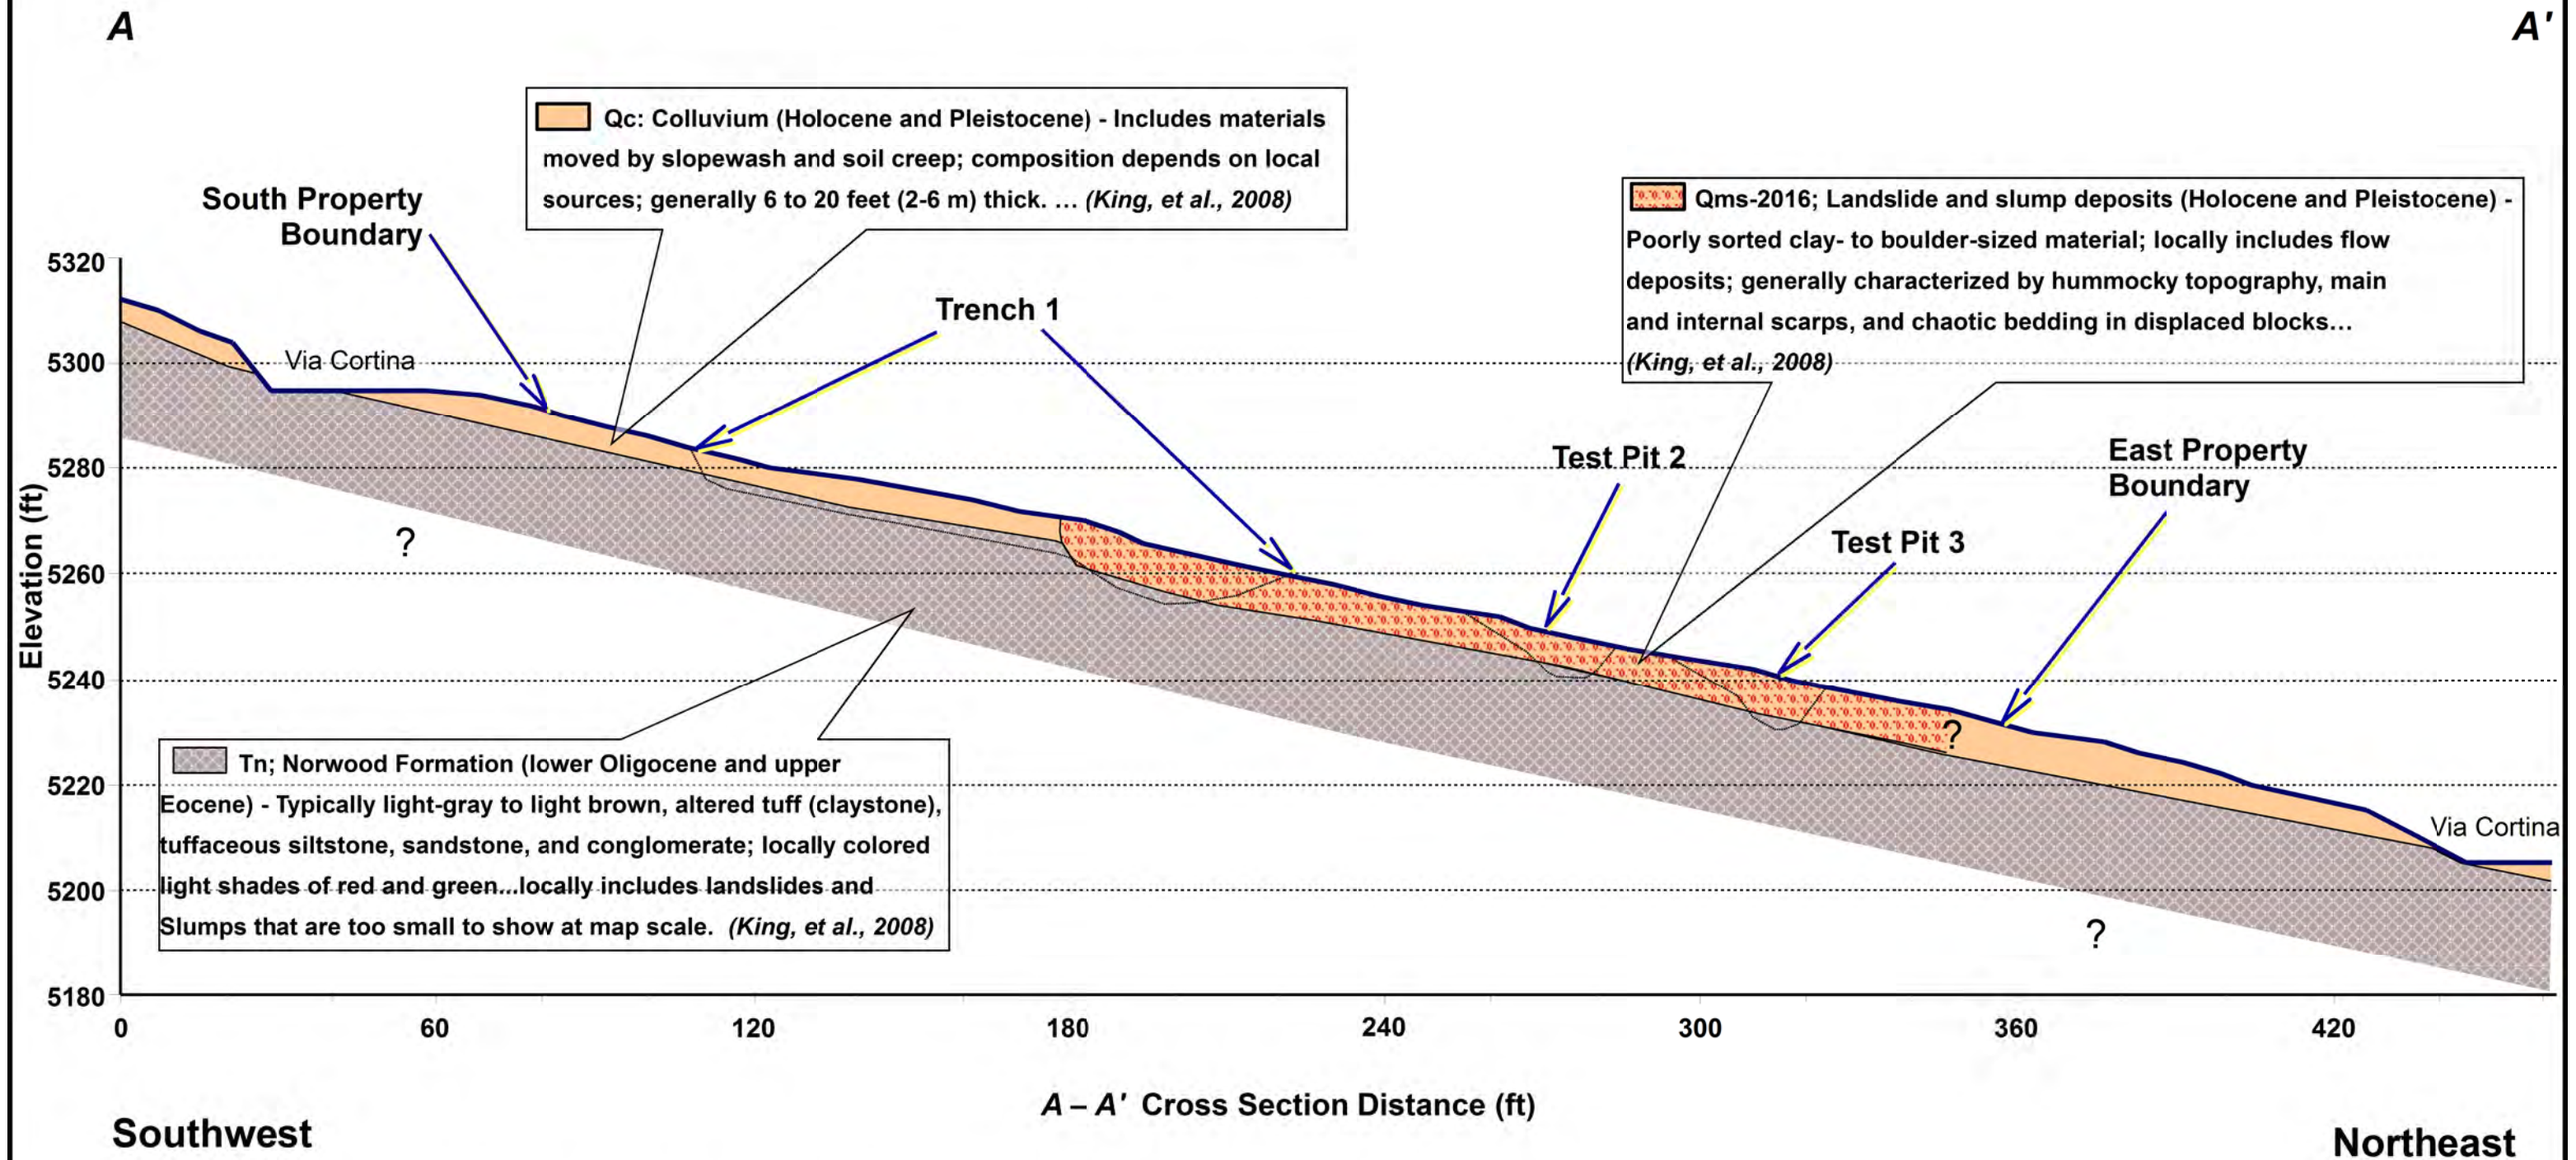
FIGURE 10  
GEOLOGIC SLOPE  
CROSS SECTION A-A'  
**GSH**

\*Elevation data for the cross section were developed from 2.0 meter 2006 LiDAR digital elevation data. Elevations for the Via Cortina cut slopes were recorded using a hand-held GPS receiver device during our field program.

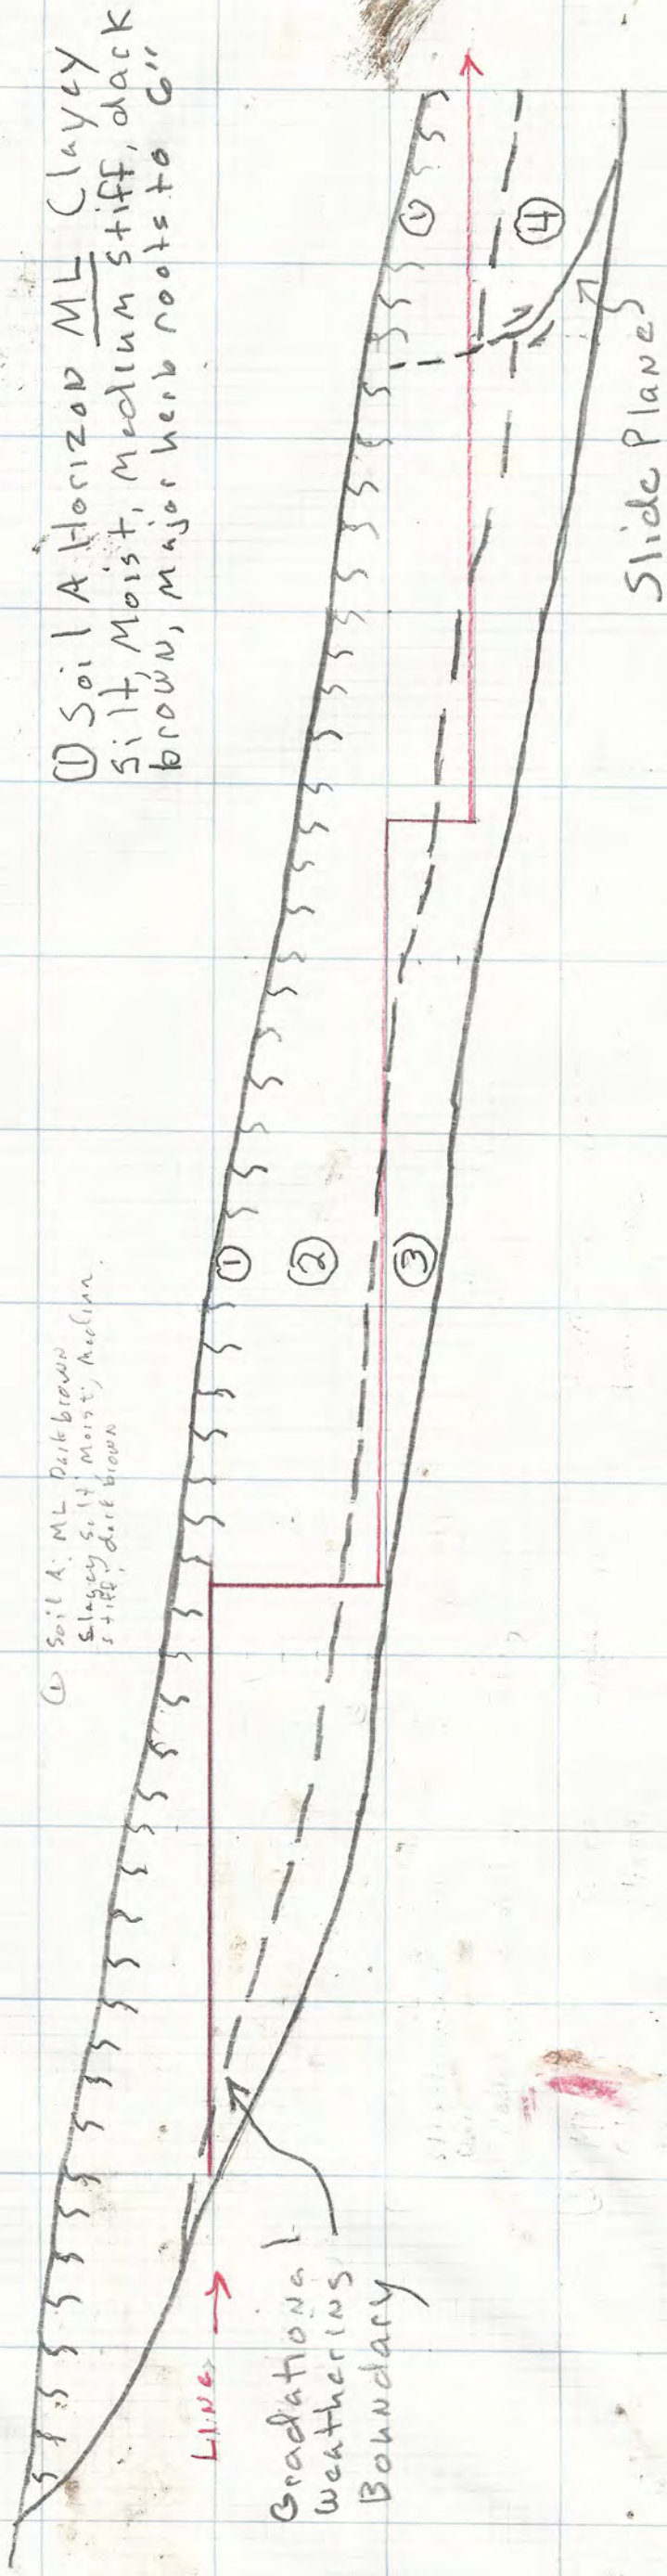
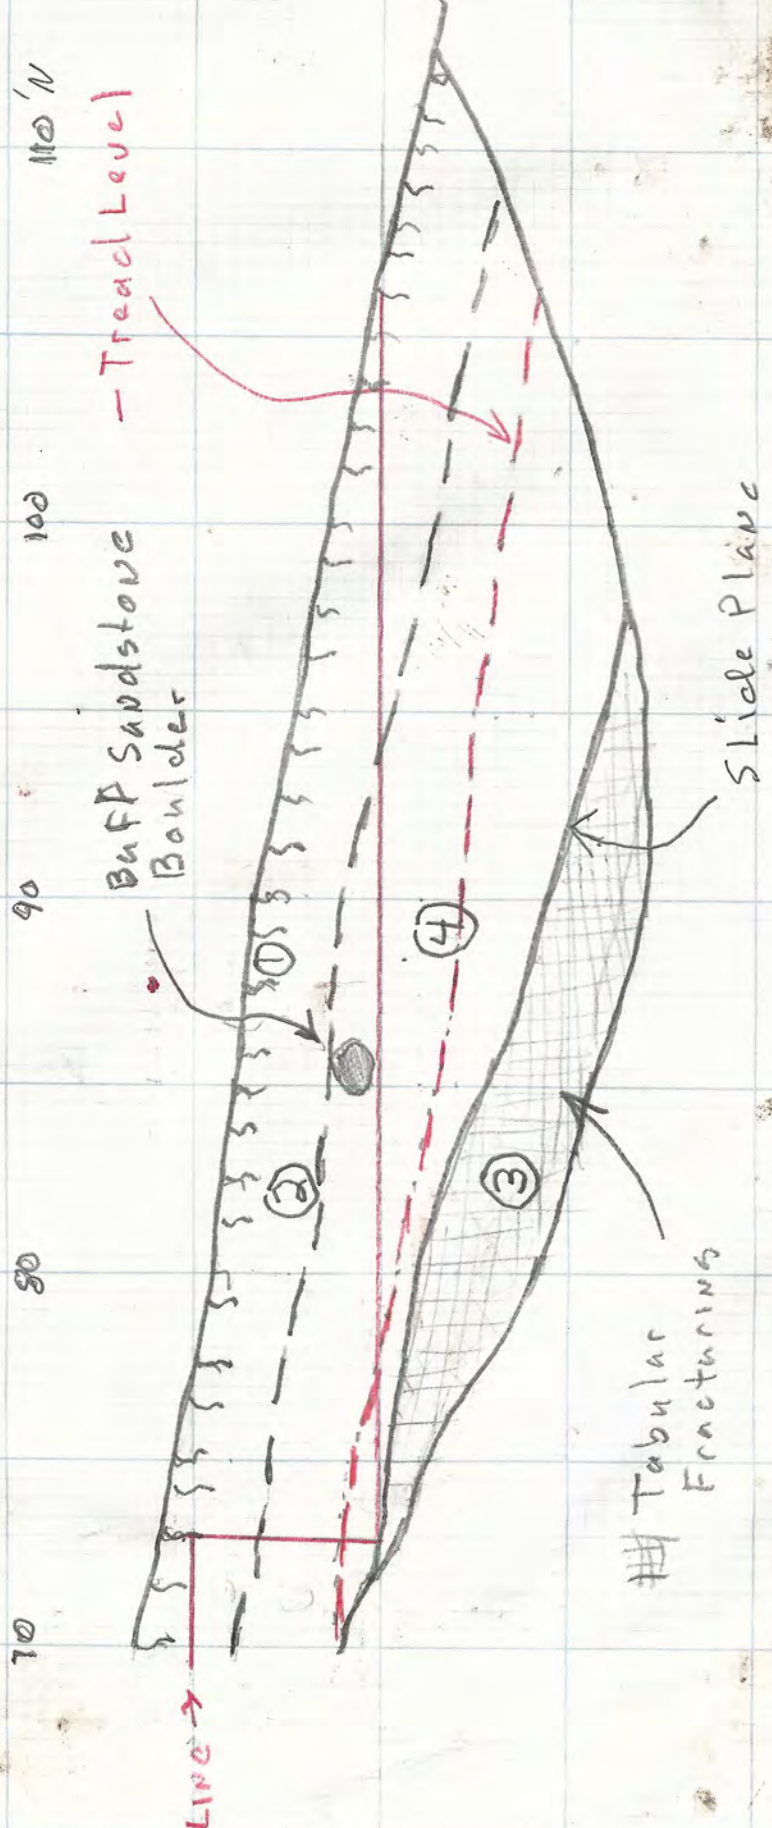
Trench 1 0-113'  
West Wall of Trench

① Soil A Horizon ML Clayey silt, Moist, medium stiff, dark brown, major herb roots to 6"

Slide Planes

② Soil B Horizon. CL Silty clay, slightly moist, stiff, dark brown, grading down to reddish brown, vertical cracks (vertisol)

③ ML-ST weathered siltstone, clayey silt, slightly moist, very stiff, light olive, weak weathered tabular structure

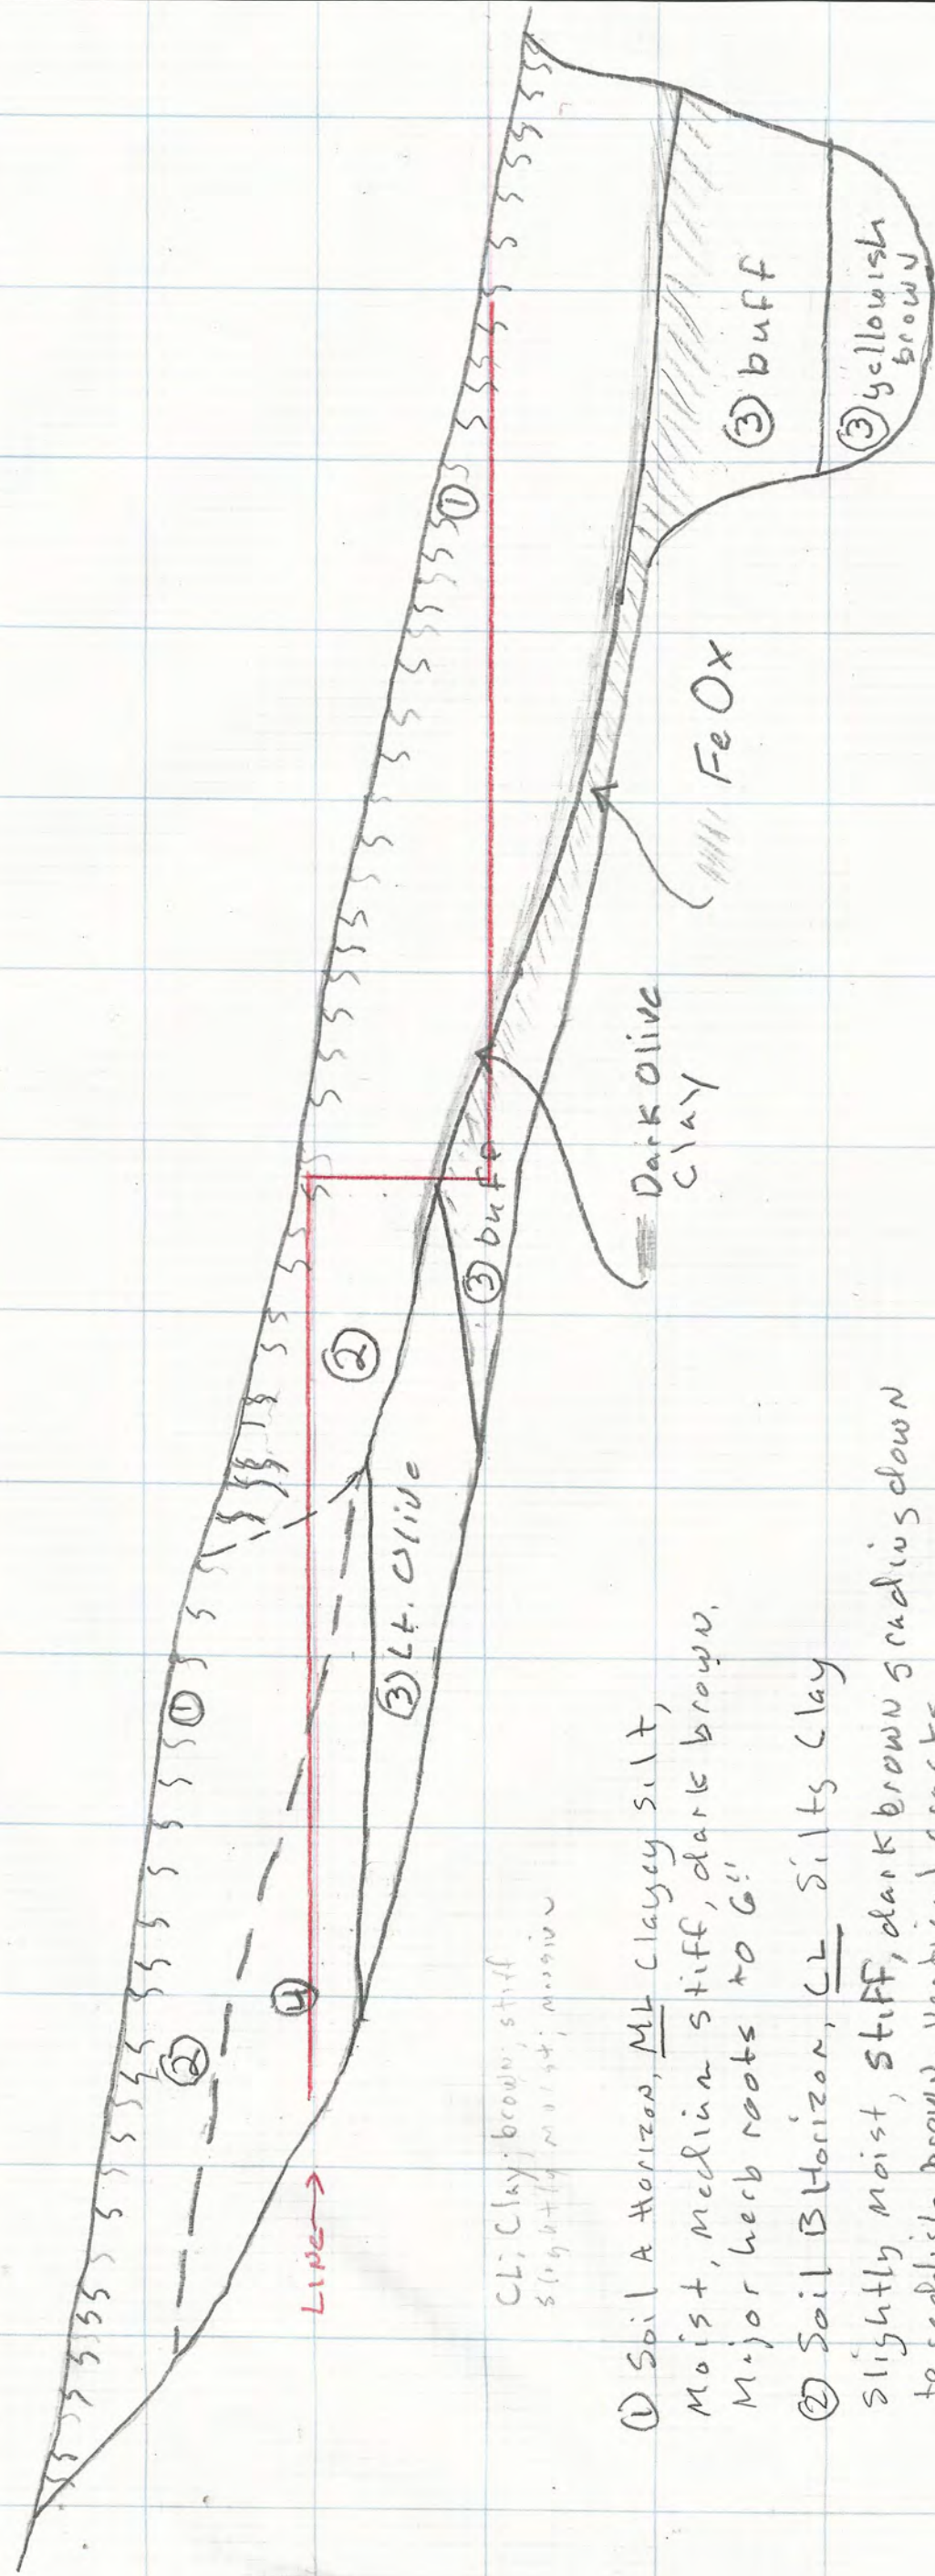
Trench 2 0-72'

CL: Clay, brown, stiff  
slightly moist, massive

- ① Soil A Horizon, ML Clayey silt, Moist, medium stiff, dark brown, Major herb roots to 6"
- ② Soil B Horizon, CL Silty Clay slightly moist, stiff, dark brown, radiating down to reddish brown, vertical cracks (Vertisol)
- ③ ML-ST weathered siltstone, clayey silt, slightly moist, very stiff, light olive-buff and yellowish brown, weak weathered tabular structure
- ④ CL Silty Clay, slightly moist, stiff reddish brown, massive.

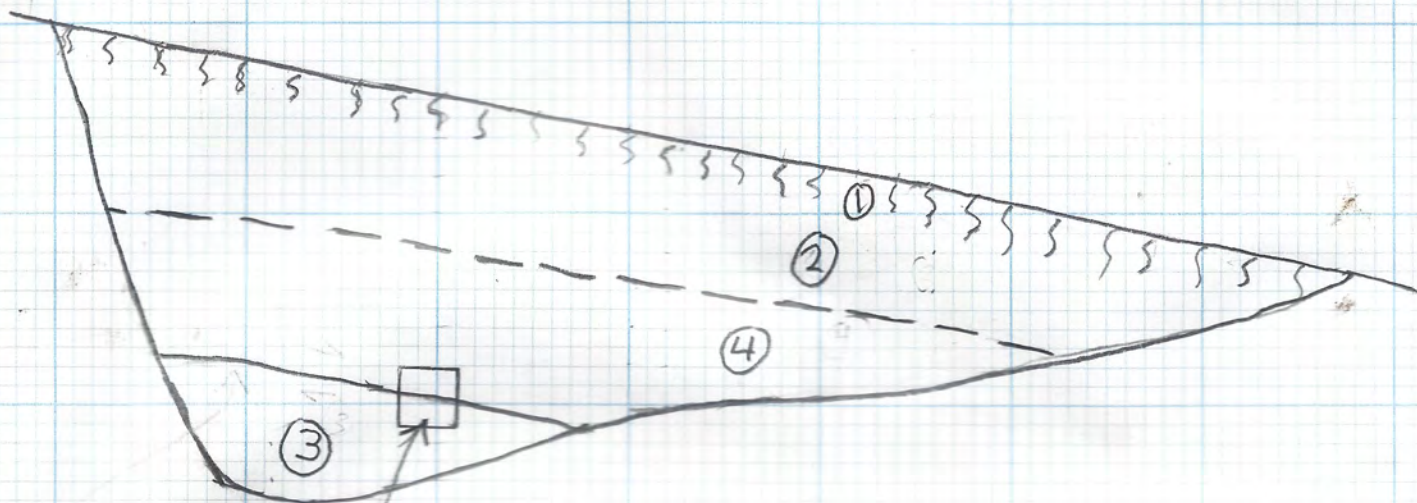
Test Pit 1  
West Wall of Pit

Dip  $17^{\circ}$  N  
Trench Az.  $70^{\circ}$

stopped excavation at 11.5'  
No GW encountered
