Staff Report for Administrative Subdivision Approval

Application Request: Consideration and action on a request to approve a Hillside Review for the Combe residence located on lot 12R in the Cedar Cove Estates 3rd Amendment.

File Number: HSR 2017-02

SUPPLEMENTAL GEOLOGIC HAZARDS RECONNAISSANCE

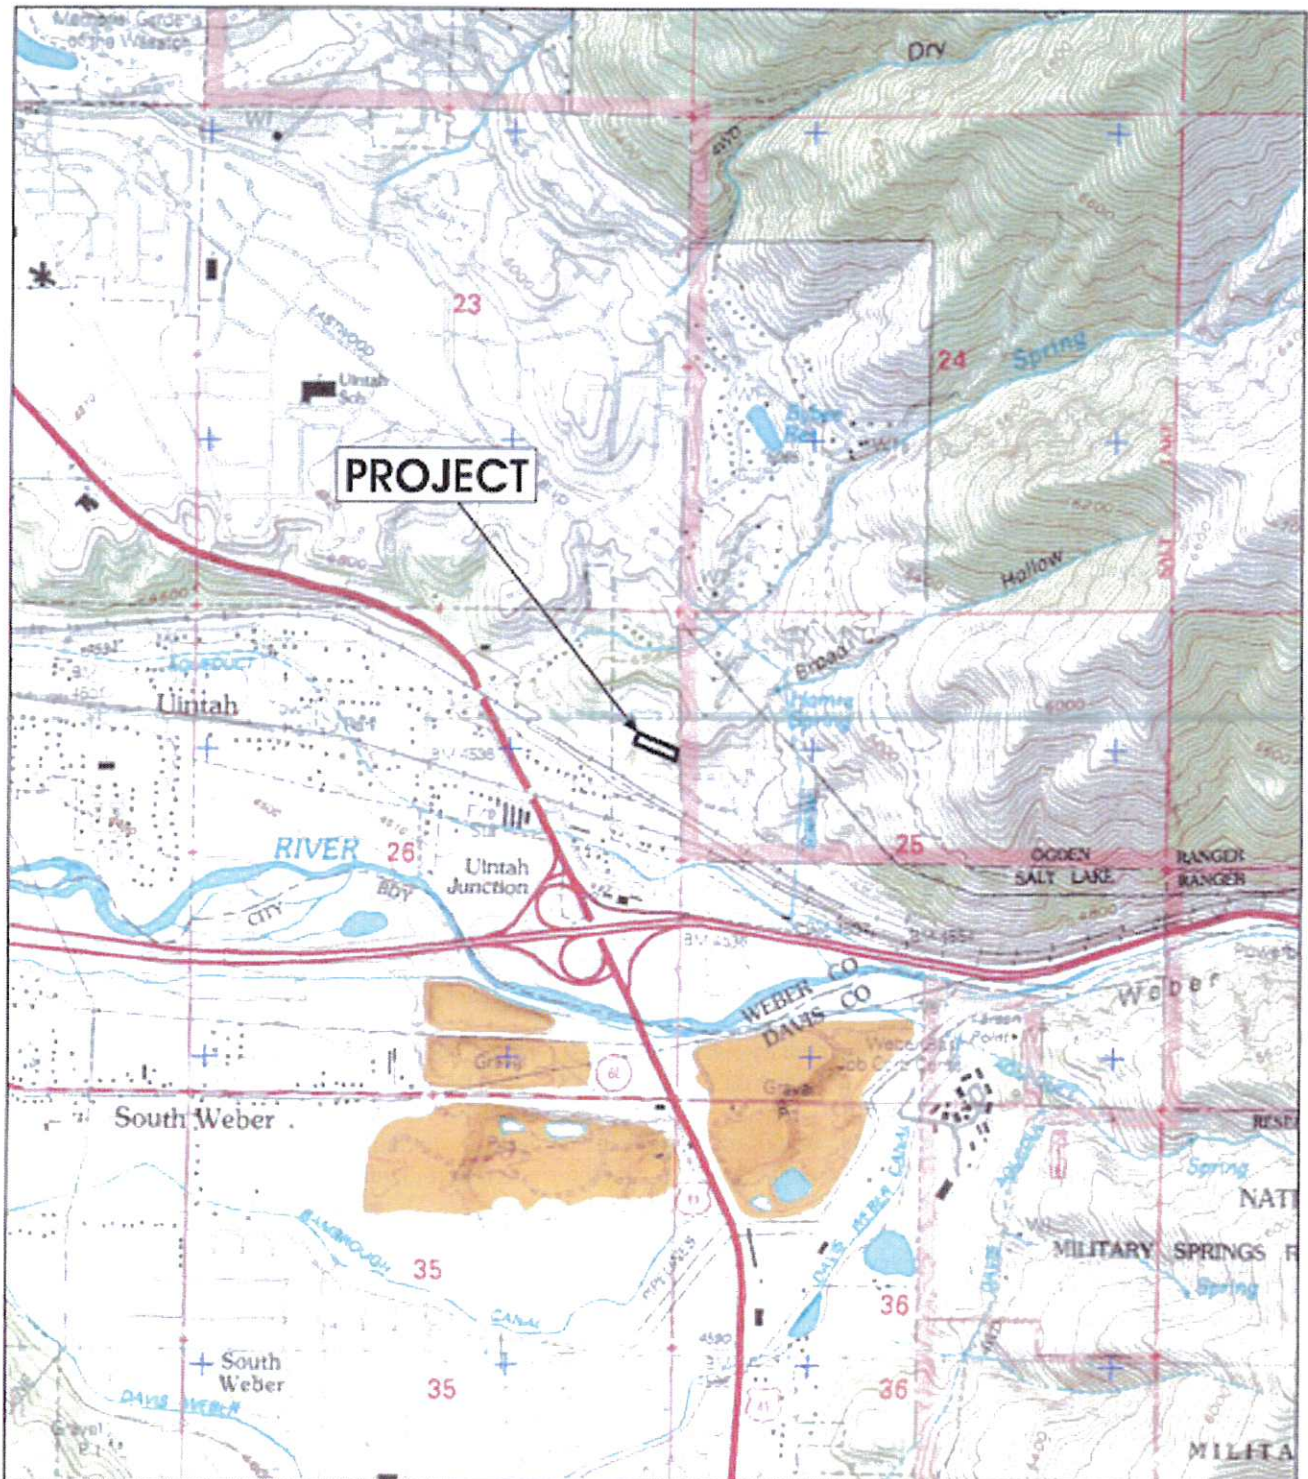
FIGURE 1

The U.S. Geological Survey (USGS) topographic map of the Ogden Quadrangle (Figure 1) shows no surface-water impoundments, springs, or active drainages at the property. No springs, seeps, or wetland areas were also observed at the Project or in the vicinity in 2007 or in our field reconnaissance. Slopes at the site appeared very dry in both 2007 and currently. The nearest spring on Figure 1 is Hamre Spring about 1,250 feet northeast of the site.

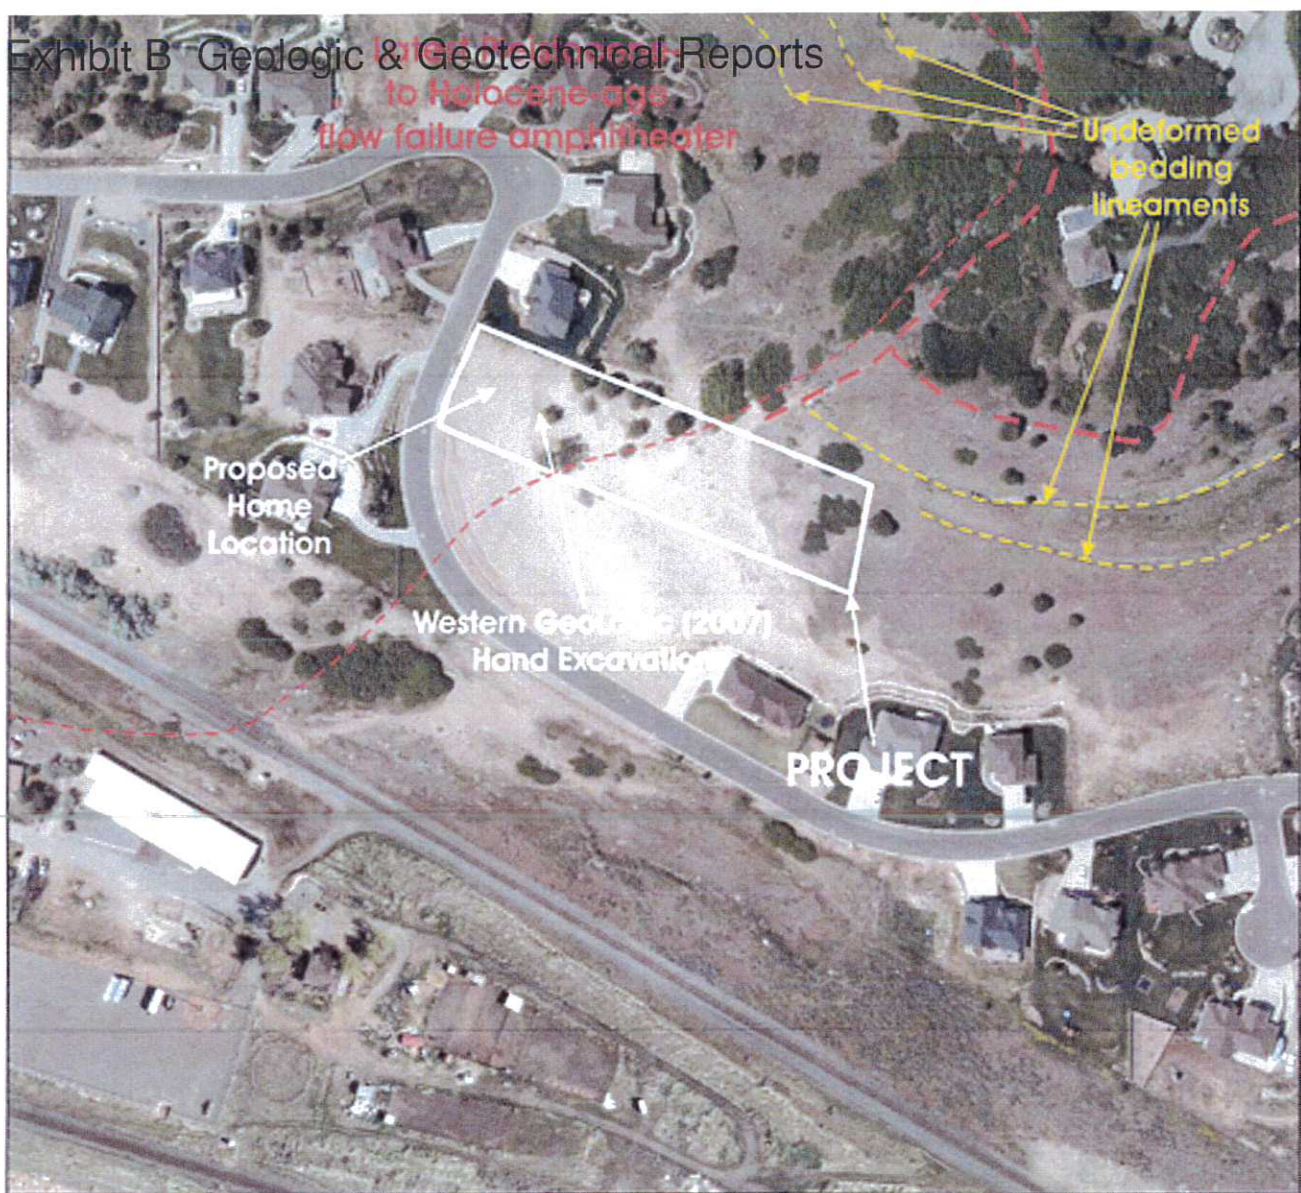
2012 AIR PHOTO
SUPPLEMENTAL GEOLOGIC HAZARDS RECONNAISSANCE Cedar Cove Subdivision Lot 12 2670 East Bybee Drive Ogden, Weber County, Utah
FIGURE 3A

High-resolution orthophotography from 2012 (Figure 3A) and 0.5-meter bare earth DEM LIDAR from 2013-2014 (Figure 3B) were reviewed to obtain information about the geomorphology of the Project area. The site is below the crest of a south-facing terrace on slopes that have been impacted by a prehistoric flow failure; the Project straddles the south flank of this failure (Figures 3A-B). This area has old river terraces that are part of a discontinuous landslide complex along the Weber delta from Weber Canyon to Washington Terrace (unit Qmsy, Figure 2). The river terraces are remnants of the former Weber River floodplain stranded by downcutting through the Weber delta after the retreat of Pleistocene Lake Bonneville. The

No other evidence of geologic hazards was observed on the air photos at the site or in the area.

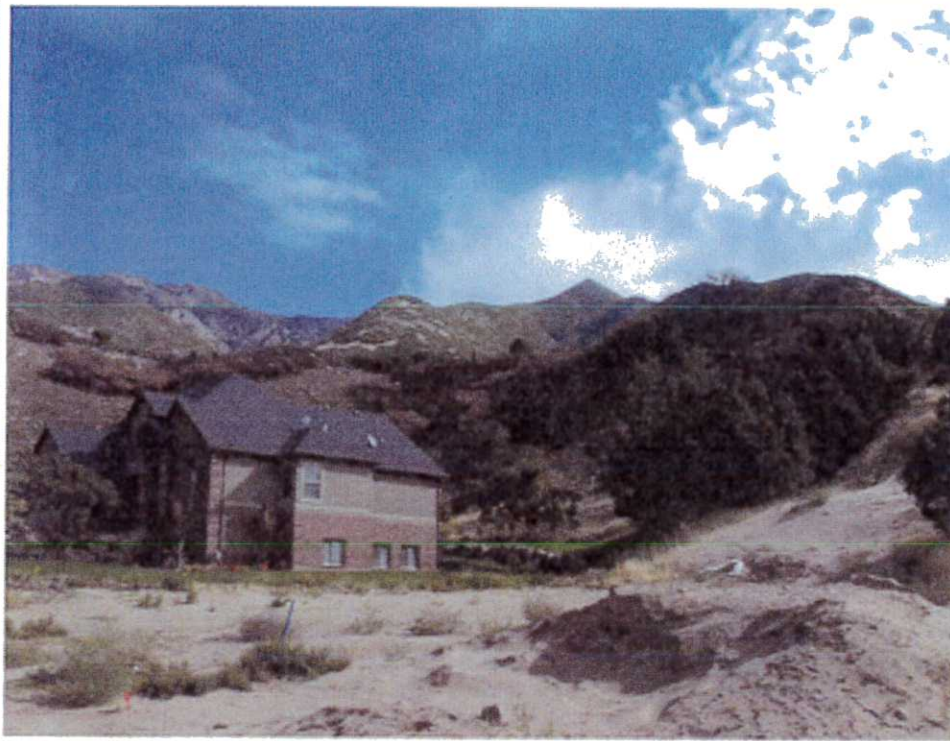
Photo 1. View north across proposed home area toward amphitheater

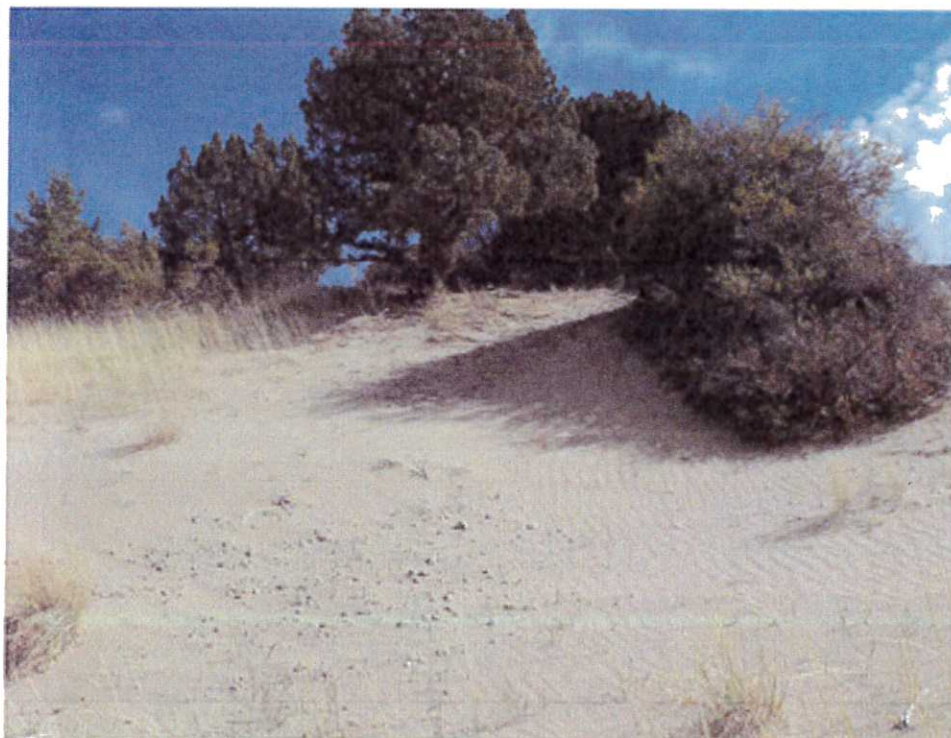
Photo 2. Typical surficial soils

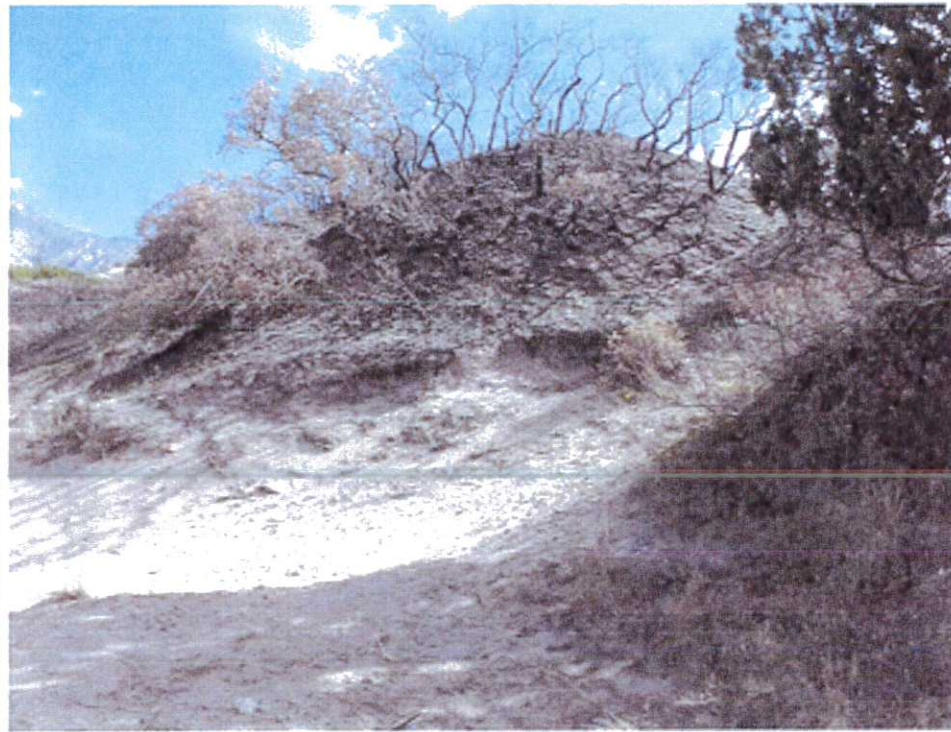
Except for several homes to the north, west, and south developed after 2007, and evidence for a recent wildfire that burned much of the amphitheater north of the Project, no other differing conditions were observed or noted in our reconnaissance from those previously reported. The wildfire reportedly occurred in September 2017 and engulfed over 600 acres, including several homes in the area.

Photo 3. View north toward burned area

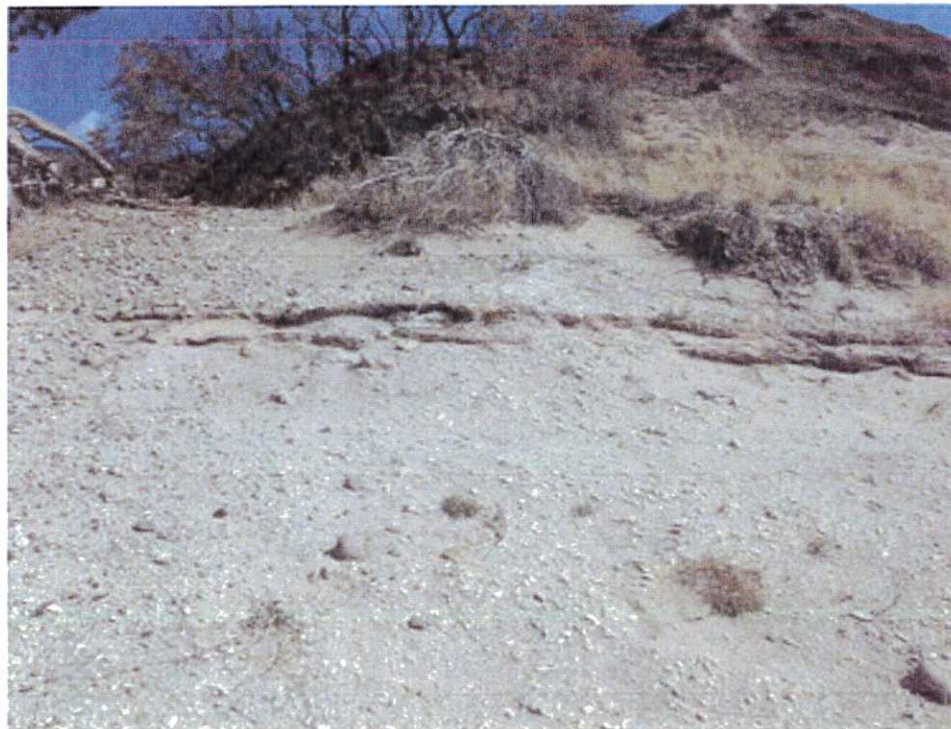
deltaic sediments forming the terraces have experienced instability from a variety of causes in both prehistoric and historic time. However, undeformed, sub-horizontal deltaic beds were observed in the eastern part of the site during our reconnaissance, and are evident on Figures 3A-B further north and east. Undeformed deltaic sands were also observed in Western GeoLogic's (2007) hand-excavated test pit. All the above evidence suggests the site is in a zone of depletion where the deltaic sediments failed and flowed downslope to a lower accumulation (depositional) zone further west and southwest.

Photo 4. Bedded lacustrine deltaic sediment exposed on slope in east part of site.

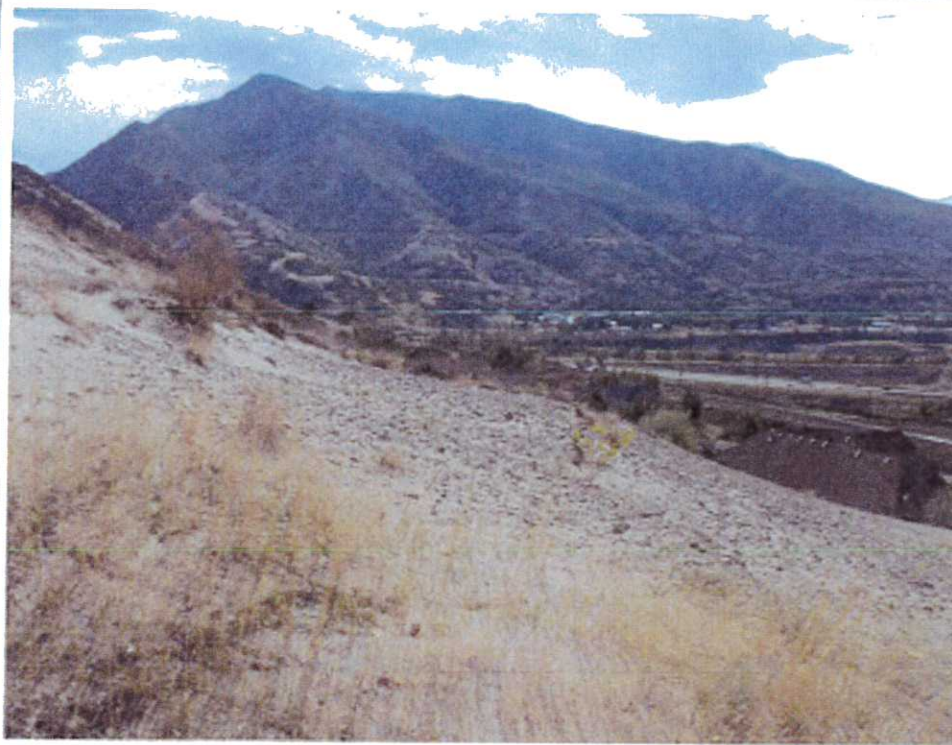
Photo 5. View east toward Weber Canyon

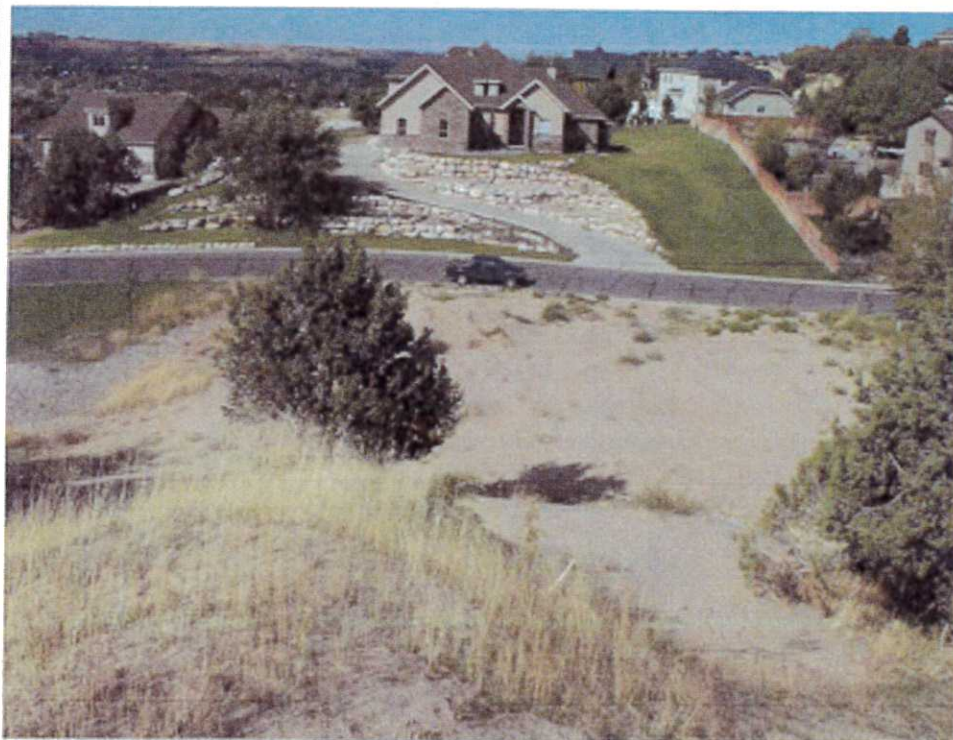
Photo 6. View west of western part of site and adjacent home
