Simon Associates LLC  
geologic & environmental consultants

Subject:       **Geologic Reconnaissance**  
Wadman Subdivision Phase 1  
Part of the West 1/2 of the Southeast 1/4 of Section 1, T7N, R1W.  
Approximately 6089 N. 2250 East Street, Liberty, Utah  
Weber County Parcel No: 16-003-0036  
SA Project No: 18-283

Report for Geologic Reconnaissance  
Wadman Subdivision Phase 1  
Approximately 6089 N. 2250 East Street, Liberty, Utah

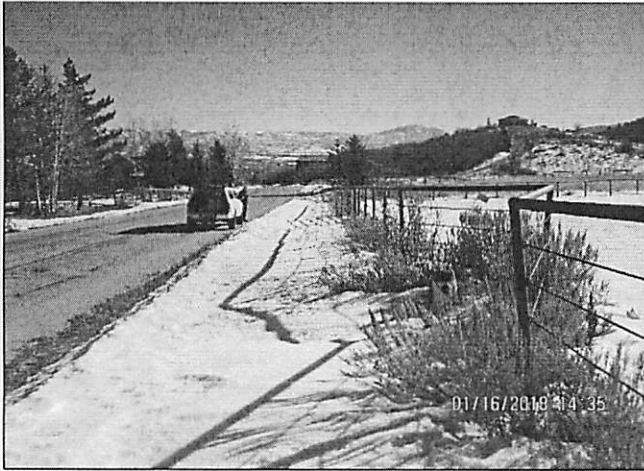
1. Northeast property line, view to southeast.

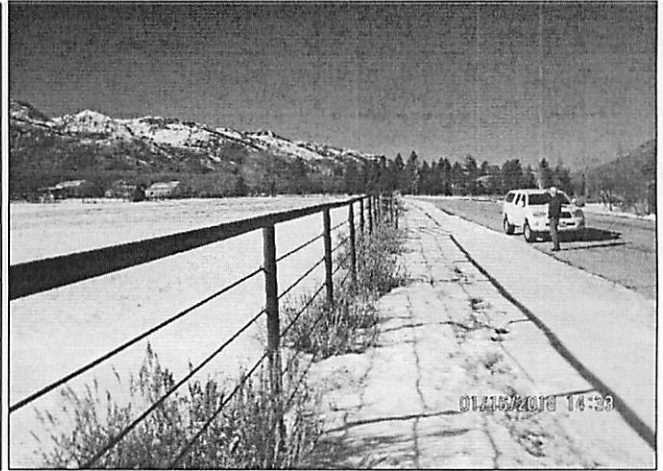
2. Northeast property line, view to northwest.

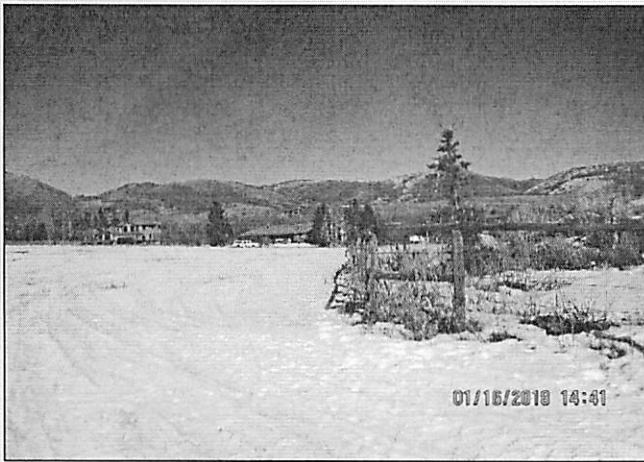
3. Southeast property line, view to northeast.

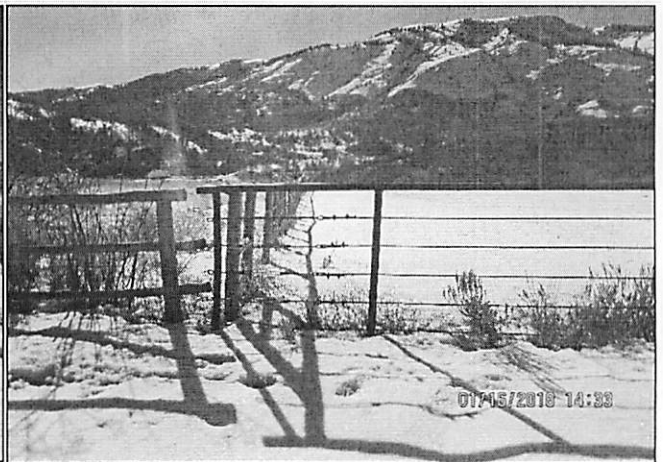
4. Southeast property line, view to southwest.

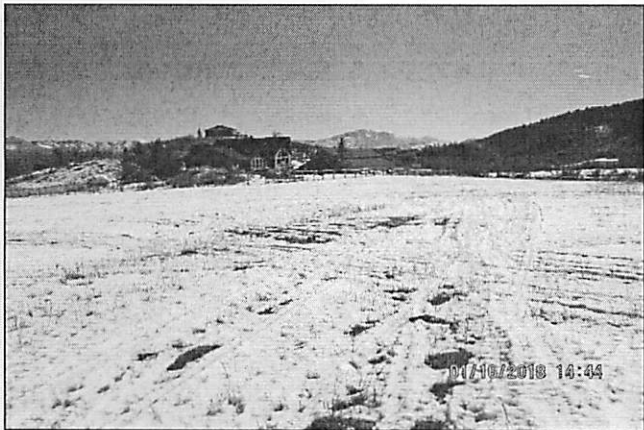
5. South property line, view to east.

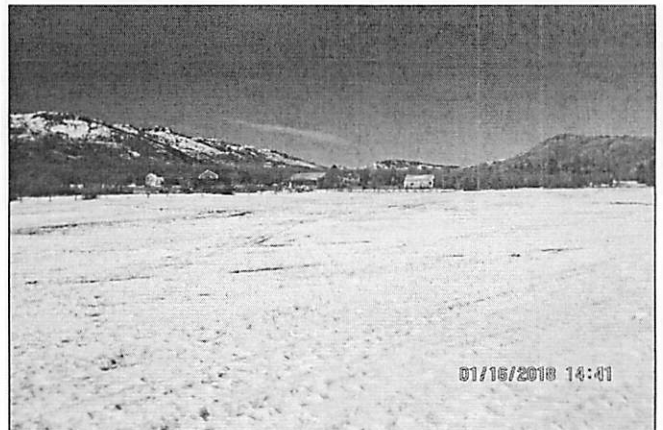
6. South property line, view to west.

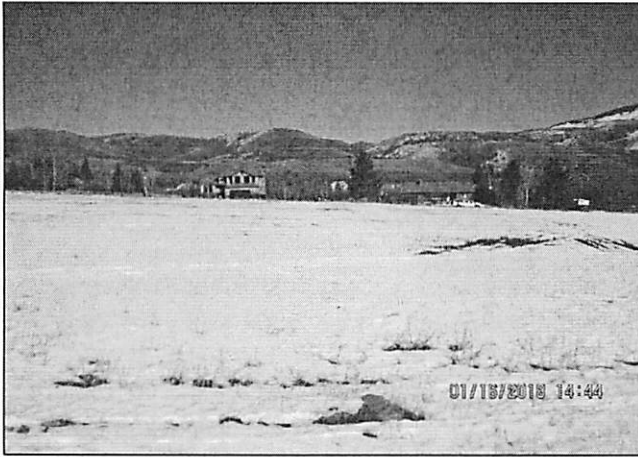
7. Northwest property line, view to northeast.

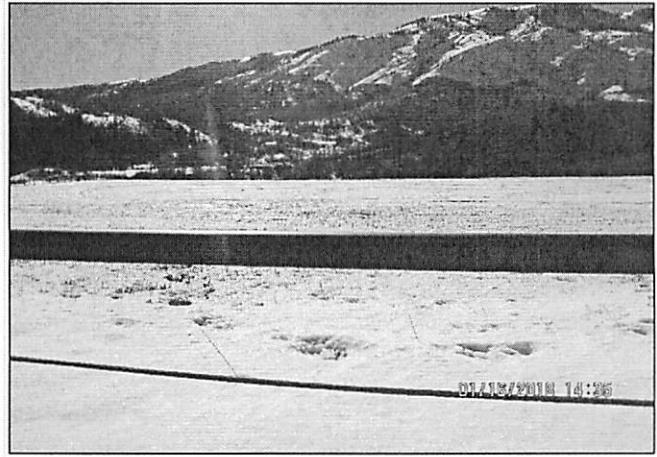
8. Northwest property line, view to southwest.

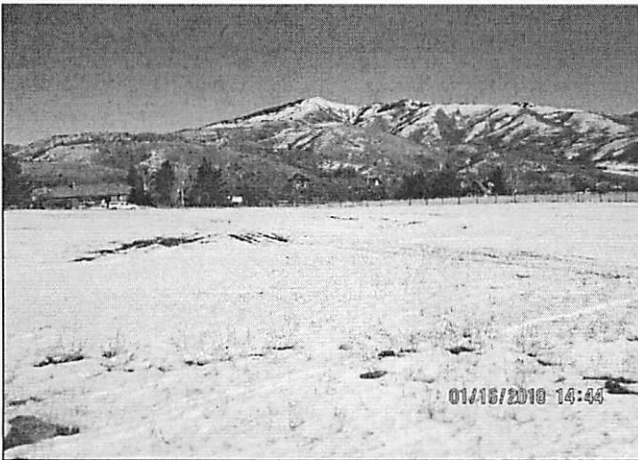
9. Overview of parcel, view to north.

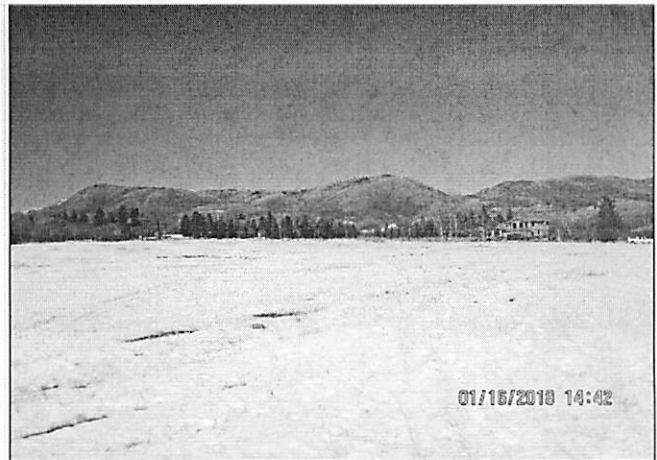
10. Overview of parcel, view to northwest

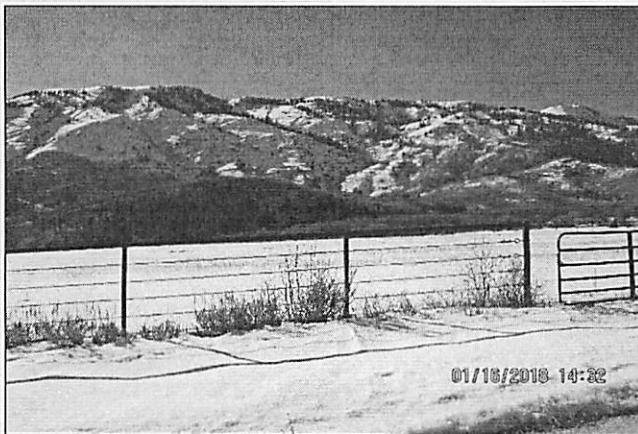
11. Overview of parcel, view to south/southeast.

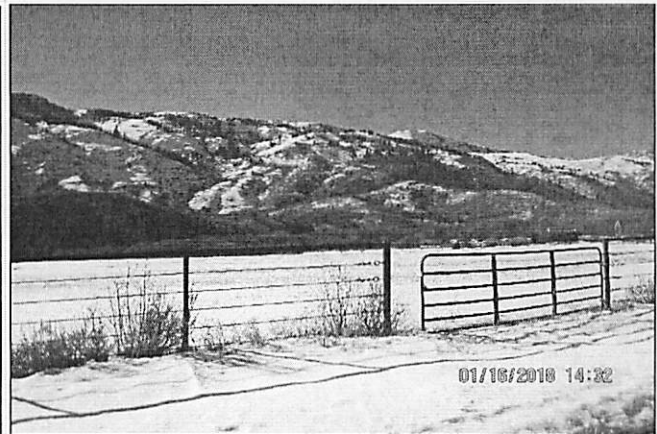
12. Overview of parcel, view to south/southeast .

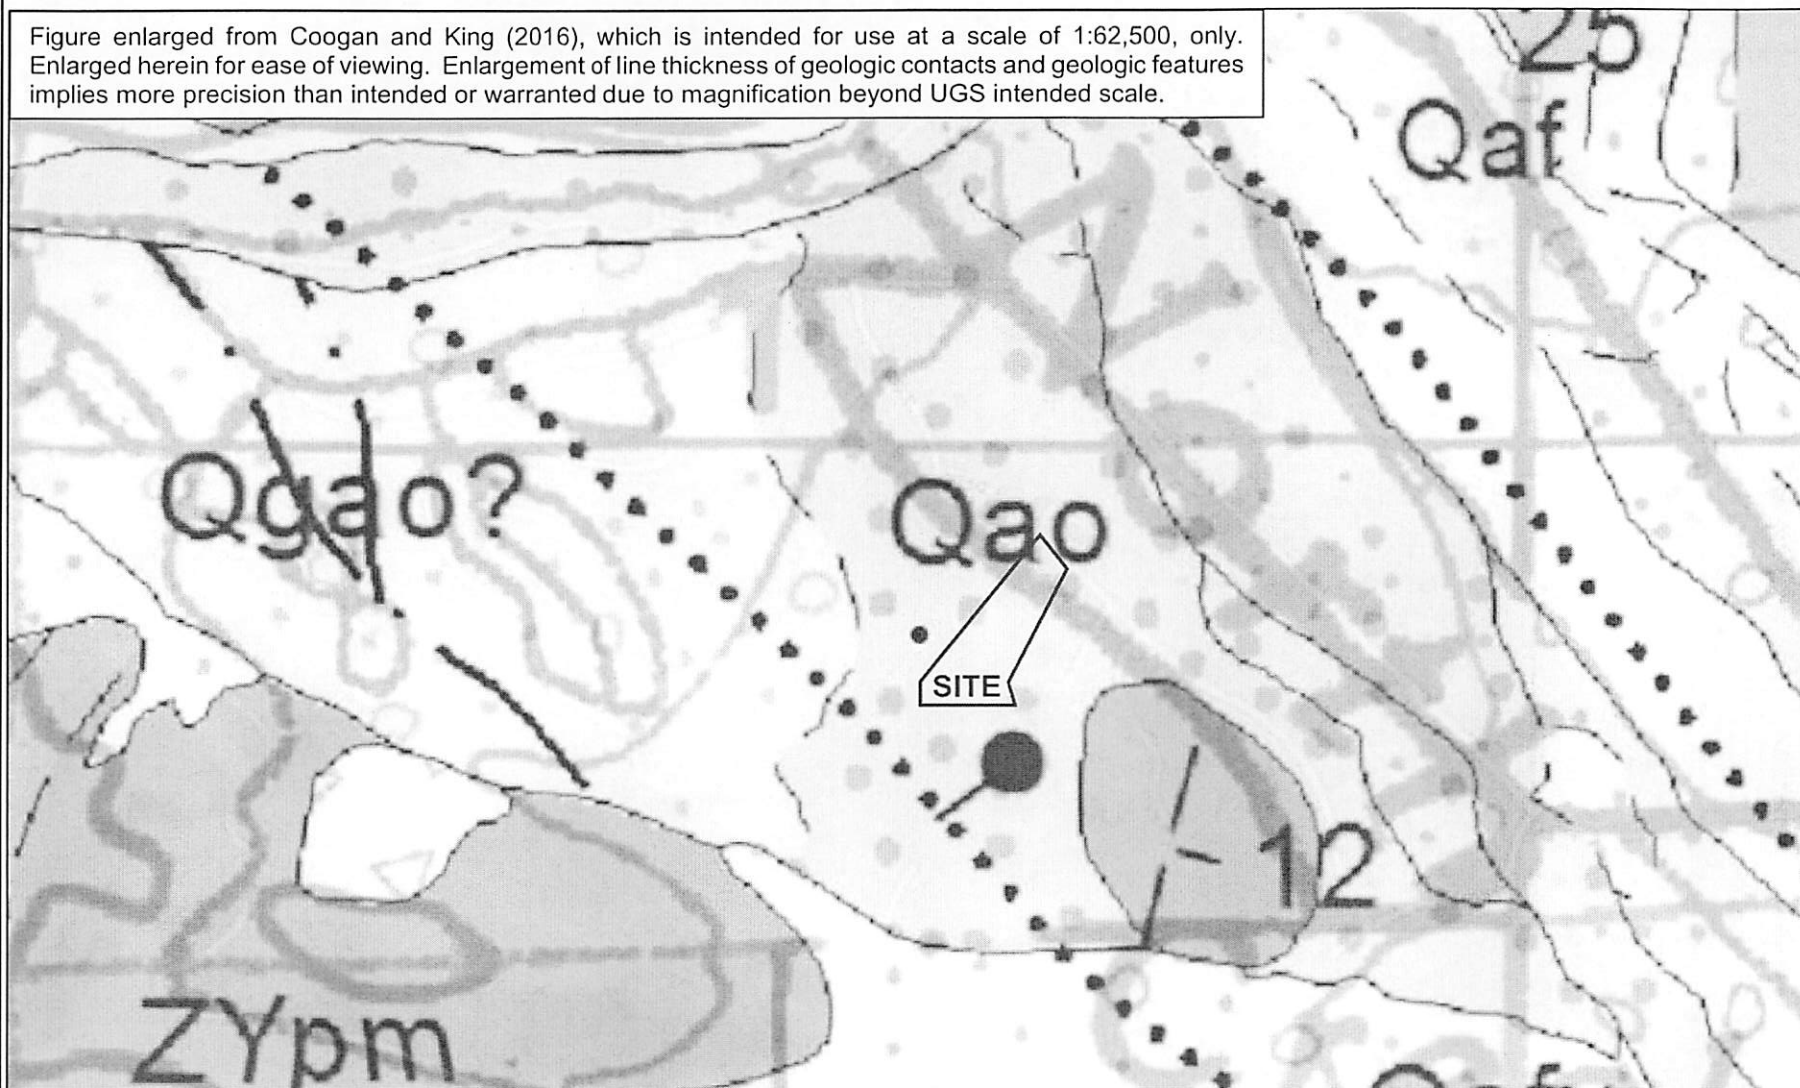
## GENERAL GEOLOGIC MAP

General geology of the site is shown in Figure 8, General Geologic Map. An explanation for the geologic units and symbols in Figure 8 are presented in Figure 9, Legend for General Geologic Map. According to Coogan and King (2016), the Property is underlain by older alluvium (mostly upper Pleistocene-age) (geologic unit Qao on Figure 8). Coogan and King (2016) describe this geologic unit as follows:

Coogan and King (2016) indicate a "dotted" fault immediately southwest of the Property. A dotted fault indicates the particular fault is concealed (e.g., buried) by younger deposits, which in this case implies the "dotted" fault is buried by Pleistocene-age alluvial deposits. Upon review of Coogan and King (2016), SA could not determine the basis for the concealed fault and contacted Mr. Jon King for clarification. Mr. King indicated, based on additional work in the area after publication of Coogan and King (2016), the fault immediately south of the property will be removed on subsequent versions of the geologic map of the Ogden 30' x 60' Quadrangle (Jon King, written communication, January 31, 2018; Jon King email/map to SA attached).
