**Geologic Hazards Screening Assessment  
Approximately 4400 North 2900 East  
Eden, Utah 84310  
Parcel # 22-088-0076**

GeoStrata Job No. 1348-001

December 4, 2017

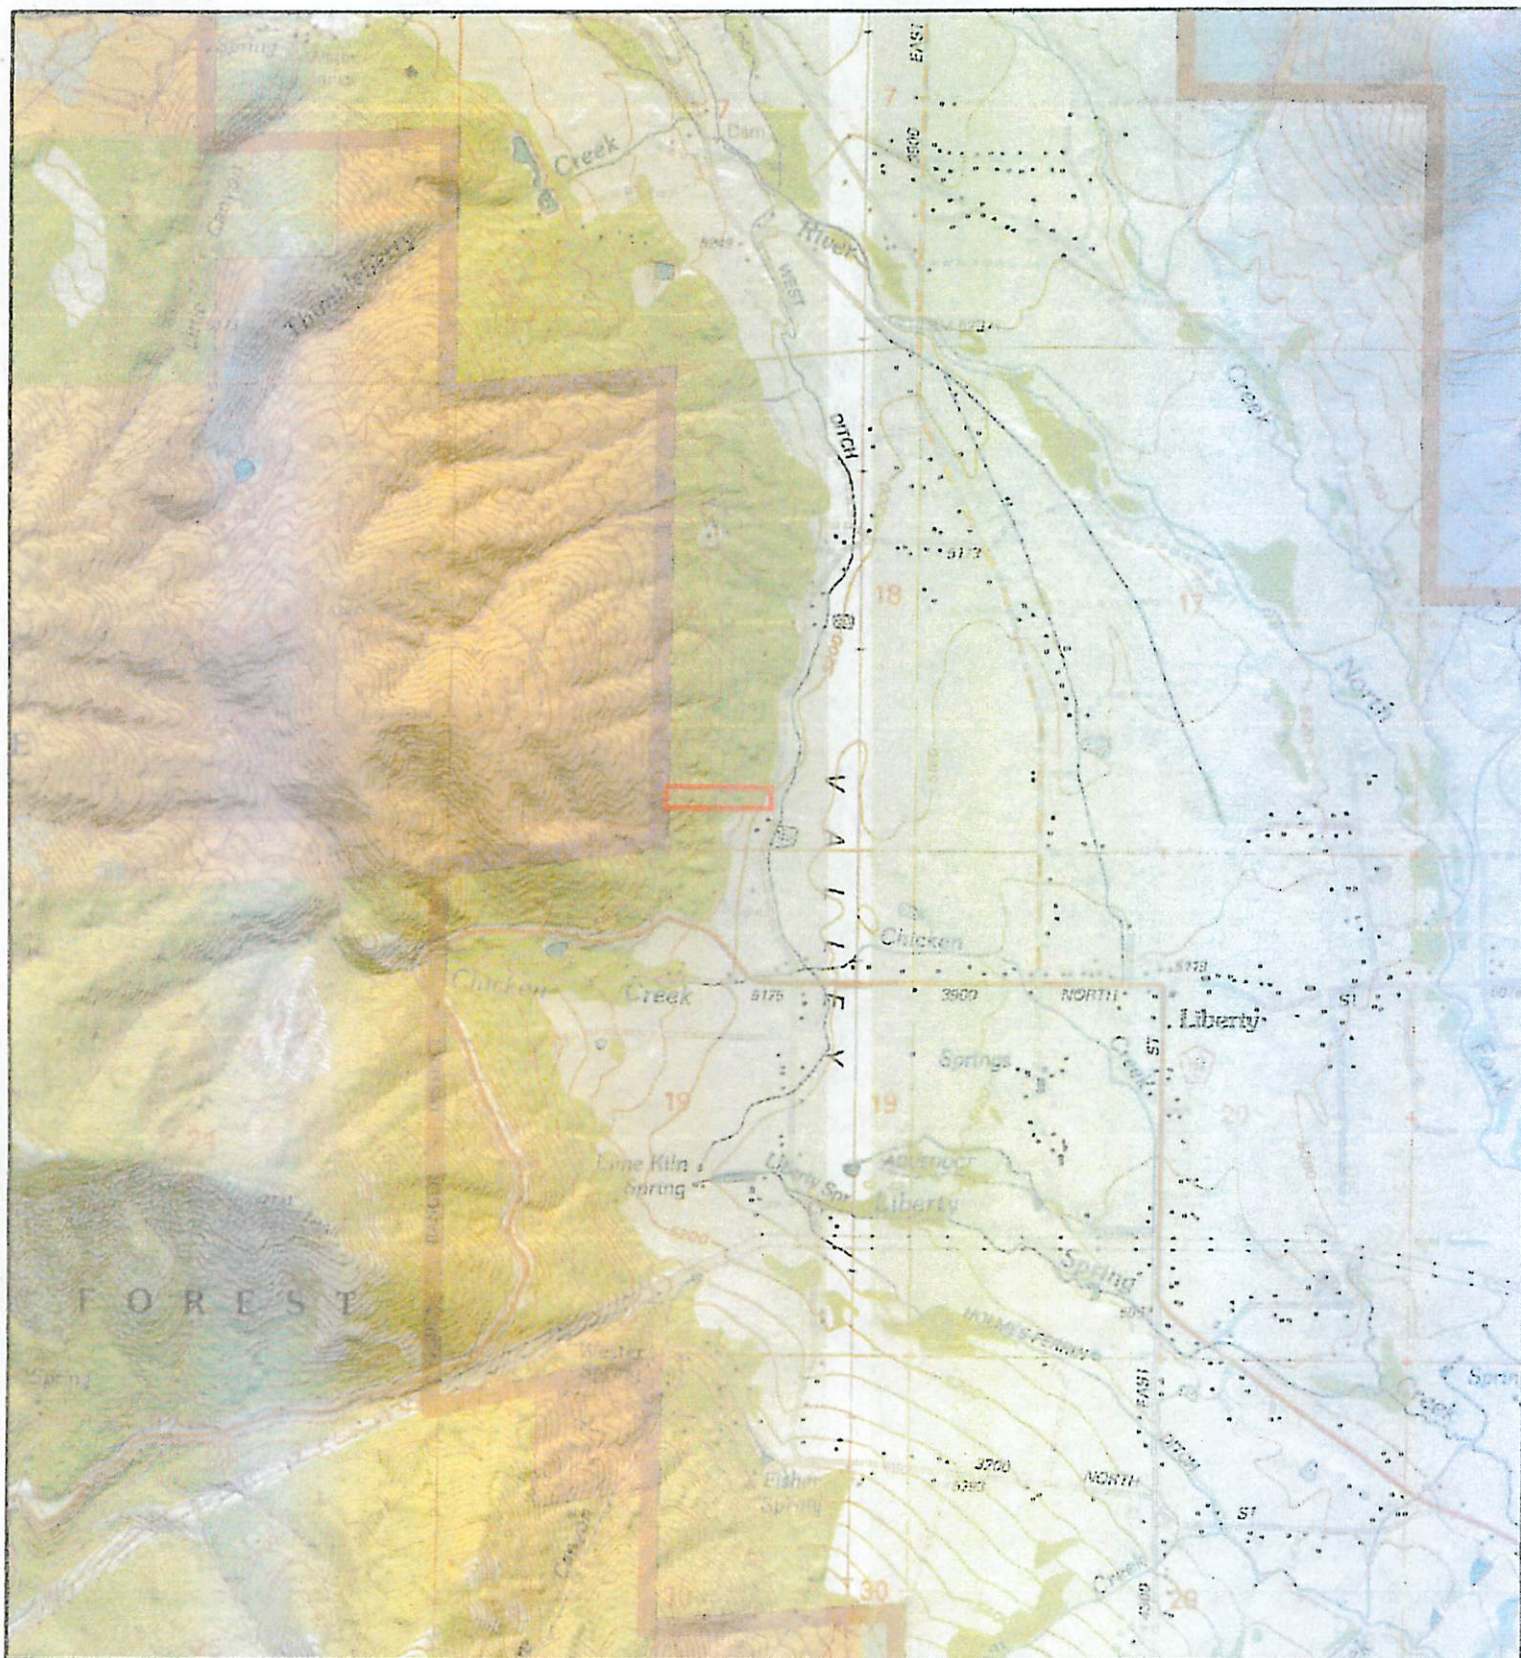
**Plate  
2**

Slope stability of the subject site was not assessed as part of this geological hazard assessment. The subject site was observed to be moderately sloping to the east and relatively flat (Plate 2 Topographic Map). Based on our understanding of the project, the proposed building site is located in the relatively flat areas of the subject site (Plate 3 Proposed Building Site). The possibility that development of the site could negatively affect slope stability within the subject site is increased if development is planned for areas of the site with slopes steeper than

As stated previously, the project site is located within the northwestern extent of Ogden Valley in Eden, Utah. The subject site is situated on a moderately to relatively flat undeveloped 5.68 acre parcel within Weber County (Plate 2 Topographic Map). The area extending from the eastern property boundary and west approximately 100 to 125 feet was observed to be relatively flat. Test pits were excavated within the subject site as part of infiltration testing and were separate from this investigation. One test pit was left open at the time of our field investigation and was observed to extend to a depth of approximately 8 feet. Areas of surface disturbance were also observed as remnants of buried test pits. Soils within the open test pit and in the areas of disturbance were observed to consist of clays with sand and gravel. The subject site was observed to be densely vegetated with large brush and scrub oaks up to 30 feet tall. No structures were observed within the subject property. The properties to the south and east of the subject site are undeveloped parcels and the area west of the subject site is a native hillside. A single family residence is currently in the development stages on the property adjacent to and immediately north of the subject site.

approximately 3 horizontal: 1 vertical, GeoStrata recommends that slope stability at the site be assessed as part of a site specific geotechnical assessment of the subject lot. If improvements are planned as a part of the development of the lot that include cuts and fills other than excavation of the foundation, minor grading of the driveway and minimal landscaping, then it is our opinion that a site specific geotechnical investigation which includes a detailed slope stability assessment of the lot needs to be conducted prior to development of the lot and the recommendations contained in the geotechnical report be followed as a part of the grading design for the lot.

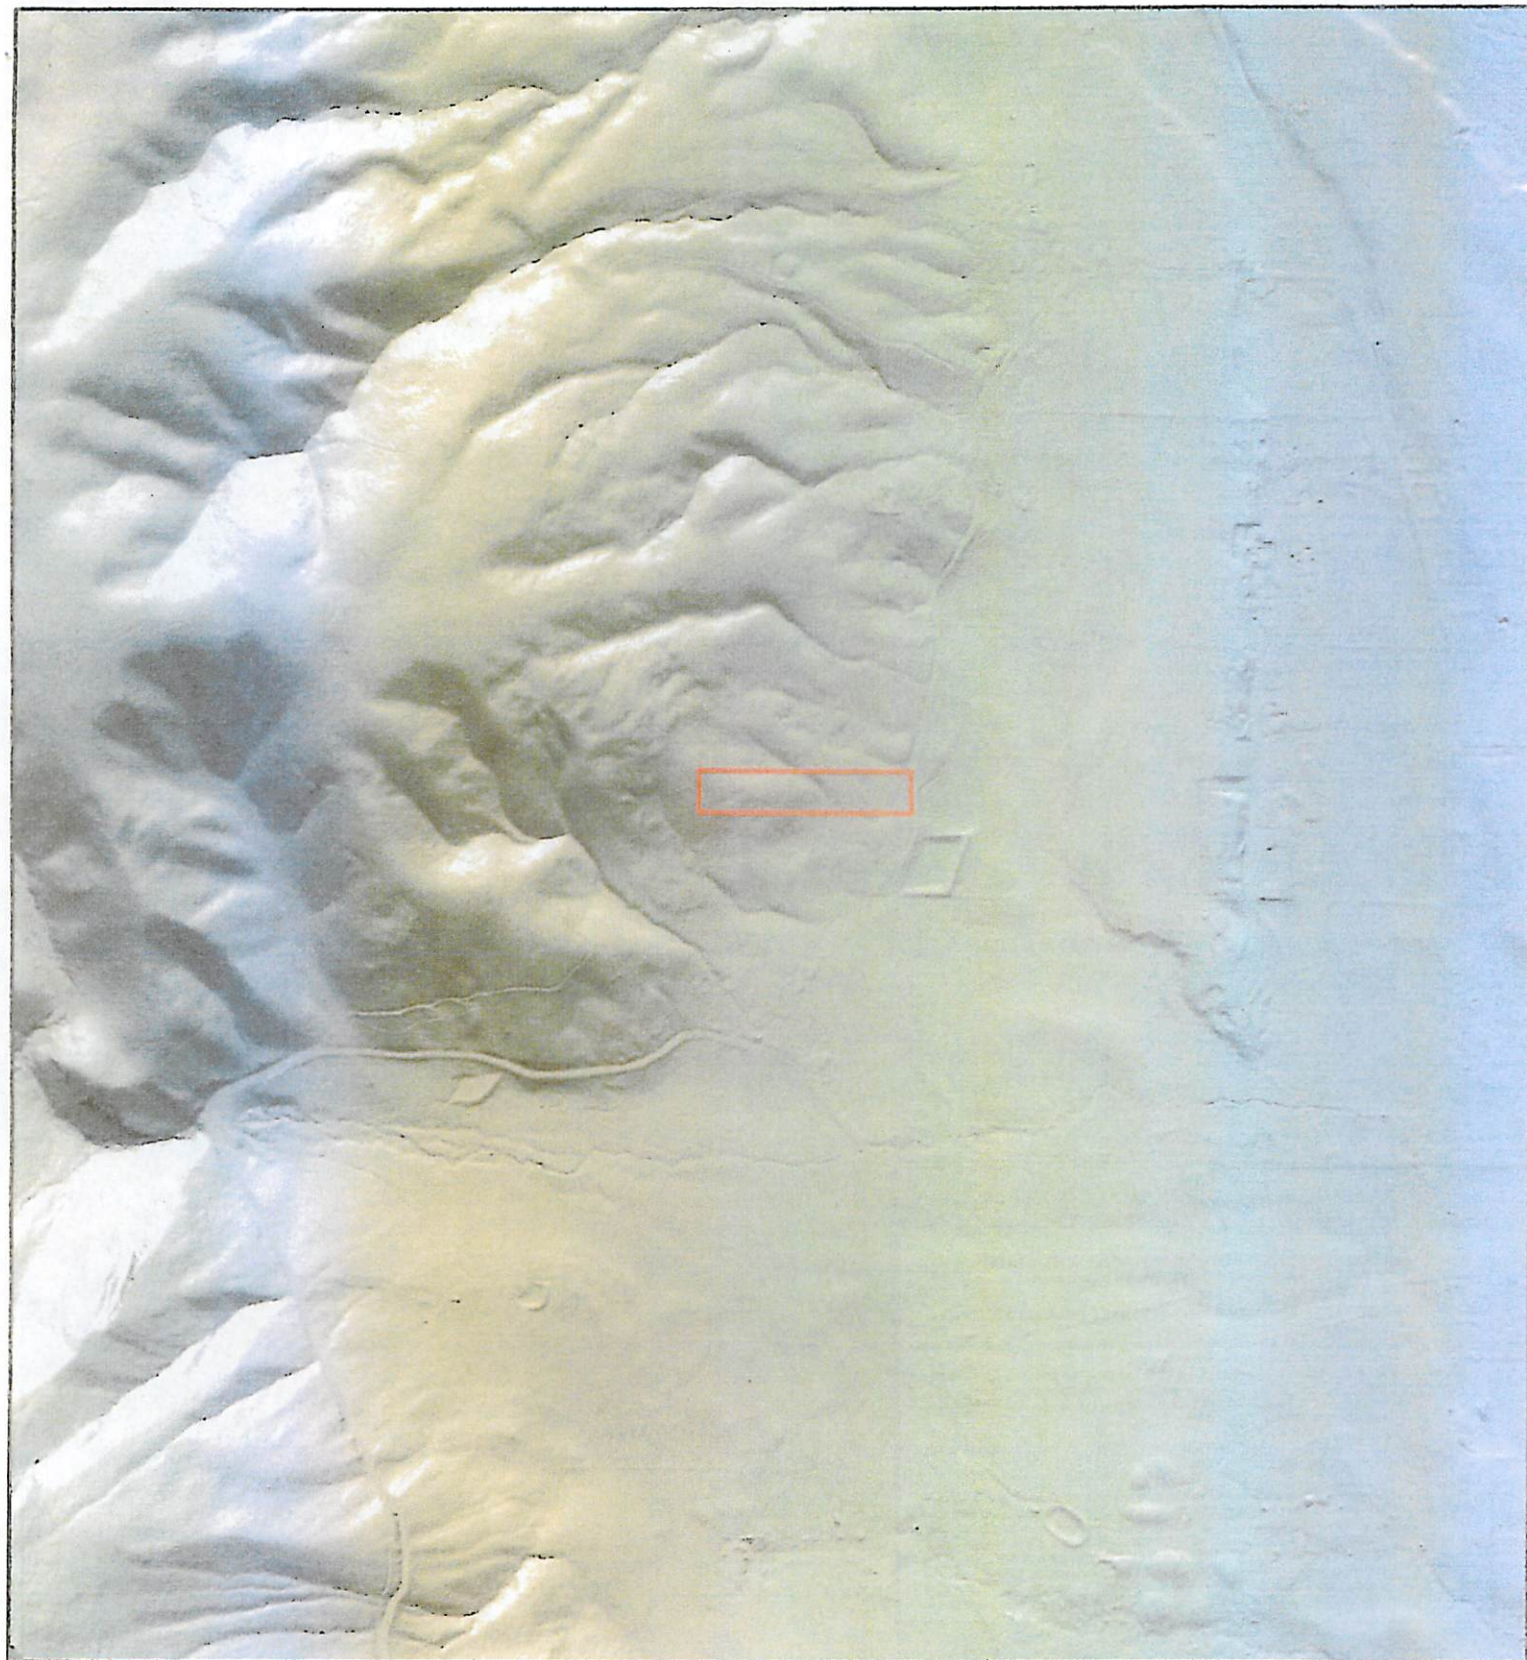
**Plate  
4**

GeoStrata also conducted a review of 2011 1 meter LiDAR data obtained from the State of Utah AGRC to assess the subject site for visible lineations or other geologic related geomorphology. The LiDAR data was used to create hillshade imagery that could be reviewed for assessment of geomorphic features related to geologic hazards (Plate 4).

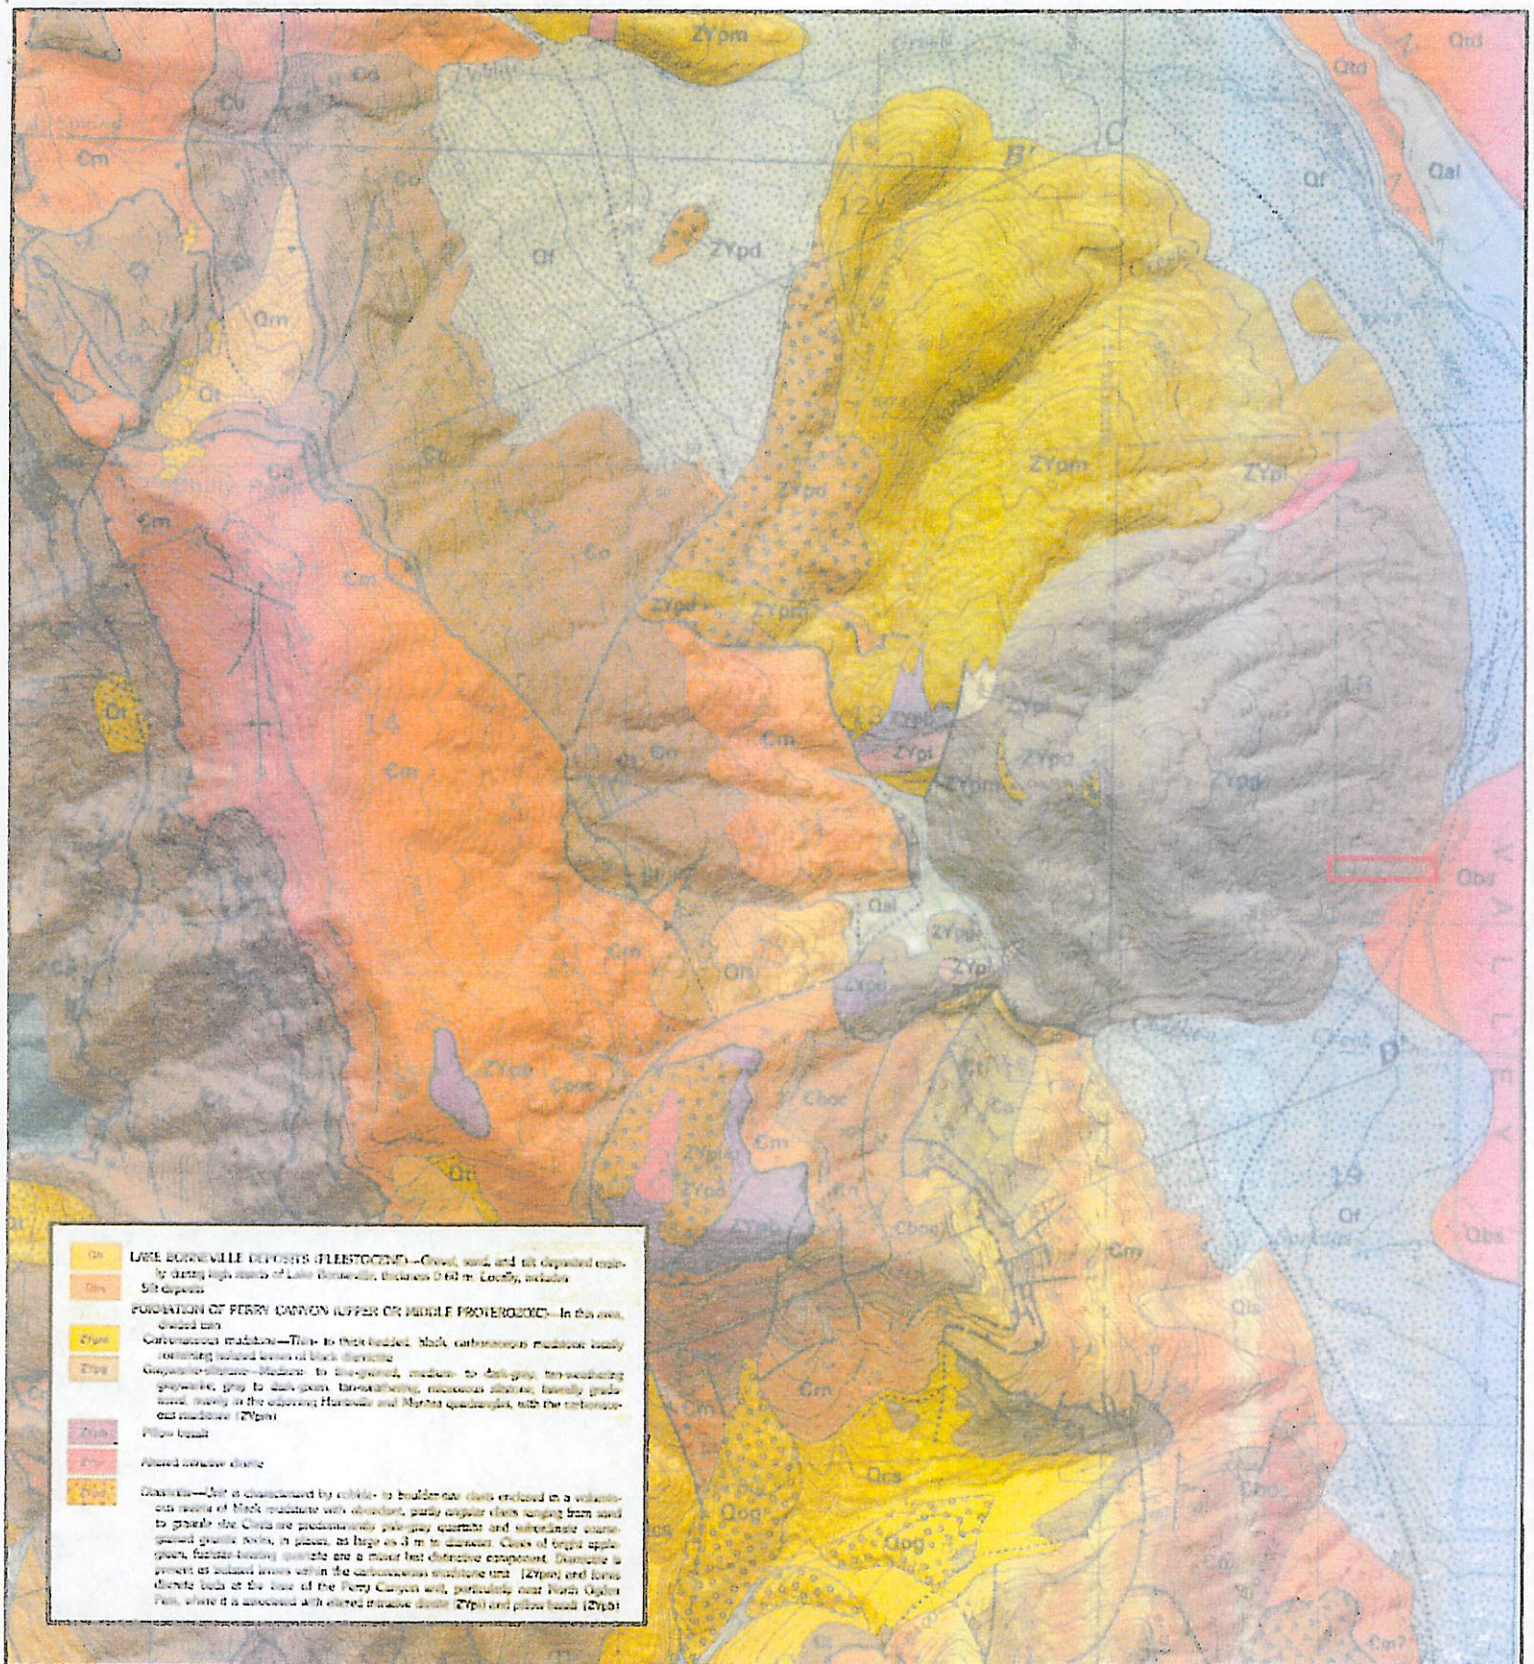
**Plate  
5**

within or adjacent to the subject site (Plate 5 Site Vicinity Geologic Map; Plate 6 Site Vicinity 30' X 60' Geologic Map). Given our field and office investigations, the alluvial fan flooding hazards within subject site is considered low and it is considered unlikely that debris flows will impact the proposed development. It is the opinion of GeoStrata that alluvial fan flooding hazard should not preclude development at the subject lot.

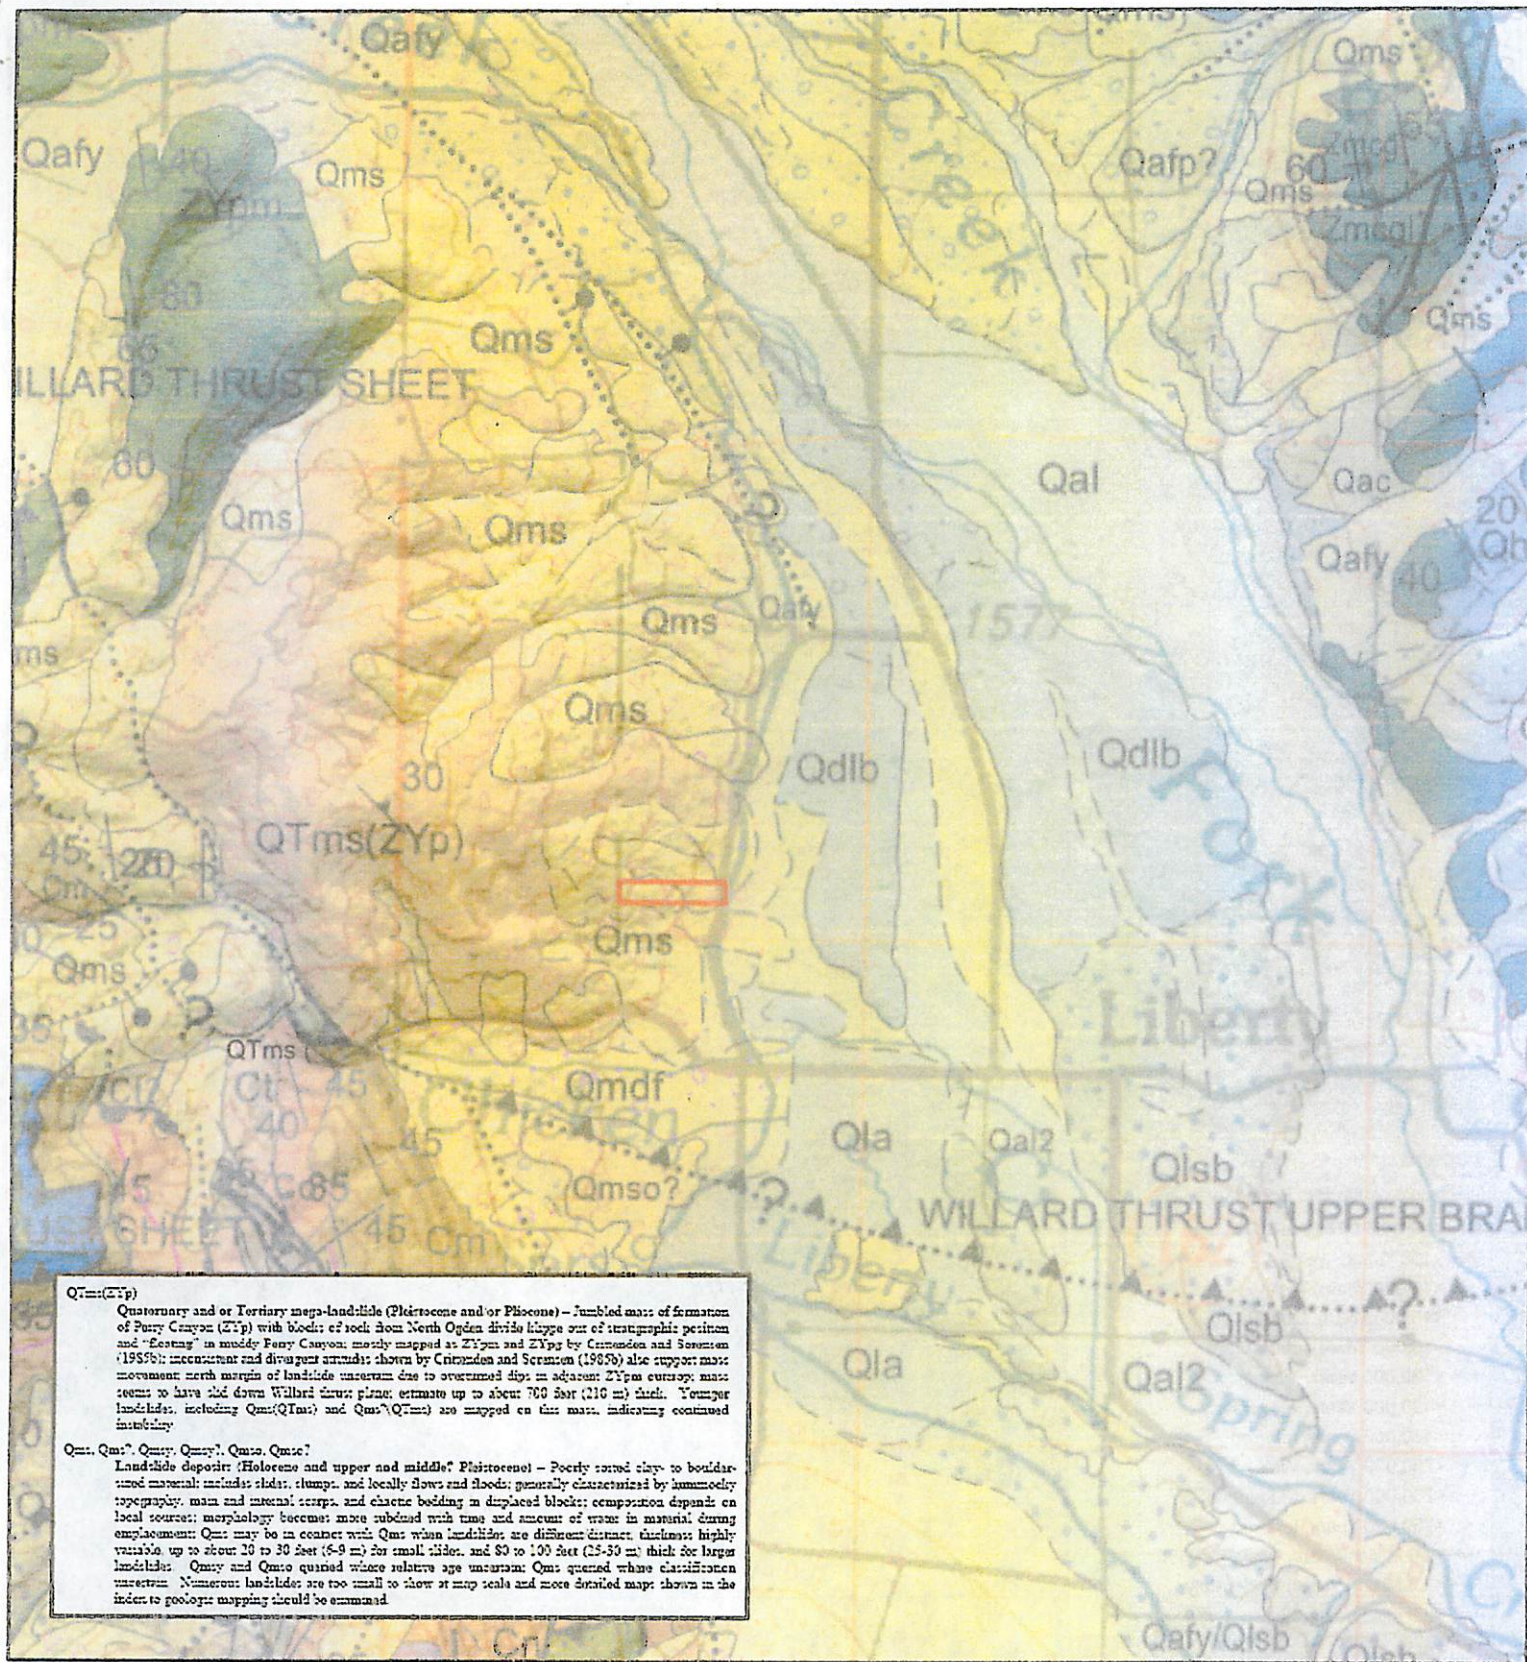
Based on our review of published geologic maps, a coalescence of landslide deposits are mapped as underlying the subject site as indicated on Plate 6 Site Vicinity 03' x 60' Geologic Map and Plate 8 Landslide Hazard. The landslide deposits mapped as underlying the subject site are not indicated on the 1 to 24,000 scale geologic map compiled by Crittenden and Sorensen (Plate 5 Site Vicinity Geologic Map). The age and description of these landslide deposits as indicated on the Interim Geologic Map of the Ogden 30' x 60' Quadrangle are Holocene and upper and possibly middle Pleistocene age deposits generally characterized as hummocky topography. During our field observations no hummocky topography was observed within the subject site. Our review of hillshades derived from 2011 1 meter LiDAR data did however indicate hummocky topography north and northwest of the subject site as indicated on Plate 9 Delineated Landslide Features. The landslide deposits are mapped as overlying an older, Pleistocene and/or Pliocene age, mega-landslide. The mega-landslide deposit is described as a large mass of the Perry Canyon formation (ZYP) that slid along the northwest trending Willard thrust plate. If a study of the stability of the landslide as a whole is required, a more detailed study of the landslide including subsurface exploration utilizing deep borings of the hillside above the subject site would be necessary and is out of the scope of this geologic hazards screening.

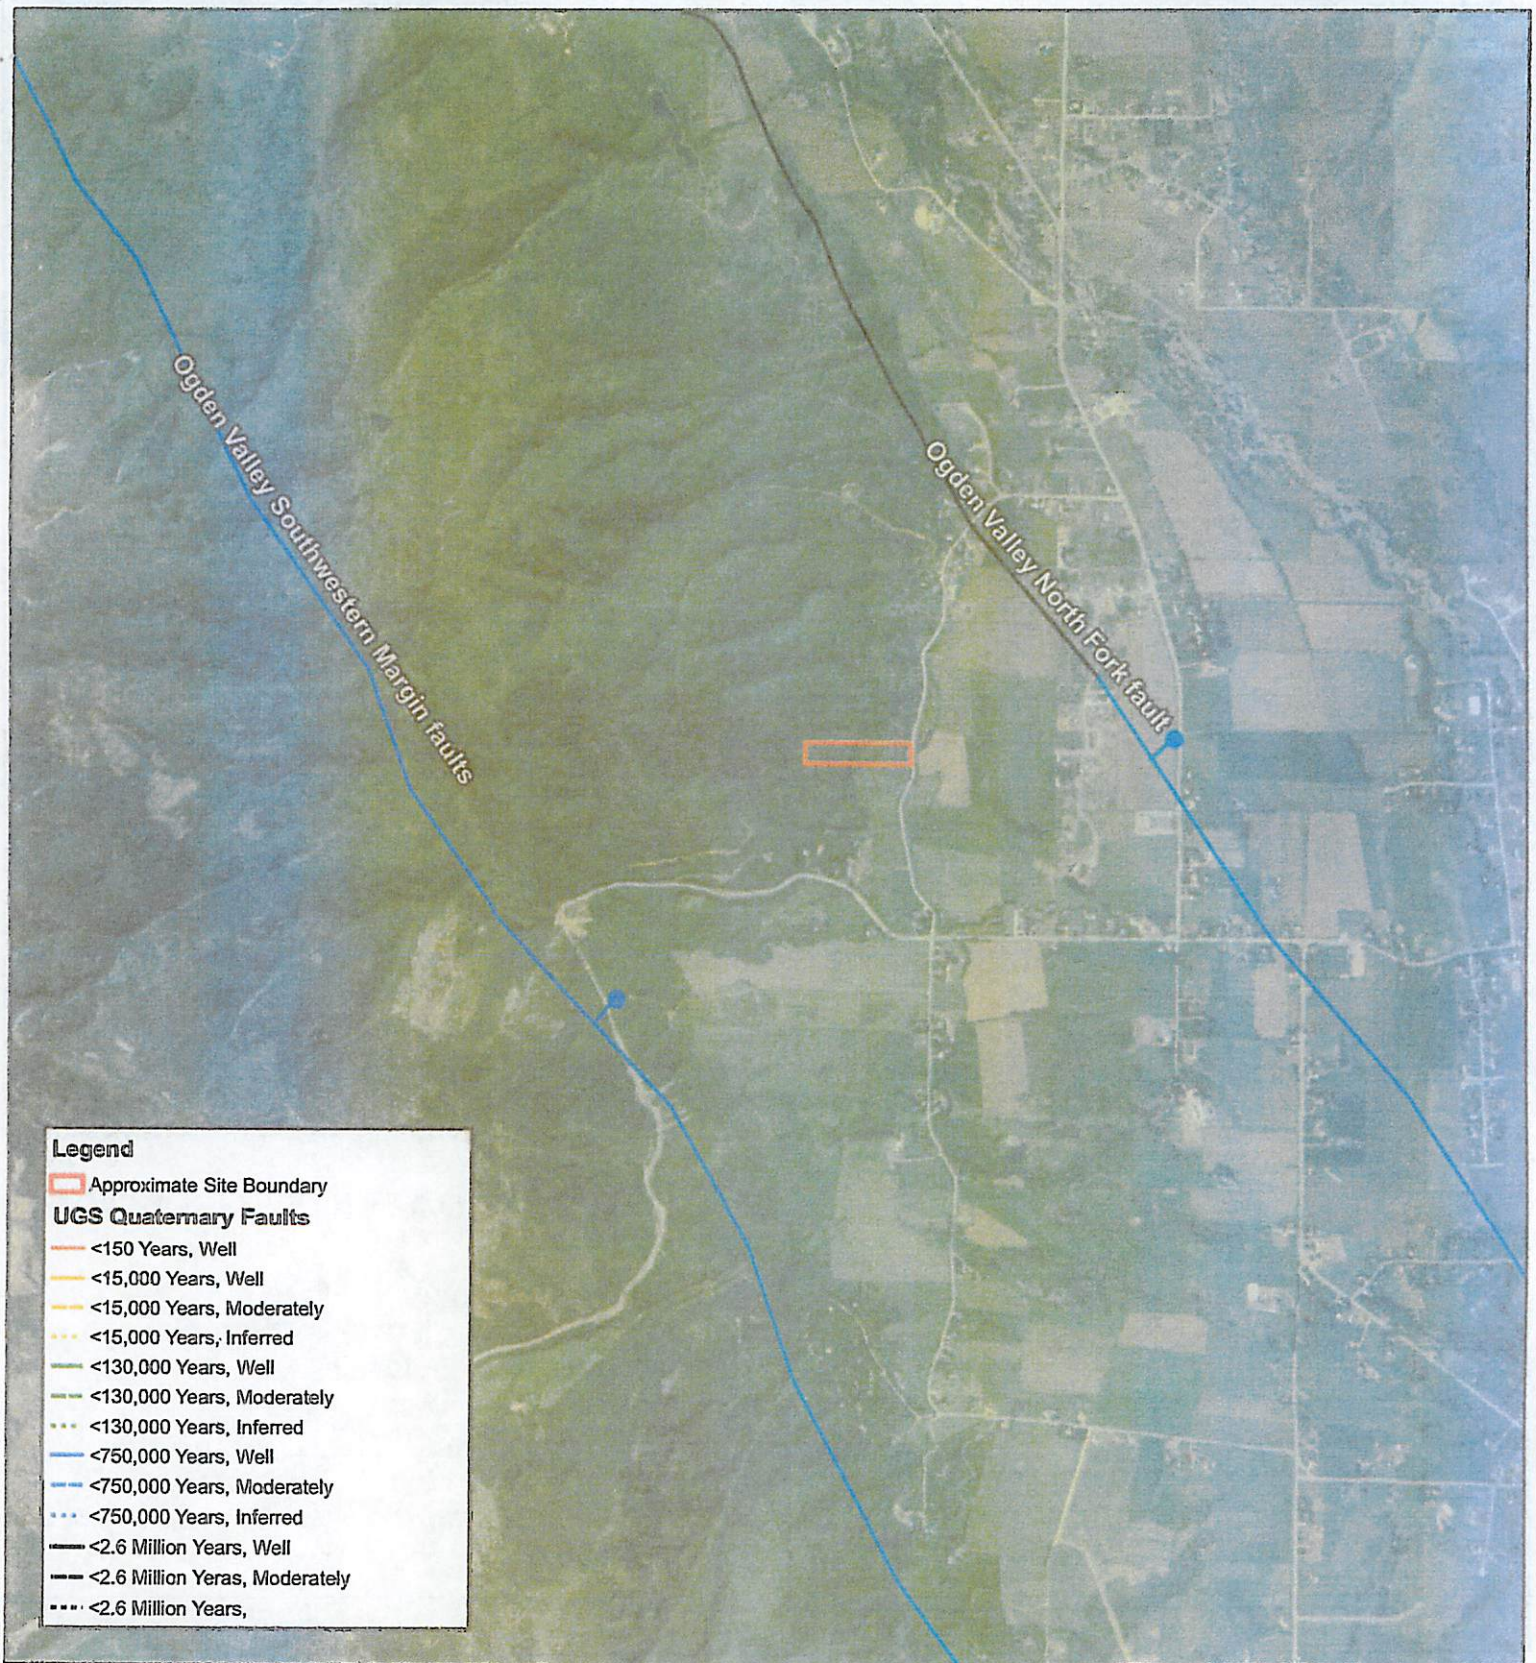
**Plate  
7**

Based on review of published geologic maps, our stereographic aerial photograph interpretation, our review of the hillshades derived from 2011 1 meter LiDAR and our field observations, no active surface ruptures are located near the subject site (Plate 7 UGS Quaternary Fault Map). The nearest fault is the Ogden Valley North Fork Fault and is Quaternary in age with an undetermined reoccurrence interval and a slip rate of less than 0.2 mm/yr (Black and others, 2003). This fault is trending northwest approximately 0.42 miles east of the subject site. Given our field and office investigations, the surface fault rupture hazard within the subject site is considered low and it is

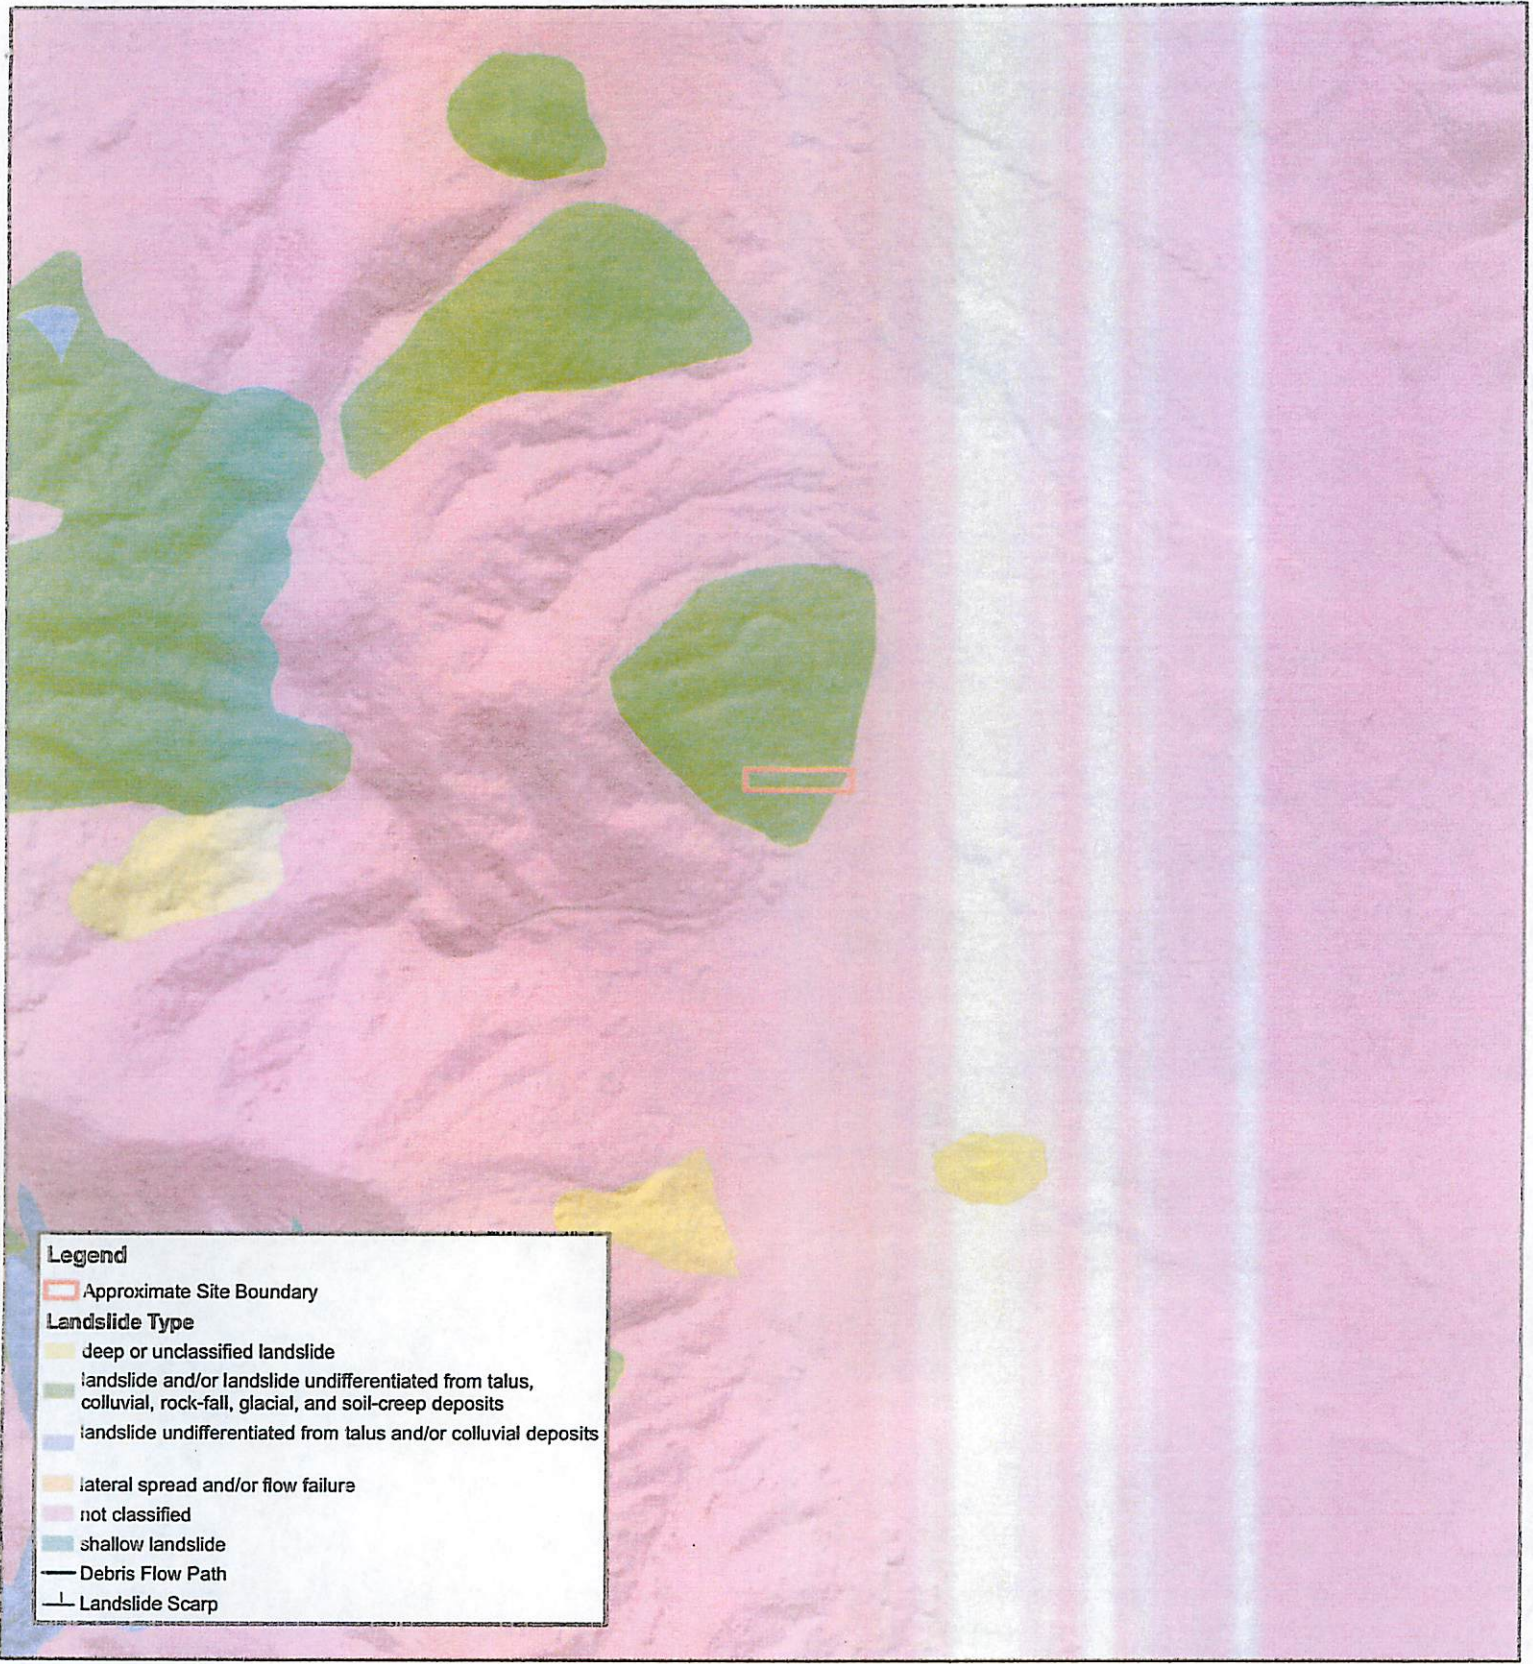
**Plate**  
**8**

It is the opinion of GeoStrata that based on the landslide prone deposits underlying the subject site it is possible that some movement could occur in areas underlying and above the subject lot. In order to reduce the potential for movement of the landslide prone deposits underlying the site, GeoStrata recommends that no mass grading, cuts and fills or construction of retaining structures be conducted as part of the development of the lot. Where landscaping is planned as part of the development of the subject site, we recommend that native drought resistant vegetation be used in the landscape design and that minimal irrigation water be introduced to the subject site. The subject site should remain in a relatively native state. Site design should be engineered to facilitate surface water runoff and to insure that no water be introduced into the hillside through infiltration. GeoStrata also recommends that the area of development should be restricted to relatively flat areas within the subject site as indicated on Plate 11 Recommended Buildable Area. GeoStrata recommends that a geotechnical investigation be performed to provide soils information for the design of the planned structure, groundwater data, and to provide an assessment of the slope stability within the subject site. If the location of habitable structures are planned outside of this recommended buildable area, we feel a geotechnical investigation that includes slope stability assessment within the subject site is necessary to reduce the risk of the development increasing the possibility of slope failure within the subject site. It is the opinion of GeoStrata that landslide hazards should not preclude development within the subject lot,

however, the potential for movement of the landslide underlying and adjacent to the subject lot should be understood and designed for. Reinforcement of footing and foundation elements by the structural engineer could also be utilized to mitigate potential damage of the proposed residence by reactivated movement of the landslide deposits. It is the opinion of GeoStrata that the landslide hazard within the subject site is considered moderate. It is considered possible that landslides could impact the proposed development even if the recommendations stated above are implemented. Our recommendations are provided to reduce the risks associated with landslide hazards within the subject lot, not completely remove them. It is the opinion of GeoStrata that landslide hazard should not preclude development at the subject site.

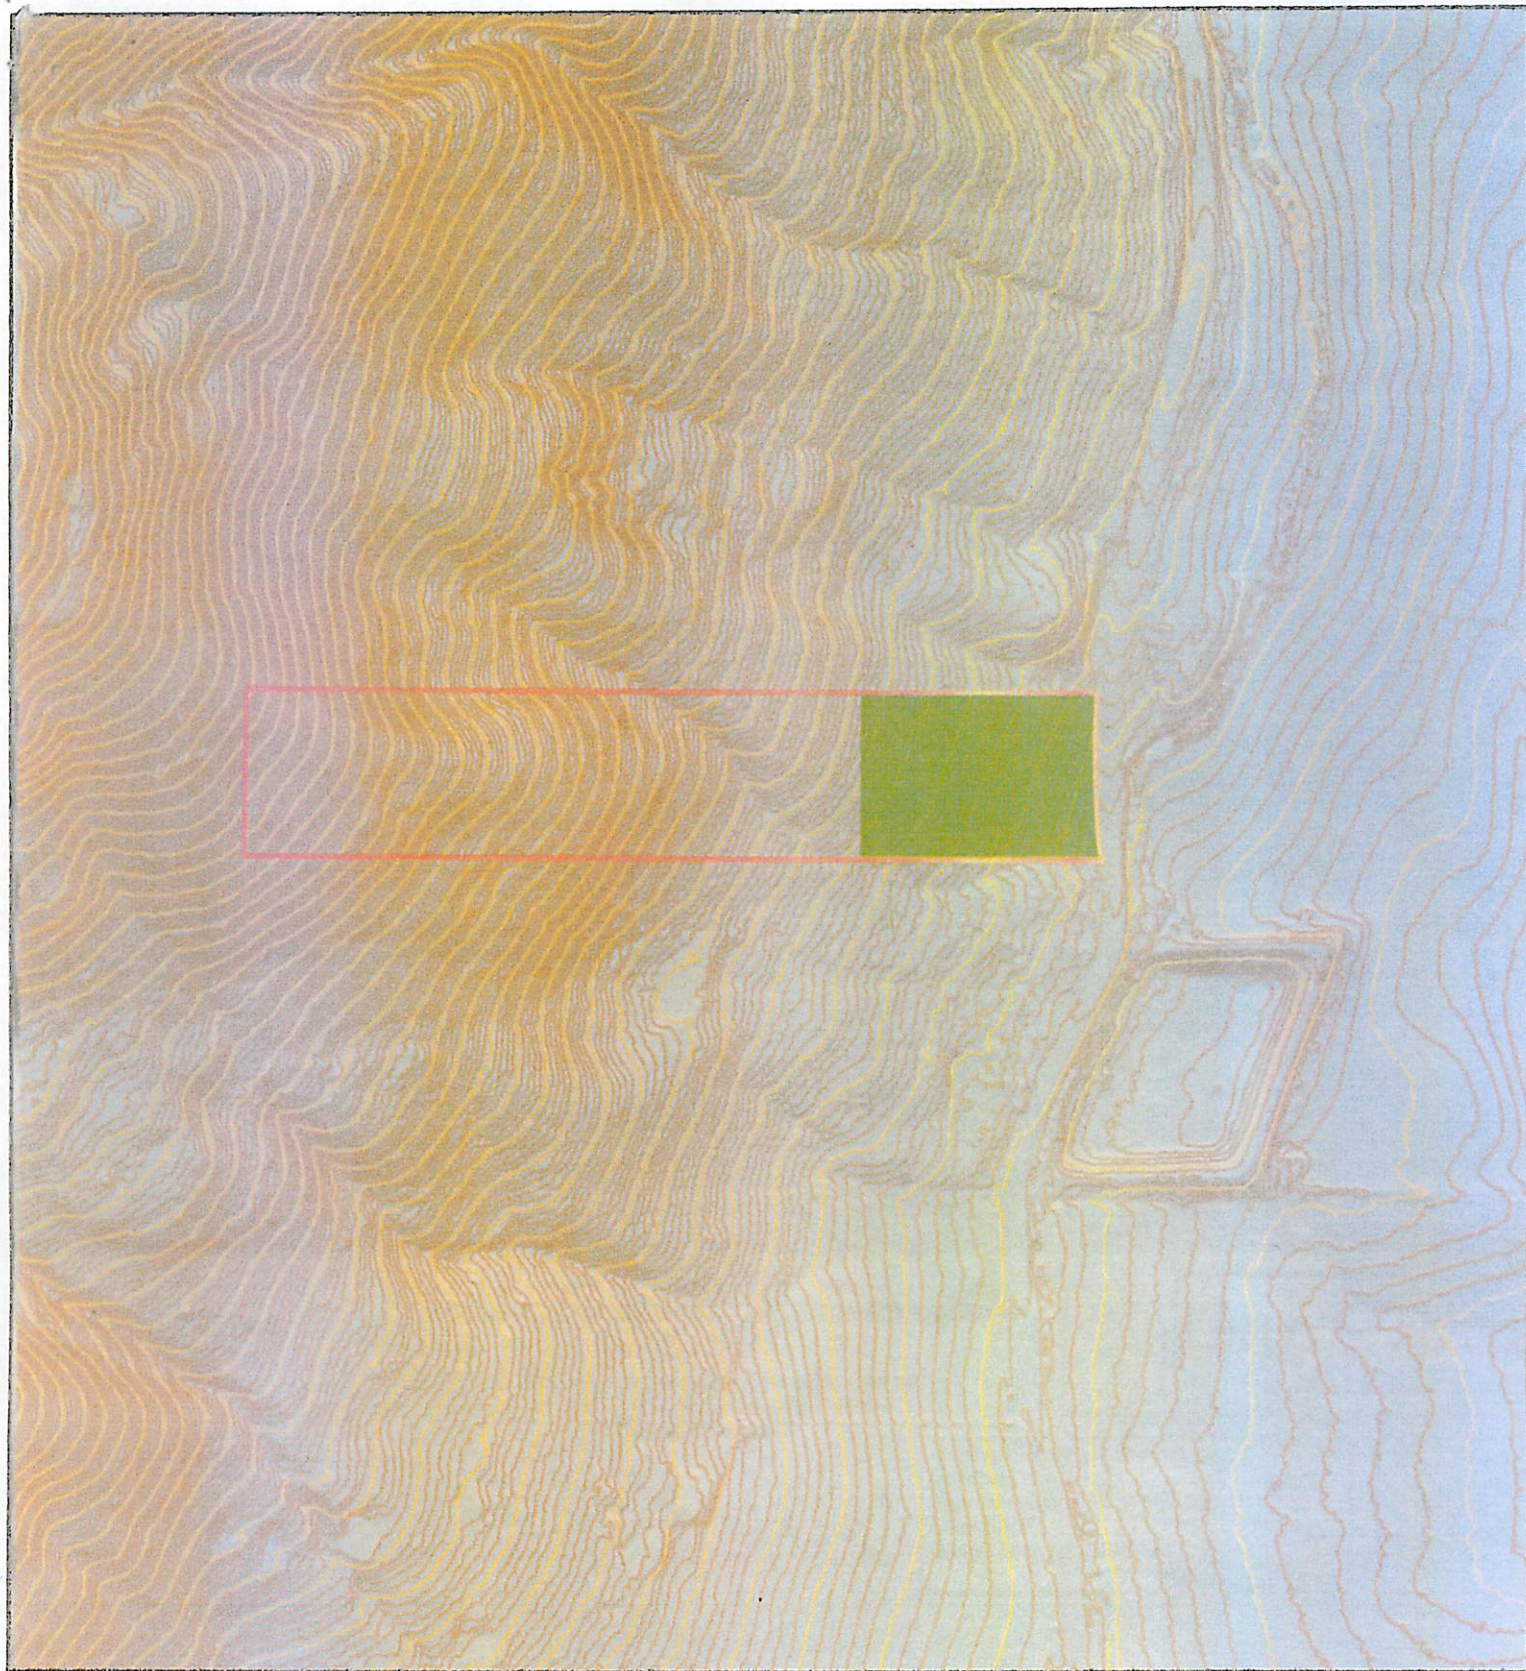
Plate  
10

Based on review of published topographic maps, no drainage is mapped within the subject site. Drainage swales were observed adjacent to and trending through the subject site as indicated during our stereographic aerial photograph interpretation, our review of the hillshades derived from 2011 1 meter LiDAR data and our field observations (Plate 11 Drainage Map). GeoStrata recommends a setback of 15 feet from the observed drainage swales, as indicated on Plate 11. No development or mass grading should occur within the setback area unless the flow within the drainage is maintained and designed by a civil engineer as part of the development and grading within the drainage. Given our field and office investigations, the stream flooding hazard within

The stream flooding hazard that would potentially impact the site was assessed as part of this study. Drainage swales are mapped adjacent to and trending through the subject site. GeoStrata recommends a setback of 15 feet from drainage swales. No development or mass grading should occur within the setback area unless the flow within the drainage is maintained and designed by a civil engineer as part of the development and grading within the drainage. Given our field and office investigations, the stream flooding hazard within the subject lot is considered low and it is considered unlikely that stream flooding will impact the proposed development. It is the opinion of GeoStrata that stream flooding hazard should not preclude development at the subject lot.

the subject lot is considered low and it is considered unlikely that stream flooding will impact the proposed development as long our recommendations for avoidance of the drainage swales are followed. It is the opinion of GeoStrata that stream flooding hazard should not preclude development at the subject lot. Proper site grading and drainage plans should be developed for the subject site as a part of the civil engineering design for the lot.
