**Geologic Hazards Assessment
Parcel #'s 23-012-0019 & 23-012-0105
Eden, Utah**

GeoStrata Job No. 1236-003

July 31, 2018

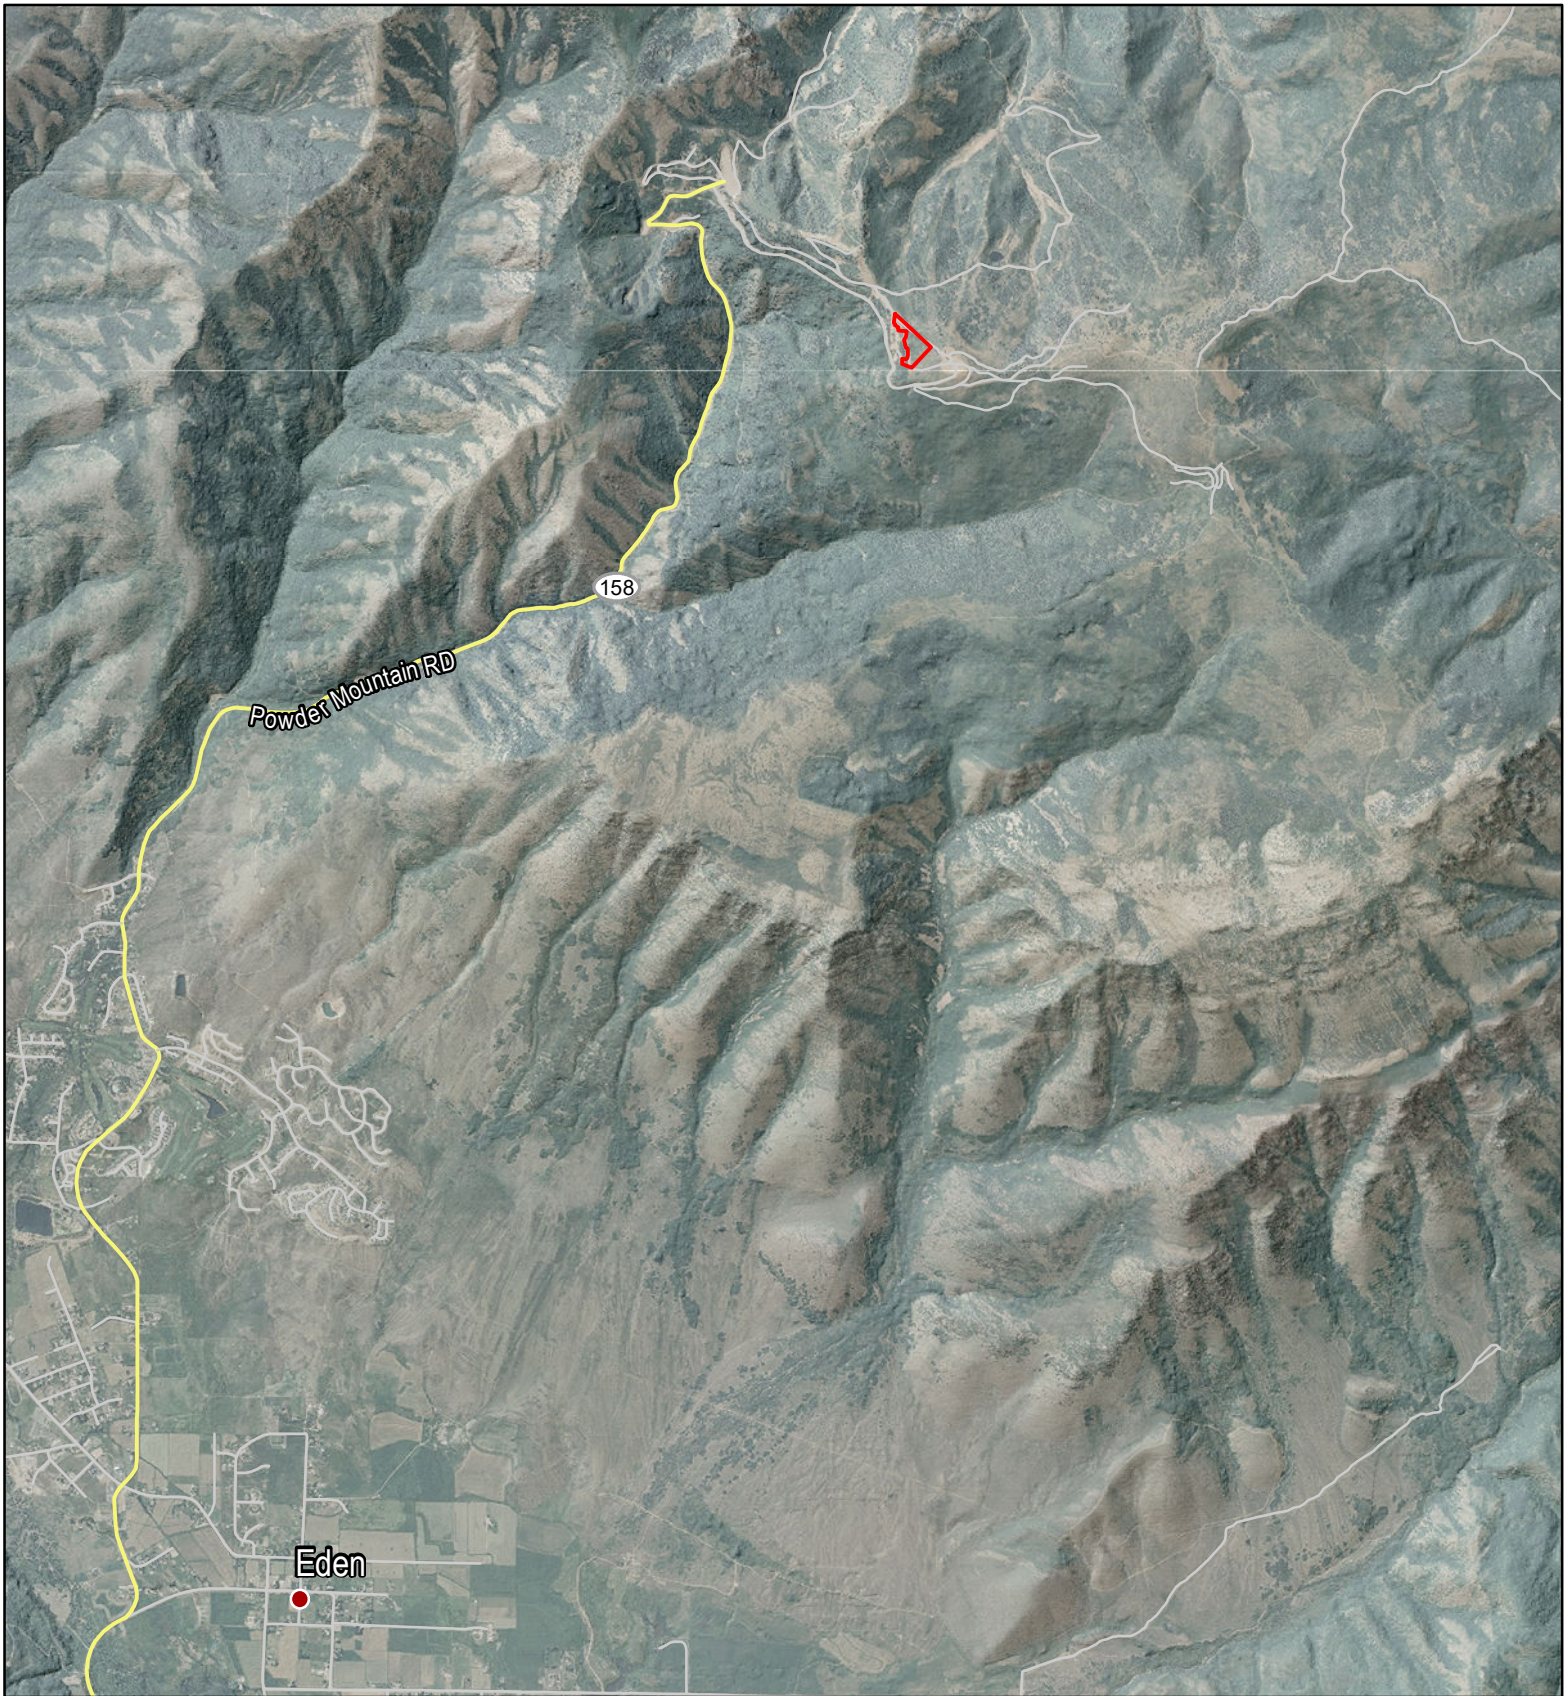
**Plate
1**

Based on our review of the Mantua, James Peak, Sharp Mountain and Huntsville topographic quadrangles and our field investigation, no dams or reservoirs are located up-gradient of the subject site (Plate 1 Site Vicinity Map; Plate 2 Topographic Map). Given our field and office investigations, the dam failure hazard within the subject site is considered low and it is

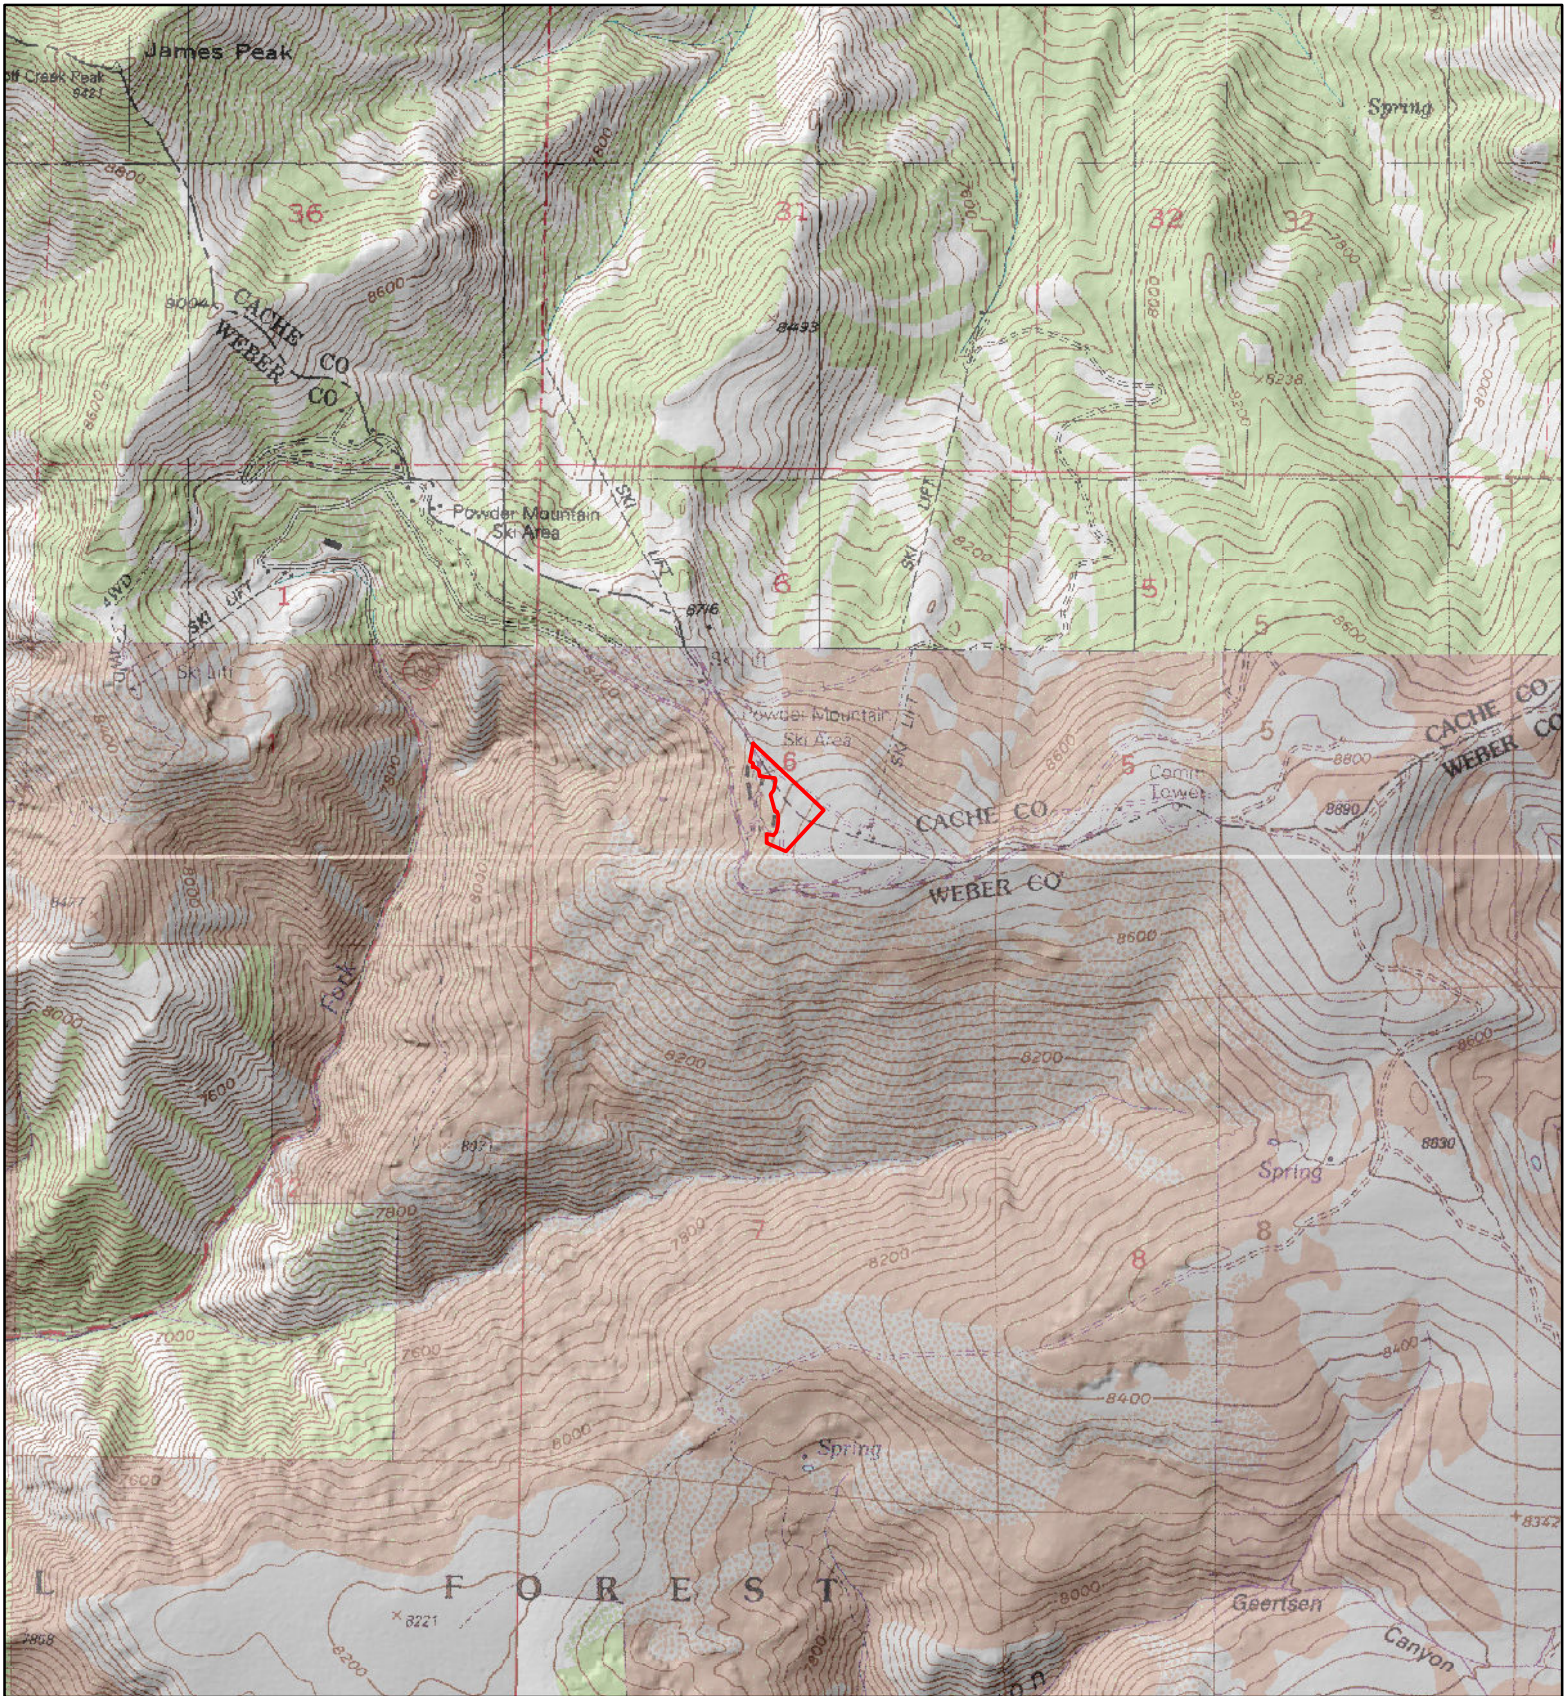
**Plate
2**

Slope stability of the subject site was not assessed as part of this geological hazard assessment. The subject site was observed to be gently sloping to the west toward a nearby drainage (Plate 2 Topographic Map). The possibility that development of the site could negatively affect slope stability within the subject site is increased if development is planned for areas of the site with slopes steeper than approximately 3 horizontal: 1 vertical. It should be noted that grading or development adjacent to the subject site could potentially impact the stability of the area within the subject site and assessment of that hazard is out of the scope of this assessment. Again, given the potential landslide deposits mapped within the vicinity of the subject site and the volume of planned development, GeoStrata recommends that a geotechnical report including a slope stability assessment be compiled prior to any development within the subject site.

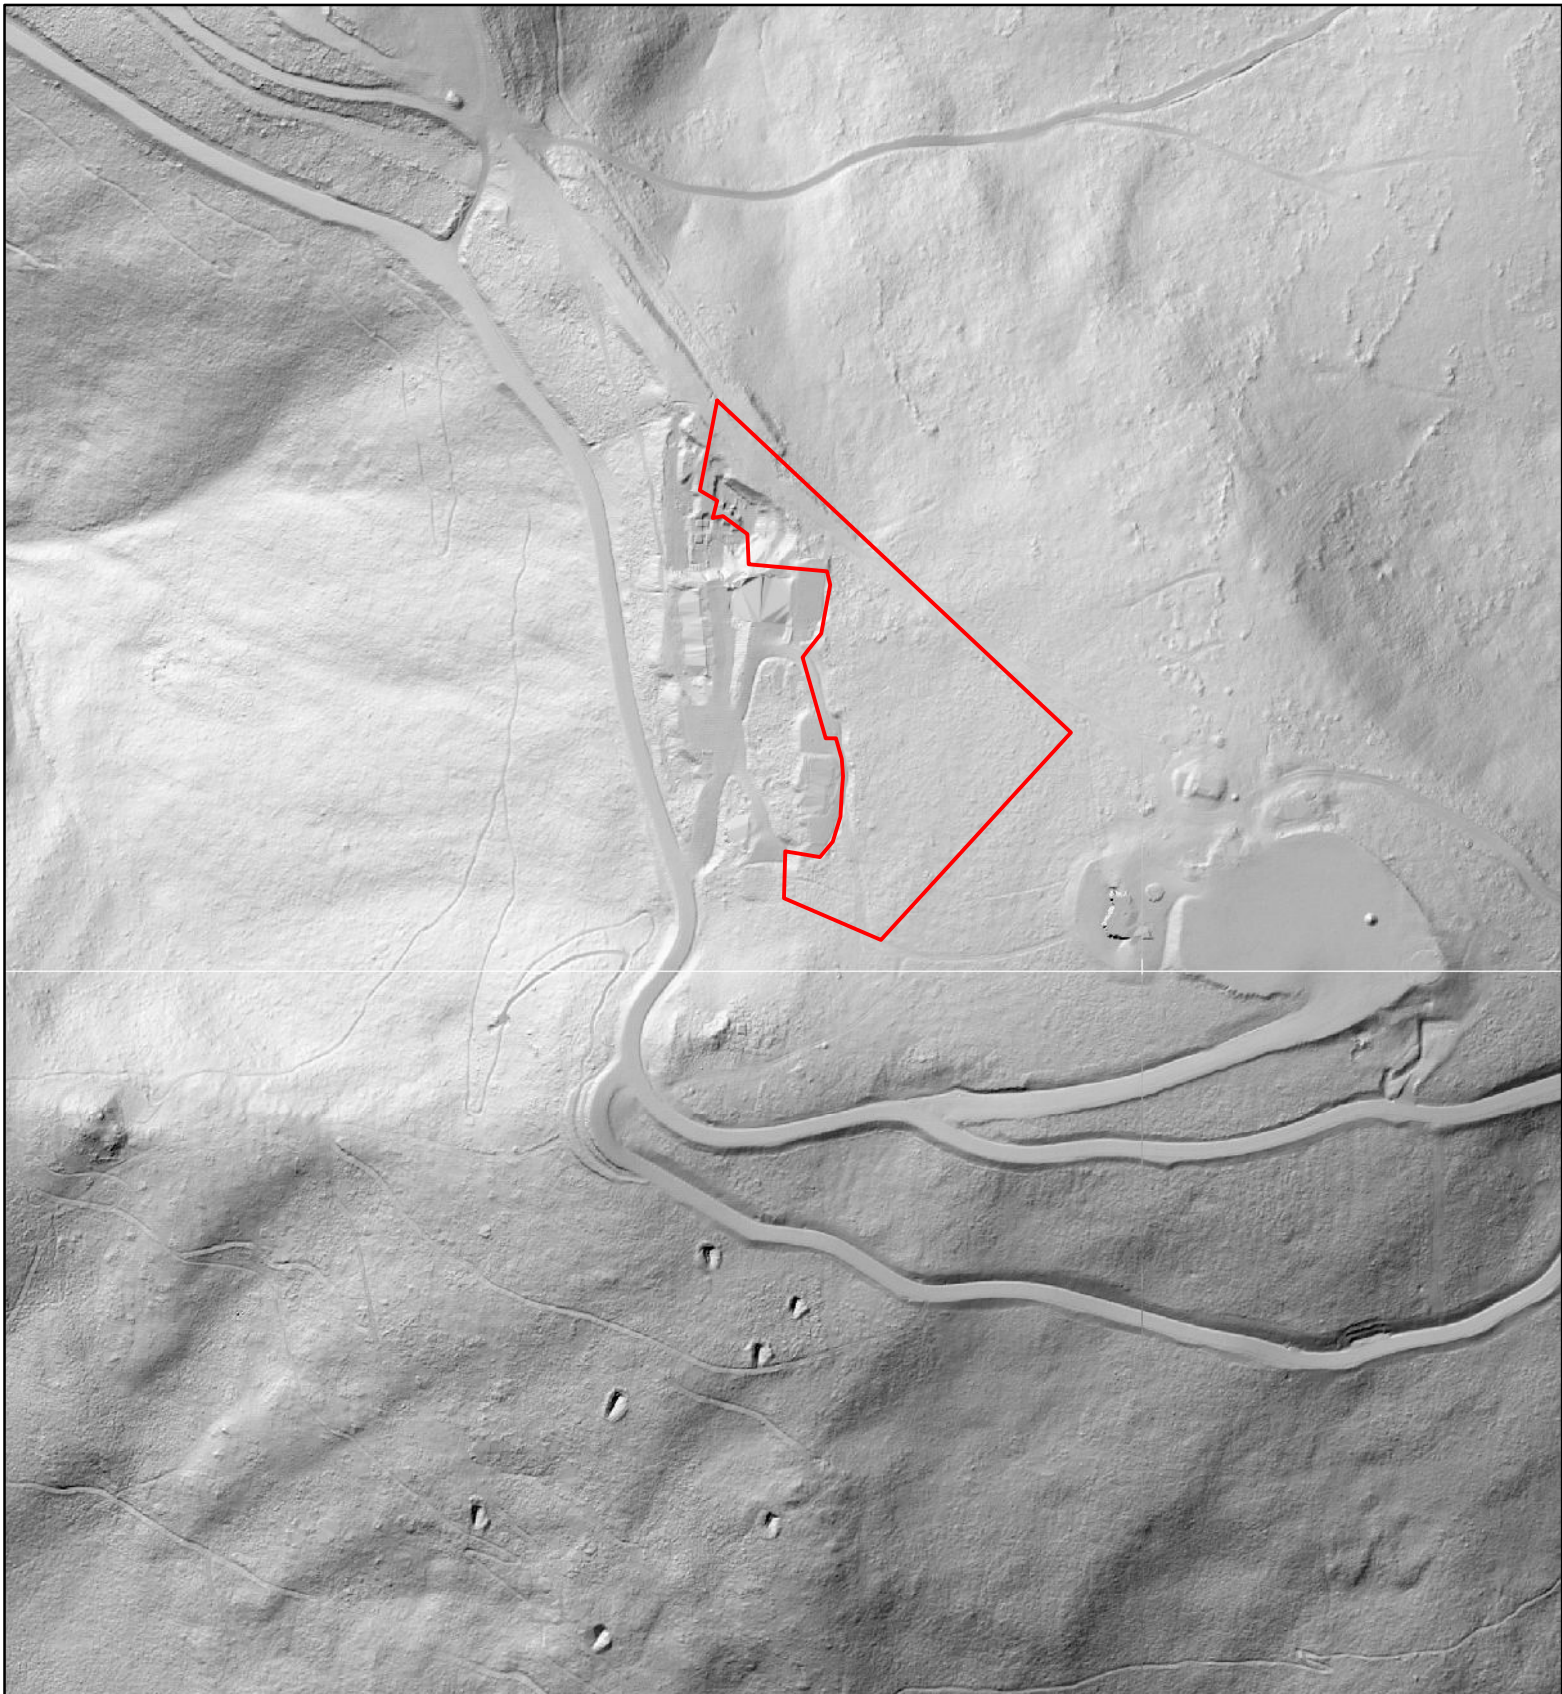
**Plate
3**

GeoStrata also conducted a review of hillshades derived from 2016 0.5 meter LiDAR obtained from the State of Utah AGRC to assess the subject site for visible alluvial fan deposits, scarps associated with landslide geomorphology and lineations related to stream flooding hazards or surface fault rupture related geomorphology. The LiDAR elevation data was used to create hillshade imagery that could be reviewed for assessment of geomorphic features related to geologic hazards (Plate 3 Hillshade Map).

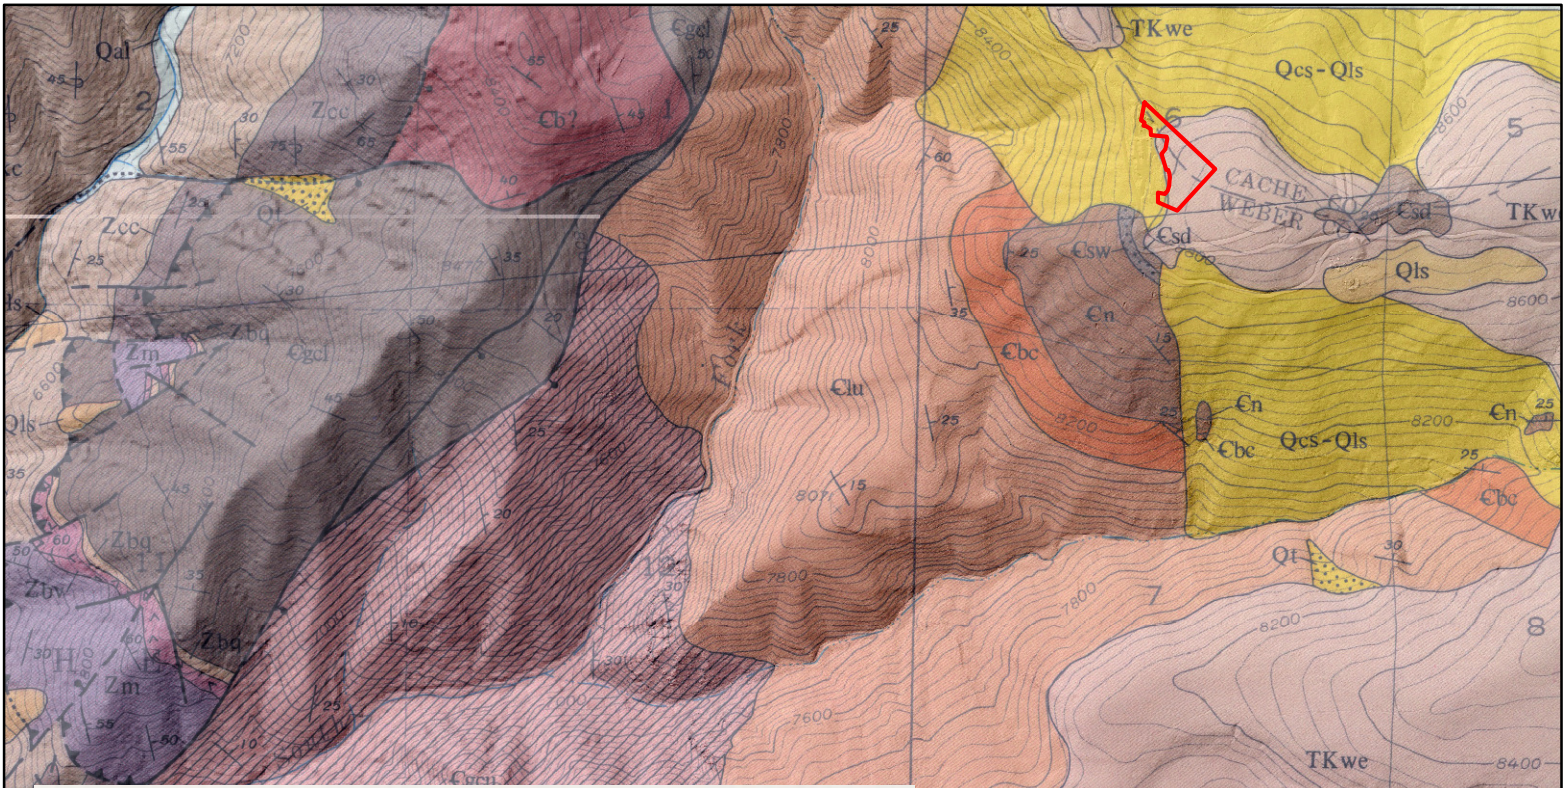
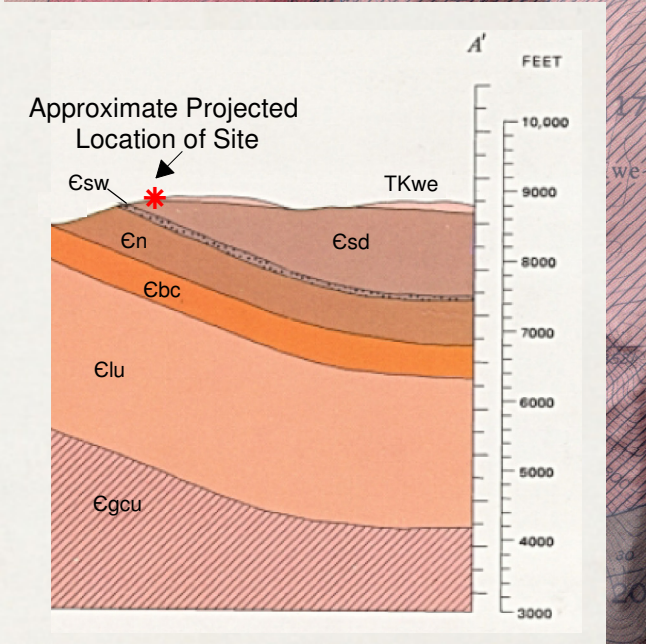
Plate 4

Based on review of published geologic maps, review of stereographic aerial photographs and hillshades derived from 2016 0.5 meter LiDAR, no Holocene age alluvial fan deposit is mapped within or adjacent to the subject site (Plate 4 Site Vicinity Geologic Map; Plate 5 Site Vicinity 30' X 60' Geologic Map). Given our field and office investigations, the alluvial fan flooding hazards within subject site is considered low and it is considered unlikely that debris flows will impact the proposed development. It is the opinion of GeoStrata that alluvial fan flooding hazard should not preclude development at the subject site.

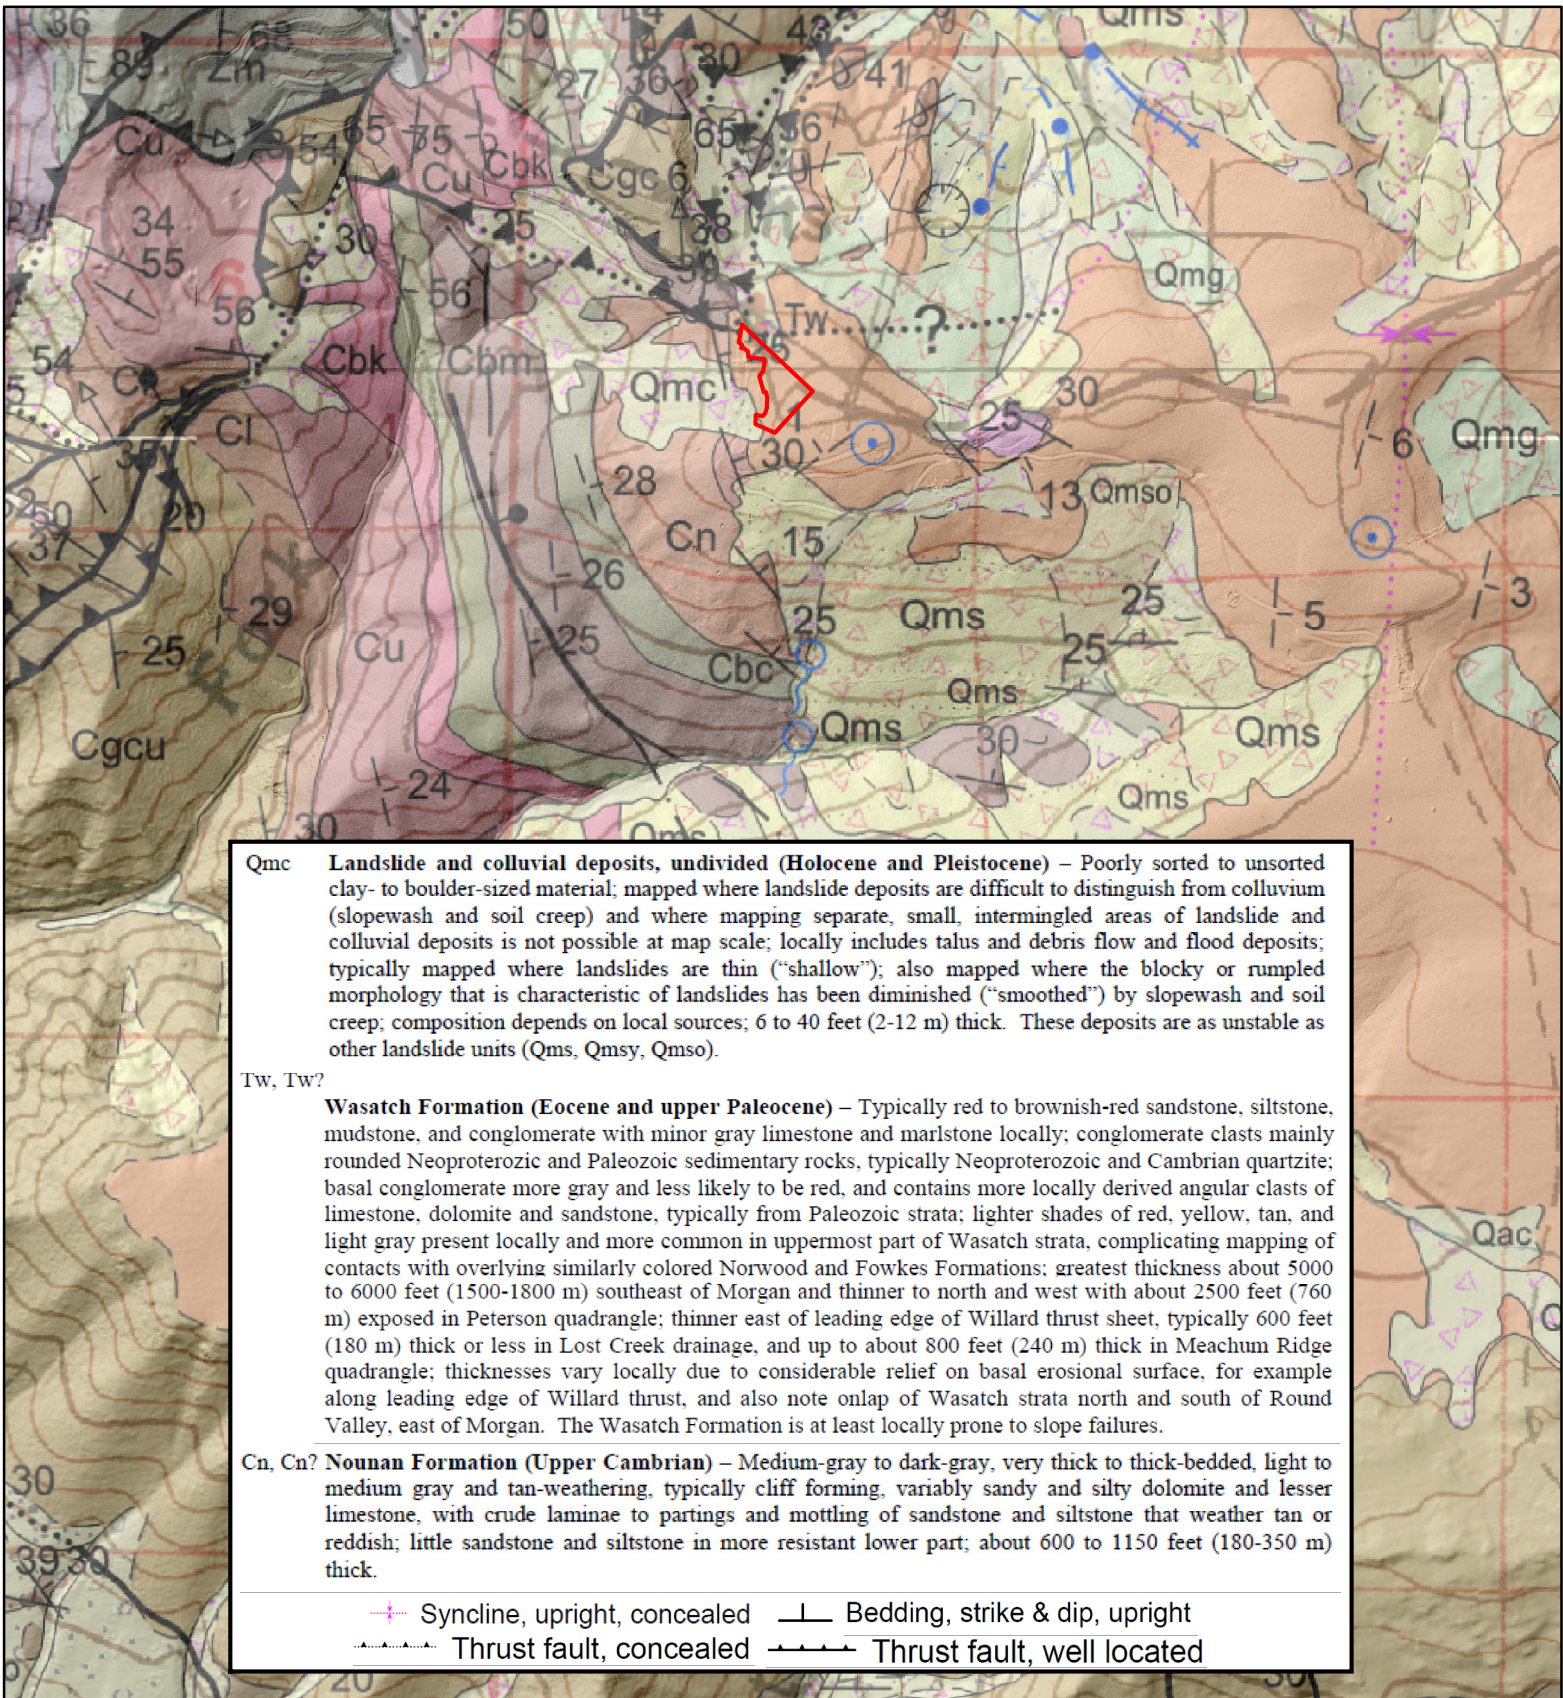
**Plate
5**

Alluvial-fan flooding hazard that would potentially impact the site was assessed as part of this study. No Holocene age alluvial fan deposit is mapped within or adjacent to the subject site (Plate 4 Site Vicinity Geologic Map; Plate 5 Site Vicinity 30' X 60' Geologic Map). Given our field and office investigations, the alluvial fan flooding hazards within subject site is considered low and it is considered unlikely that debris flows will impact the proposed development. It is the opinion of GeoStrata that alluvial fan flooding hazard should not preclude development at the subject site.
