Project Name: Klinefelter - SFD
Project Location: 8469 East Spring Park
 Eden, UT

The following residential plan review comments address non-compliance with governing 2015 IRC, as adopted by the State of Utah and potential errors or omissions in the proposed design.

PLAN REVIEW COMMENTS:

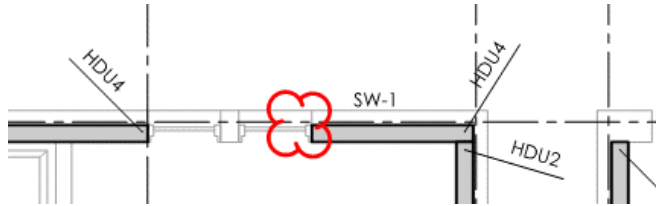
- C. GL-12, B: The shear wall has hold down only on one side. Typically, two are required. Please verify if both ends of the shear walls require hold downs. Please verify all locations. (IBC 1609, 1613)

The missing holddown has been added. See the updated plans.

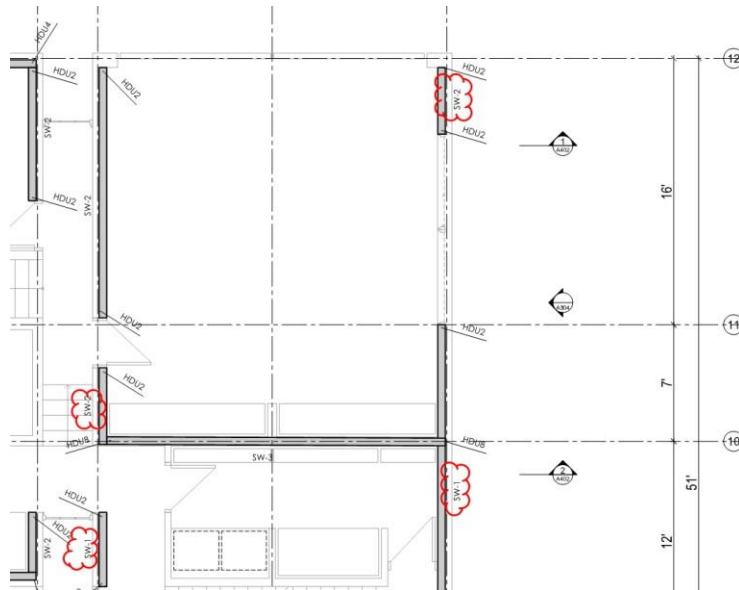
- E. Shear walls on the same line appear to vary. The seismic design story shear is distributed based on relative lateral stiffness for shear walls along the same line. Please verify that this has been considered. (ASCE 7 12.8.4, AWC SDPWS 4.3.3.4)

There is an open-ended diaphragm at the garage. The forces in the shear walls surrounding the garage have been increased as required. The shear wall and holdown callouts are correct.

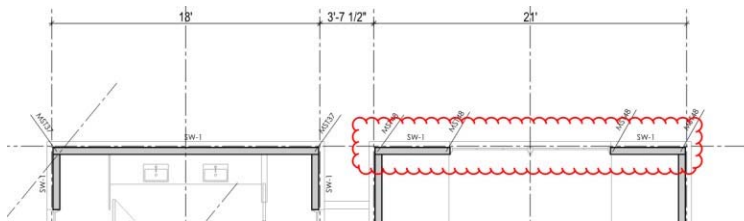
- A. The structure appears to have vertical in-plane discontinuity irregularity. Please verify that the increase load requirements of ASCE 7 12.3.3.3, 12.3.3.4 have been satisfied. (ASCE 7 T12.3-1)

The seismic forces were increased for snow and for the irregularity. The wind loads still govern the design. The supporting steel beam does satisfy the increased load requirements indicated above.

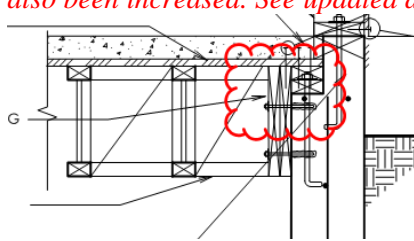
- B. Detail 4, 5, 8, 9:

- I. Anchor bolts are shown epoxied into the concrete foundation wall. Information for type, embed depth, spacing, brand of epoxy, edge distance...etc are not obvious on the drawing. Please verify and provide. (IBC 107)

- II. The edge distance appear to be very close to the edge. This may be ineffective. Please verify and provide adequate edge distance. (IBC 1604)

The anchor bolts are intended to be cast-in place, with an option to drill and epoxy them if desired. There are notes for post installed anchor bolts on sheet S02. More information and options have been added to the plans. See additional calculations and updated drawings.

The edge distance for the lower sill plate has been calculated at 2". See additional calculations. Although not taken into account in the calculations, the ledger will also help confine the connection. An option has been added to use Simpson SB or SSTB anchors to make the bolt placement easier. The length of the anchor bolts for the top sill plate has also been increased. See updated details and additional calculations.

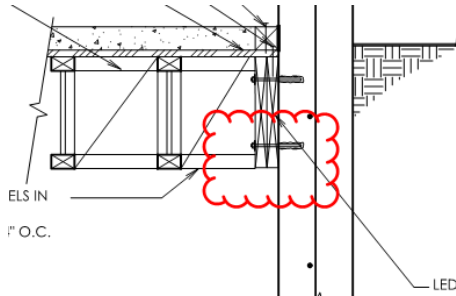
- C. Detail 7, 8, 9, 6: The ledger framing appears to experience cross grain bending. This is not permitted. Please consider providing tension device to the concrete foundation wall. (ASCE 7 12.11.2.2.3)

Straps have been added to eliminate the potential cross grain bending in the ledgers. See updated drawings.

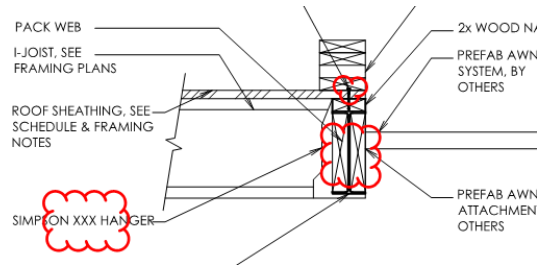
- B. Detail 4:

- I. Simpson hanger has not been identified. Please verify and provide hanger information for all details. (IBC 107)
See framing notes, and updated details. STD hangers are adequate.
- II. Please clarify connection of wood to steel beam. Connection information is not obvious on the plans. (IBC 107)

See updated details.
