Staff Report for Hillside Review Approval

Weber County Planning Division

Report Professional Geologist Site
Reconnaissance and Review
Proposed Lift 5 and Snowmaking Expansion
Parcel #22-029-0010
Nordic Valley Ski Resort, 3567 Nordic Valley Way
Eden, Weber County, Utah

NORDIC VALLEY LIFT EXPANSION
Cross Section E-E (TOWER 6 REVISED LOCATION)
STATIC

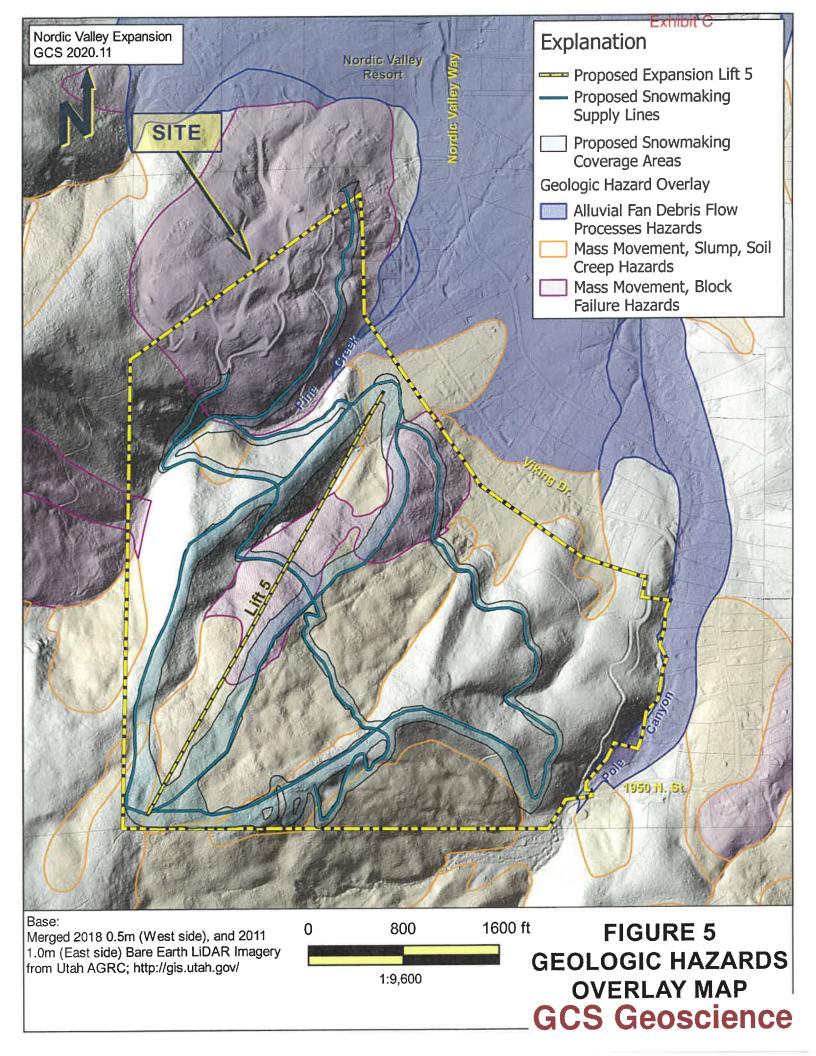
Figure 5, Geologic Hazards Overlay Map

The identified geologic hazards mapping units for the expansion parcel area are presented on Figure 5, Geologic Hazards Overlay Map. The hazard areas identified through this reconnaissance study should generally be studied in greater detail relative to specific affects and effects of the proposed project improvements to better define hazard margins, probabilities, and exposure detail relative to the proposed improvements. The units are broken down in to three hazard classifications and the basis of processes and morphology. The hazard classifications on Figure 5 are as follows:

- 1. Landsliding: The active landslide units were not identified on the expansion parcel as part of this review. However presently inactive mass movement, slump, soil creep hazards (Qms) deposits, and mass movement, block failures including Qms(ZYp), Qms?(ZYp), and Qms(Zpu), consist of slopes that have moved during the past. Because of the past movement, the soils and rock structures that comprise these units have been weakened by the past movement and deformation, the areas mapped as mass movement on Figure 5 should be considered susceptible to renewed movement, and site development grading, cuts and fills, and foundations placement should not be conducted in these areas without specific design-level geotechnical engineering and supervision.

- 2. Alluvial fan debris flow processes including flash flooding and debris flow hazard: The Qafy and Qmdf deposits on the represent areas of potential future debris flow process hazards on the site. With the present layout plan for site improvements, we do not believe the potential debris flow hazards are an impact to the proposed site improvements.

- 2. Combined Mass Movement Hazards and Steep Slope Overlay areas on Figure 5 and Figure 6: For areas that are shown on Figure 5 and Figure 6 to be exposed to both Mass Movement Hazards and Steep Slope conditions, we recommend that these areas be considered for avoidance where practical, however specific engineered design for the improvements in these areas, such as slope retention structures, and deep foundations, may be considered for mitigating the effects of the improvements and exposure to the natural hazards in these areas.

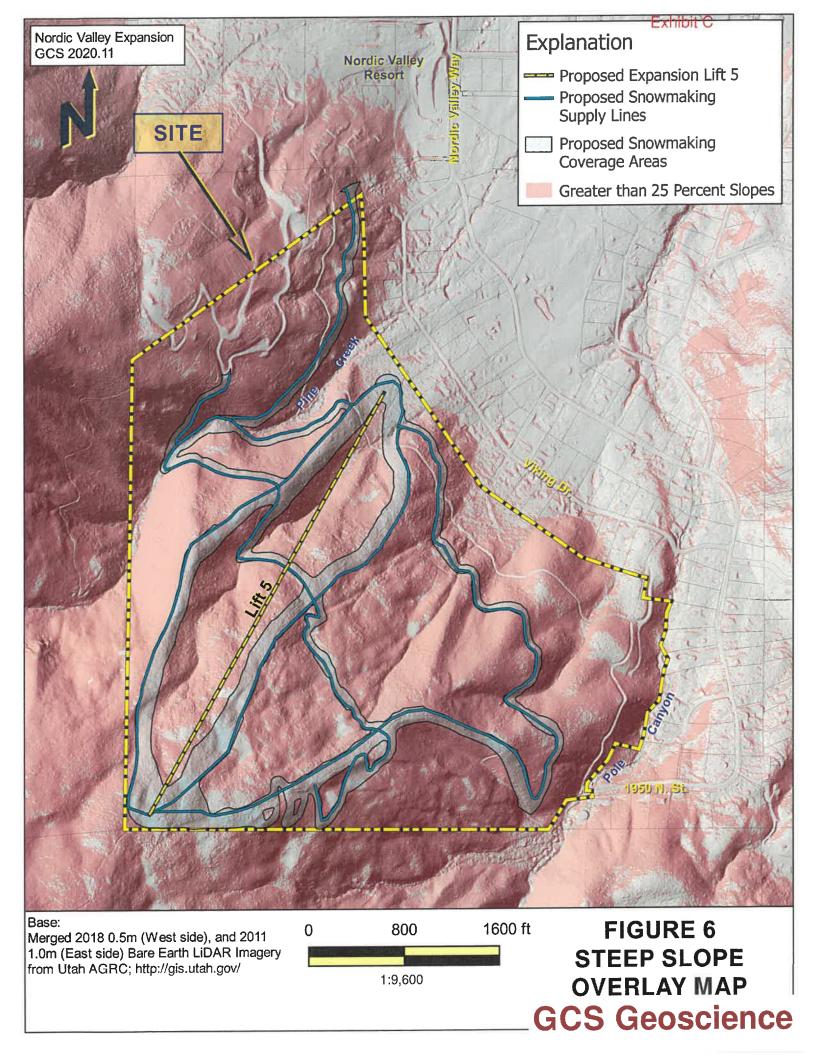
Figure 6, Steep Slope Overlay Map

County staff agreed that permitting and construction for the terminal locations could be allowed to proceed, pending the submittal of this letter, confirming that the terminal locations were outside the 25-percent slope areas. A review of our April 2, 2020 GCS Reconnaissance and Review, found that both the upper and lower terminal locations were outside the 25-percent slope areas (see Figure 6 of April 2, 2020 GCS report).

- 1. Steep Slope Overlay areas on Figure 6: These areas should undergo the requirements of Section 108-14 Hillside Development Review Procedures and Standards, with specific attention to excavation, grading and filling guidelines provided in Section 108-14-8. These standards should also be supported by site specific geotechnical engineering studies including slope stability analysis as outlined by Weber County Natural Hazards Overlay Districts Section 104-27-2.

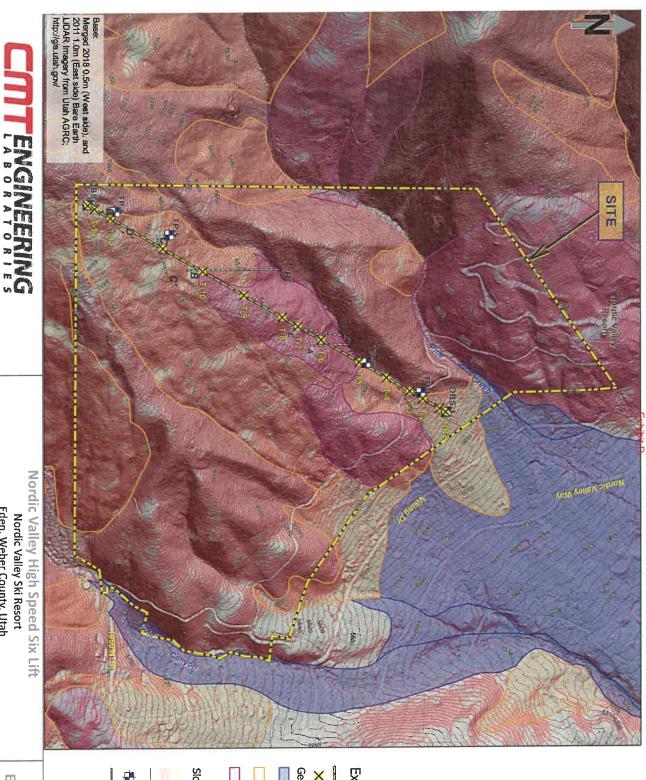
Nordic Valley High Speed Six Lift Eden, Weber County, Utah Nordic Valley Ski Resort

However, since the time of the report the proposed locations of towers 5, 6, and 9 have been moved upslope and downslope (see the revised Figure 3 Attached to this addendum letter) to locations where the sloping conditions at the new tower locations are at about 22 degrees (2.5 Horizontal to 1.0 Vertical) or shallower. Additional slope stability analysis have been completed along the added cross section E-E and cross section A-A (See revised figure 3 attached) which indicate that if towers 6 and 9 are placed a minimum 50 feet upslope of the crest where the slope increases from about 22 degrees to about 41 degrees, then they will be located within zones meeting the minimum factors of safety (1.5 for static conditions and 1.0 for seismic conditions). The graphical stability results for the revised tower 6 location, which is representative, are attached as Figures 21 through 24. Tower 5 has been moved downhill to a similarly flatter sloped area.

All other recommendations provided in the referenced geotechnical report remain applicable.
