GEOTECHNICAL AND GEOLOGIC HAZARD INVESTIGATION Lot 74R of Summit Eden Phase 1C 8464 E. Spring Park Road Summit Powder Mountain Resort Weber County, Utah

IGES Project No. 02565-001

June 22, 2018

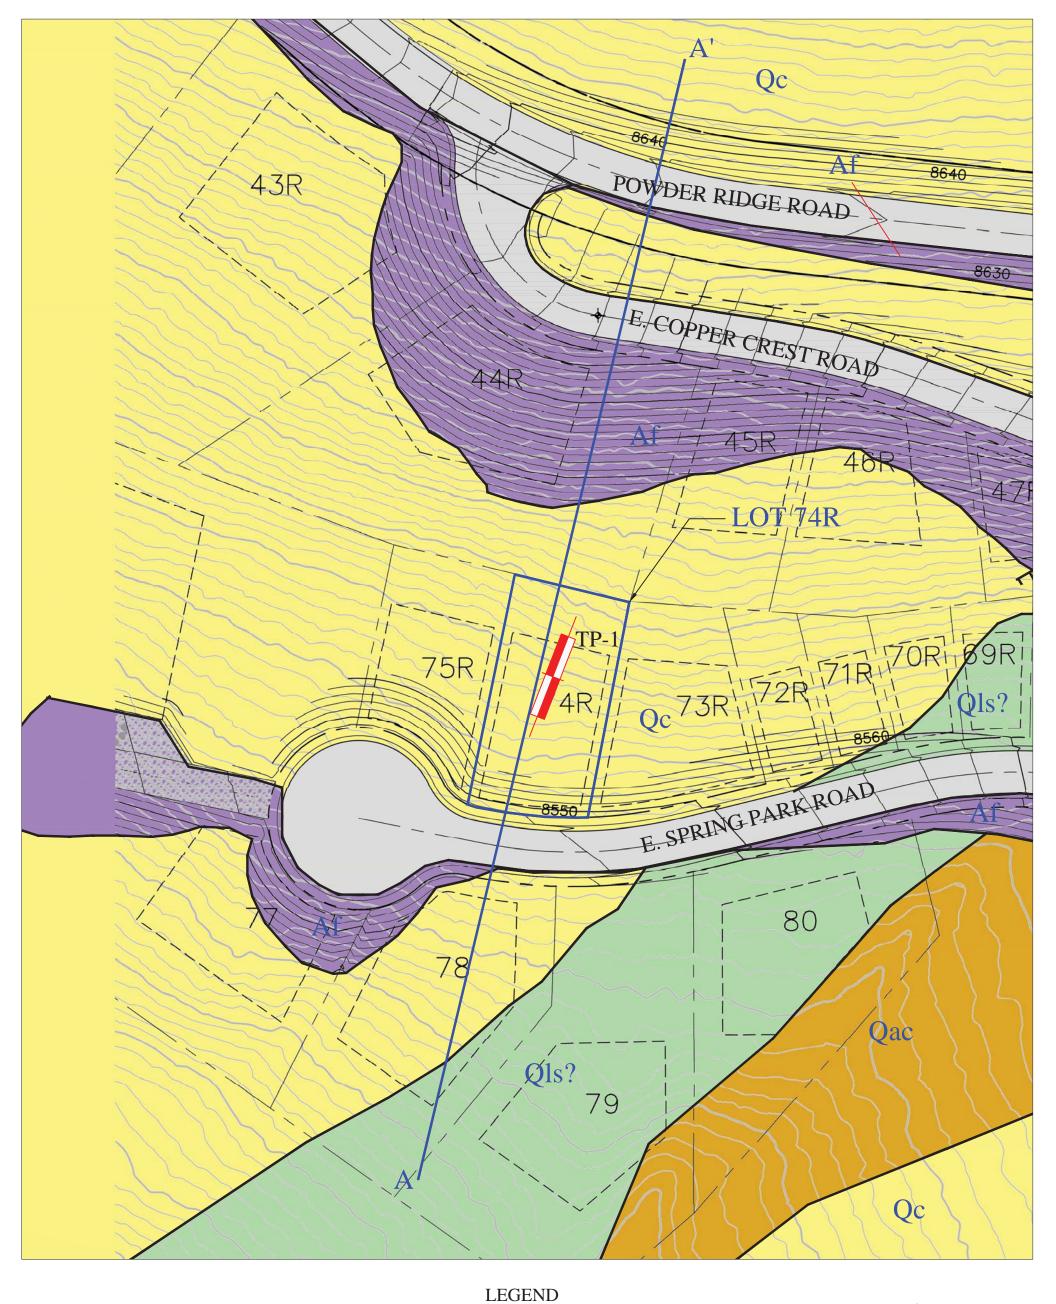
Mr. Peter E. Doumit, P.G., C.P.G., of IGES conducted reconnaissance of the site and the immediate adjacent properties on May 31, 2018. The site reconnaissance was conducted with the intent to assess the general geologic conditions present across the property, with specific interest in those areas identified in the geologic literature and aerial imagery reviews as potential geologic hazard areas. Additionally, the site reconnaissance provided the opportunity to geologically map the surficial geology of the area. Figure A-2 is a site-specific geologic map of the Lot 74R property and adjacent areas.

There is about 18 feet of vertical relief across the building envelope. Site-specific geologic mapping of the property found the local geology to be consistent with that as-mapped by Coogan and King (2016), consisting of a relatively thin veneer of topsoil and colluvium that is underlain by the Wasatch Formation (see Figure A-2).

On May 31, 2018, a single exploration test pit was excavated in the north-central portion of the lot (see Figure A-2). The test pit was excavated to a depth of approximately 12.5 feet below existing grade with the aid of a Caterpillar 315C tracked excavator. Upon completion of logging, the test pit was backfilled without compactive effort. A detailed log of the test pit is displayed in Figure A-3. Three distinct geologic units were encountered in the subsurface. The soil and moisture conditions encountered during our investigation are discussed in the following paragraphs.
