### **GEOLOGIC EVALUATION SHANGHAI CANYON SUBDIVISION, WEBER COUNTY, UTAH**

**Shanghai Canyon Subdivision  
Weber County, Utah**

**July 27, 2015**

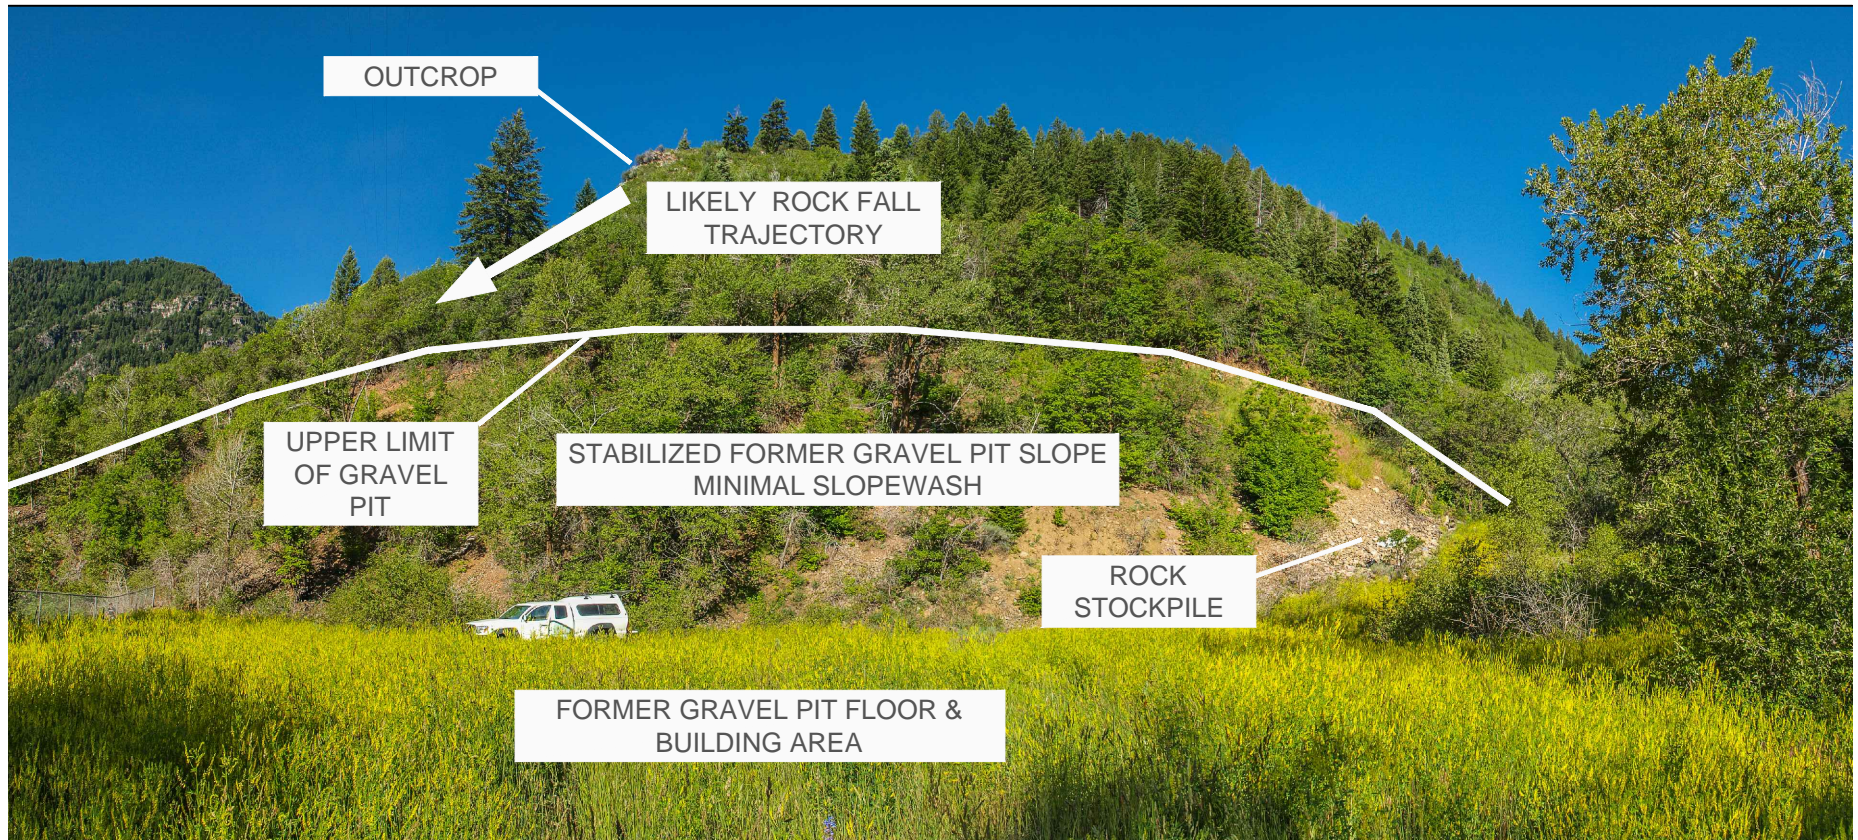
No outcrops are located immediately adjacent to the Building Area. One outcrop is visible in Figure 6. This outcrop has been mapped by Sorensen and Crittenden (1979) and King and McDonald (2014) as Mississippian Humbug Formation. This outcrop has an east-west strike and dips 8 degrees to the north (King and McDonald, 2014). The slope directly above the Building Area consists of colluvium.

A site specific calculation of the shadow angle for the outcrop in Figure 6 is 36 degrees. This angle is due to a consistently steep acceleration zone. An abruptly flat runout zone reduces the extents of potential impacts to the Building Area.

This Section documents the results of a Rock Fall Analysis for the Building Area presented in Figure 2. One outcrop is visible from the Property (Figure 6). There is no well developed talus field below this outcrop. The westernmost portion of the Property falls within the 36 degree shadow angle of the outcrop. Topographic (Figure 3) and visual analysis (Figure 6) indicate that the likely trajectory for rock fall emanating from this outcrop may include the southwest corner of the Property. However, the predominate trajectory would fall to the south of the Property and hence, outside of the Building Area. The likelihood of rock fall emanating from this outcrop and impacts to the Building Area is low as evidenced by the lack of talus.

No rock fall mitigation is required.

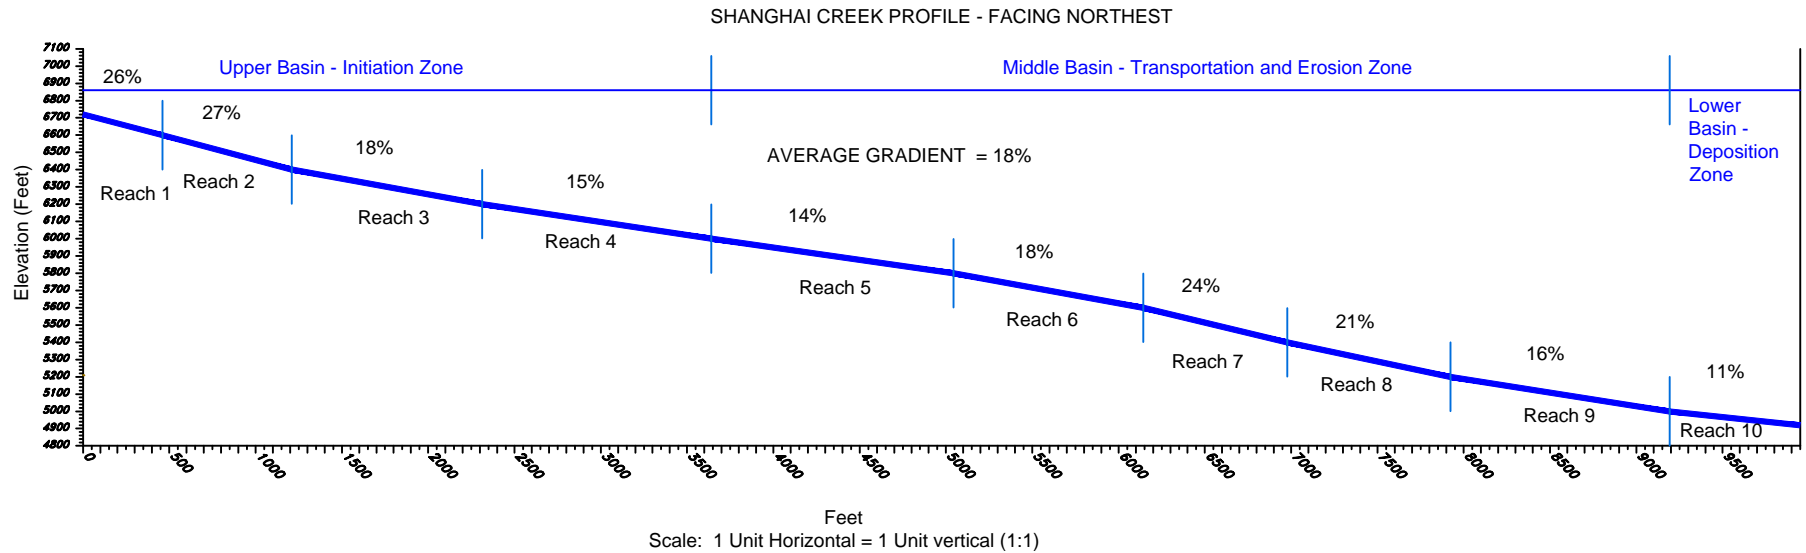
As discussed in Section 4.2 and presented on Figure 9, the average gradient of Shanghai Creek is 18%. As stated above transportation and erosion generally require a gradient of greater than 15 degrees (27%) (VanDine, 1996). The gradient of the channel is not sufficient for basin-wide movement of the volumes of material theoretically available for transport. Gradients are summarized in Table 2. The area mapped by King and McDonald (2014) as debris flow material in the upper reaches of the basin, as highlighted in green and presented in Figure 3, indicates that the overall gradient is insufficient for the large-scale transportation of debris flows from the upper to lower zones of the basin. The middle area of the basin with gradients of 14 and 15% inhibits and/or attenuates debris flow emanating in the upper reaches of the basin (Figure 9) from impacting the Building Area.

AVERAGE GRADIENT = 0.18 FT/FT

Due to the low gradient of the Shanghai Creek channel, no recommendations for debris flow mitigation are necessary.

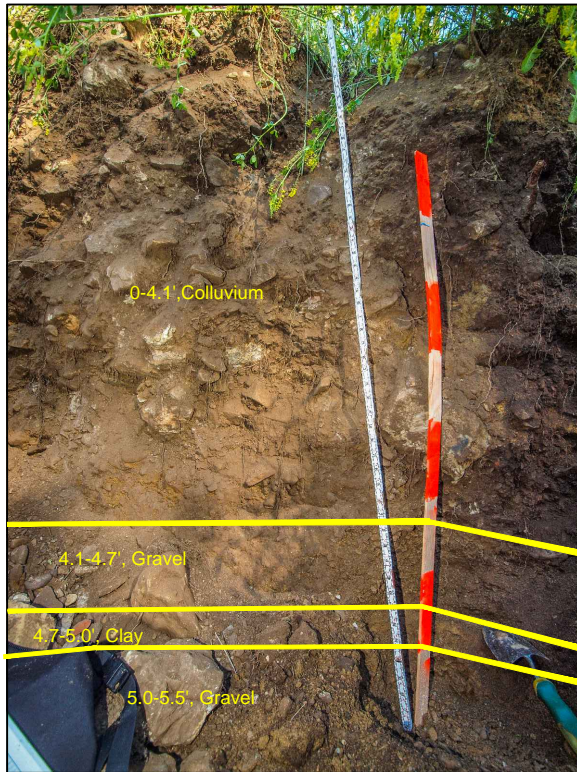
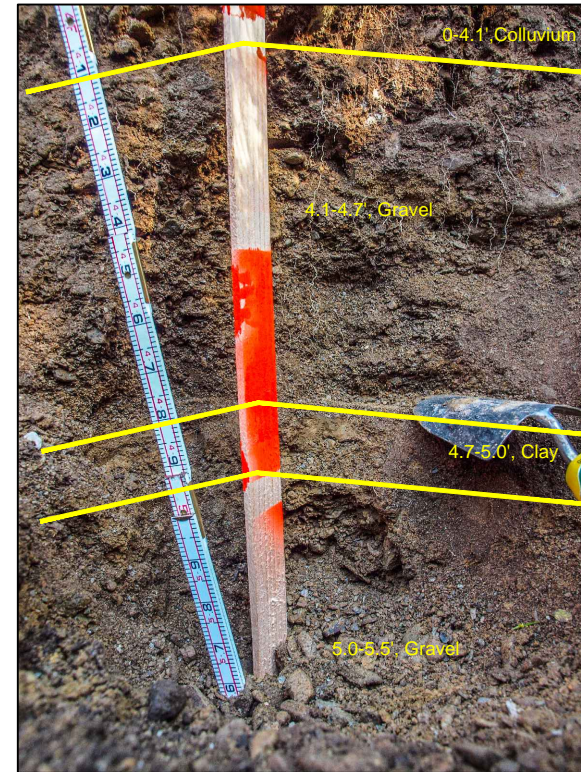
FIGURE 10, SHEET 1  
TEST PIT 1

No indications of debris flows were observed in the two test pits. One test pit was inspected by Greg McDonald of the UGS during a site visit on June 18, 2015. Mr. McDonald inspected Test Pit 2 and confirmed the occurrence of colluvium and Lake Bonneville lacustrine deposits. Mr. McDonald hypothesized that the lacustrine deposits may be of a transgressive regime.

TEST PIT 1  
TOTAL DEPTH - 5.5'

0-4.1', Colluvium, loamy soil with angular to slightly rounded clasts up to 1'. Dense, in place native material.

4.1-4.7', Gravel, Pebbles and weathered shale fragments with sand. Fragments to 1". Loose, Lake Bonneville deposit.

4.7-5.0', Clay, moderately plastic, loose, Lake Bonneville deposit.

5.0-5.5', Gravel, weathered pebbles and shale fragments with sand. Fragments to 1". Loose, Lake Bonneville deposit.

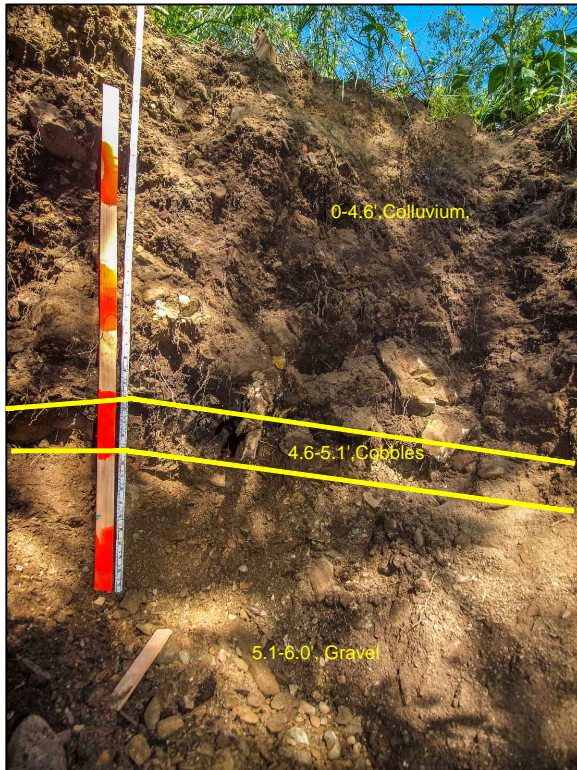
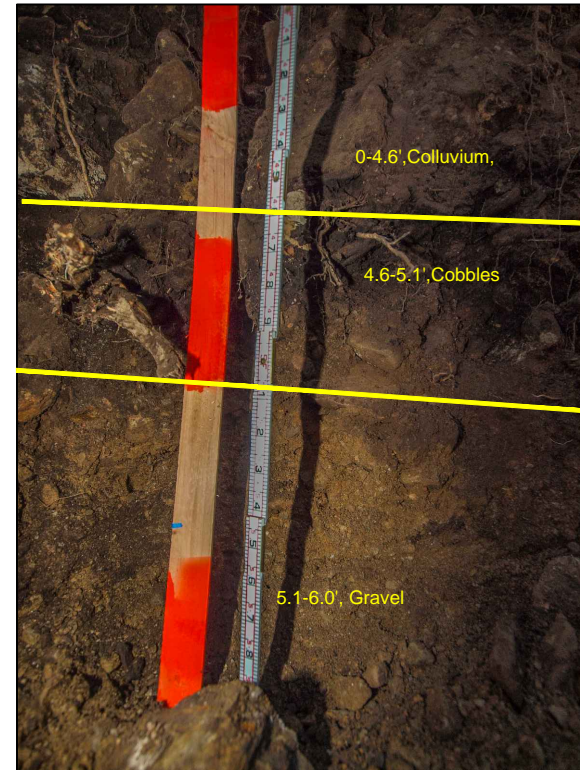
TEST PIT 2  
TOTAL DEPTH - 6.0'

0-4.6', Colluvium, loamy soil with angular to slightly rounded clasts up to 1'. Dense, in place native material.

4.6-5.1', Cobbles with gravel, rounded, Cobbles to 3". Lake Bonneville deposit.

5.1-6.0', Gravel, weathered pebbles and shale fragments with sand. Fragments to 1". Loose, Lake Bonneville deposit.
