Project Number 2014-023 Date Issued 05/27/2015 Drawn by Karl Lundin Checked by Cristofer Scale 1" = 20' ±	The Nobs Residence 6640 E 1100 S - SKI LAKE LOT #3
	Topo Site
	C1

LUNDIN DESIGN GROUP
 THE NOBS RESIDENCE
 GRADING PLAN
 6640 E 1100 S - SKI LAKE LOT #3

**Re: Engineering Geology Assessment
Lot 15, Ski Lake Estates No. 3
6640 East 1100 South
Huntsville, Utah
Job No. 145150**

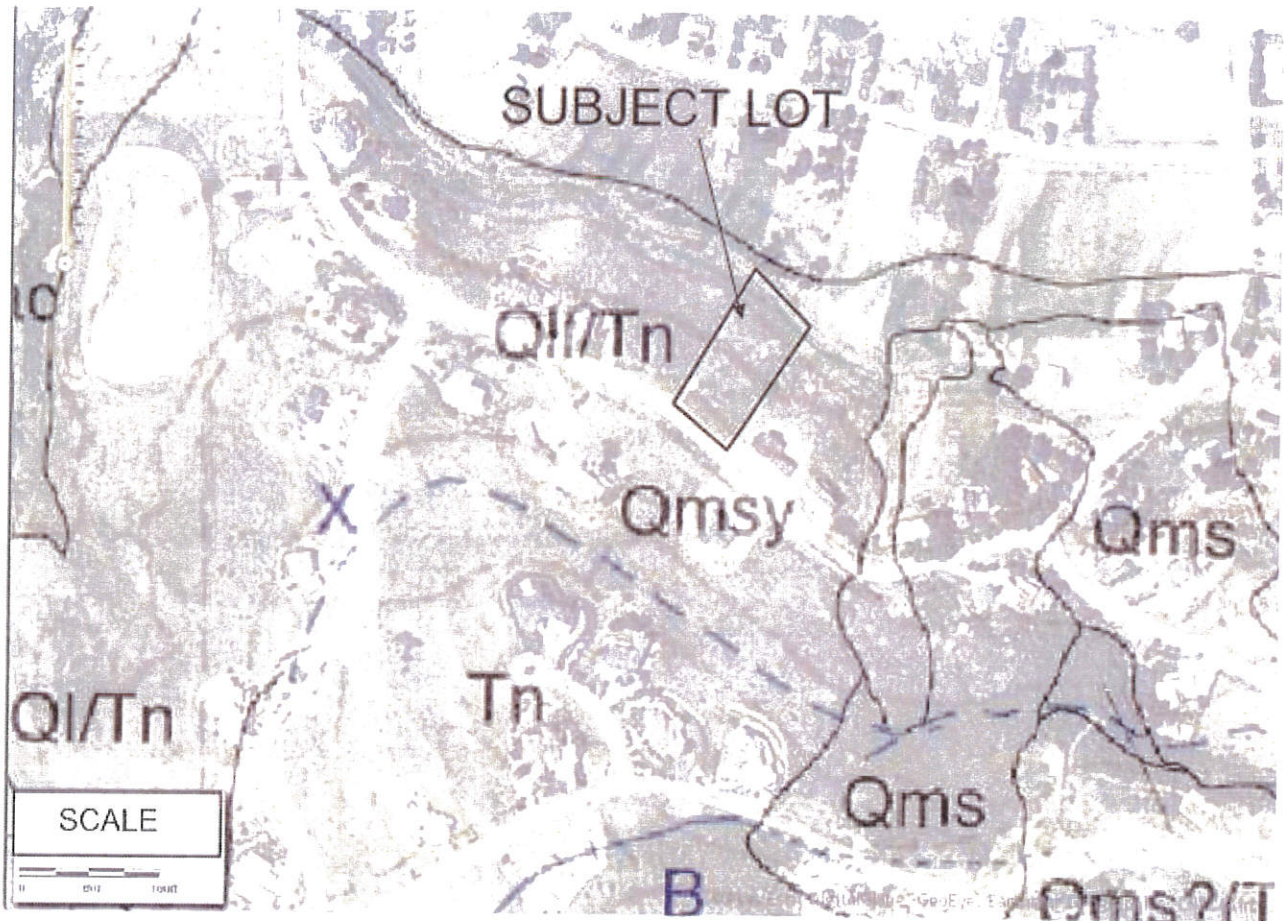
SITE GEOLOGIC MAP
LOT 15, SKI LAKE ESTATES NO. 3
6640 EAST 1100 SOUTH
HUNTSVILLE, UTAH

Yonkee, and Coogan⁵. The geology at the location of the subject lot as shown on the referenced map is Lake Bonneville fine-grained deposits (Map Unit Qlf, upper Pleistocene) overlying older deposits of the Norwood Formation (Map Unit Tn, lower Oligocene and upper Eocene). The Norwood Formation is extensive along the margins of the Ogden Valley, the Morgan Valley to the south, and in the hilly terrain between the valleys. The formation is known to be very prone to experiencing landslide activity. Several landslides (Map Units Qmsy and Qms) are mapped approximately 200 to 360 feet to the east of the subject lot on the referenced geologic map. These mapped landslides appear to have occurred within the Norwood Formation. No landslide deposits or features are mapped on or immediately adjacent to the subject lot on the referenced map. However, the literature accompanying the referenced map states that some landslides and other slope failure features may not have been mapped due to scale. A portion of the referenced geologic map that includes the location of the subject property and surrounding area is included as Figure No. 2, *Site Geologic Map*, at the end of this report. It should be noted that the geologic units included on Figure No. 2 are only those mapped at the location of the subject lot and immediate surrounding areas.

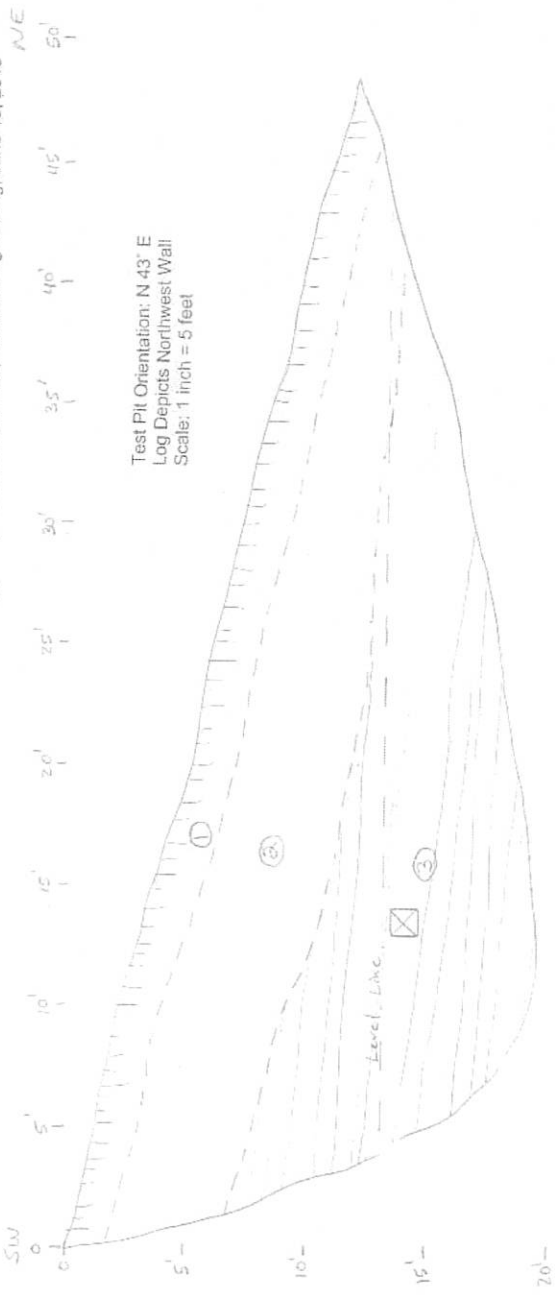
Job No. 145150
 Figure No. 4

As shown on Figure No. 4, TP-3 exposed approximately 1½ to 2 feet of relatively well-formed, modern topsoil (Soil "A" Horizon) at the surface (Unit 1, Figure No. 4). The topsoil was formed

on what is interpreted to be slope wash deposits consisting of sandy Lean Clay (CL) (Unit 2, Figure No. 4) observed to be approximately 2½ to 5 feet thick at the location of the test pit. No significant internal stratification was observed within the slope wash deposits and the in-situ soils were estimated to be soft to medium stiff. Underlying the slope wash deposits, and extending to the base of the test pit which was approximately 16½ feet below the surface at its deepest point, we observed thin to moderately bedded deposits of Silty Sand (SM) with thin layers of interbedded Silt (ML) and occasional Lean Clay (CL) layers. These deposits (Unit 3, Figure No. 4) are interpreted to be lacustrine deposits of the Bonneville lake cycle and correlate with mapped Unit Q1f mapped by King and others (2008). Bedding within Unit 3 was measured to dip (apparent) down to the northeast at between approximately 3 and 8 degrees. The Bedding was observed to be continuous and relatively undisturbed through the length of the test pit. Bedding in the upper portion of Unit 3 at the contact with Unit 2 was observed to be truncated by the overlying material of Unit 2 suggesting that the contact is likely an erosional unconformity. No planes of shearing or zones of gouge suggesting past slope movements were observed within TP-3. It should be noted that TP-3 was excavated just down-slope of the location of the previous TP-2. In TP-2 a layer of gravel (logged as "sandstone" in the referenced geotechnical report) was encountered between the near-surface slope wash deposits and the underlying lacustrine deposits. However, this gravel bed was not encountered in TP-3. It is our interpretation that the gravel bed observed in TP-2 may be a lense of granular slope wash material or older debris flow deposits placed on the underlying lacustrine deposits.

The extension of TP-3 down-slope to the elevation of TP-4 on the lot showed that the lacustrine sands (Unit 3, Figure No. 4) thinned down slope and eventually pinched out at the elevation of TP-4 where the gravel bed (Unit 3, Figure No. 5) was encountered below the overlying slope wash deposits. TP-5 excavated adjacent to the southwest side of the footprint of the proposed house exposed approximately 1 to 2 feet of topsoil followed by approximately 4 feet of the

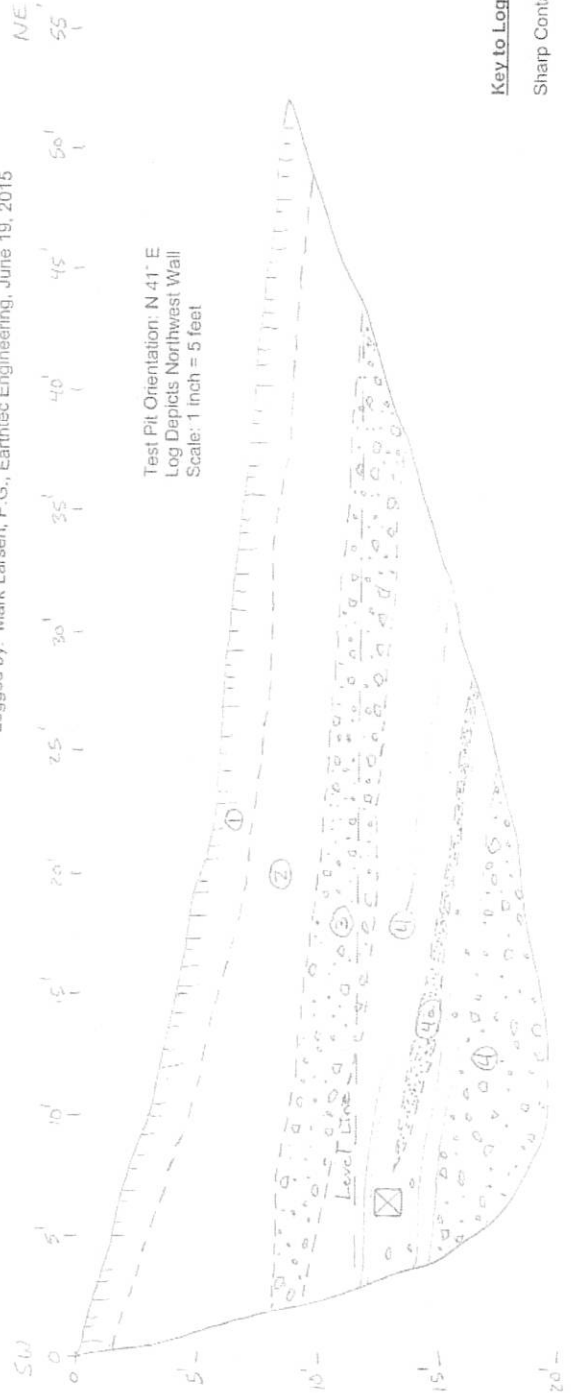
Test Pit Log, TP-4, Lot 15, Ski Lake Estates No. 3
 6640 East 1100 South, Huntsville, Utah
 Logged by: Mark Larsen, P.G., Earthtec Engineering, June 19, 2015

As shown on Figure No. 5, TP-4 exposed similar near surface topsoil and slope wash deposits (Units 1 and 2, Figure No. 5) as those observed in TP-3. Underlying the slope wash deposits in TP-4 we observed an approximately 1 to 2½ foot thick gravel bed (Unit 3, Figure No. 5). According to the engineer who logged the gravel bed (logged as "sandstone") in TP-2, this gravel bed in TP-4 appeared very similar to the gravel bed in TP-2. The gravel bed was comprised predominantly of angular to subangular, pebble to small cobble sized sandstone clasts that were generally clast supported. The matrix of the gravel bed included some pinhole voids. Unit 3 was observed to thin up-slope in the test pit suggesting it may pinch out upslope from the test pit. As with the gravel bed observed in TP-2, Unit 3 in TP-4 is interpreted to be a bed or lense of granular slope wash material or older debris flow deposits. This gravel bed was not encountered in TP-1 down-slope of TP-4. Underlying Unit 3 in TP-4 we encountered beds of the Norwood Formation (Unit 4, Figure No. 5) extending to the base of the test pit at approximately 16½ feet below the surface at its deepest point. The beds of the Norwood formation observed in TP-4 consisted of sandy Lean Clay (CL) and sandy Elastic Silt (MH) grading downward to Poorly Graded Gravel with Silty Sand (GP-GM). The gravels in the lower portion of the test pit may be a weathered sandstone bed and displayed some weak bedding structure. A lense of Silty Sand (SM) (Unit 4a, Figure No. 5) was observed in the exposed Norwood Formation Deposits. Bedding in the observed Norwood Formation deposits was measured to dip (apparent) down to the northeast at between 10 and 13 degrees. The bedding in the exposed Norwood Formation deposits in TP-4 was observed to be continuous and relatively undisturbed through the length of the test pit. No evidence of slip or shearing, or zones of gouge, was observed in the exposed soils and bedrock (Norwood Formation). None of the beds or bedding contacts within the exposed Norwood Formation appeared to be a slip plane.

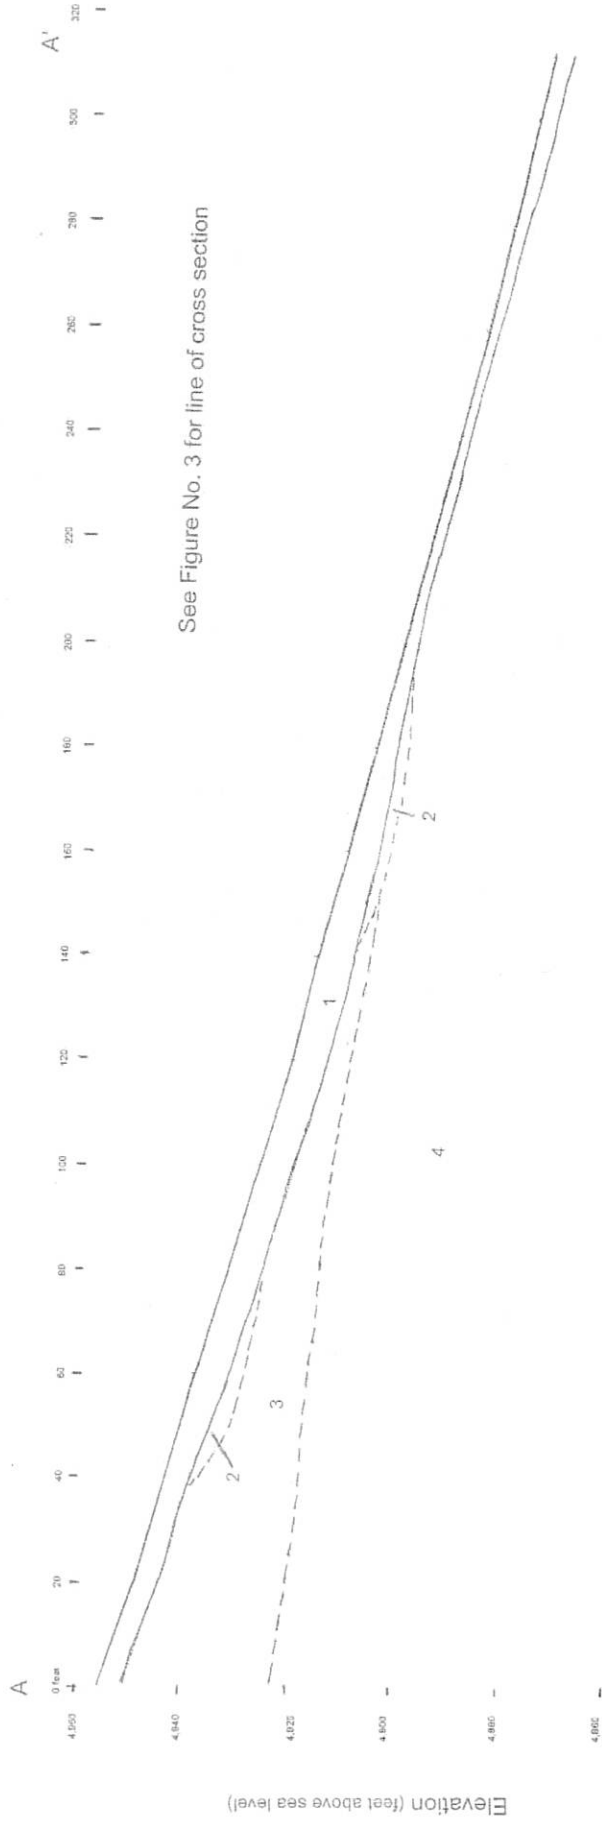
Figure No. 6

Based on the subsurface information obtained from the test pits and our geologic interpretations, a geologic cross section through the subject lot was produced. The cross section is included at the end of this report as Figure No. 6, Geologic Cross Section. The line of cross section through the lot is shown on Figure No. 3 as A – A'. Several assumptions were made in the completion of the cross section. First, due to the fact that the gravel beds/lenses observed immediately below the near-surface slope wash deposits in TP-2 and TP-4 were not observed in any of the other test pits we decided to show the gravels as two separate lenses at the elevations of TP-2 and TP-4. It is our opinion, that, due to relatively small thickness of the gravels and their apparent lack of lateral continuity across the lot, the gravels will not likely have significant influence on slope stability on the lot. Second, the depth of the lacustrine sands encountered in TP-2, TP-3, and TP-5 was not determined as none of these test pits penetrated the sands. We did observe that the sands thinned and pinched out down-slope of TP-3. As such, the base of the lacustrine sands shown on the cross section is inferred primarily based on the depth of TP-3 and the grade of the slope, however, the sands may be thicker than shown below the southwestern portion of the lot. And lastly, the thickness of the Norwood Formation below the lot could not be determined. So, for the purposes of the cross section, it was assumed that the Norwood formation extends through the remainder of the profile shown on Figure No. 6.
