September 12, 2016

IGES Project No. 02348-001

Subject: Geologic Hazards Assessment The Ridge Subdivision Phases 3, 4, and 5 Eden, Utah

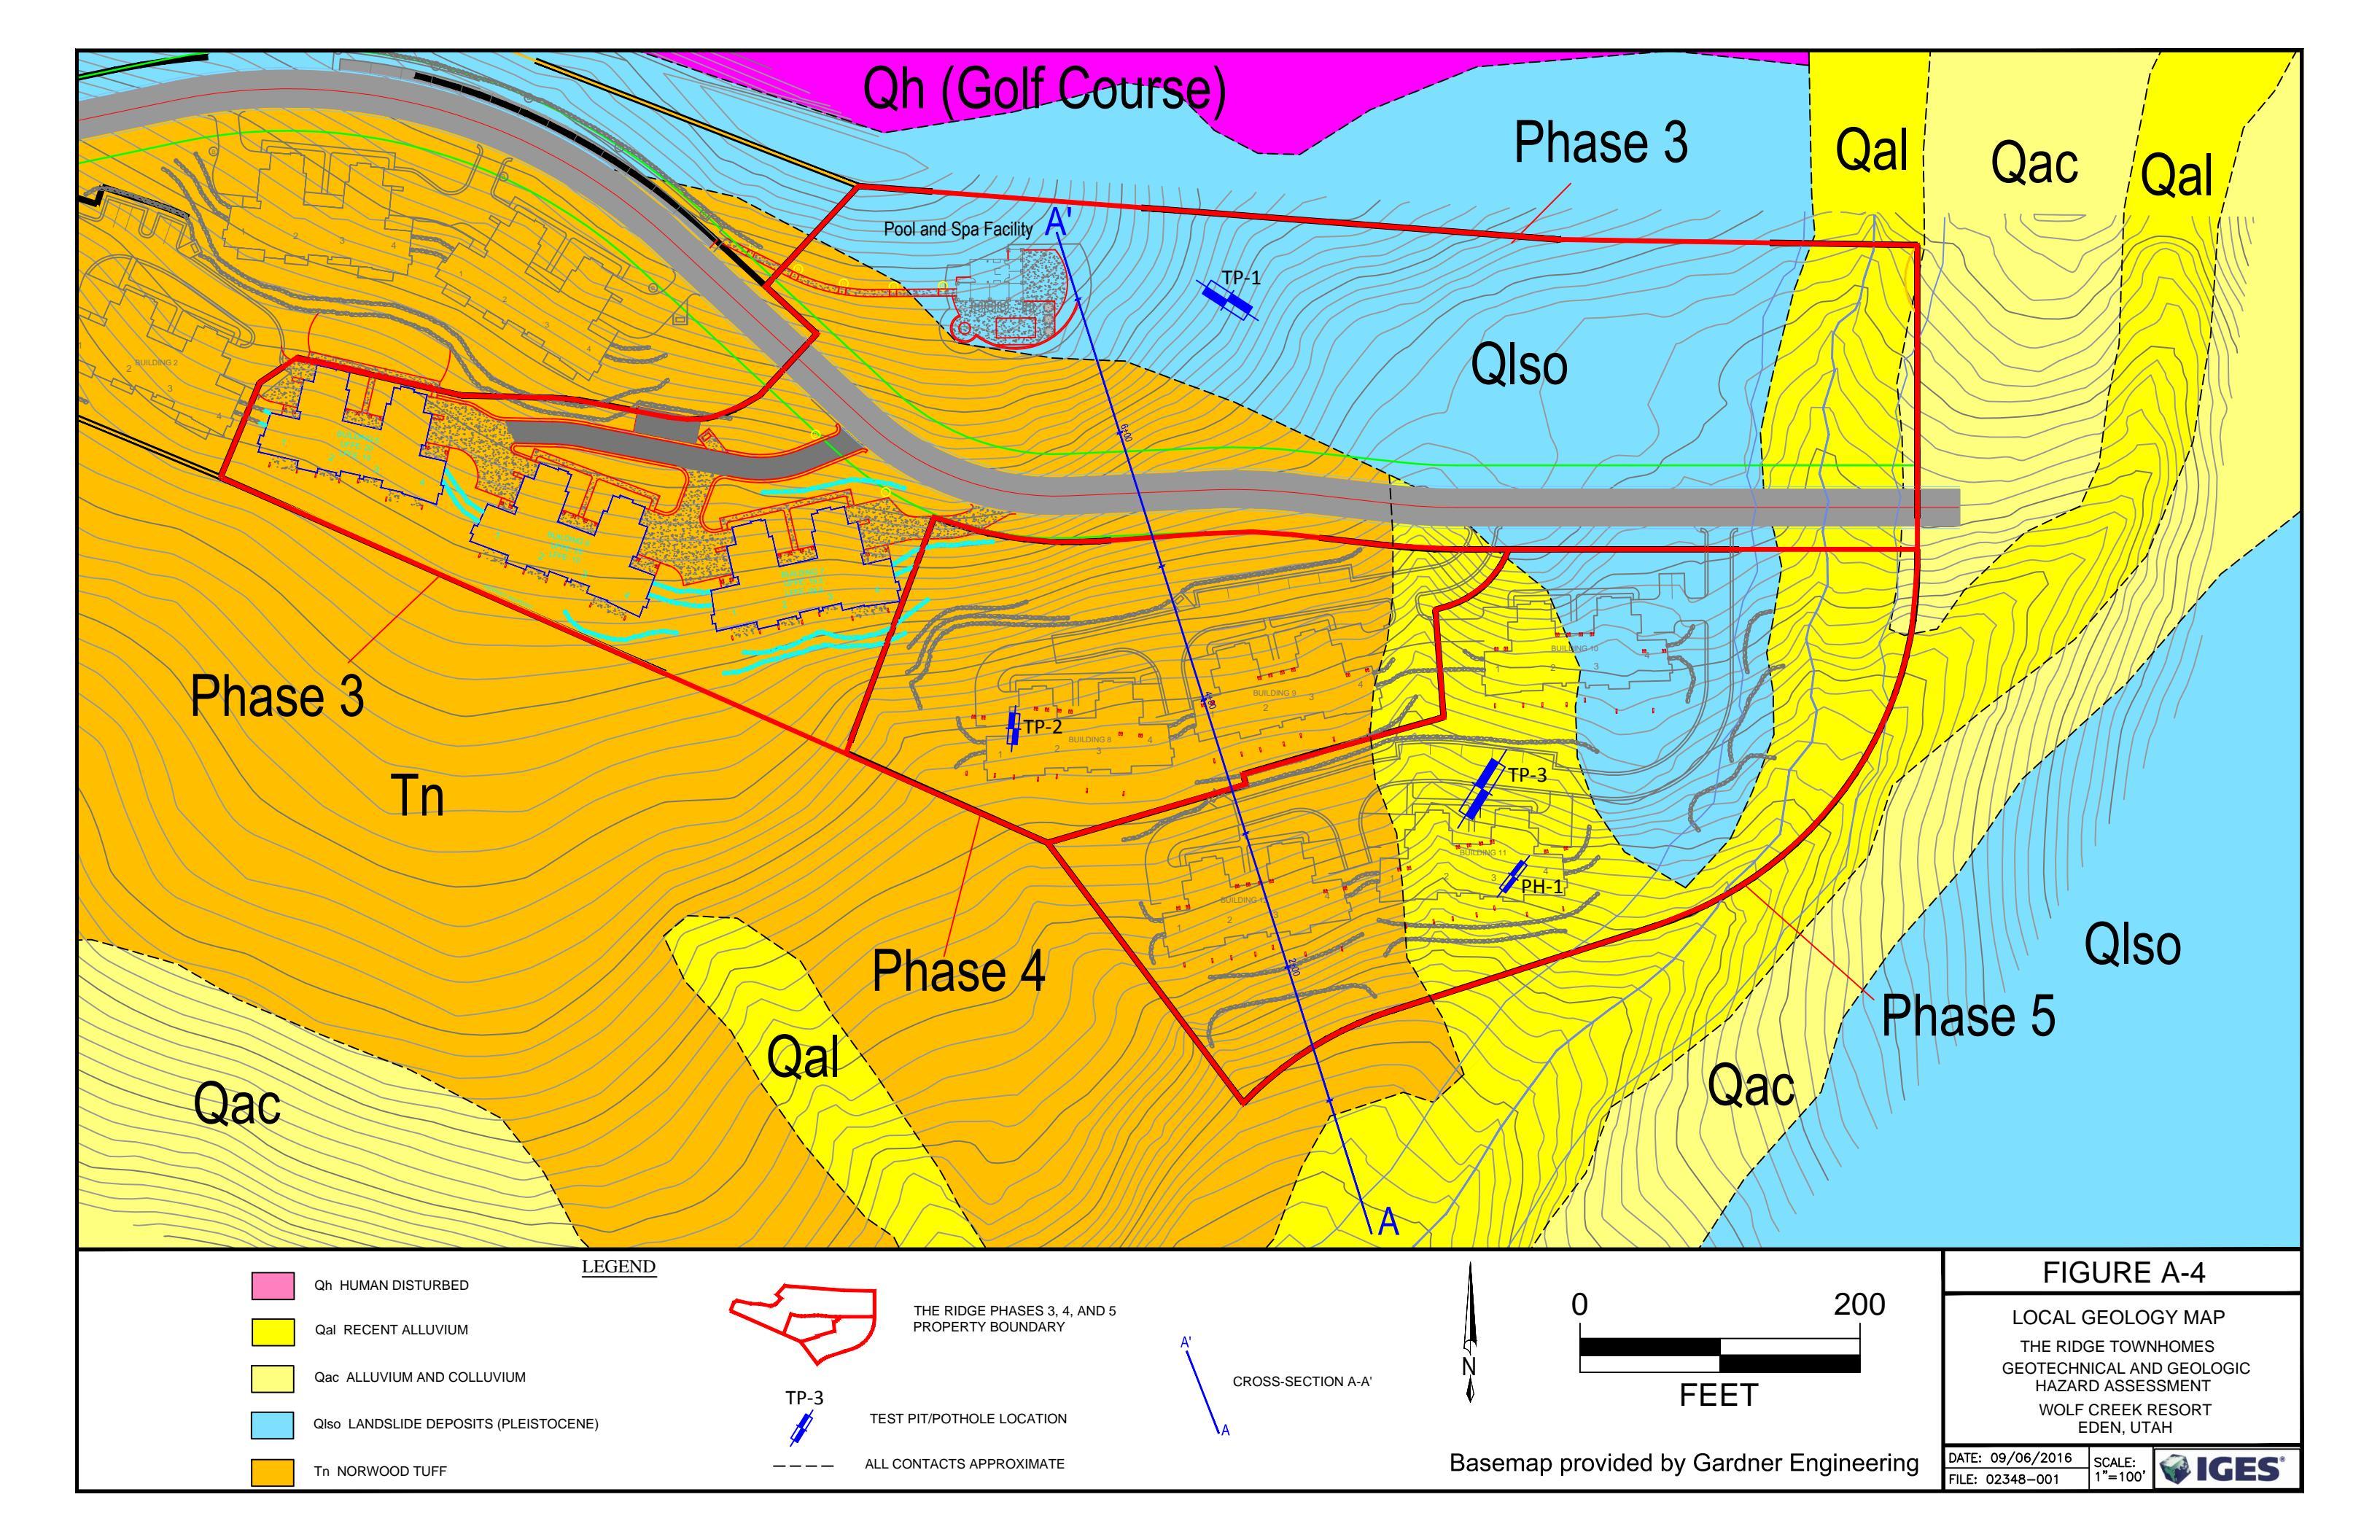
The subsurface investigation, however, showed the landslide deposits to be limited to the northern part of the Phase 3 area and the northeastern part of the Phase 5 area (see Figure A-4). Of the four subsurface excavations, explicit landslide evidence was only observed in TP-1 in the form of irregular, chaotic bedding and multiple slide planes exhibiting slickensides. The landslide deposits were estimated to be Pleistocene-aged due to the presence of a rounded morphology and well-developed topsoil (up to 3 feet thick). However, there may be smaller areas within the mapped landslide lobe where more recent movement has taken place, evidenced by topsoil as thin as 3 inches in some places along the road cut.

Our slope stability analysis indicates that areas outside of the mapped landslide areas (designated as Qlso on Figure A-4) meet the minimum acceptable factors-of-safety of 1.5 (static) and 1.0 (seismic or pseudo-static). It should be noted that our model only took into consideration the existing grade and not proposed topography (e.g., the finish grade after the townhomes are built). The results of the stability analyses are presented in Appendix C.

easternmost two 4-Plex units in the Phase 5 area. These areas may potentially be developed; however, recommendations for development will be contingent upon additional subsurface investigation to further define the limits of the landslide, *particularly depth to competent bedrock*. Landslide mitigation in this area would likely consist of mass-grading to break-up continuous shear structures upon which the slide took place. The extent of mass grading, assuming it is feasible, would not be known until several additional trenches can be completed within the landslide mass to better understand the landslide geometry. TP-1 suggests that over-excavation would likely be on the order of 5 to 6 feet below existing grade (note that the upper 1 to 3 feet consists of topsoil, which cannot be re-used as structural fill). The structural fill would have to be placed on horizontal benches; recommendations for benching can be provided upon request.
