**Geologic Hazards Screening Assessment
4400 North 2900 East, Liberty, Utah
Northern 5 Acres of Parcel ID# 22-008-0060**

GeoStrata Job No. 1193-001

July 21, 2016

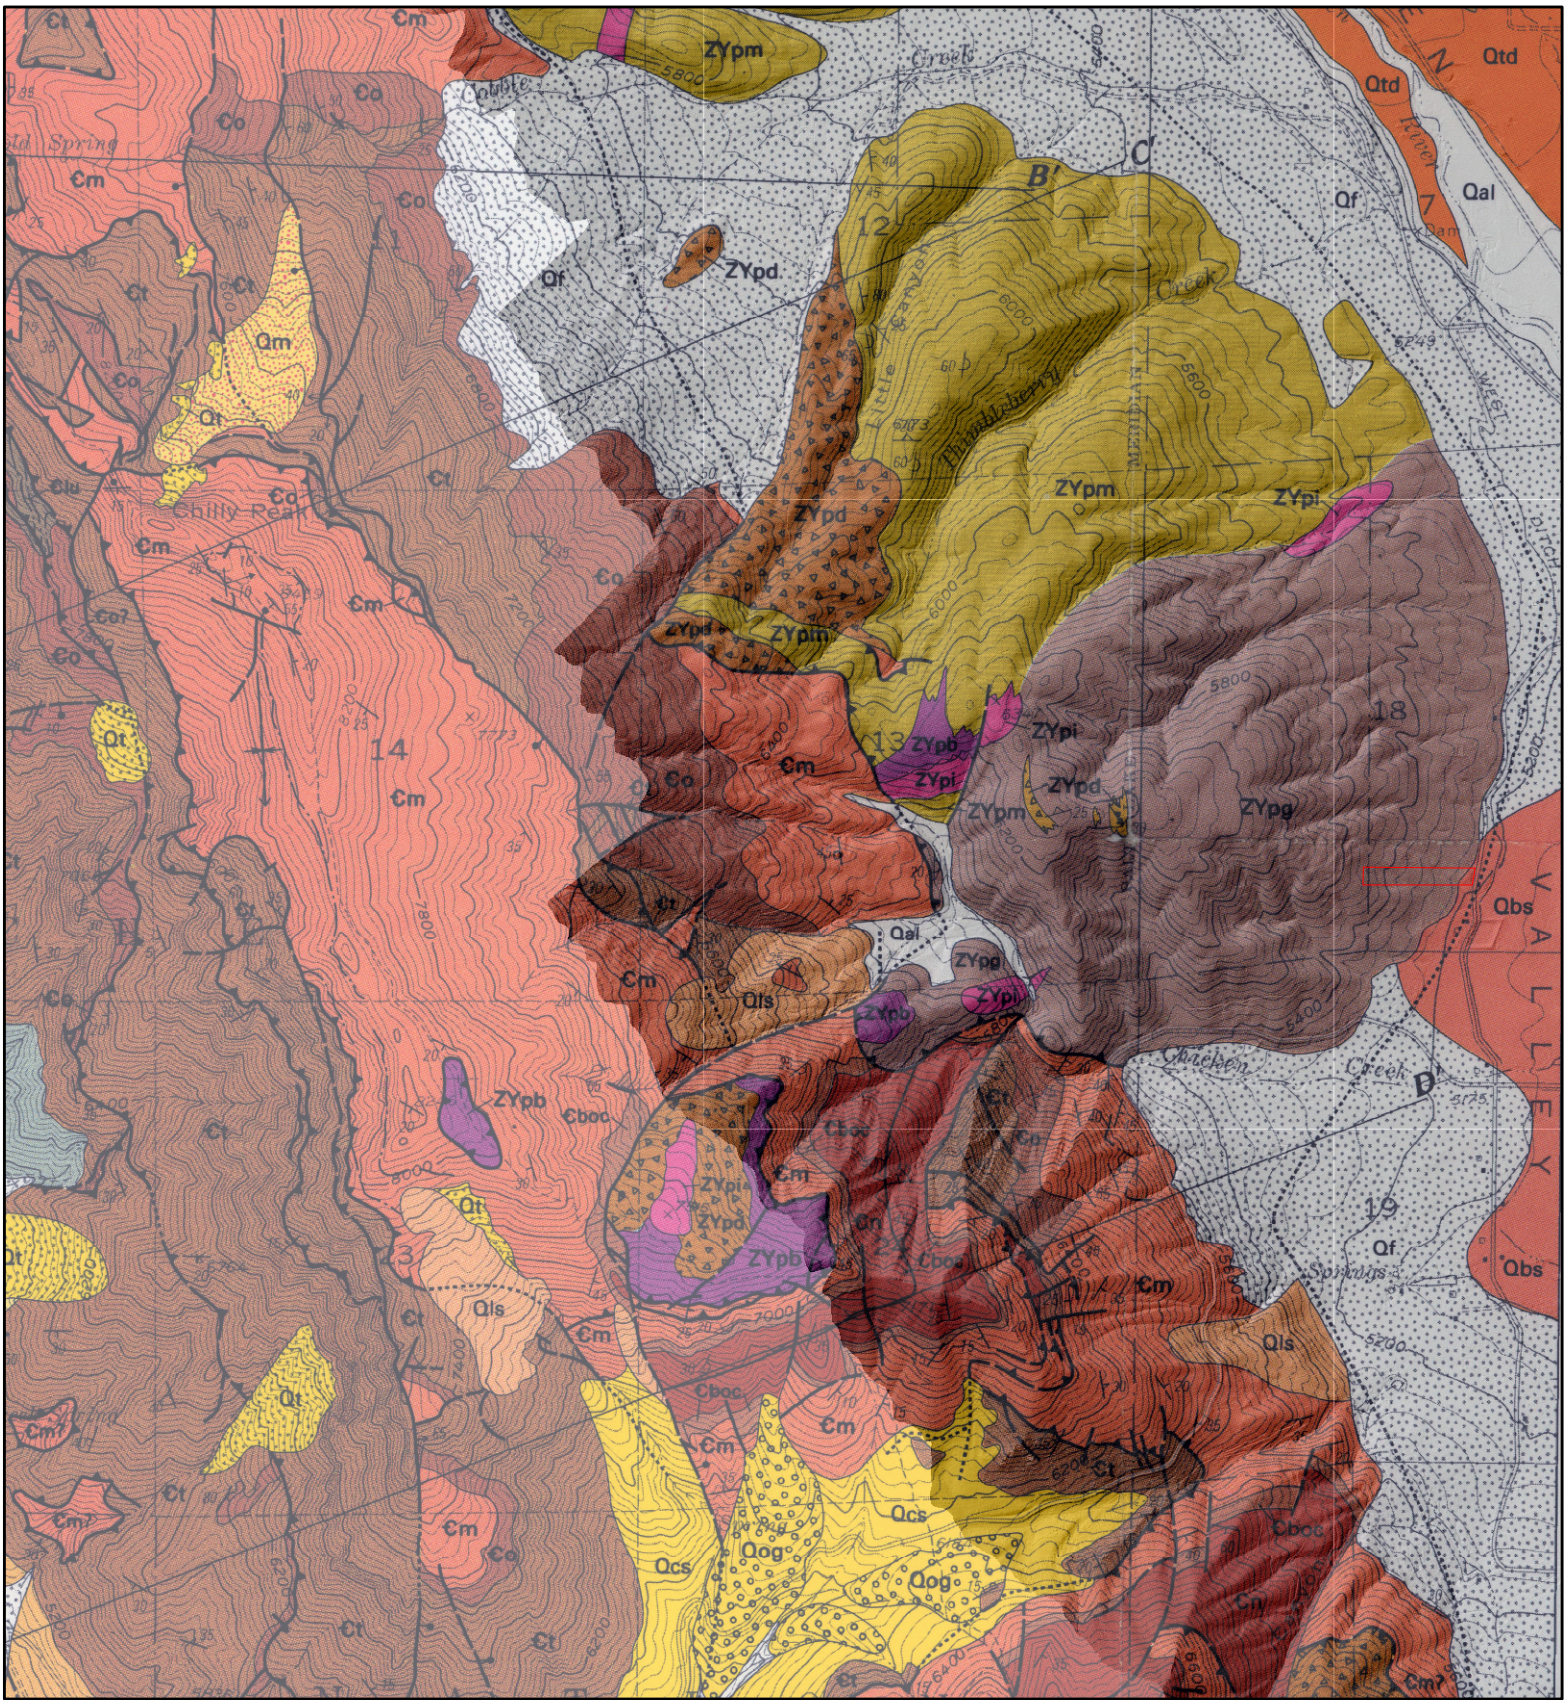
**Plate
 3a**

Surface sediments within the subject site, as shown on Plate 3a Site Vicinity Geologic Map and Plate 4 Site Vicinity 30' X 60' Geologic Map, are mapped as upper or middle Proterozoic Graywacke-siltstone Member of the Perry Canyon Formation (ZYpg) and characterized as medium to dark grey or grey to dark green, weathering to tan, micaceous siltstone (Crittenden and Sorensen, 1985). Quaternary age Lake Bonneville deposits (Qbs) are mapped as overlying ZYpg in the eastern edge of the subject lot and are described as gravel, sand, and silt deposited during the high stand of Lake Bonneville.

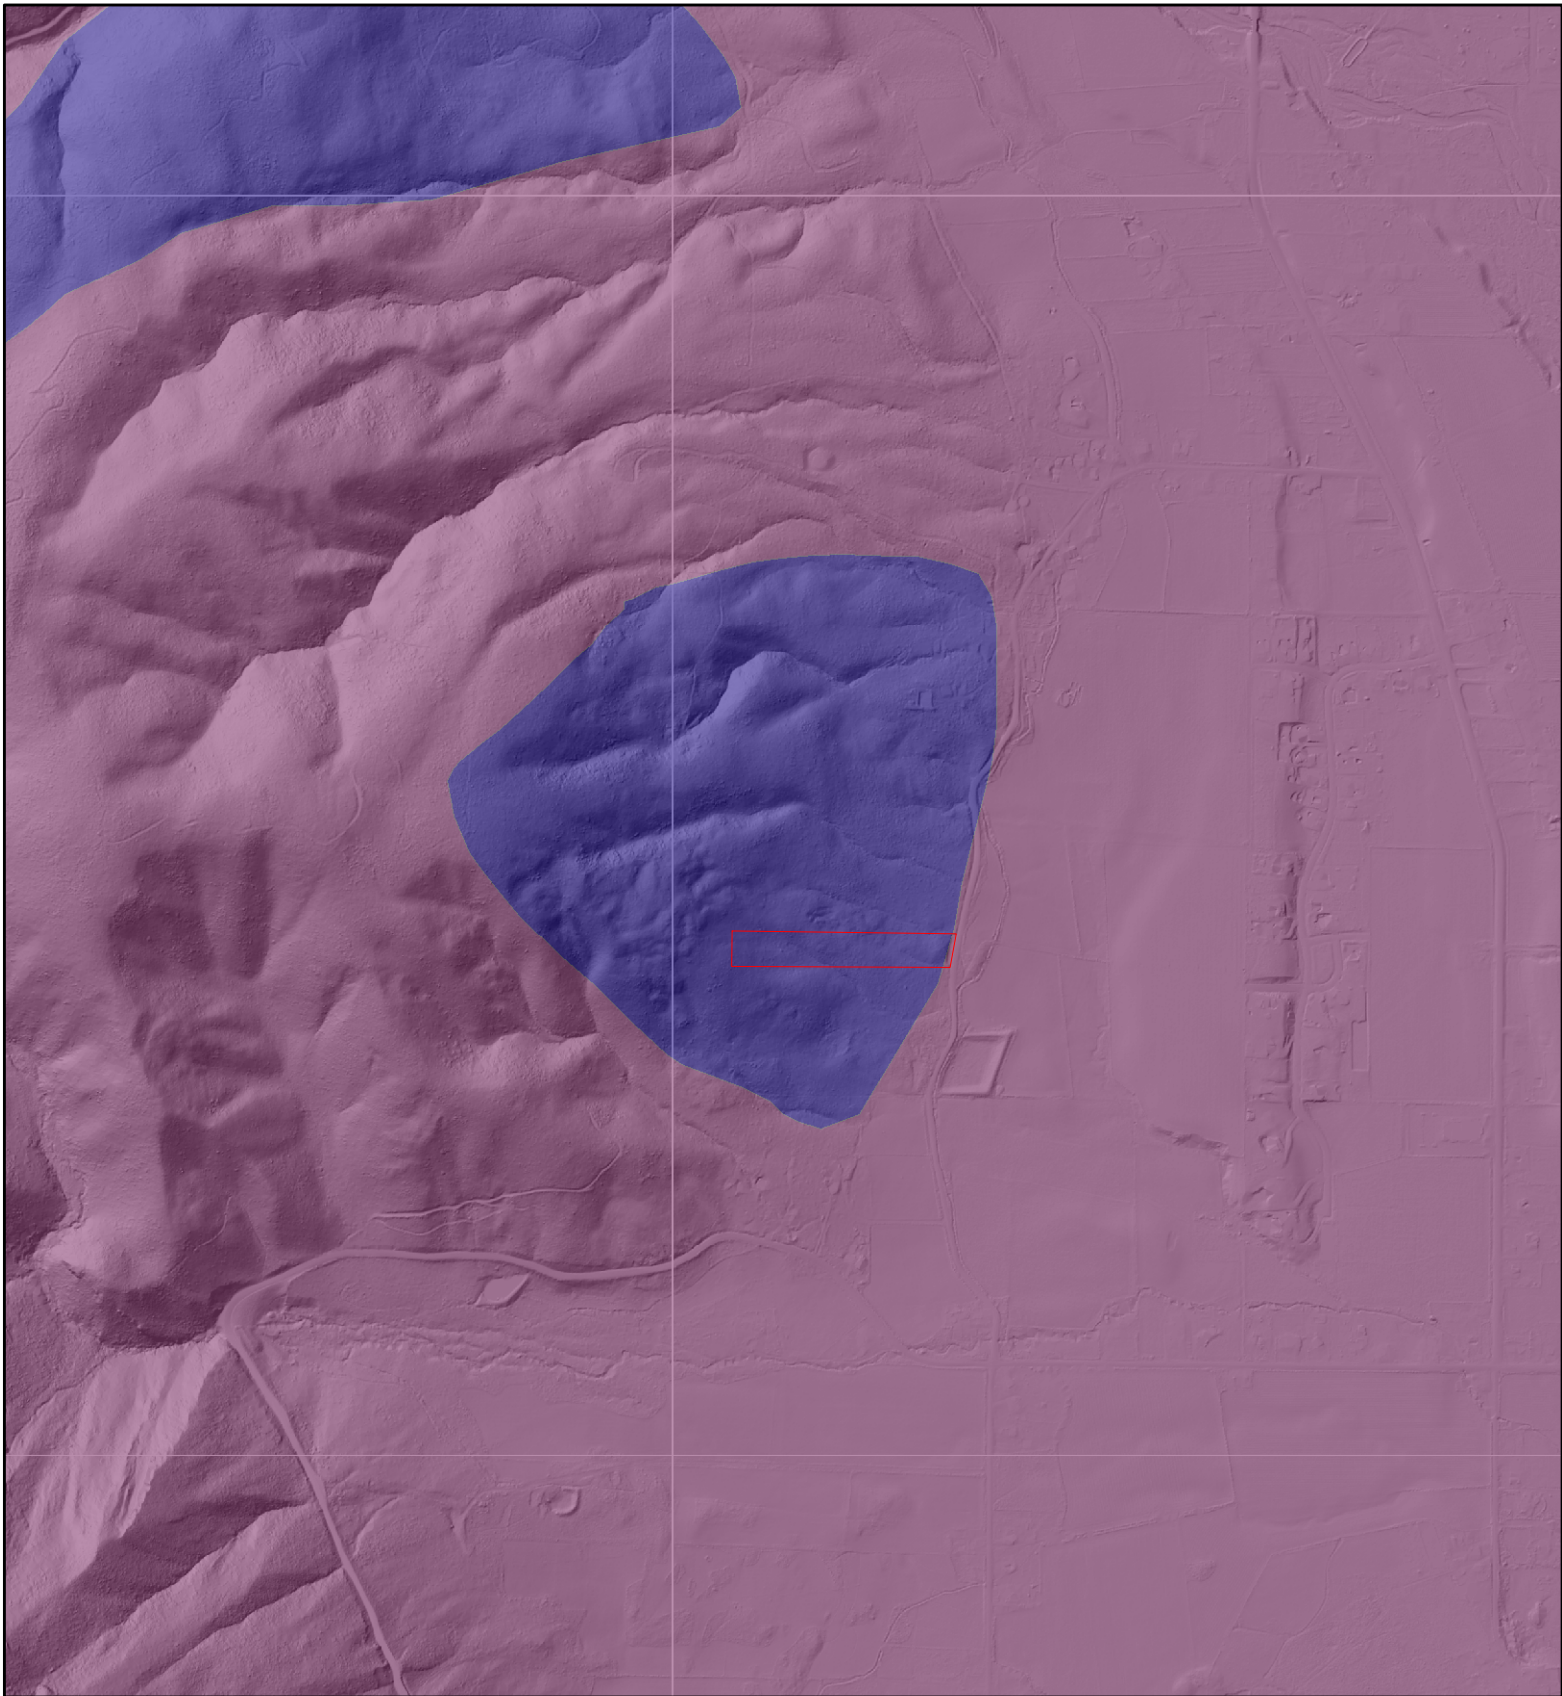
**Plate
 5**

Based on the review of published geologic hazard maps a landslide deposit is mapped within the subject site as shown on the Plate 5 Landslide Hazard Map and is characterized as a landslide undifferentiated from talus, colluvial, rock-fall, glacial, and soil creep (Elliot and Harty, 2010). No landslide deposits were observed within the subject site during our stereographic aerial photograph interpretation, our review of geologic maps, our review of the hillshades derived from 2011 1 meter LiDAR and 2013-2014 0.5 meter LiDAR and our field observations. Furthermore, no landslide deposits are mapped within the subject site as indicated on the Geologic Map of the North Ogden Quadrangle and part of the Ogden and Plain City Quadrangles compiled by Crittenden and Sorensen (Plate 3a Site Vicinity Geologic Map) and on the Progress Report Geologic Map of the Ogden 30' X 60' Quadrangle compiled by Coogan and King (Plate 4 Site Vicinity 30' X 60' Geologic Map). Given our field and office investigation, it is the opinion of GeoStrata that the deposit delineated within the subject site by Elliot and Harty is an alluvial deposit related to the transgressive and regressive phases of the Lake Bonneville cycle. Therefore, the landslide hazard within the subject site is considered low and it is considered unlikely that landslides will impact the proposed development. It is the opinion of GeoStrata that landslide hazard should not preclude development at the subject lot.

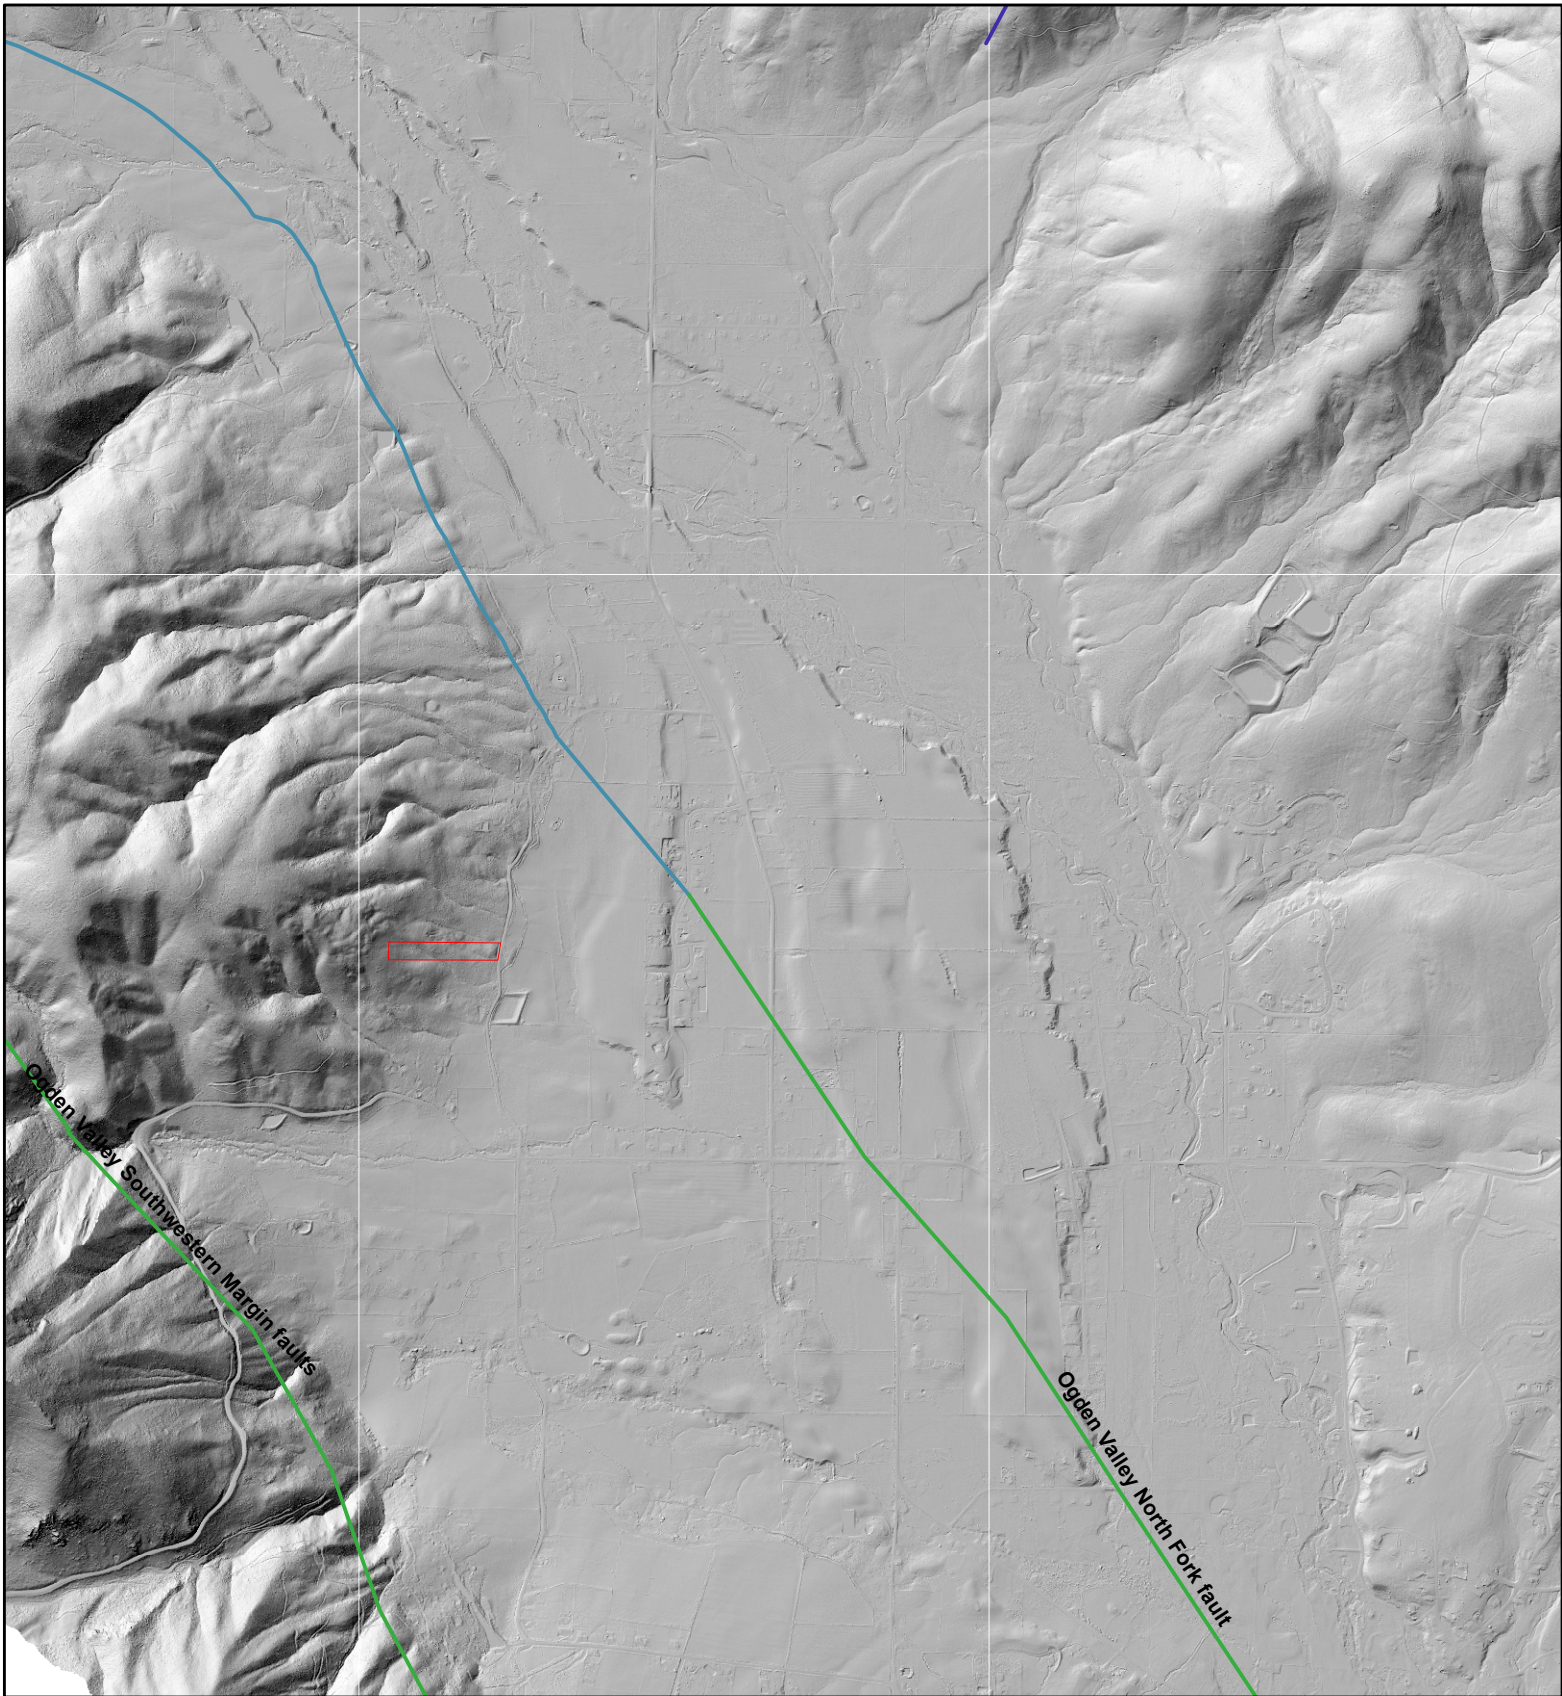
**Plate
6**

There are no active faults mapped trending through or within the vicinity of the subject site. The nearest fault is the Quaternary age Ogden Valley North Fork Fault and is trending northwest approximately 1,550 feet northeast of the subject site. Given our field and office investigations,

the surface fault rupture hazard within the subject site is considered low and it is considered unlikely that surface fault rupture will impact the proposed development.
