GEOTECHNICAL AND GEOLOGIC HAZARD INVESTIGATION
Building 4 Lodge, Development Parcel D7R
8569 E. Spring Park
Summit Powder Mountain Resort
Weber County, Utah

IGES Project No. 01628-024

August 7, 2017

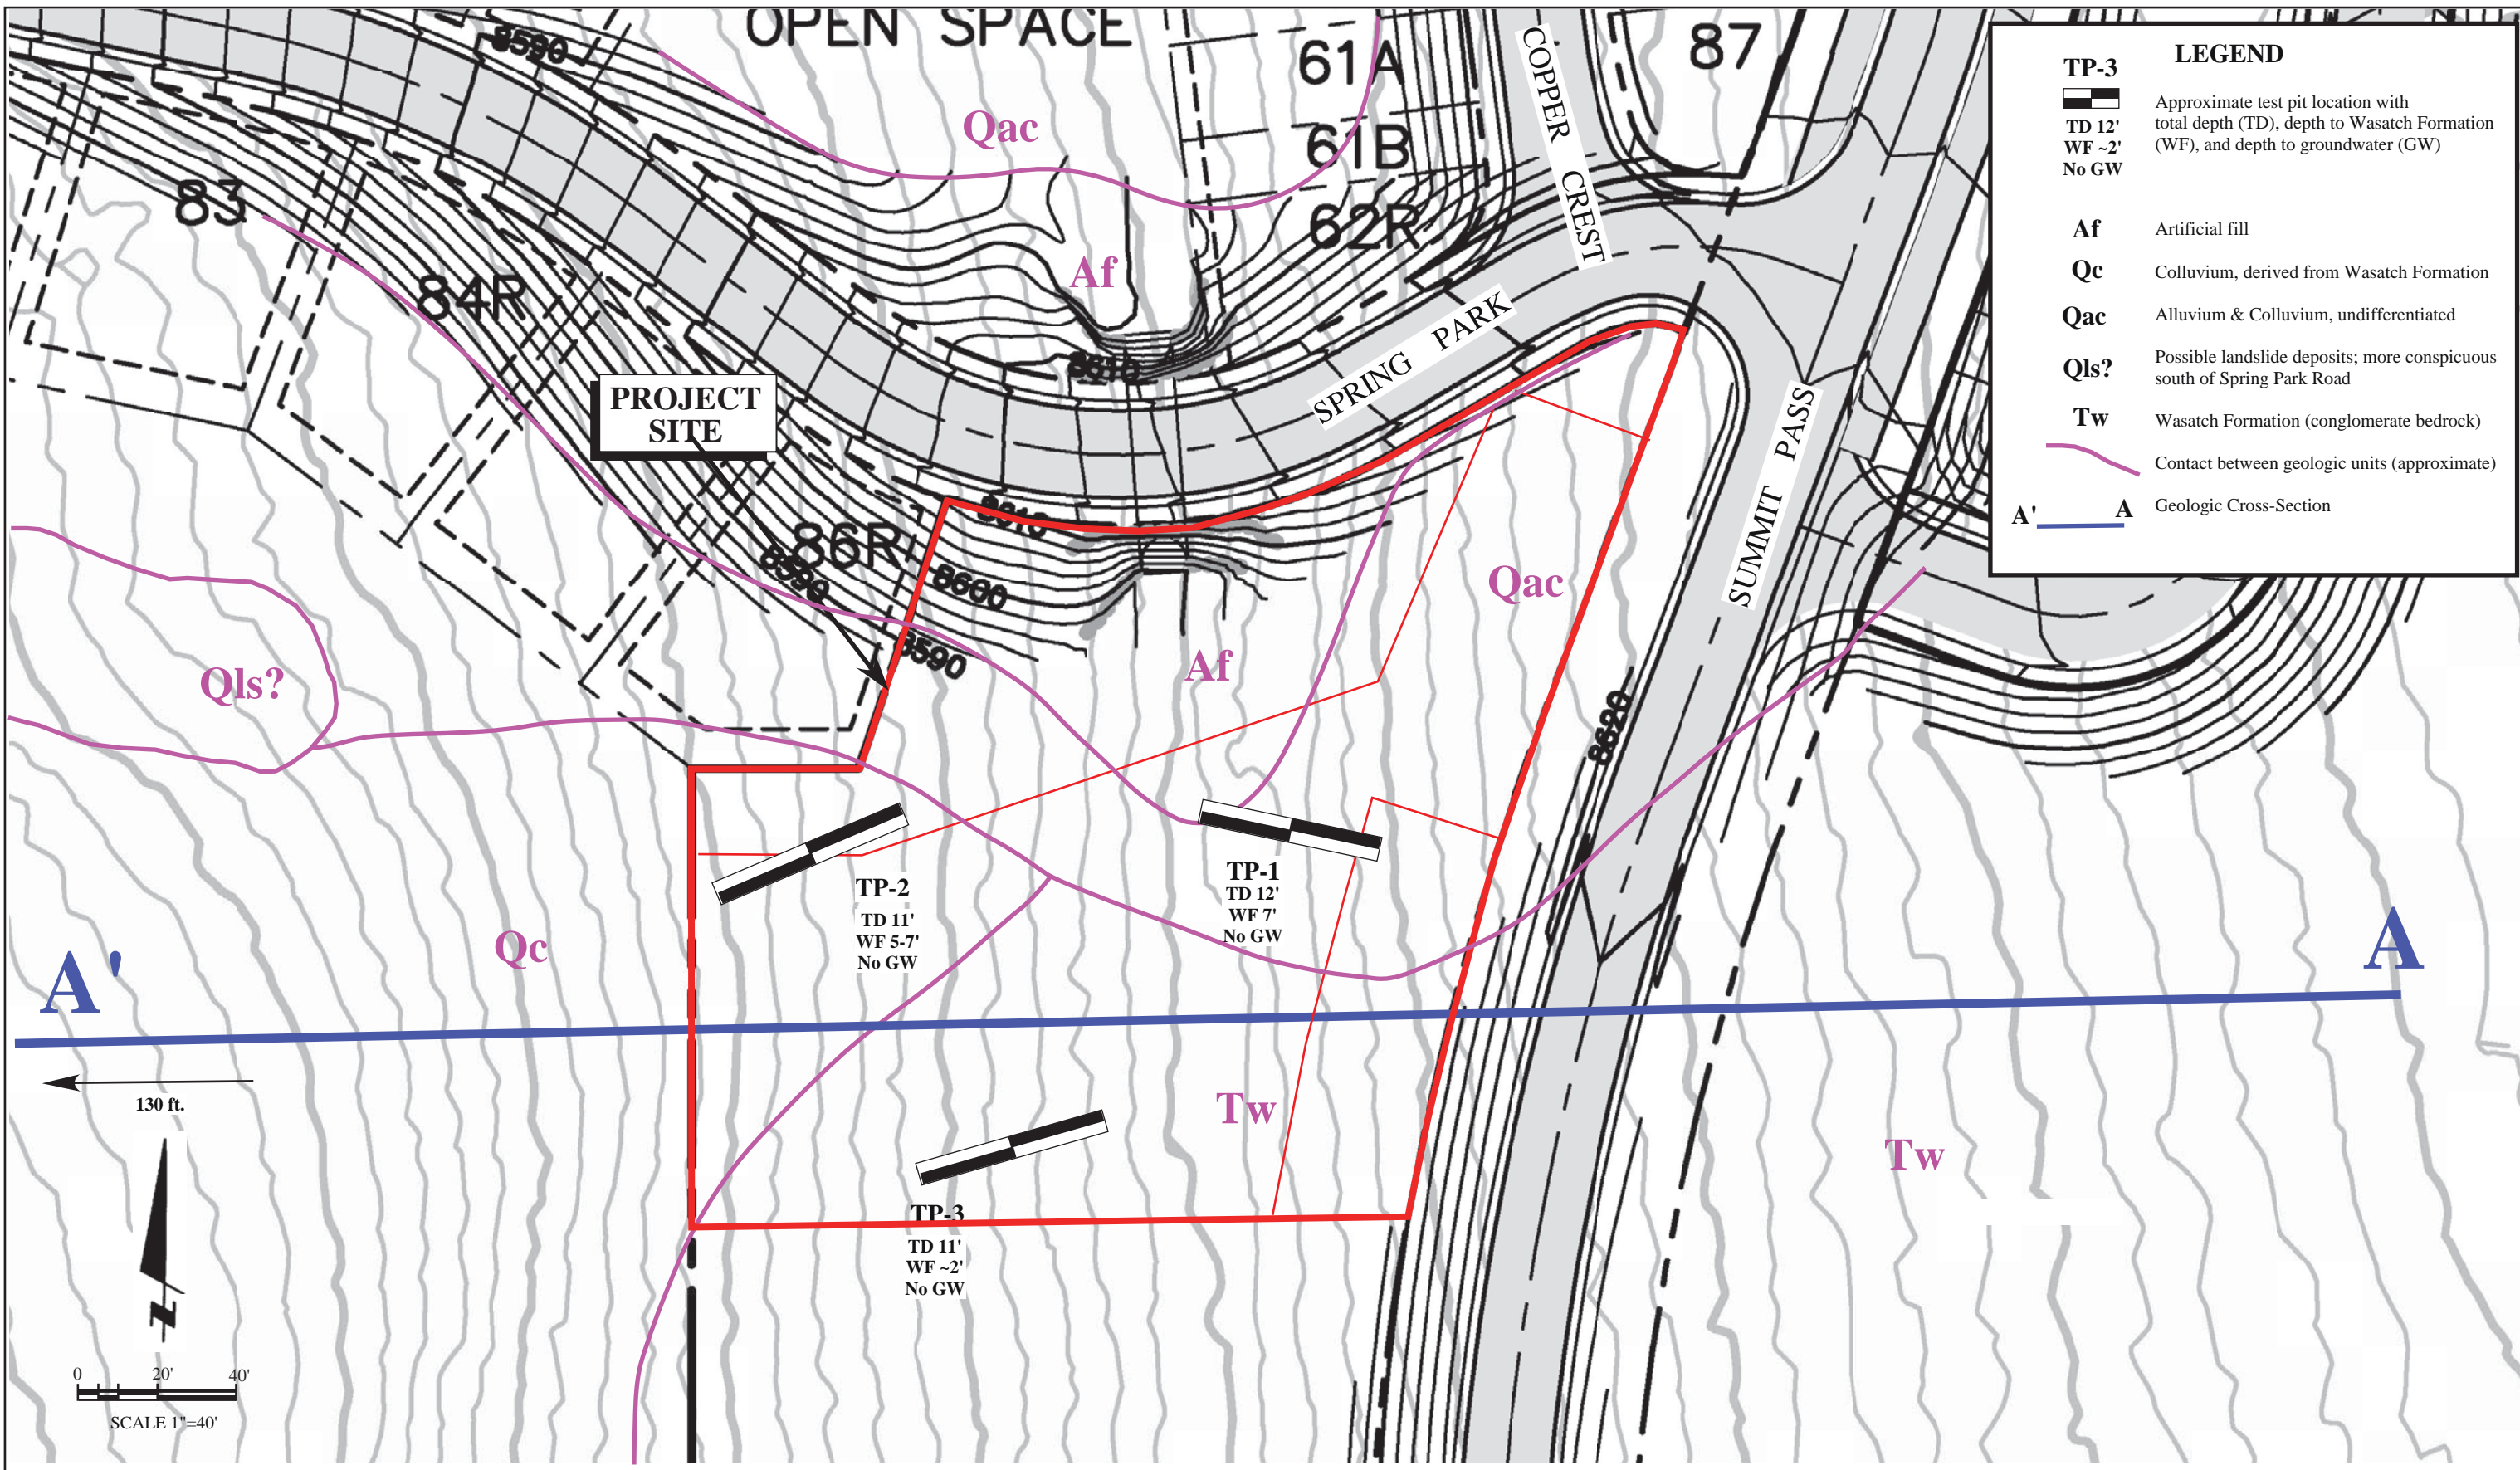
Figure
A-2

Approximately 100 feet west of the western margin of the property, a small, localized lobe of material interpreted to be possible landslide deposits was observed at the surface, though no associated headscarp was observed (see Figure A-2).

No springs, seeps, or running water were observed on the property at the time of the site visit. Additionally, no evidence of landsliding or other geologic hazards was observed on the property, though potential localized landslide features were observed to the west of the property, and a small break in slope was observed immediately west of the property (see Figure A-2).

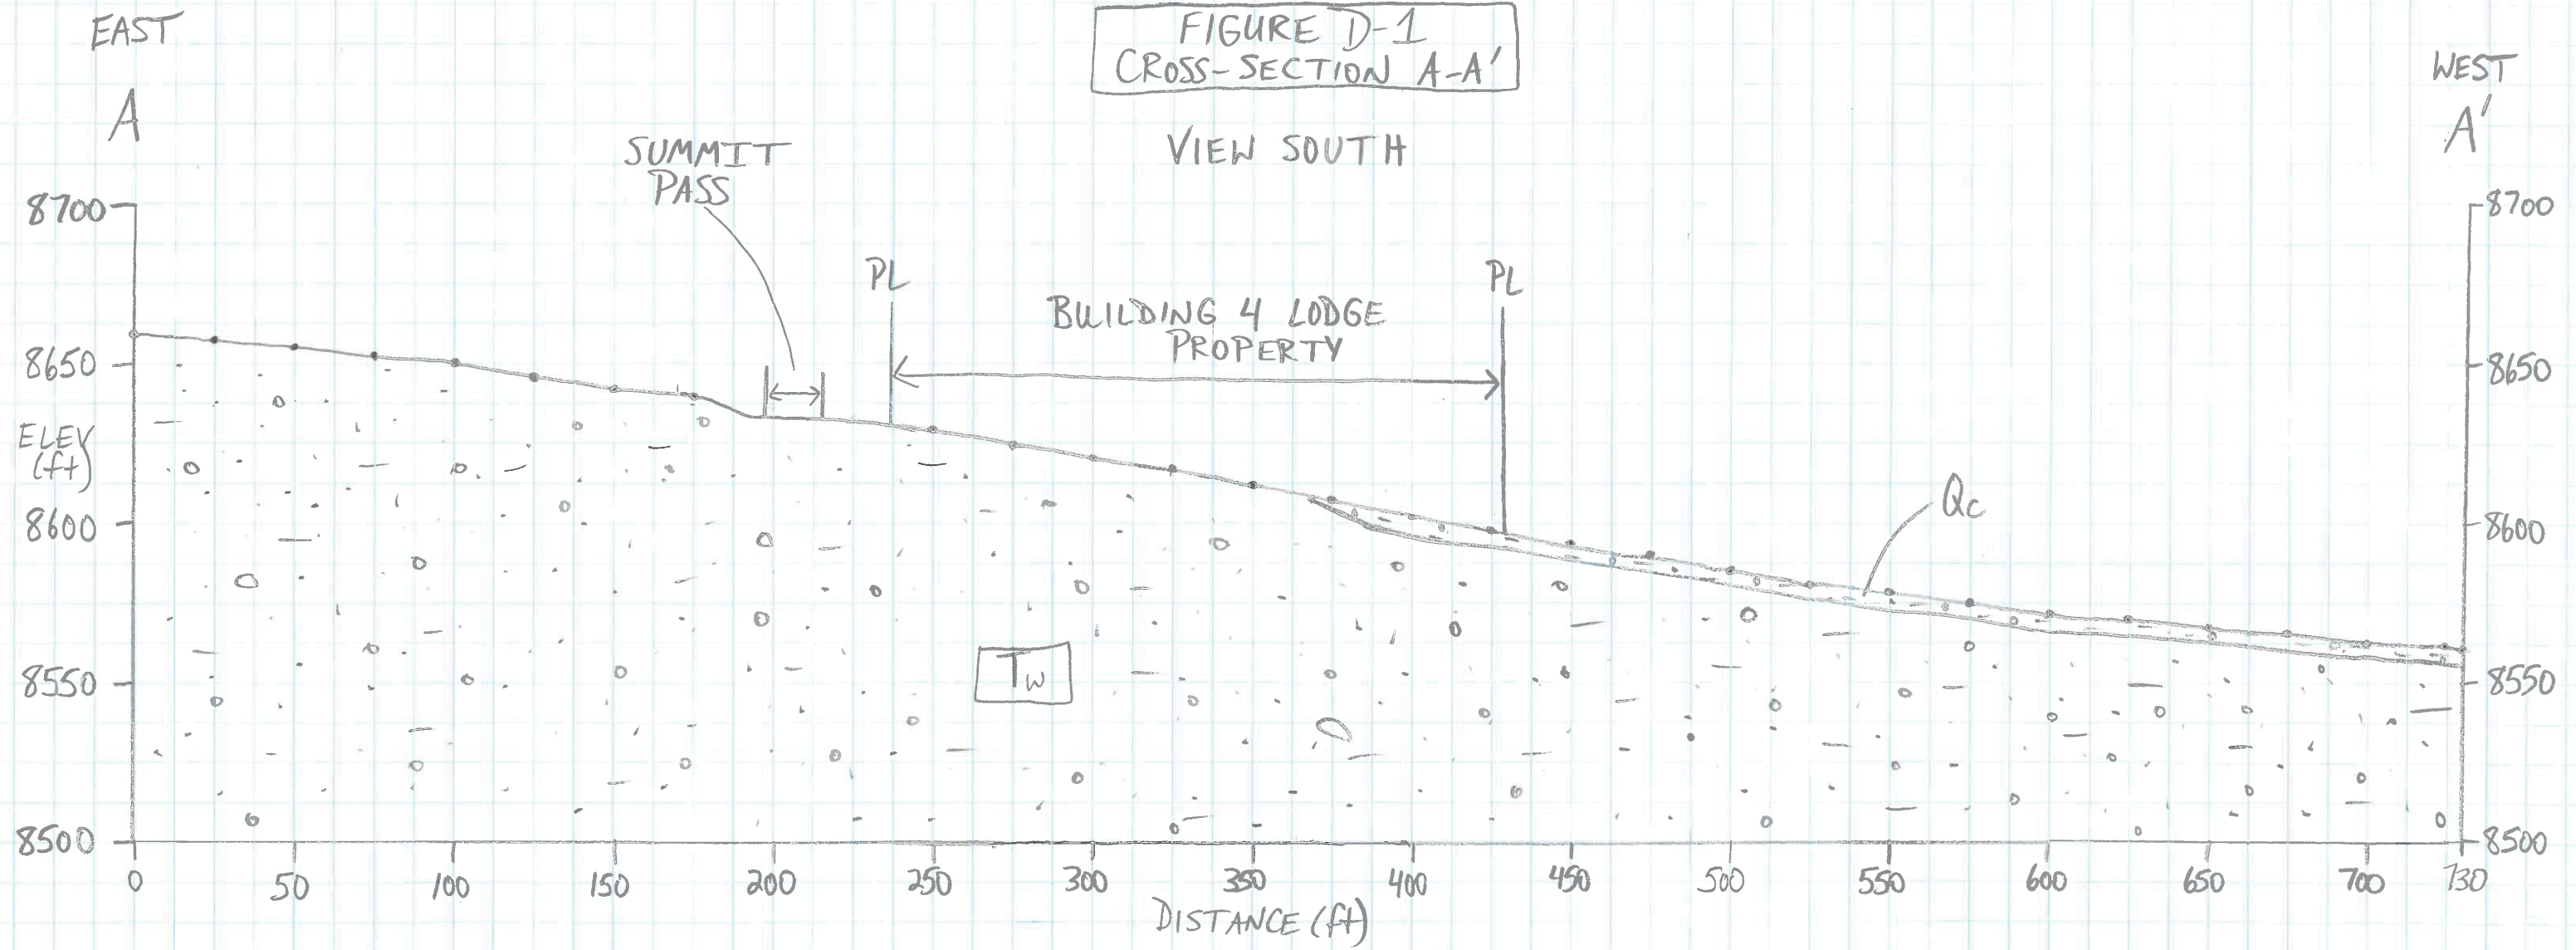
FIGURE D-1
CROSS-SECTION A-A'

Section	Static Factor of Safety	Pseudo-Static Factor of Safety
Existing Condition	5.68	2.99

The results of the analysis indicated the existing conditions meet the minimum required factors-of-safety of 1.5 and 1.0 for both the static and seismic (pseudo-static) case, respectively. The planned improvements will include a deep basement level, which would tend to unload the slope and further improve the stability of the slope; significant fill placement on the slope, which would tend to load the slope and decrease stability, is not anticipated. A summary of the slope stability analysis is presented in Appendix D.
