GEOTECHNICAL STUDY CEDAR COVE LOT 12 WEBER COUNTY, UTAH

ETE JOB NO.: 07-2202

SEPTEMBER 19, 2007

GEOLOGIC HAZARDS RECONNAISSANCE CEDAR COVE SUBDIVISION LOT 12 2670 BYBEE DRIVE, WEBER COUNTY, UTAH

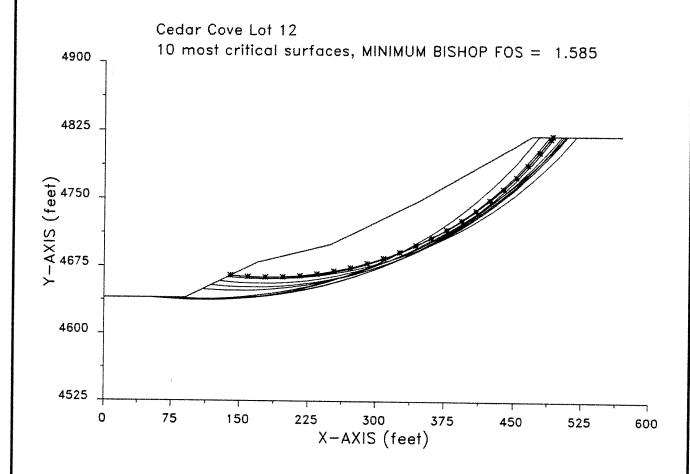
GLOBAL SLOPE STABILITY

Slopes with safety factors of 1.5 and 1.0 or greater for static and pseudo-static conditions, respectively, are typically considered suitable for residential development. Our analysis indicates that the slope at the site has global safety factors greater that 1.5 and 1.0 for static and pseudo-static conditions, respectively (see Figures 4 and 5). As a precaution, we recommend that the structure be placed at least 20 feet from the toe of the slope. If desired, an engineered retaining wall may be used at the toe of the slope to increase the buildable area.

To prevent destabilizing the slopes at this site we recommend that permanent cut and fill slopes be graded no steeper than a 2 to 1 (horizontal to vertical) unless an engineered retainage system is used.

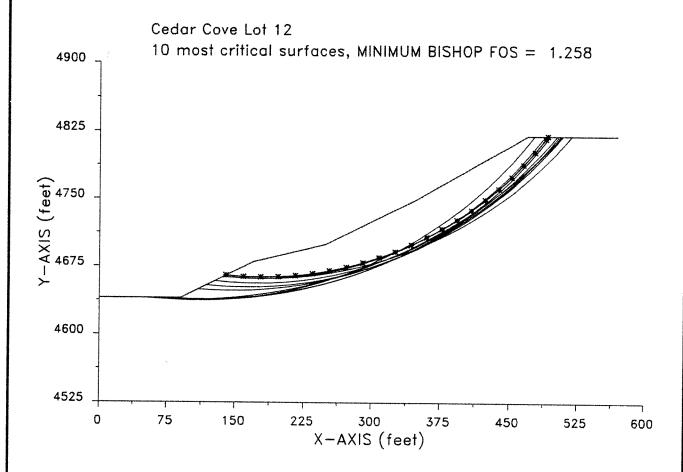
GLOBAL SLOPE STABILITY - (PSEUDO STATIC)

conditions. The pseudo-static condition is used to evaluate the stability of the slope during a seismic event. The expected maximum bedrock acceleration from large earthquakes at this site with a 10 percent probability of exceedance in 50 years is $0.20g^2$. Since earthquake loads are cyclic loads, one half of the peak acceleration is commonly used for the pseudo-static condition and this value was used in our analysis.

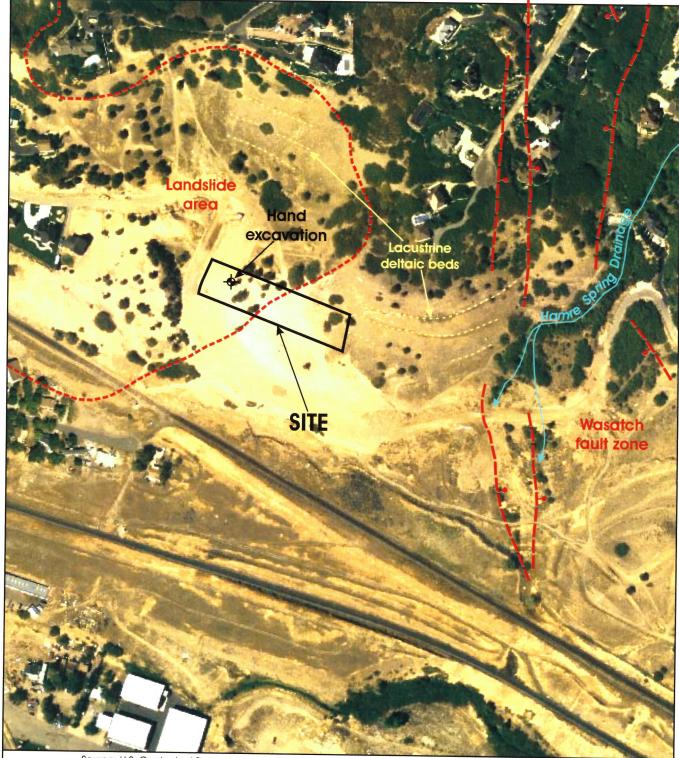
The nearest mapped faults to the site are two discontinuous, east-dipping antithetic traces of the Weber section of Wasatch fault zone about 475 to 500 feet east of the eastern site boundary on Figure 3. No evidence of surface faulting such as fault scarps or lineaments was evident at the property or on air photos. However, at this distance, the eastern roughly 25 feet of the site would be in the Surface Fault Rupture Special Study Zone on Weber County Planning maps where trenching studies would be needed. Given that the proposed home location is in the western part of the lot, we do not anticipate surface fault rupture will be a concern.

The site straddles the eastern margin of a prehistoric earthflow. Well-defined head scarps of this landslide are below the existing homes north of the property on Figure 3. Well-bedded lacustrine deltaic sediments are exposed in slopes in the eastern part of the site, and bedded deltaic sands were also observed in our hand excavation in the west-facing slopes at the proposed home location (Figure 3). Deformed and steeply dipping beds were observed on lot 13 to the south that may be intact failure blocks of this slide at its margin. Slopes in the eastern part of the site and to the north show no evidence of ongoing deformation and appear currently stable. The surficial and air photo evidence suggest that the site is in a zone of depletion where sediments failed and moved downslope to the southwest to a lower (depositional) accumulation zone.

Based on all of the above, the risk from landslides in the western part of the site is high; the eastern part of the site would have a lower hazard. We therefore recommend a geotechnical engineering slope-stability evaluation be conducted prior to building. Recommendations to reduce the risk of landsliding, including setbacks or engineered mitigation measures, should be provided if the factors of safety are deemed unsuitable. Care should also be taken that site grading does not destabilize the toes of the slopes without prior geotechnical analysis and grading plans, and that no ponded water is allowed to remain on the slopes that may reduce stability.
