GEOTECHNICAL AND GEOLOGIC HAZARD INVESTIGATION The Overlook – Phase I Summit Powder Mountain Resort Weber County, Utah

IGES Project No. 01628-021

January 30, 2017

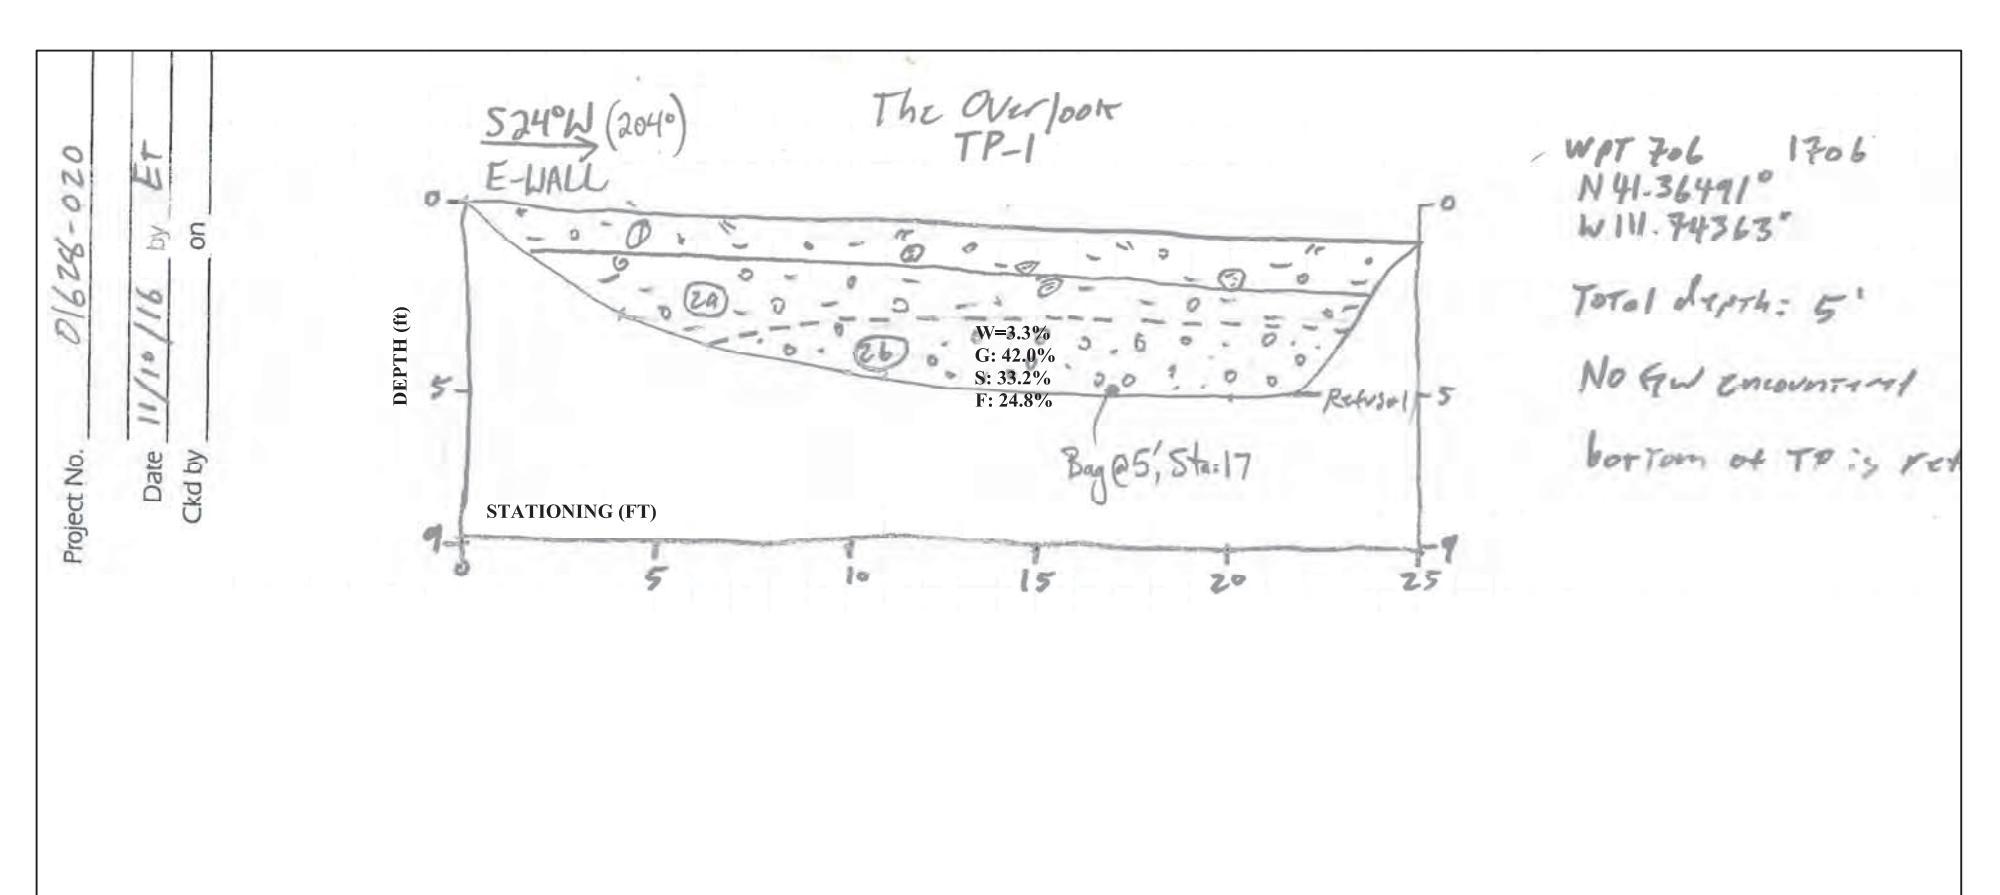
Geotechnical & Geologic Hazard I	nvestigation	Figure
	The Overlook - Phase I Summit Powder Mountain Resort		• •
J	Weber County, Utah	TEST PIT LOG TP-1	A-2

<u>A/B Soil Horizon</u>: ~1' thick; dark yellowish brown (10YR 4/2) sandy lean CLAY with gravel (CL), loose, moist, low to moderate plasticity, massive; gravel and larger sized clasts comprise ~15-20% of unit; clasts entirely subangular quartzite up to 10" in diameter, though mode size 1-2"; abundant plant and tree roots; gradational, irregular basal contact.

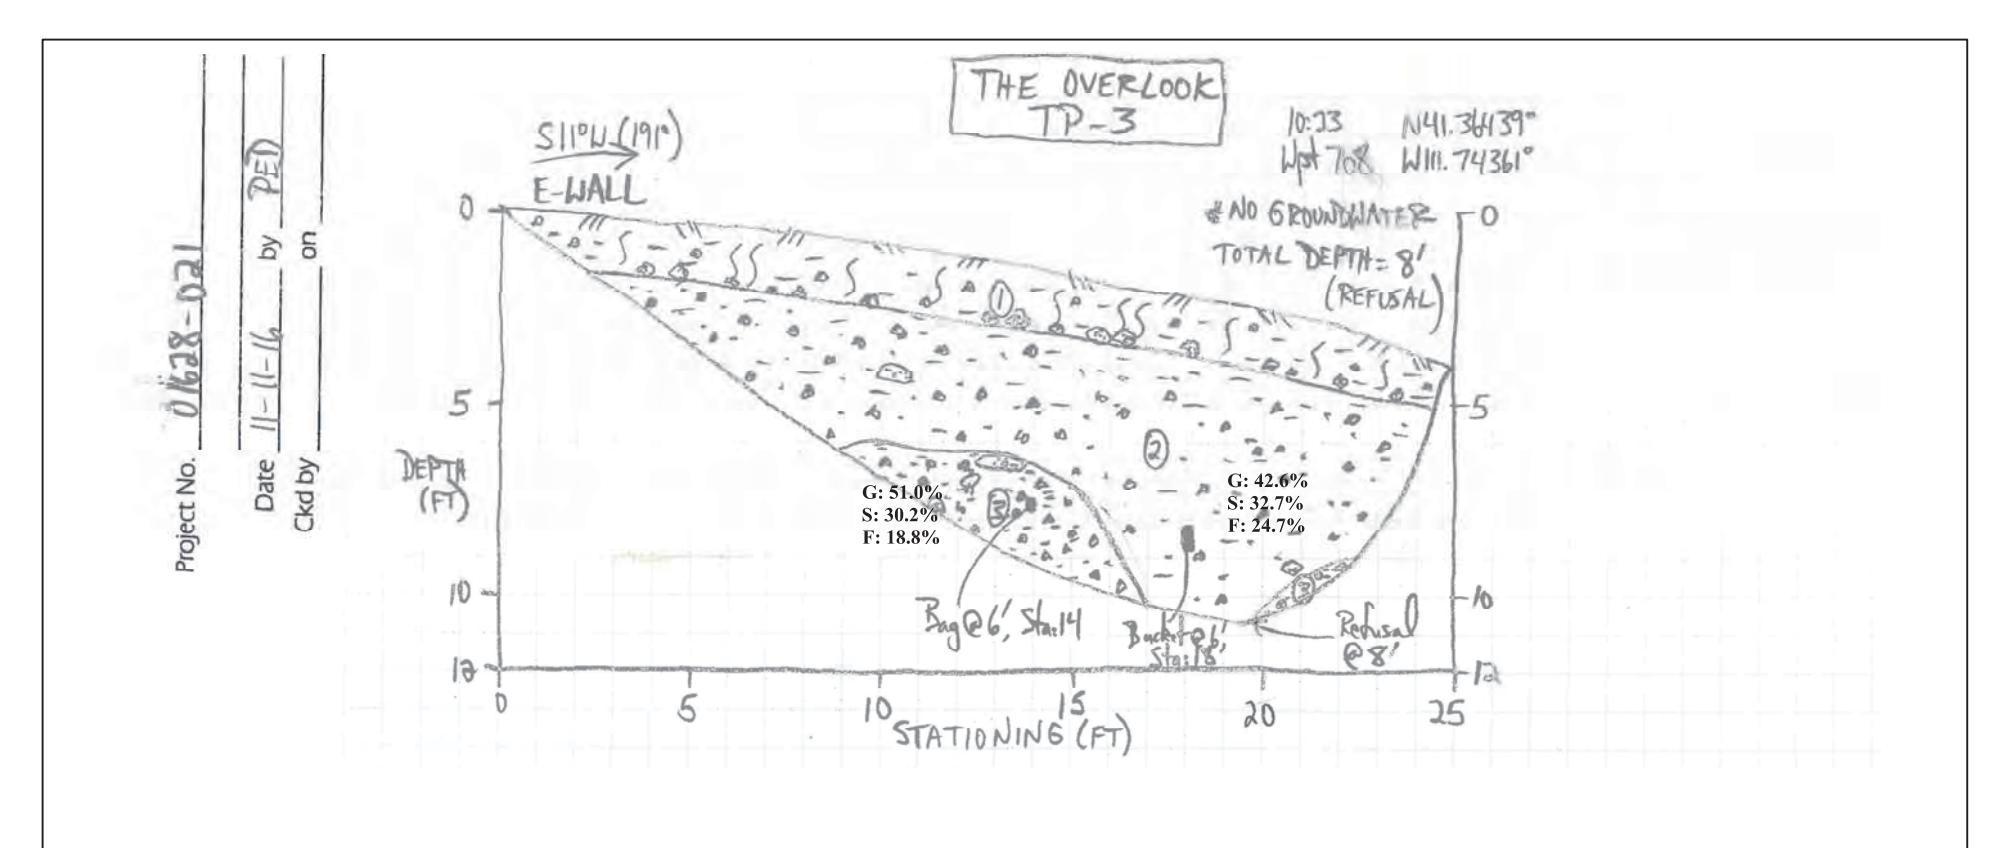
Geotechnical & Geologic Hazard	Investigation	Figur
The Overlook - Phase I Summit Powder Mountain Resort		A /
Weber County, Utah	TEST PIT LOG TP-3	A-4

- 1) A/B Soil Horizon: ~1.5-2' thick; grayish brown (5Y 3/2) to dark yellowish brown (10YR 4/2) lean CLAY 3) Wasatch Formation: At least ~2.5' thick; competent conglomerate bedrock, partially disaggregated to with gravel (CL), loose to medium-stiff, moist, low plasticity, massive; gravel and larger sized clasts comprise ~15-20% of unit; clasts entirely medium gray (N5) subrounded to subangular quartzite up to 10" in diameter, though mode size $\sim 2-4$ "; basal ~ 6 " is highly cobbly and may represent a thin, loose colluvium unit with topsoil matrix; cobbles within thin colluvial horizon comprise ~30-35% of basal 6"; abundant plant and tree roots; sharp, largely planar basal contact.

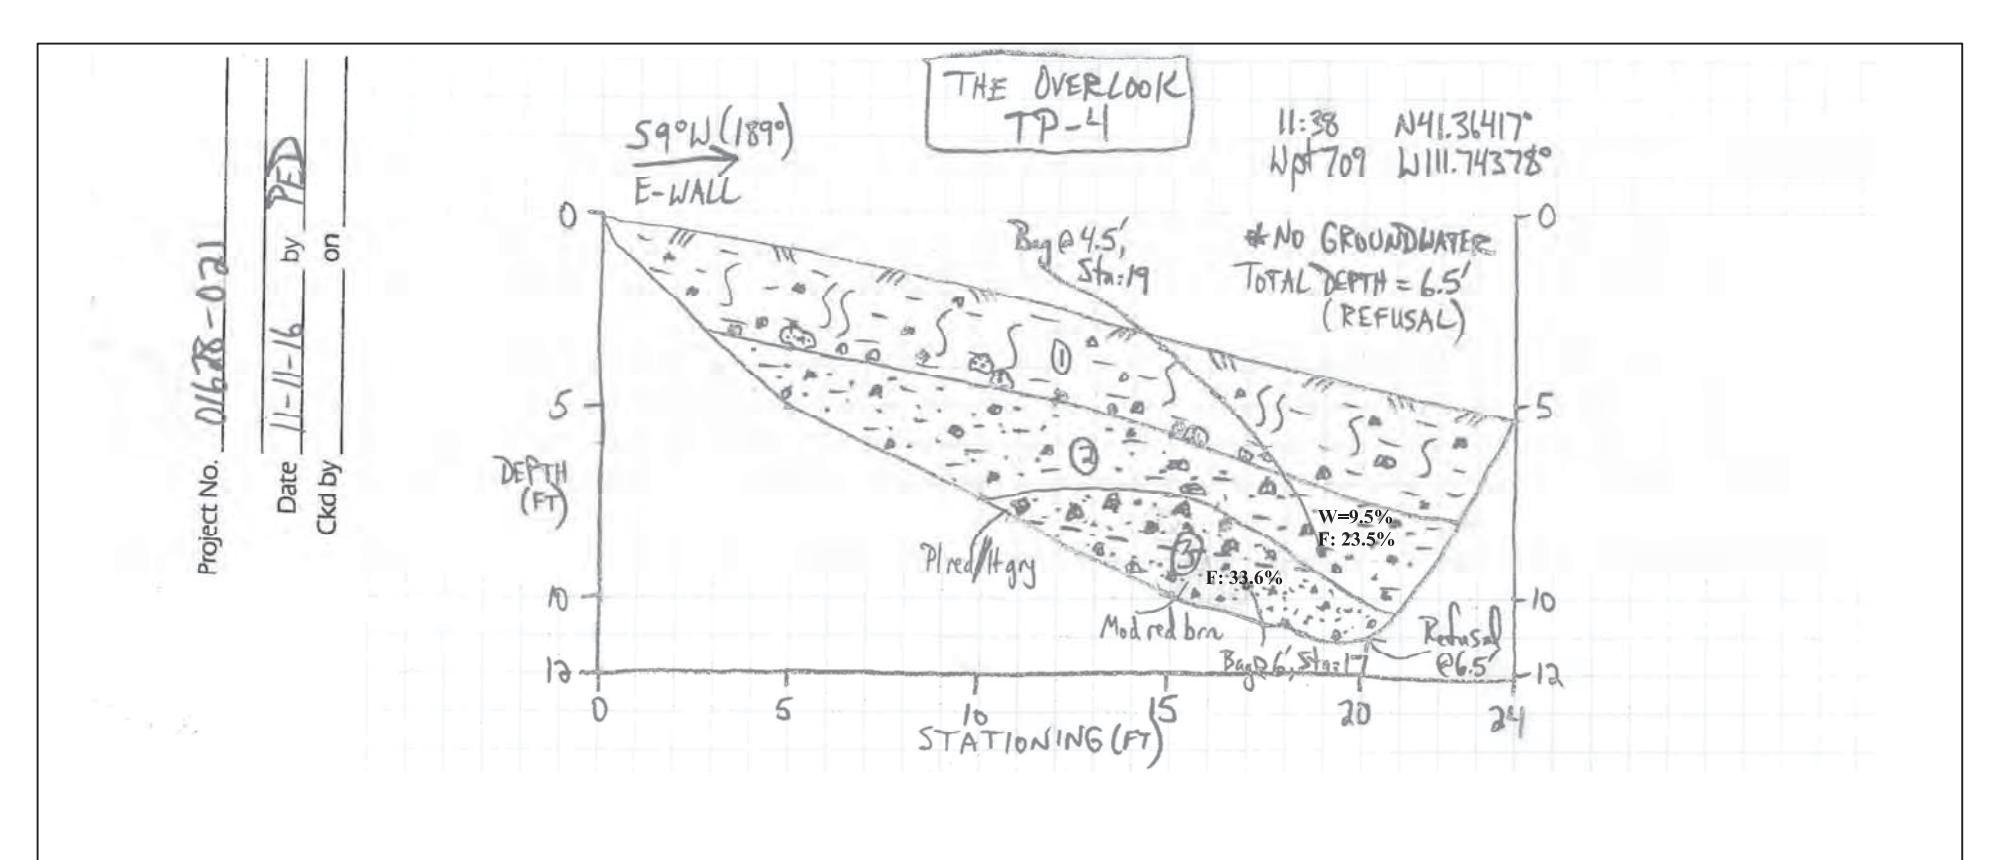
Geotechnical & Geologic Hazard I	nvestigation	Figure
	Geotechnical & Geologic Hazard I The Overlook - Phase I Summit Powder Mountain Resort		• -
ig)	Weber County, Utah	TEST PIT LOG TP-4	A-5

- 1) <u>A/B Soil Horizon:</u> ~2.5-3' thick; grayish brown (5Y 3/2) to dark yellowish brown (10YR 4/2) lean CLAY with gravel (CL), loose to medium-stiff, moist, low plasticity, massive; gravel and larger sized clasts comprise ~10-15% of unit; clasts entirely medium gray (N5) to pale yellowish orange (10YR 8/6) subrounded to subangular quartzite up to 10" in diameter, though mode size ~2-4"; basal ~6"-1' is a possible thin, loose colluvium unit with topsoil matrix; cobbles within thin colluvial horizon comprise ~25% of basal 6"-1' of unit; abundant plant and tree roots; gradational, planar basal contact.

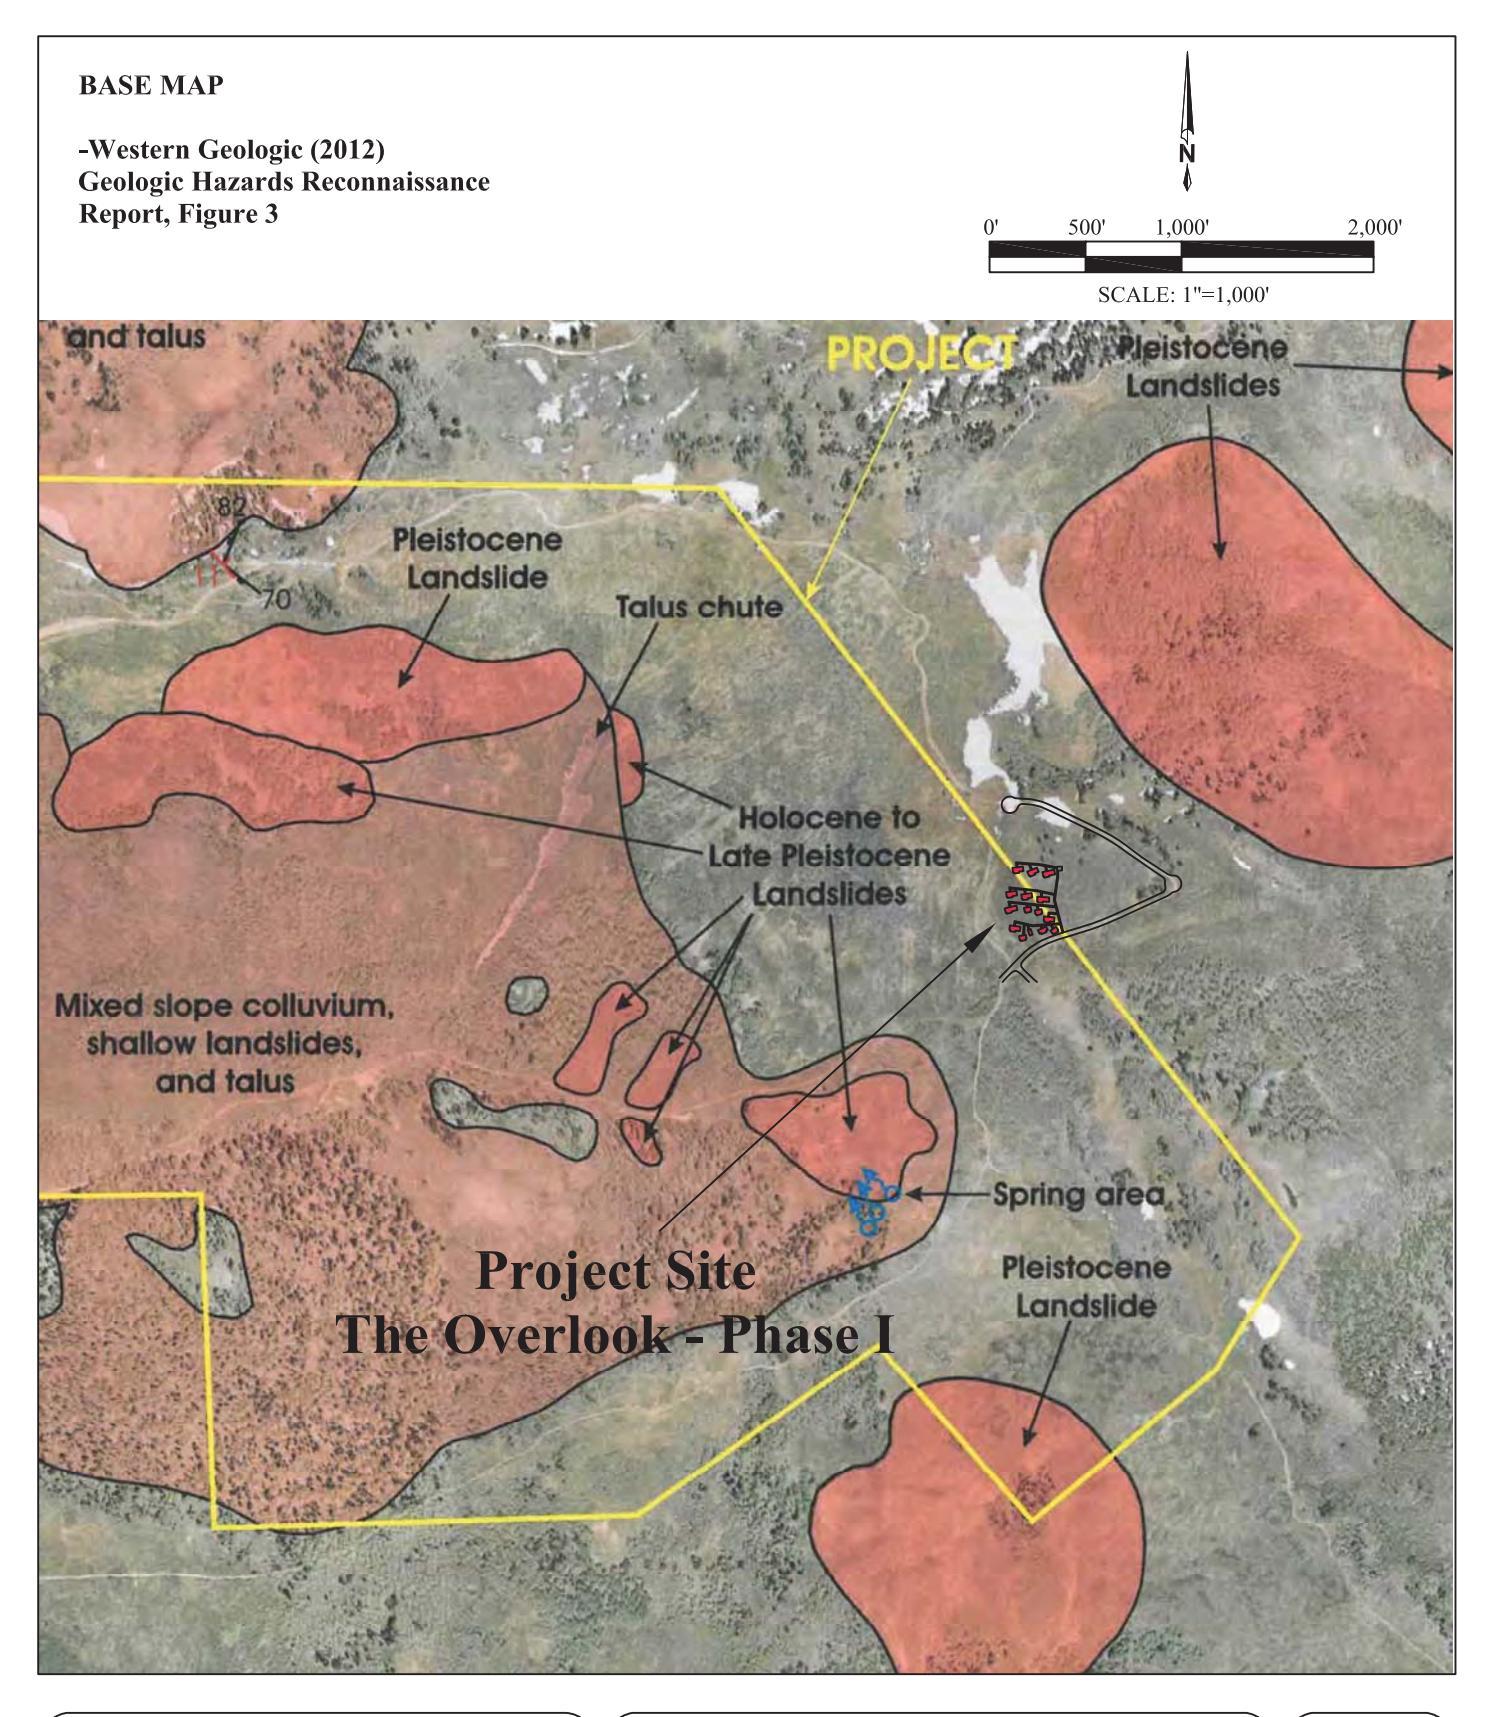
A-9

Two regional-scale landslide hazard maps have been produced that cover the project area. Colton (1991) does not show the property to be underlain by or adjacent to landslide deposits, though landslides are mapped near the northeastern and southeastern margins of the property. Consistent with Colton (1991), Elliott and Harty (2010) shows deposits mapped as "Landslide undifferentiated from talus and/or colluvial deposits" near the northeastern and southeastern margins of the property. Most recently and more site-specific, Western Geologic (2012) used the Elliott and Harty (2010) map as a base map, which shows Pleistocene landslide deposits northeast of the property, though the landslide deposits shown to the southeast of the property on Colton (1991) and Elliott and Harty (2010) are not present (see Figure A-9).
