July 3, 2018

IGES Project No. 01628-028

**RE: Preliminary Findings – Geotechnical and Geologic Hazards Investigation (Rev.1)
Bobcat Ridge Subdivision
Summit Powder Mountain Resort
Weber County, Utah**

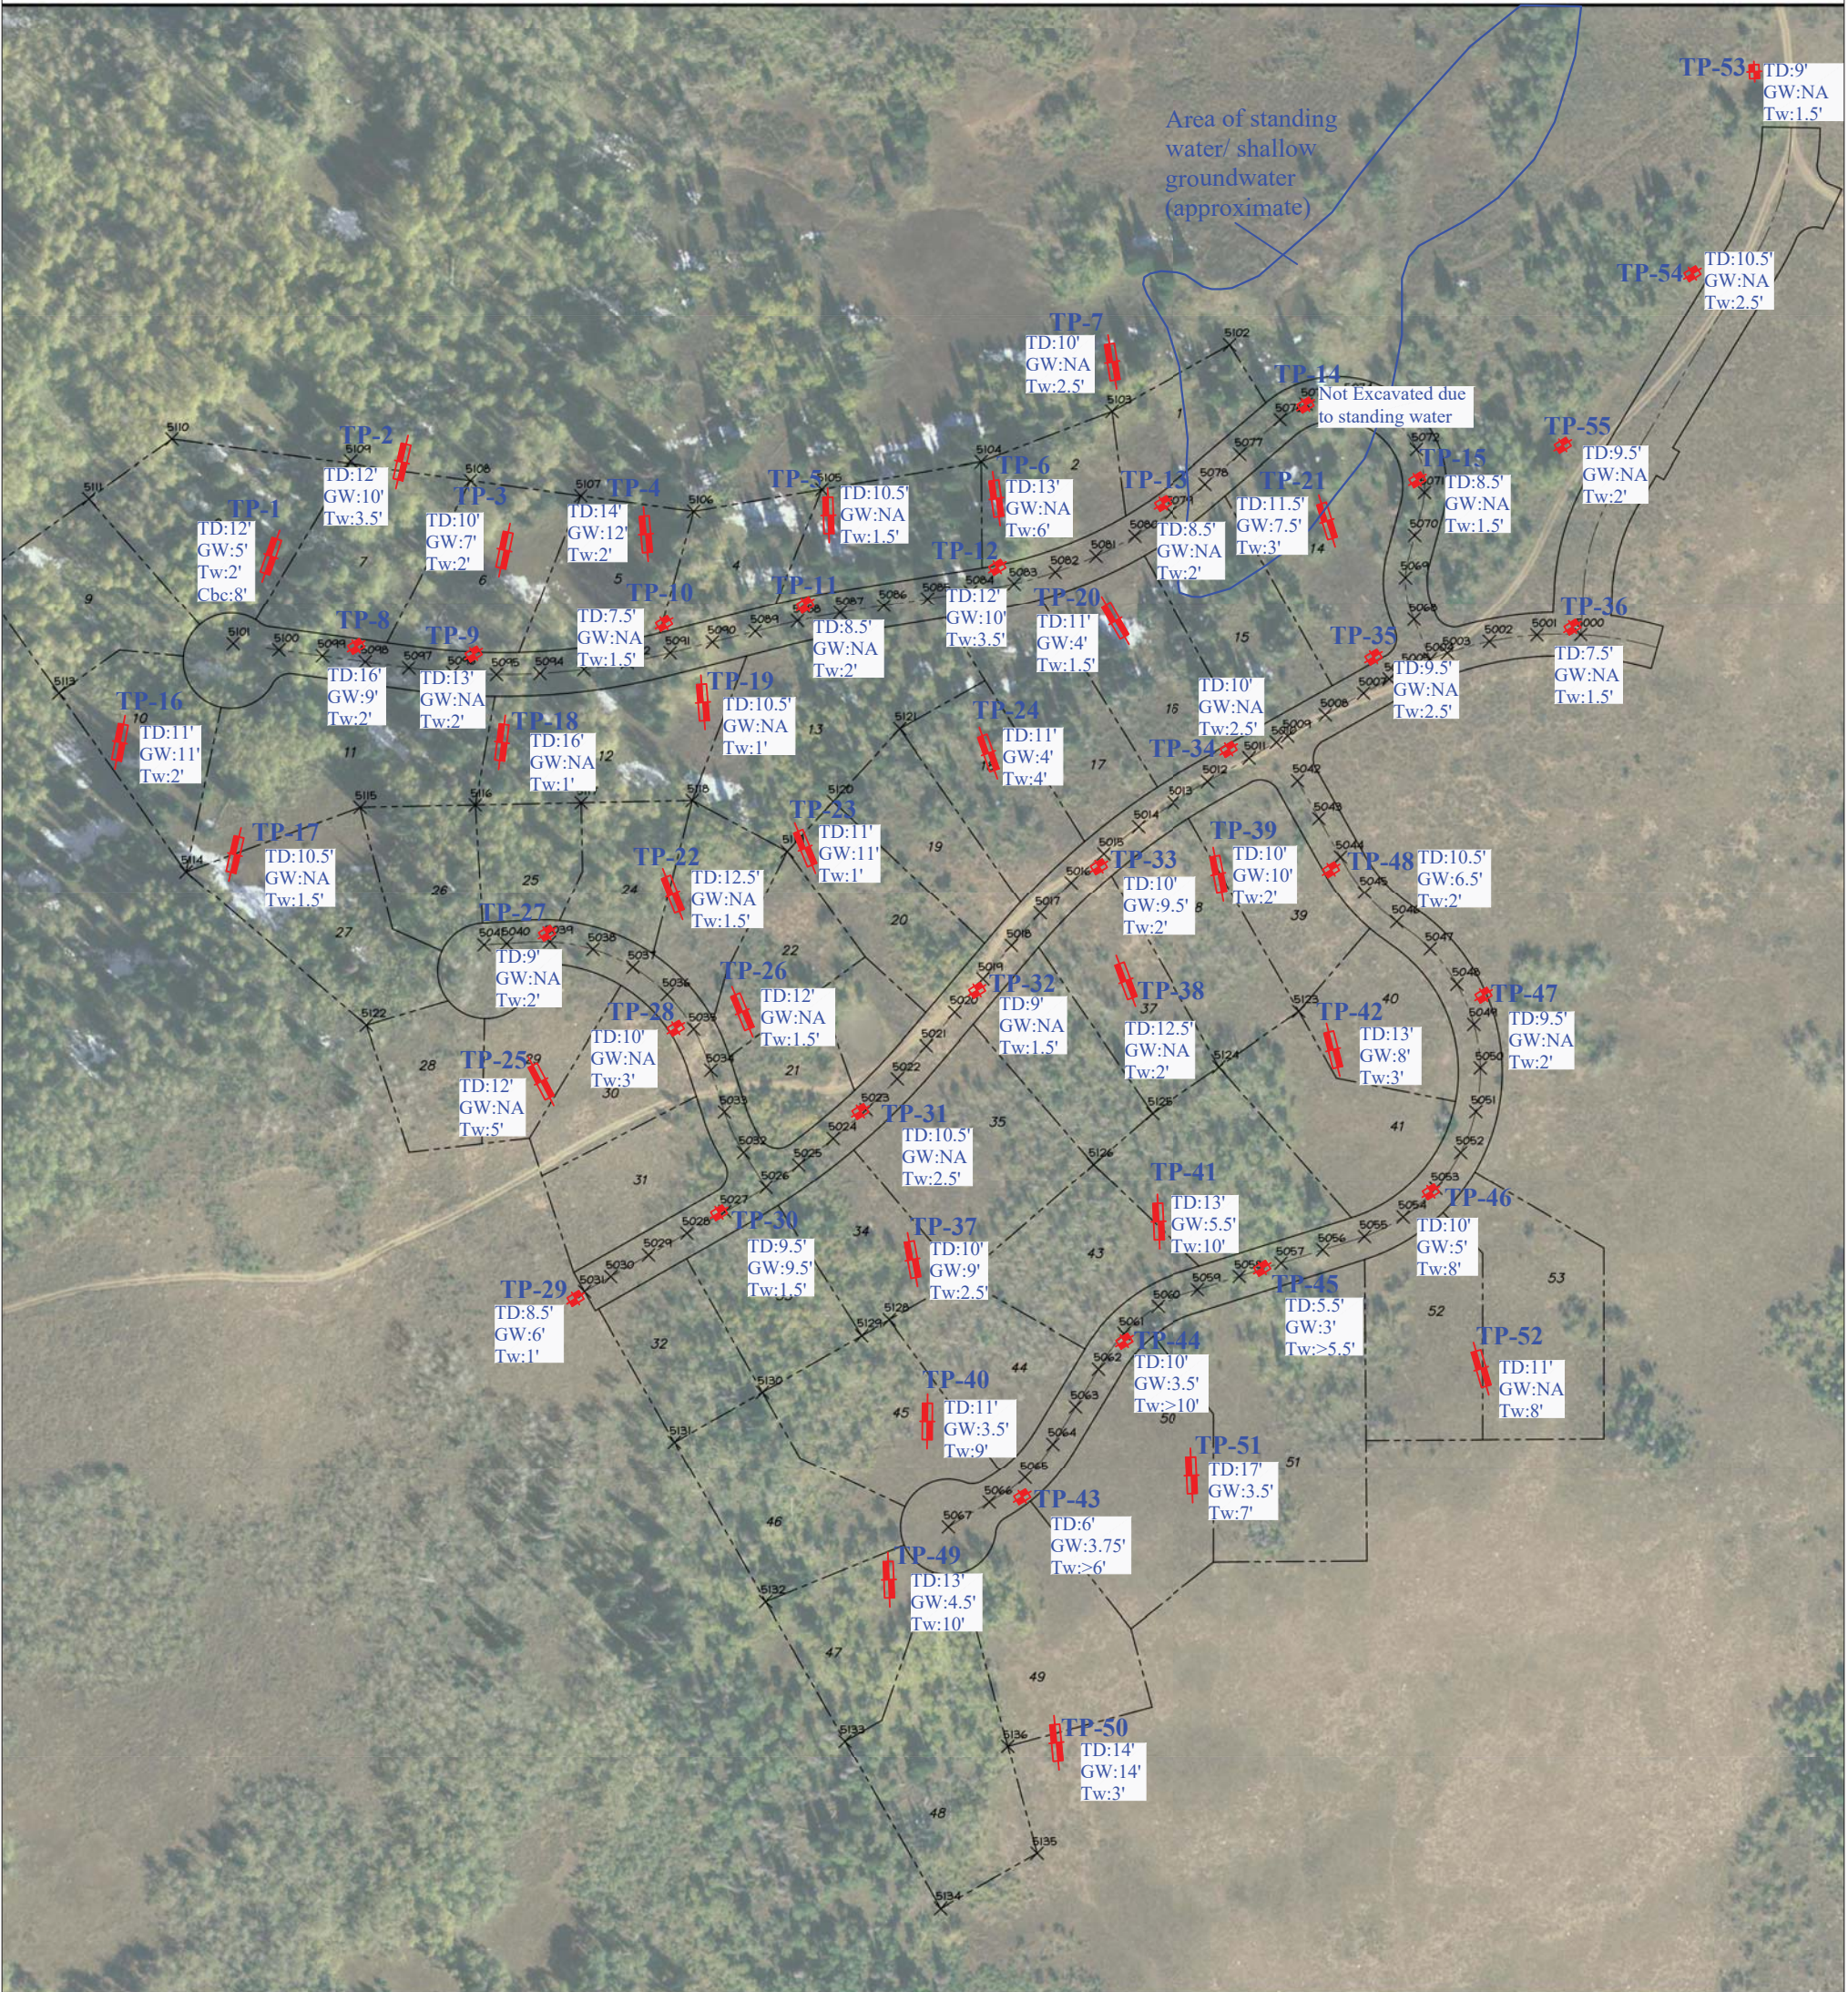
Test Pit Location and Groundwater Map

- Shallow groundwater conditions are prevalent across the property, most notably on the northern half and especially in the northeastern portion of the property, which includes an area of standing water characterized by abundant hydrophilic plants through which a road is shown on current plans (this area is approximately delineated on Figure 1). We understand that this road will be moved outside of this area, and the area is to be further assessed and delineated by a ‘wetlands’ expert. Groundwater seepage was observed in 27 of the 55 test pits excavated, with seepage typically emanating from the sandy Wasatch Formation at

depths as shallow as 3 feet below existing grade. Continuous, persistent seepage in some test pits caused the pits to be filled with as much as 3 feet of water during the test pit logging. Further delineation of the wet, swampy area and avoidance of all proposed development within this area is recommended. Additionally, because the shallow groundwater conditions extant in other parts of the property are likely to be perennial, *it is anticipated that some of the lots are better suited for on-grade structures (no basements).*
