SURFACE GEOLOGIC HAZARD STUDY

PROPOSED PAS DE CALAIS SUBDIVISION

WEBER COUNTY, UTAH

Re: Report
Surface Fault Rupture Hazard Study
Pas De Calais Subdivision
Between Melanie Lane and 2900 East
Ogden, Utah

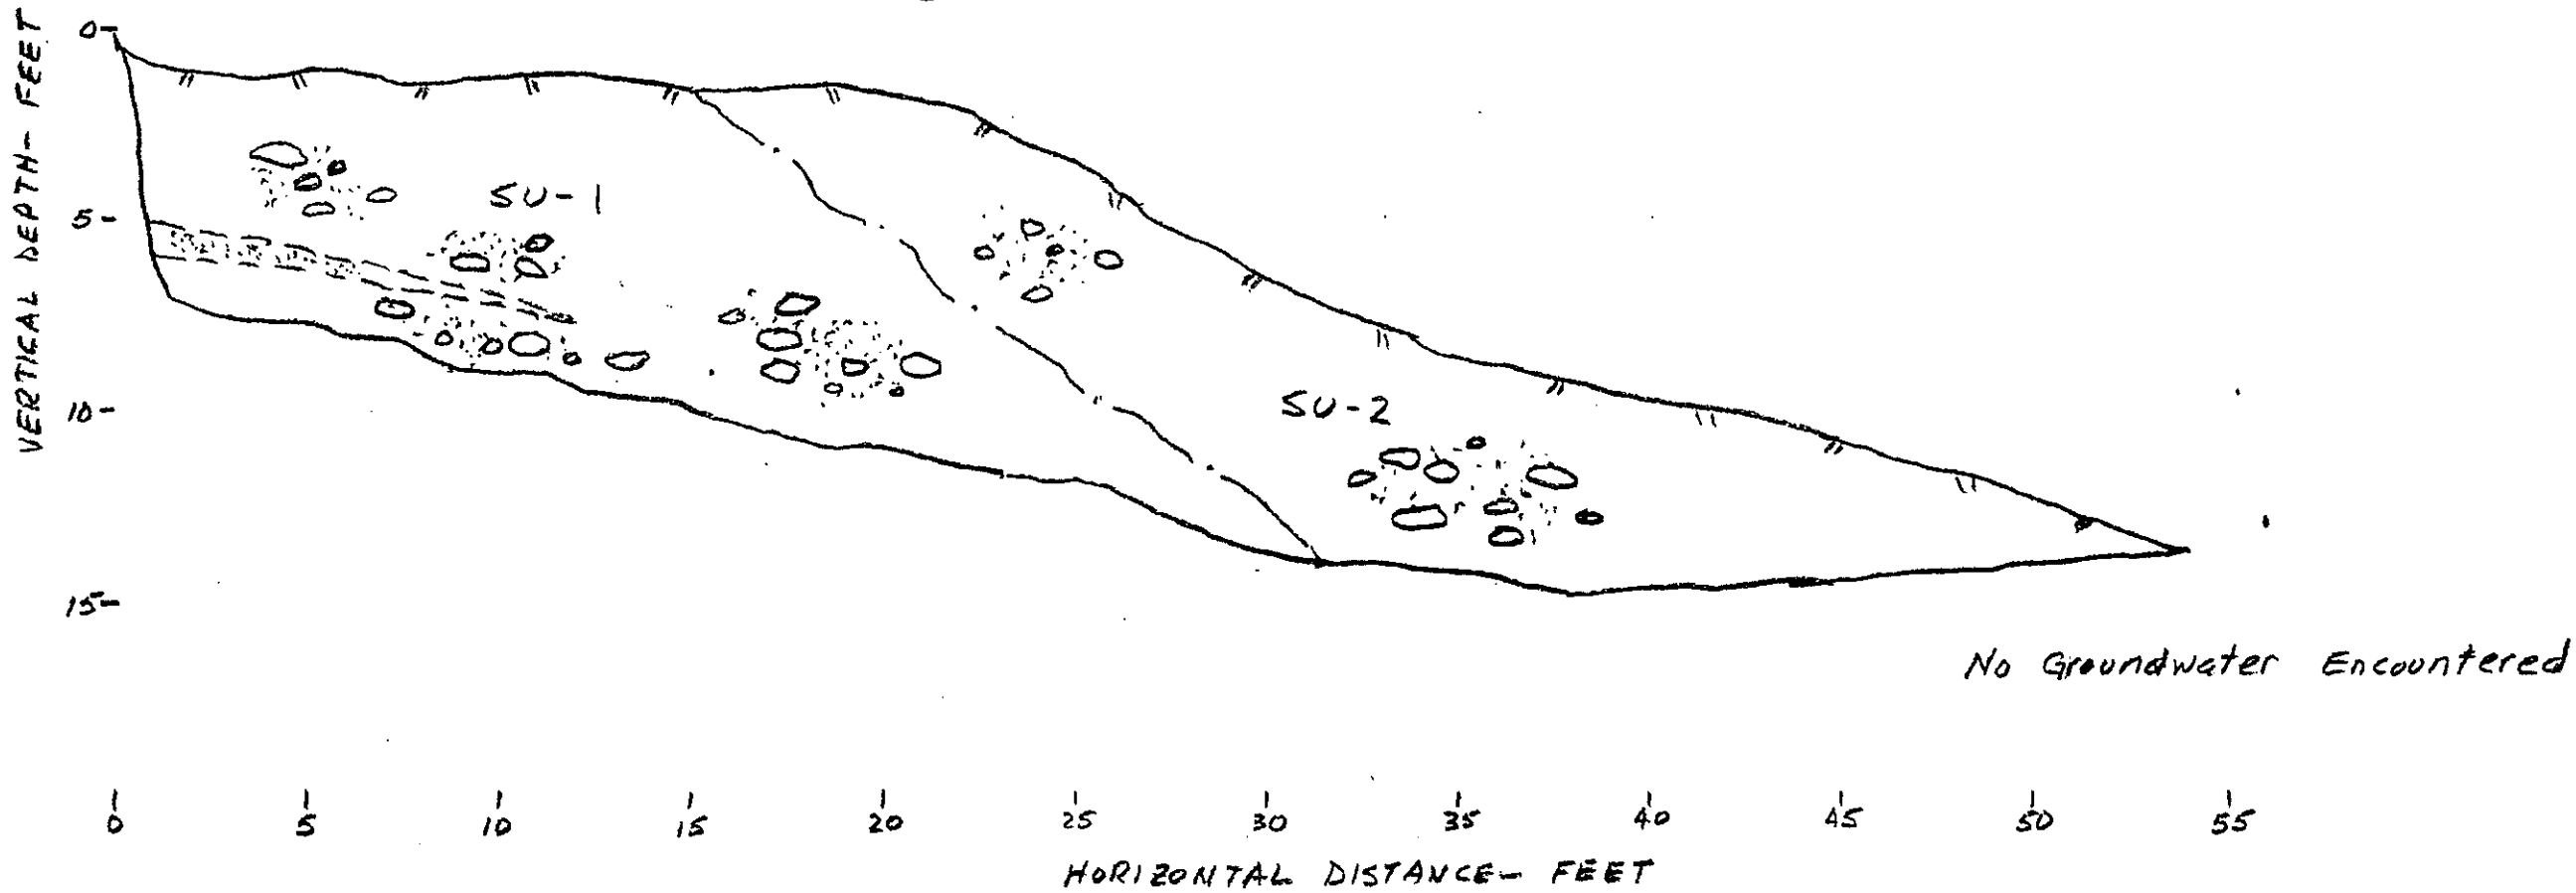
EXPLORATION TRENCH T-2A
SOUTH EAST WALL LOG

Some difficulty with the excavator resulted in the excavation of a short trench northeast of T-2. This short trench has been designated Trench 2A (T-2A). The southeast wall of the trench was logged as has been done in all the trenches within this proposed subdivision. Two soil units were logged both of them being debris flows. SU-1 is a light brown massive mixture of sand and gravel with some very hard rounded cobbles. It is dry and excavates easily. SU-2 appears to be younger and to be deposited on top and to the west of SU-1. SU-2 is also a debris flow which is dark gray, massive and a mixture of fine sand, gravel and cobbles. It is generally dry but becomes slightly damp at depth. The gravel is all rounded and very hard. No top soil was present at the top of the trench. No groundwater was encountered during the excavation of this trench. The log of this trench is shown on Figure 6.

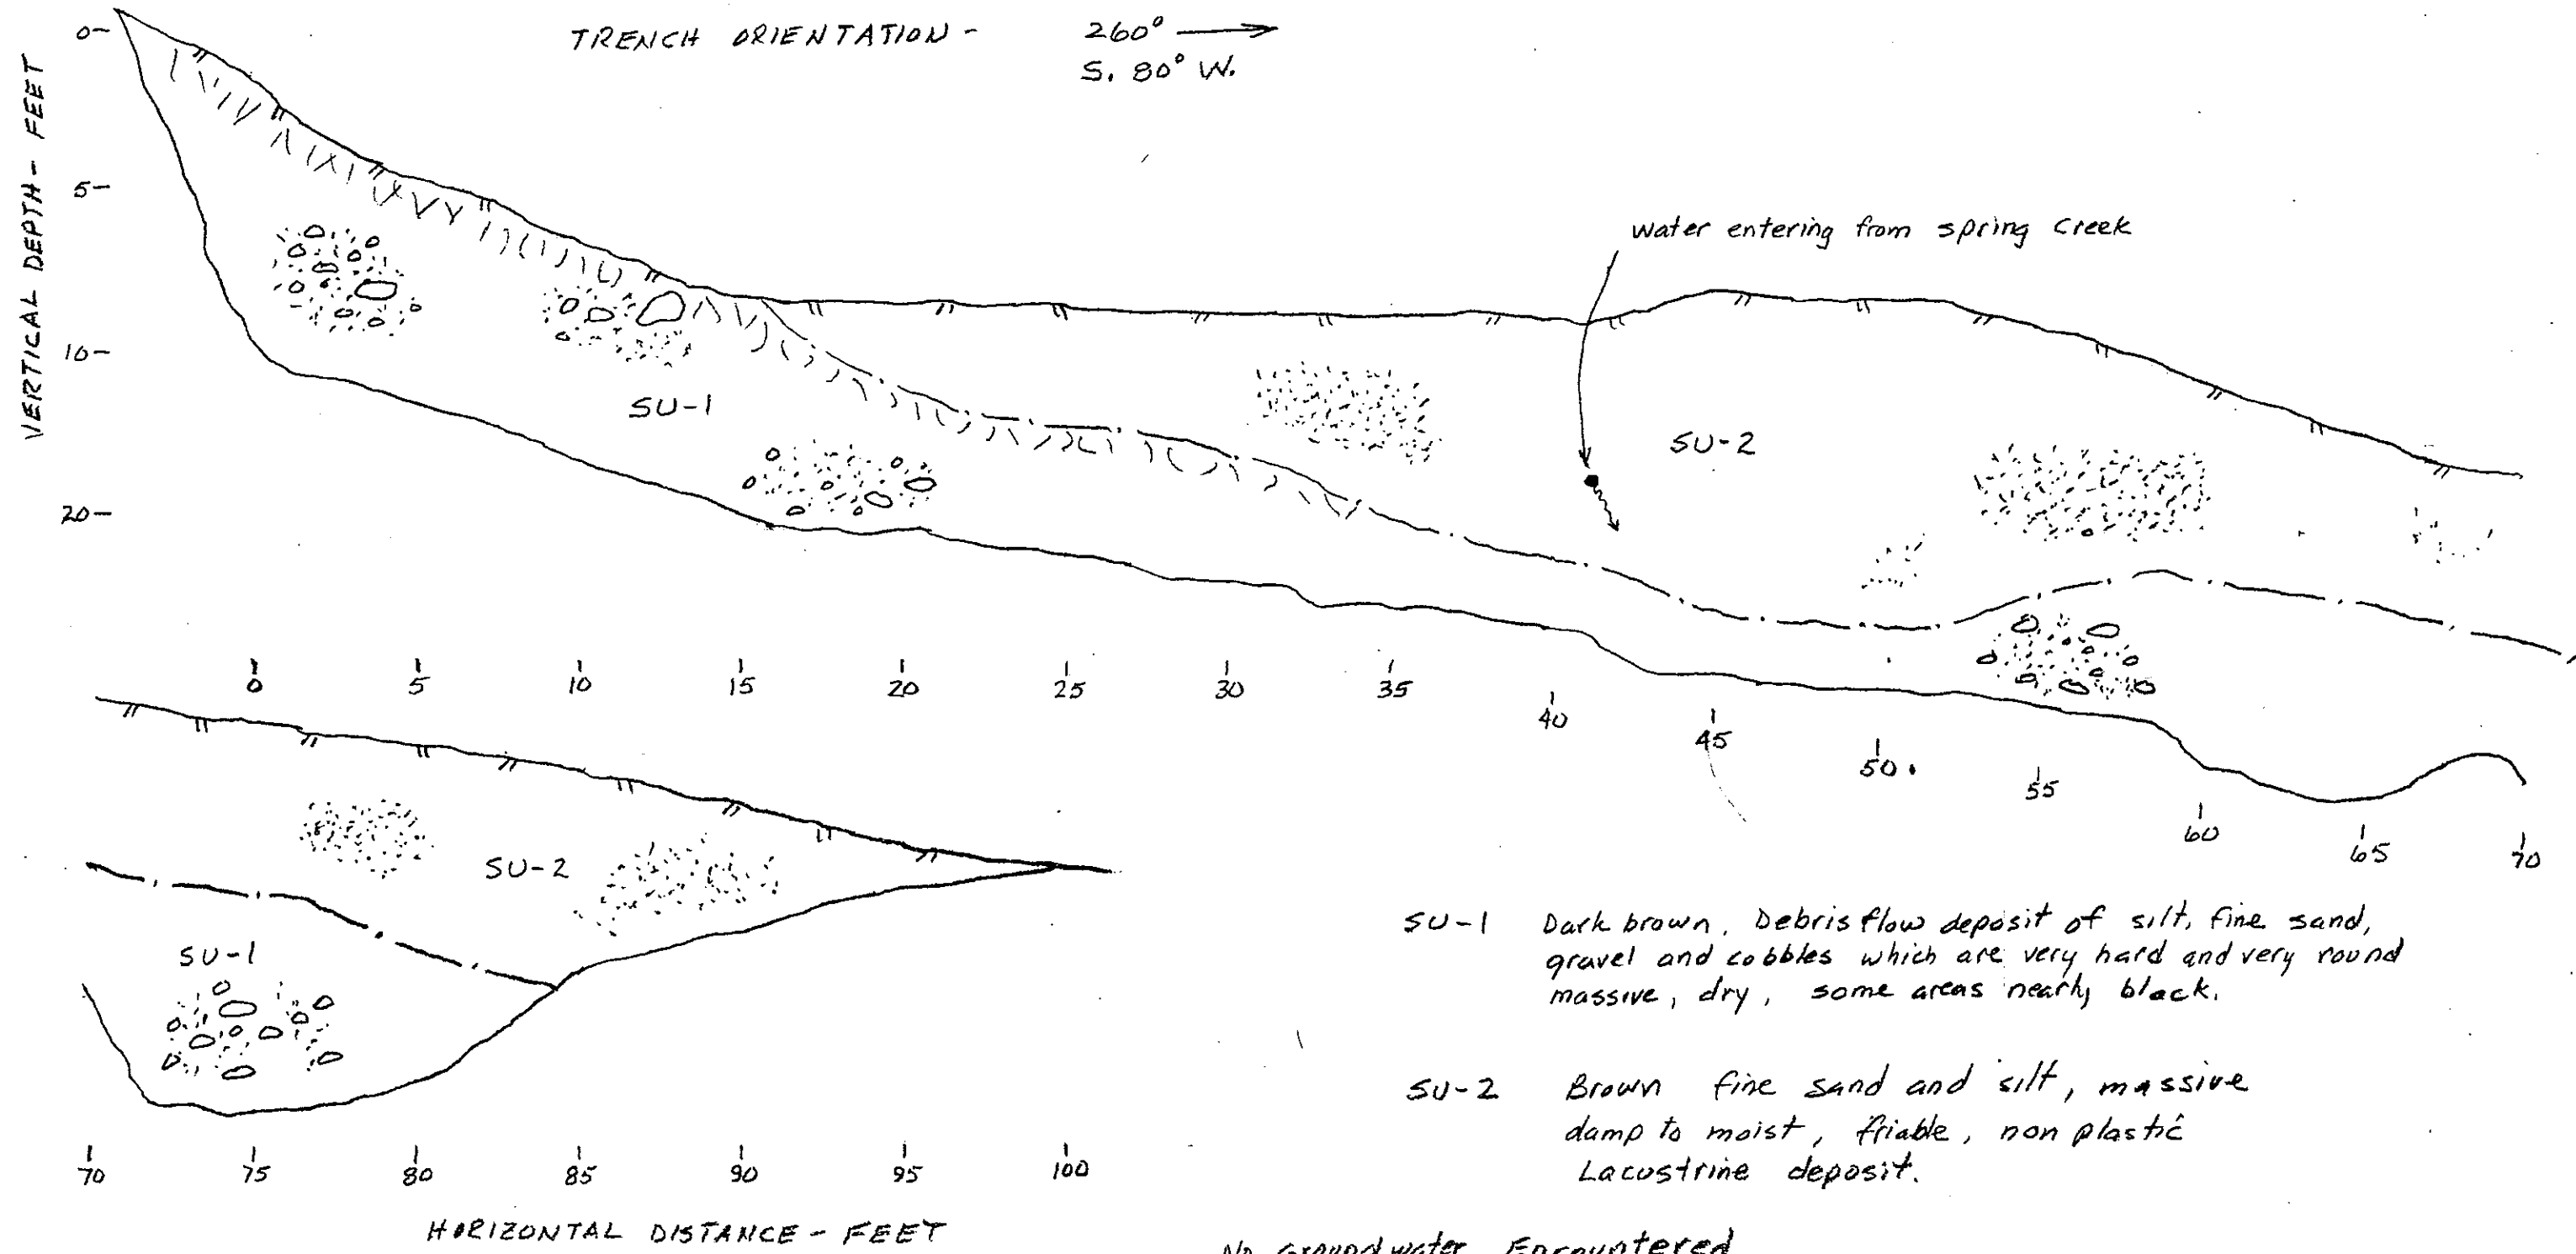
FIGURE 7

Trench 3 was excavated near the southeast corner of Lot 2 as shown on Figure 3. Trench 3 was approximately 100 feet long and the east end of it was in a debris flow soil unit SU-1 on the log which is shown on Figure 7. The debris flow was dark brown to nearly black and a mixture of silt, fine sand, gravel and cobbles. The gravel and cobbles were very hard and round. The soil unit was massive and dry. Above the debris flow deposit was a lacustrine deposit of brown fine sand and silt which was massive and damp to moist. The fine sand was friable and non-plastic. No groundwater was encountered however, surface water from the diversion of Spring Creek was seeping into the trench at about Station 0+42. This flow of water was accumulated in the bottom of the trench at about Station 0+65. After two days this seepage water stopped flowing and logging of the trench was possible. No evidence of faulting as identified in this area.

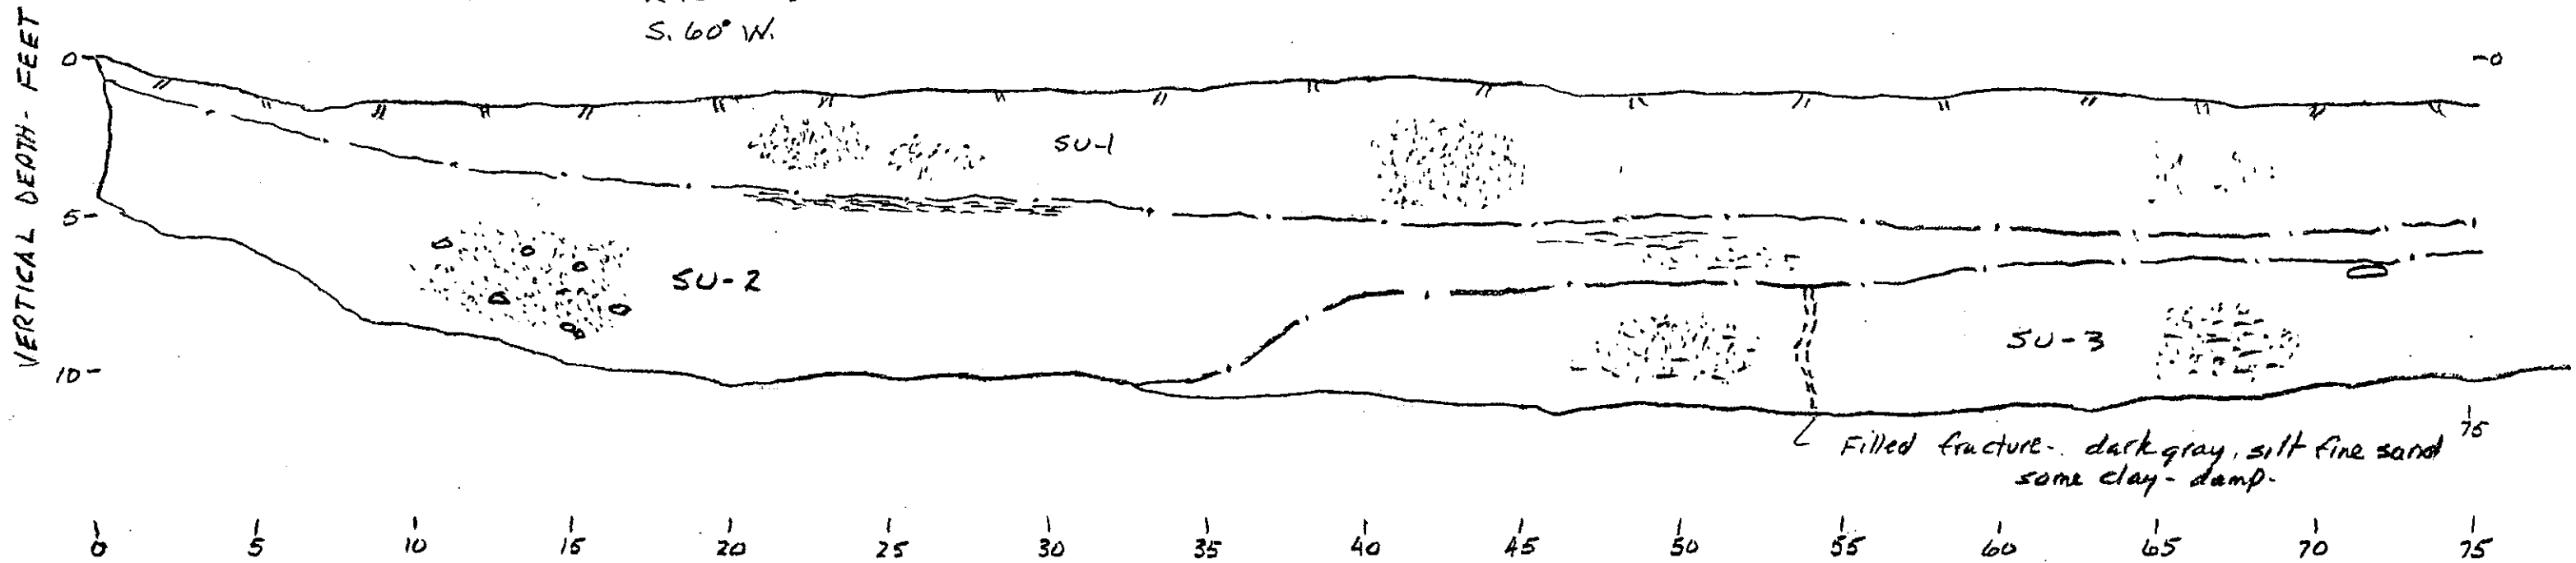
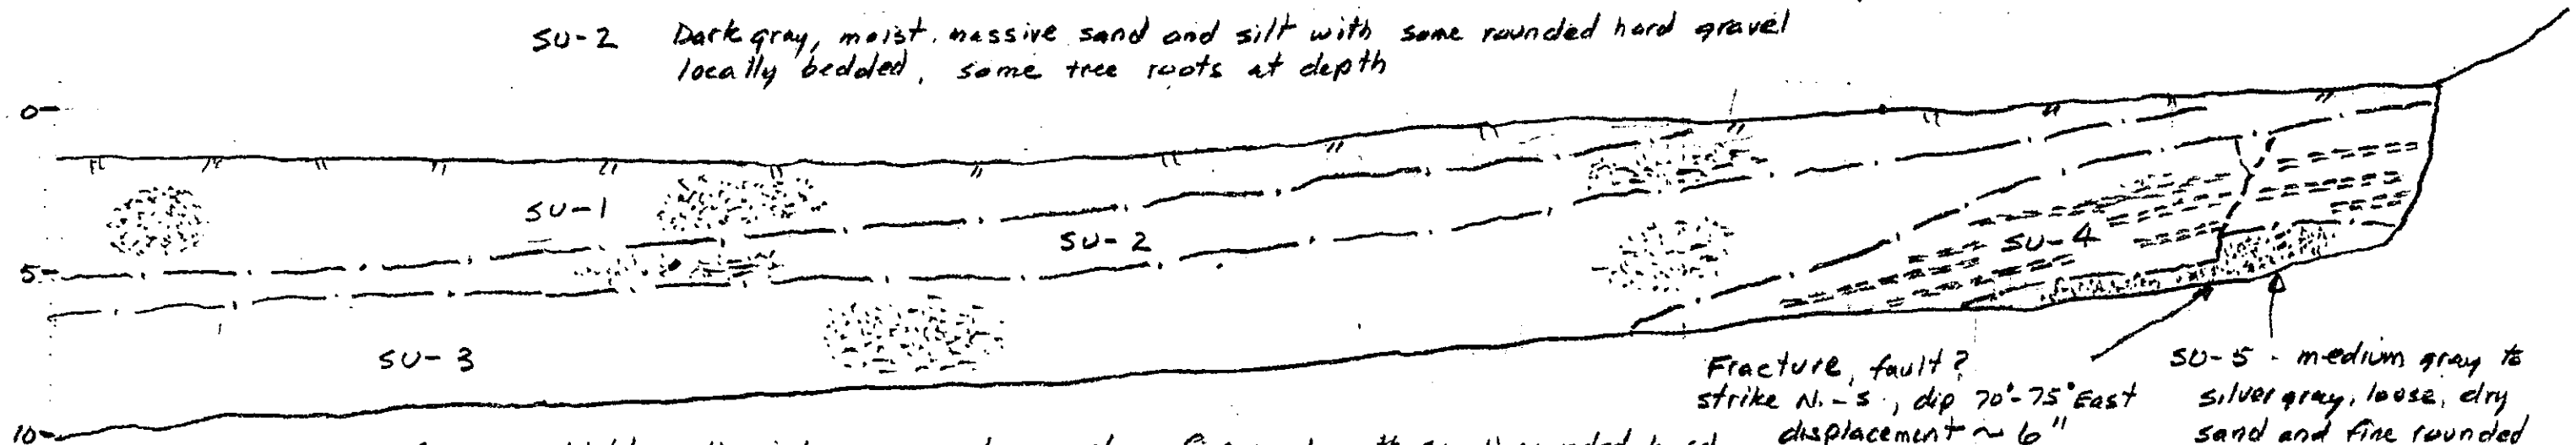
FIGURE 5

The large fracture or fault observed in Trench 2 with a possible maximum displacement of 6 inches is concluded to be an inactive minor fault or a minor lateral spread feature which resulted in the tilting of the thin clay beds to the east during a large soil block movement related to a pre-Holocene earthquake more than 10,000 years ago.

SU-4 Light gray, orange brown beds of clay, fine sand, silt, dense, dry, can be broken apart with hand pressure, beds 1-2" thick, Apparent dip 5° to 25° northward

Fracture, fault?
strike N.-S., dip 70°-75° East
displacement ~ 6"
