January 15, 2021

**Subject:** Ogden 3 West Weber Property Preliminary Wetlands Assessment

Property Parcel #15:078:0002

Approximately 40.8-acre Project Area, West Weber, Weber County, Utah

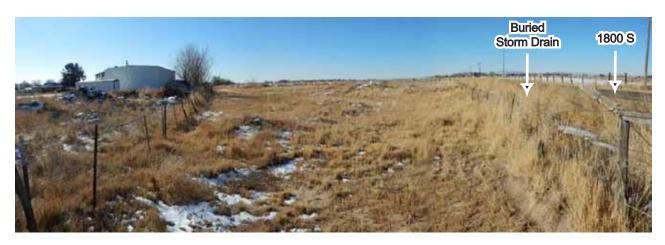
Photo 1. Southwest view of upland area taken from northeast corner of Project Area. A buried storm drain conveys water in an east/west direction along the north Project Area boundary paralleling 1800 South.

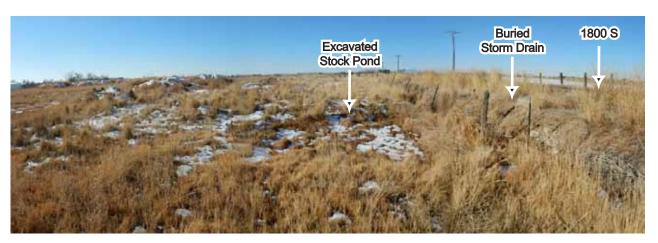
The **Stock Pond** (approximately 0.01 acre) is a remnant, man-made, excavated stock pond that was once used for livestock management. The bottom of the Stock Pond is about 2-3 feet lower in elevation than the native ground elevation. It appears that the excavation of the Stock Pond has intercepted the water table and wetland plants have established on the pond bottom. Frozen water was observed on the bottom of the stock pond during the time of the site inspection.

The remnant man-made stock pond (Stock Pond) would not likely be classified as a jurisdictional water because it appears to have been excavated in uplands, the wetland plants were artificially established by excavation that intercepted the water table, and the excavated stock pond has no tributary connections to Walker Slough, the Weber River or any other tributary to the Great Salt Lake.

Photo 2. West view of remnants of an excavated stock pond located near the northeast corner of the Project Area. Wetland plants have established on the bottom of the excavated pond. Water was observed in stock pond during December 29, 2020 site inspection. Buried storm drain also pictured.

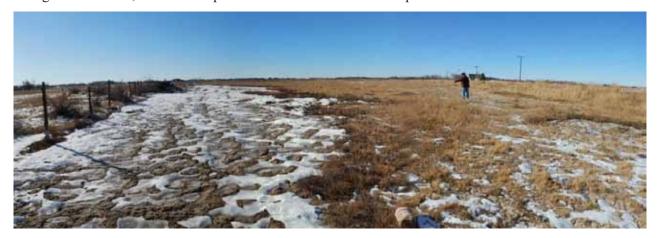
**Problem Area 1** (approximately 5.43 acres) is situated on the low lake terrace of the Project Area. It consists of mixed saline wet meadow plant community that is dominated by: saltgrass (*Distichlis spicata*). Saltgrass is a facultative and salt-tolerant plant species that can commonly occur in either wetlands or uplands. Other plants include a mix of wetland and upland species, including: seaside barley (*Hordeum marinum*), Baltic rush (*Juncus balticus*), Mexican rush (*Juncus mexicanus*), oakleaf goosefoot (*Chenopodium glaucum*), intermediate wheatgrass (*Thinopyrum intermedium*), western wheatgrass (*Pascopyrum smithii*), as well as various upland grasses and forbs. Because this problem area is situated on the lowest elevation terrace at this site, it is unknown whether the presence of the saline wet meadow plant species is due to dry saline soil conditions or due to the presence of a naturally high water table that causes prolonged soil saturation that could be indicative of a saline wet meadow wetland. Further investigation during the growing season would be needed to verify whether the problem area meets all of the USACE's Arid West wetland delineation criteria for soils, hydrology, and wetland vegetation.

Photo 3. Southwest view of the northern extent of Problem Area 1. Problem Area 1 contains saline wet meadow plant species that are found in both seasonal wetlands and uplands with saline soils.

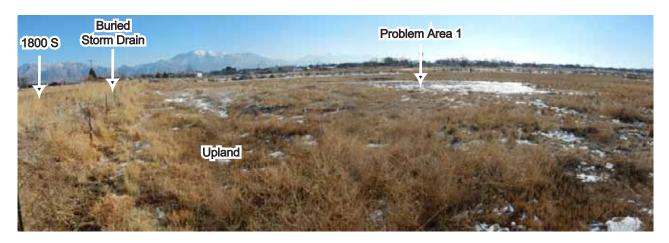
Photo 4a. Southeast view of upland area and Problem Area 1 taken from north Project Area boundary. No road culverts were observed along the entier length of the 1800 South property boundary.

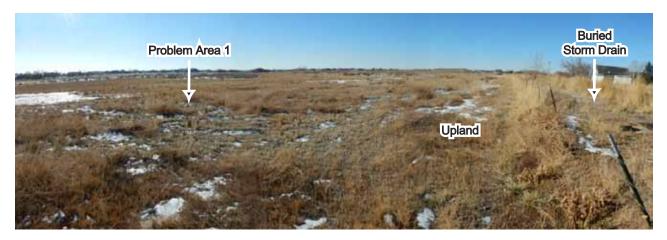
Photo 4b. Southwest view of upland area and Problem Area 1 taken from north Project Area boundary.

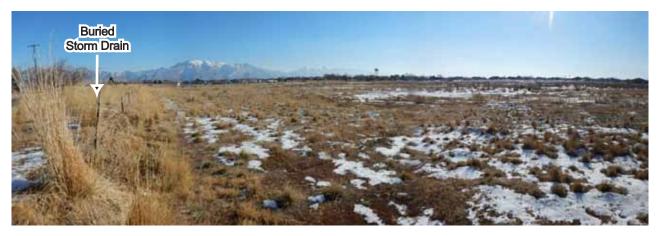
Photo 5a. Southeast view of upland area taken from northern boundary of the Project Area.

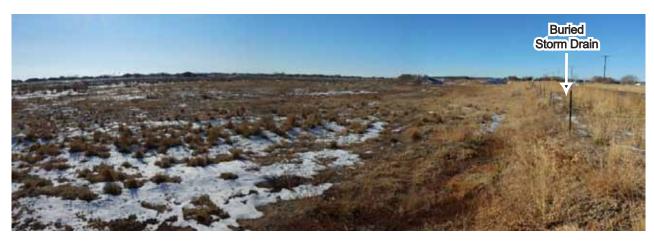
Photo 5b. Southwest view of upland area taken from northern boundary of the Project Area.

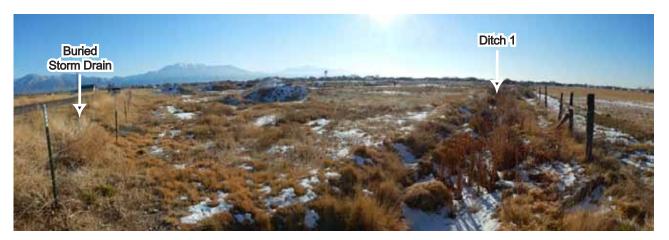
Photo 6. Southeast view of Ditch 1 where it enters the Project Area in the northwest corner of the property. It appears that Ditch 1 receives water from the buried storm drain.

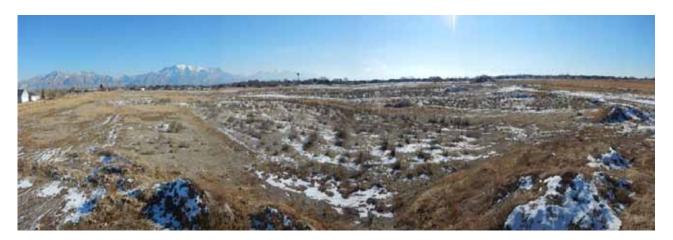
Photo 7. Southeast view of upland area recently filled and graded.

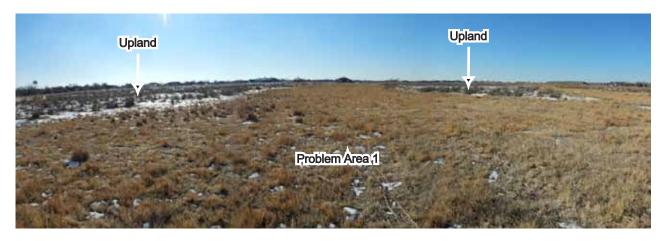
Photo 8a. South view of Problem Area 1 located in the central portion of the Project Area. Problem Area 1 is on a low terrace that is distinctly lower in elevation than the bordering uplands on the middle and high terraces.

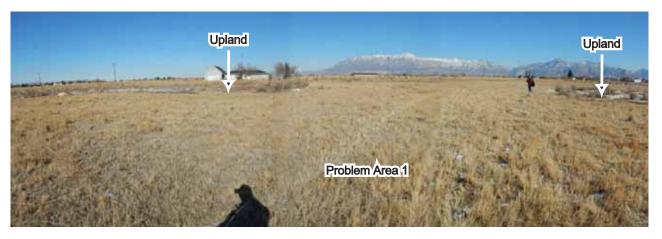
Photo 8b. North view of Problem Area 1 located in the central portion of the Project Area. Problem Area 1 contains a saline wet meadow plant community that is dominated by saltgrass.

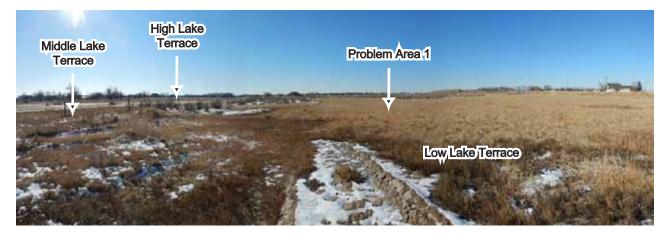
Photo 9. South view of Problem Area 1 located in the central portion of the Project Area. Problem Area 1 is situated on a low lake terrace. Uplands are on the distinctly higher middle and high lake terraces.

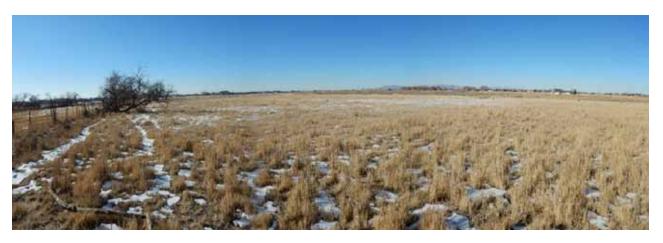
Photo 10a. Southwest view of upland area taken from western boundary of the Project Area. This upland area is located on the middle lake terrace.

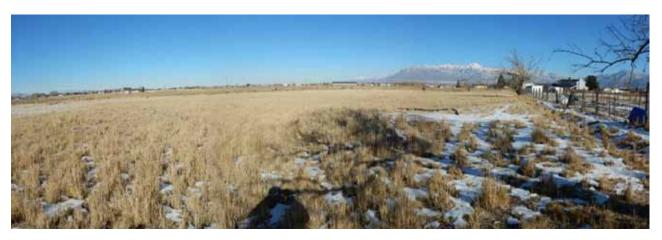
Photo 10b. North view of upland area taken from western boundary of the Project Area. This upland area is located the middle lake terrace.

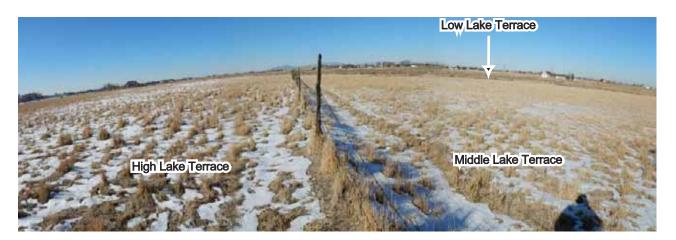
Photo 11. West view of upland area taken from the western boundary of the Project Area. The Project Area has three levels of lake terraces.

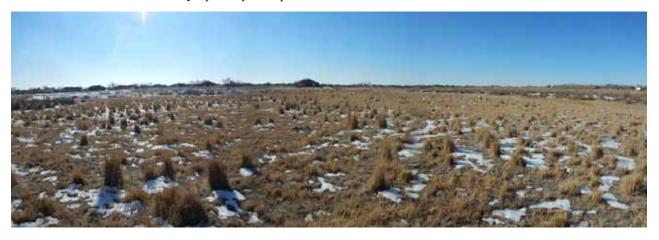
Photo 13a. Southwest view of Problem Area 1 located in the central portion of the Project Area. Problem Area 1 contains a saline wet meadow plant community dominated by saltgrass, but also containing a mix of both upland and wetland plants commonly found on saline soils.

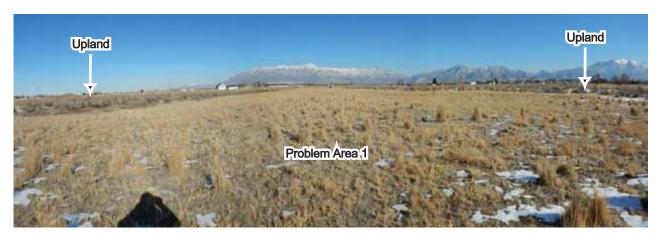
Photo 13b. Northeast view of Problem Area 1 located in the central portion of the Project Area. Problem Area 1 is distincly lower in elevation than the surrounding upland areas.

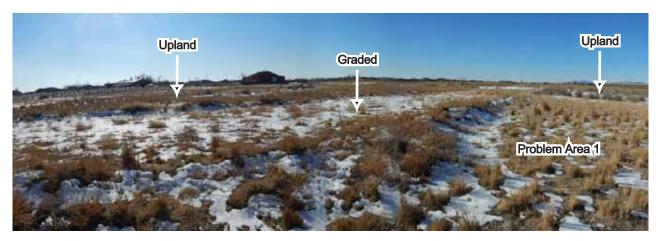
Photo 14a. Southwest view of upland, graded area, and Problem Area 1 located in the central portion of the Project Area. Problem Area 1 is on distinctly lower ground.

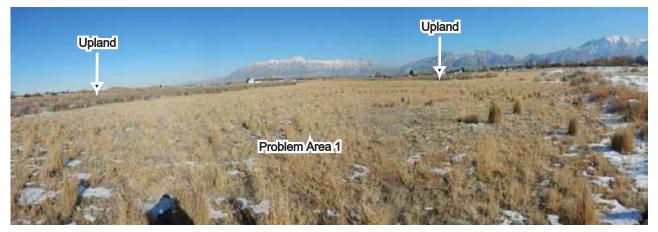
Photo 14b. Northeast view of Problem Area 1 located in the central portion of the Project Area. Problem Area 1 contains saline wet meadow plant community.

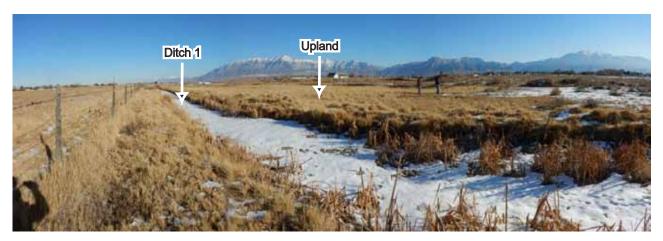
Photo 15a. Northeast view of Ditch 1 and upland area taken from the west Project Area boundary. Wetland plants were observed in Ditch 1 during the December 29, 2020 site inspection.

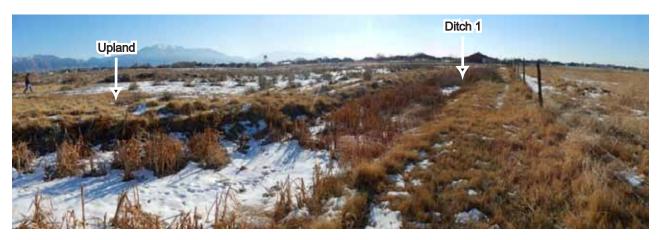
Photo 15b. Southeast view of Ditch 1 and upland area taken from the west Project Area boundary. Ditch 1 contains wetland plant species including broadleaf cattail, Baltic rush, and rabbits-foot grass.

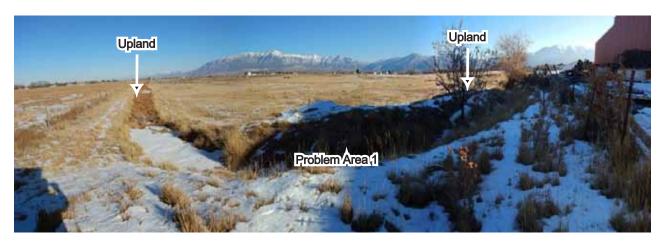
Photo 17. Northeast view of excavated, man-made irrigation Ditch 1 in the southwest corner of the Project Area. It appears Ditch 1 flows in a north/south direction along the west Project Area boundary before turning eastward along the south Project Area boundary. The ditch has been excavated several feet lower than the native ground elevation.

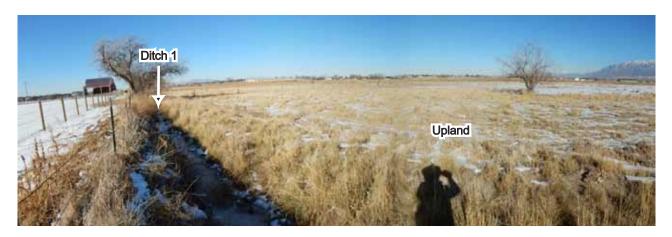
Photo 19a. Northwest view of upland area and Ditch 1 taken from south Project Area boundary. Ditch 1 is a man-made excavated irrigation ditch.

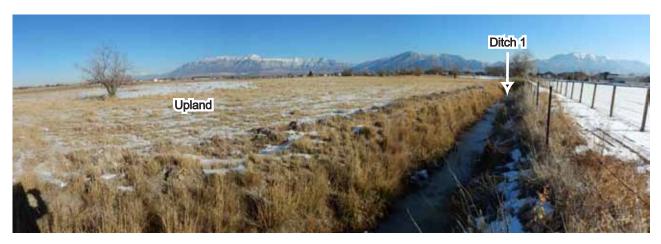
Photo 19b. Northeast view of upland area and Ditch 1 taken from south Project Area boundary. Ditch 1 had water present during the December 29, 2020 site inspection.

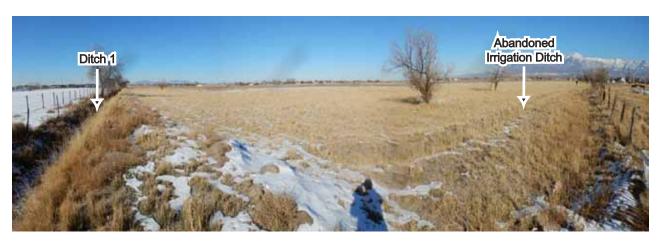
Photo 21. Northeast view of Ditch 1 and abandoned irrigation ditch taken from southeast corner of the Project Area. The abandoned irrigation ditch had no OHWM indicators present and was dominated by upland plant communities during the December 29, 2020 site inspection.
